Appendix A contains discussions of the following items: the original thermal sleeve design and installation; thermal sleeve visual and dye penetrant inspections conducted on the sleeves; laboratory examinations and analysis of removed parts; postulated cause(s) of sleeve failure; and a description of the replacement sleeve (new) design.

Replacement Thermal Sleeve Design

ATTACHMENT 1 - NON-DESTRUCTIVE EXAMINATIONS

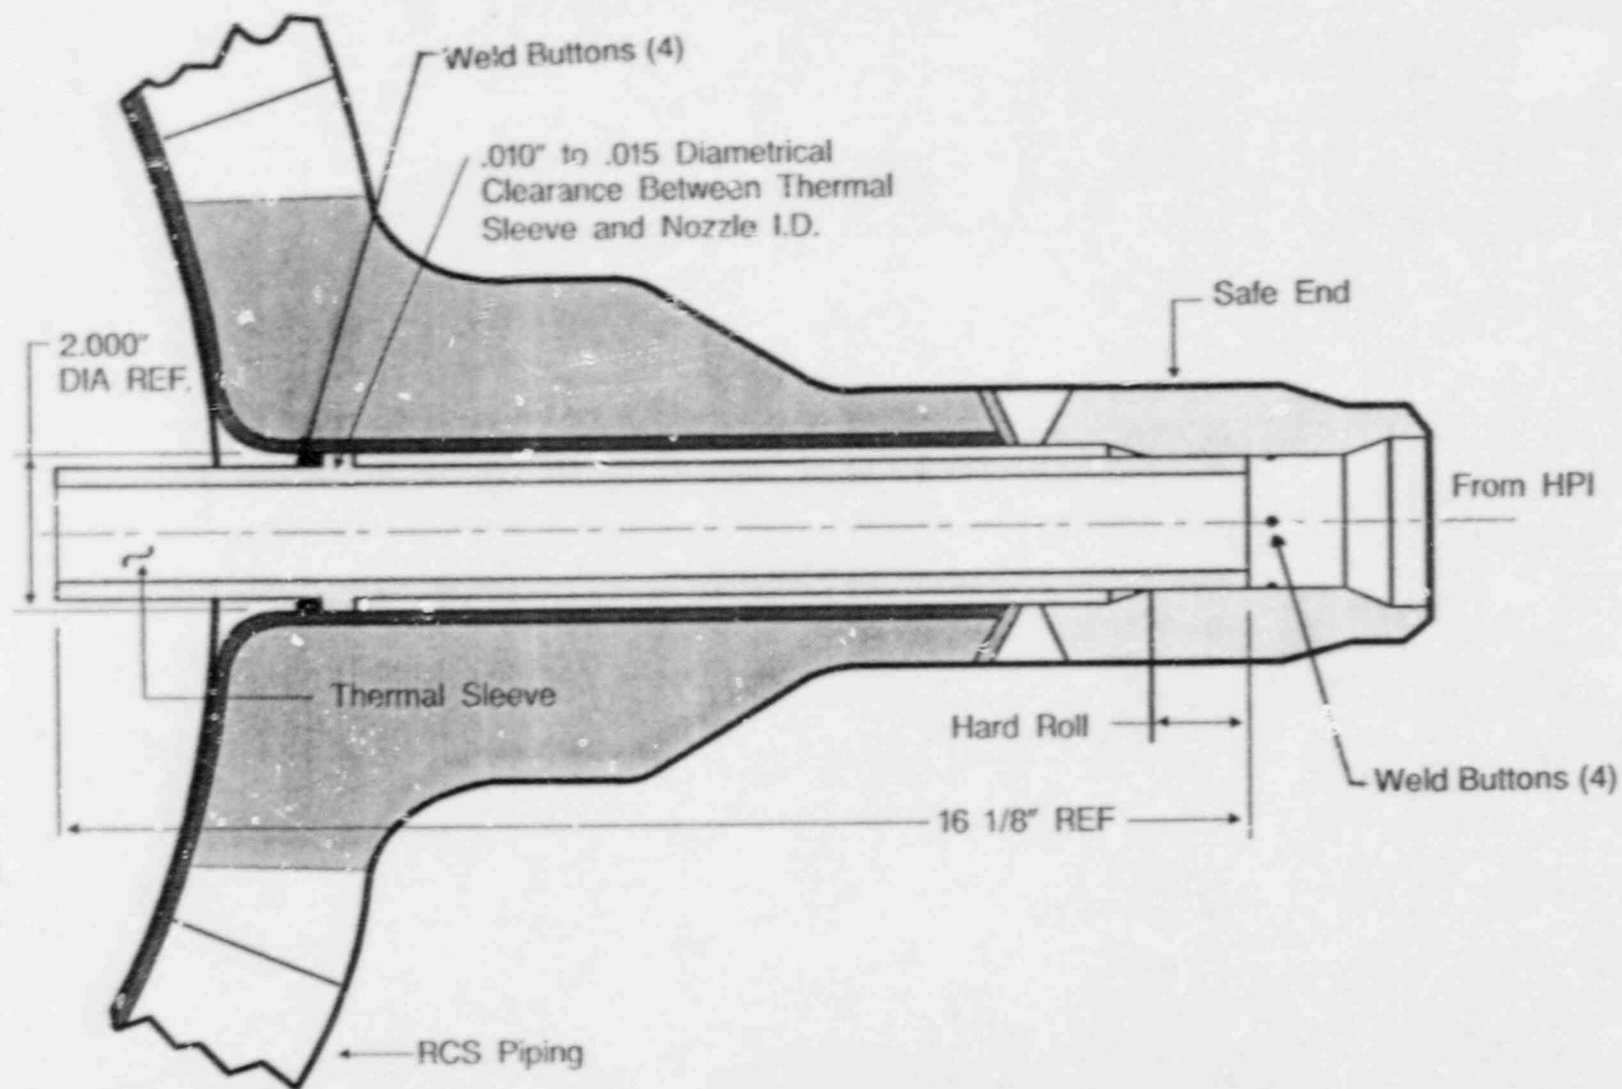
Makeup/HPI Nozzle Original Thermal Sleeve Design

Visual inspections of the failed A1 nozzle thermal sleeve showed that the outlet end of the sleeve had separated from the inlet end piece by a circumferential crack at the thermal sleeve collar fillet. The 3 1/4 inch long outlet end piece was also separated into two sections by longitudinal cracks. These cracks were oriented in a plane roughly perpendicular to the reactor coolant flow direction and were approximately 180° apart. Liquid penetrant and further visual examinations showed that the two outlet end sections contained extensive additional through-wall and part-through-wall cracking. Cracking was primarily longitudinal and was concentrated on the ID surface close to the outlet end opening. In some cases longitudinal cracks were linked by short branch cracks with a circumferential component. Longitudinal ID cracking with multiple initiation sites is generally characteristic of a thermal fatigue cracking mechanism.

Two wear areas resulting from relative motion between the thermal sleeve and the nozzle weld pads were noted at the collar end of the outlet sections. A

through-wall crack with both circumferential and longitudinal components extended from one of these wear areas a short distance into the inlet end section. This crack, an extension of the longitudinal split in the outlet end piece, and a small cluster of short linear defects (<59 mils in length) on the ID at the rolled portion of the sleeve were the only significant liquid penetrant test indications in the inlet section. In addition, the thermal sleeve collar contained impact and wear indications, providing evidence of vibration.
