U. S. NUCLEAR REGULATORY COMMISSION
REGION I

Report No. 86-05
Docket No. 50-271 License No. DPR-28
Licensee: Vermont Yankee Nuclear Power Corporation
RD 5, Box 169, Ferry Road
Brattleboro, Vermont 05301
Facility: Vermont Yankee Nuclear Power Station
Location: Vernon, Vermont
Dates: February 9-27, 1986
Inspectors: William J. Raymond, Senior Resident Inspector
Glenn W. Meyer, Project Engineer

Inspection Summary: Inspection on February 9-27, 1986 (Report No. 50-271/86-05)

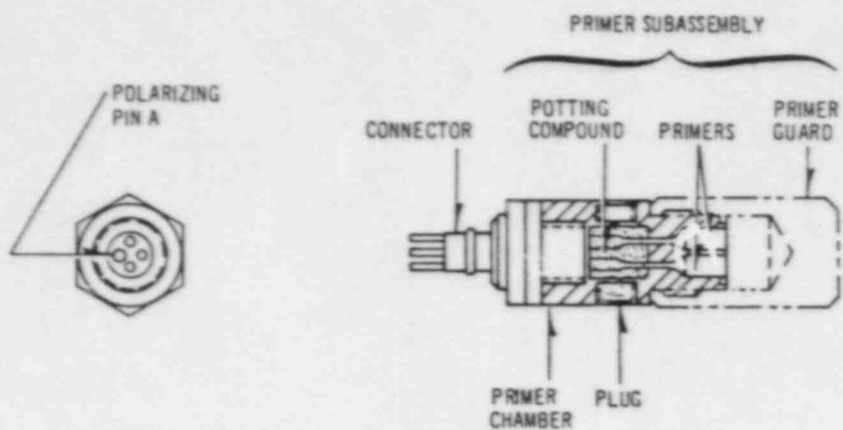
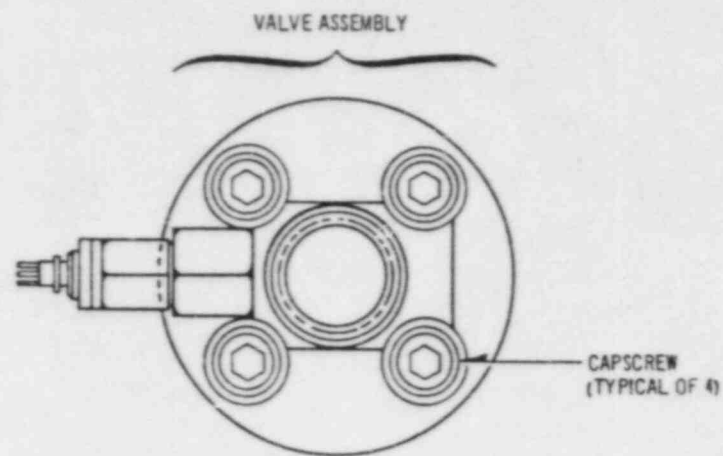
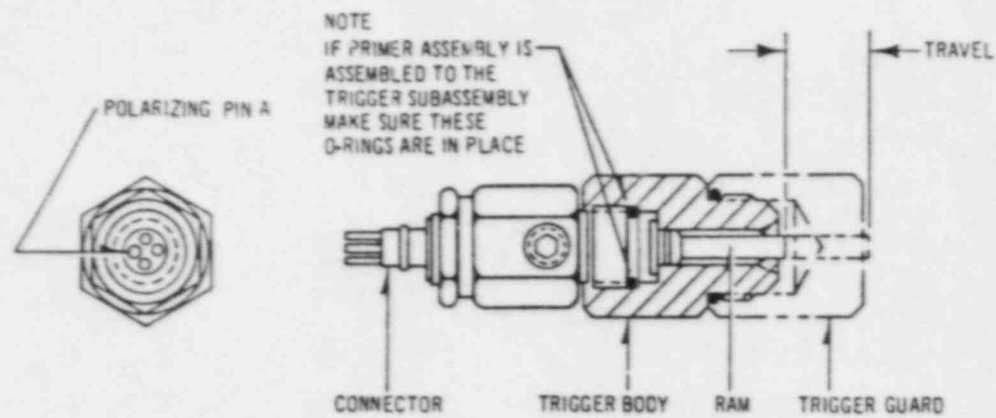
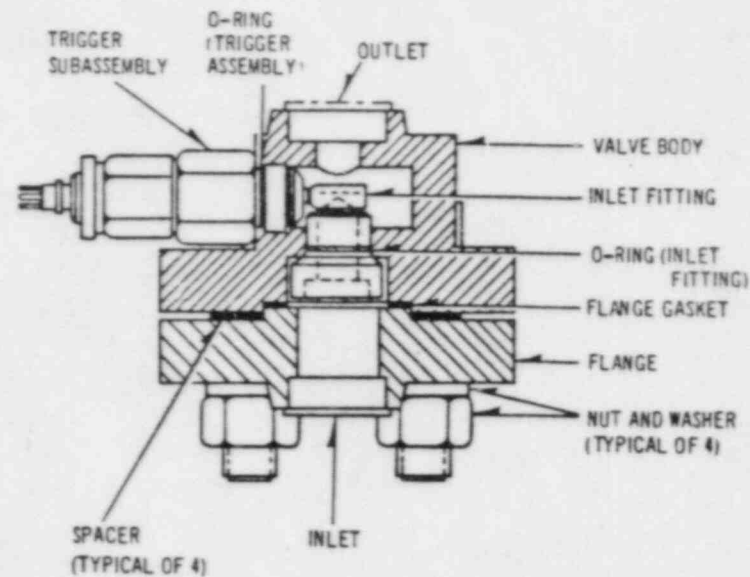
SQUIBB IGNITION & CONTINUITY

Concerning the as-found firing circuit wiring, which permitted the revised primers to fail, the inspector agreed that this probably resulted during the installation of the 1977 design change and that the as-found wiring represented an acceptable design implementation of SIL 186.

- Revise testing procedure OP 4203 to include pin to pin continuity tests and a test of new primers using the firing circuit.
- Revise terminal box wiring such that hot leads alternate around the connector and either primer type will fire.
- Revise CWD to as-built configuration.
- Revise procurement program to specify latest drawings are sent with parts.
- Review other surveillance procedures which test performance of components following use to determine whether additional testing and design changes are appropriate.
- Retest SLC system following completion of other recommendations.
