Subject: Catawba Nuclear Station, Unit 1  
Docket No. 50-413  
Special Report

SPECIAL REPORT REGARDING  
DIESEL GENERATOR 1A VALID FAILURES ON  
APRIL 19, 1988, APRIL 25, 1988 AND MAY 5, 1988  
DUE TO PRESSURE SENSOR DESIGN FLAWS

DIESEL GENERATOR 1A VALID FAILURES DUE  
TO PRESSURE SENSOR DESIGN FLAWS

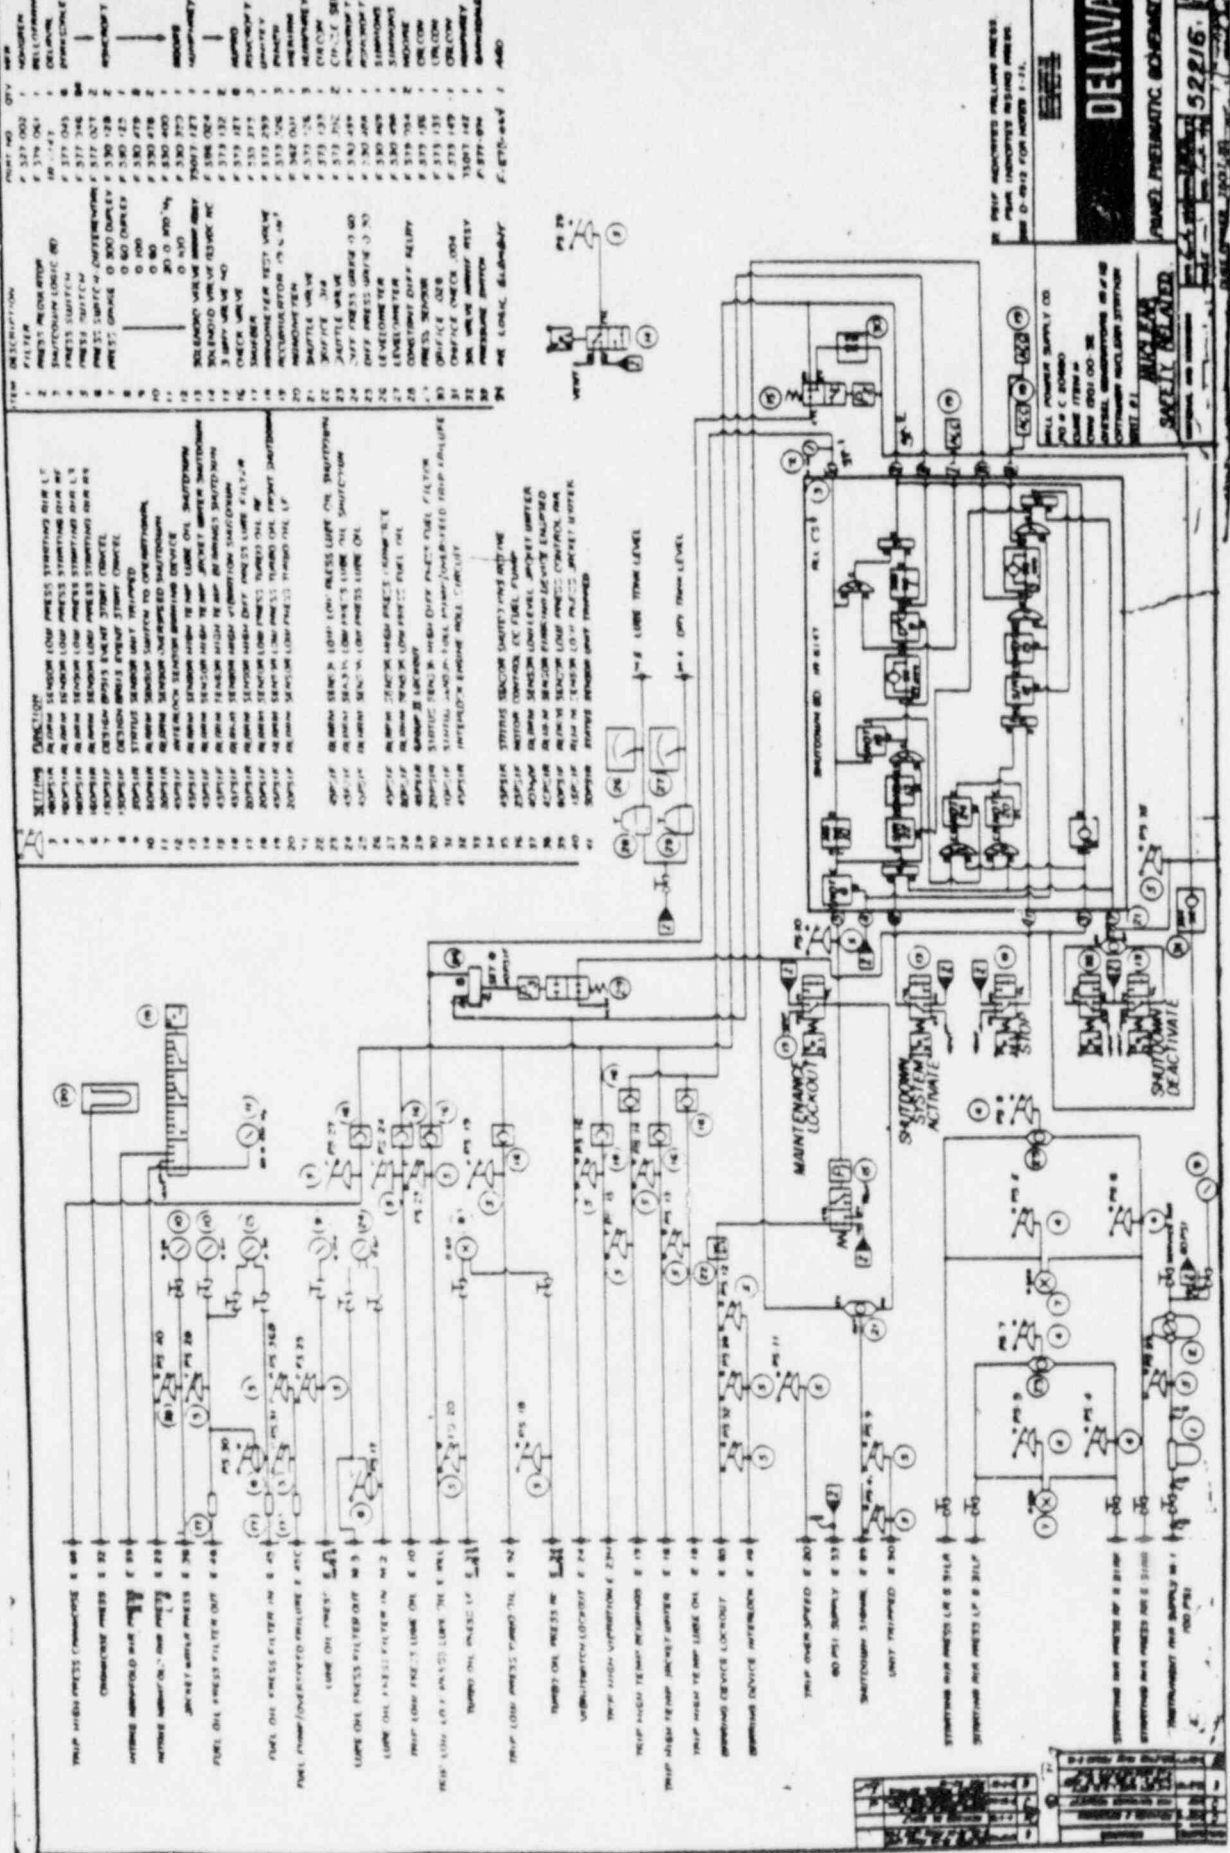
An IMO Delaval and Calcon representative arrived on site at IAE's request on May 7th, 1988, with 12 new Calcon Model B4400 pressure sensors that had been closely inspected. They observed first hand the problems that were being encountered. It was determined that a batch of sensors received on April 15, 1988, were of poor quality. The three that had failed (2 P3s and 1 Lo Lo Lube Oil) were of this lot. The Calcon rep pointed out that friction binding between the large spring and spring

housing internal to the sensor (see Enclosure 3) could lead to the high reset values that were seen. Work Requests 9277 IAE, 9278 IAE, and 9279 IAE were written to replace sensors from the suspect batch on D/Gs 2A, 2B, and 1B respectively. In addition, W/Rs 9282 IAE, 9283 IAE, and 9281 IAE were written to verify that the reset pressures for the P3 on D/Gs 2A, 2B, and 1B respectively, were not abnormally high. The P3 in 1DECPA was replaced with one delivered by the vendors per W/R 27726 OPS. The other sensors of this type on D/G 1A were not from the suspect batch, and therefore were not replaced.

Based on the discoveries made by Calcon, it is concluded that the 7th, 8th, and 9th valid failures within the last 100 valid starts on Unit 1 D/Gs are attributed to the same root cause: inadequate design and manufacture of the Calcon Model B4400 pressure sensor. Upon returning to his plant on May 9, 1988, the Calcon Rep discovered that by stacking up the tolerances allowed in the manufacture of the sensor, it was possible to have negative .022" or no gap between the diaphragm (P/N 283) and the pressure head (P/N 4370). (See Enclosure 3.) If all parts were in the middle of these tolerances, there would be a .010" gap. And, if the parts were at the other extreme of the tolerances, then a .030" gap would be present. The effect of the negative gap would cause the diaphragm to fuse to the

pressure head from spring pressure on the pressure plate (p/n 4380). This in turn reduced the normal pressure area of approximately 1 1/8" diameter down to 3/8" diameter, thus requiring more pressure to overcome the spring pressure and reset the sensor. On newly calibrated sensors, this is not seen because the diaphragm has not had time to stretch and seat itself against the pressure head. This explains the time factor involved in the failure of these sensors. The failed sensors, including the P3 removed after the 7th valid failure, were measured and verified to have a negative difference between the diaphragm and pressure head, indicating the diaphragm was actually being compressed. This was also evident from inspecting the diaphragm and noting the compression ring on the diaphragm. Calcon's modification to this type of sensor ensured that a positive gap will always be present between the diaphragm and the pressure head. With all of these type sensors being replaced, no further failures of this type should exist. Further verification of the effectiveness of this modification was demonstrated by calibrating 2 of the failed sensors and checking reset pressure. After a period of time, reset pressure was seen to raise significantly. The modification of taking .030" from the inside of the pressure head was then performed on these 2 sensors. They were again recalibrated and allowed to sit overnight. The next day they were checked and reset pressure had not changed.
