CONFIRMATORY ACTION LETTER

CAL-RIII-86-01

LETTER TO MR. HAROLD R. DENTON

NRR TRIP REPORT FROM

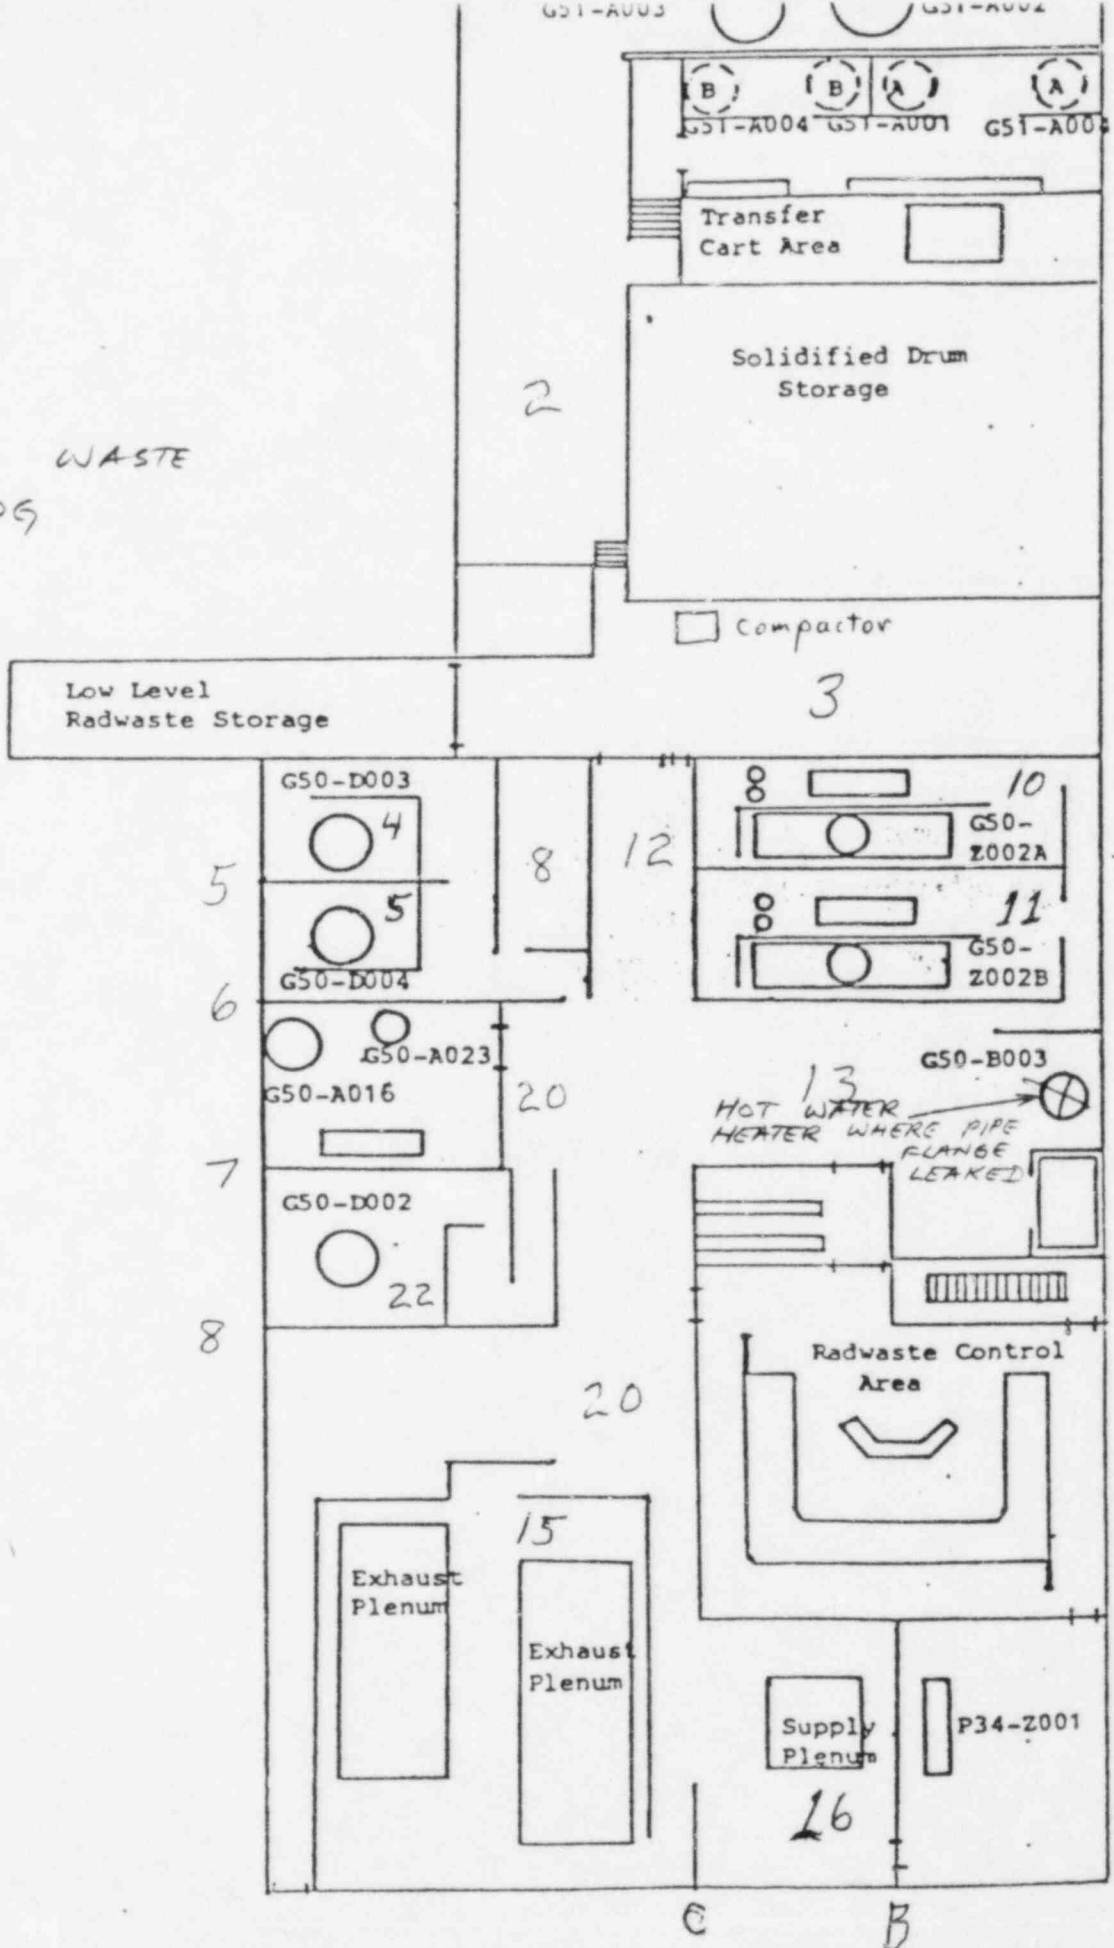
RAD WASTE  
BLDG

- Wall crack for enclosure of chemical waste tank (2' reinforced concrete wall) - <sup>see attached</sup> ~~location~~ <sup>location</sup>
- Wall crack in aux. bldg.
- seepage through Rad Waste room wall. (<sup>from</sup> ~~ground~~ <sup>table</sup> water)

HAIRLINE CRACK  
IN ISOLATION  
WALL (ENCLOSURE  
FOR CHEMICAL  
WASTE TANK)
