INSPECTION RESULTS OF SONGS - 3 MSIV - 8205

San Onofre Nuclear Generation Station

Southern California Edison

INSPECTION RESULTS OF SONGS-3 MSIV 8205 (Revised)

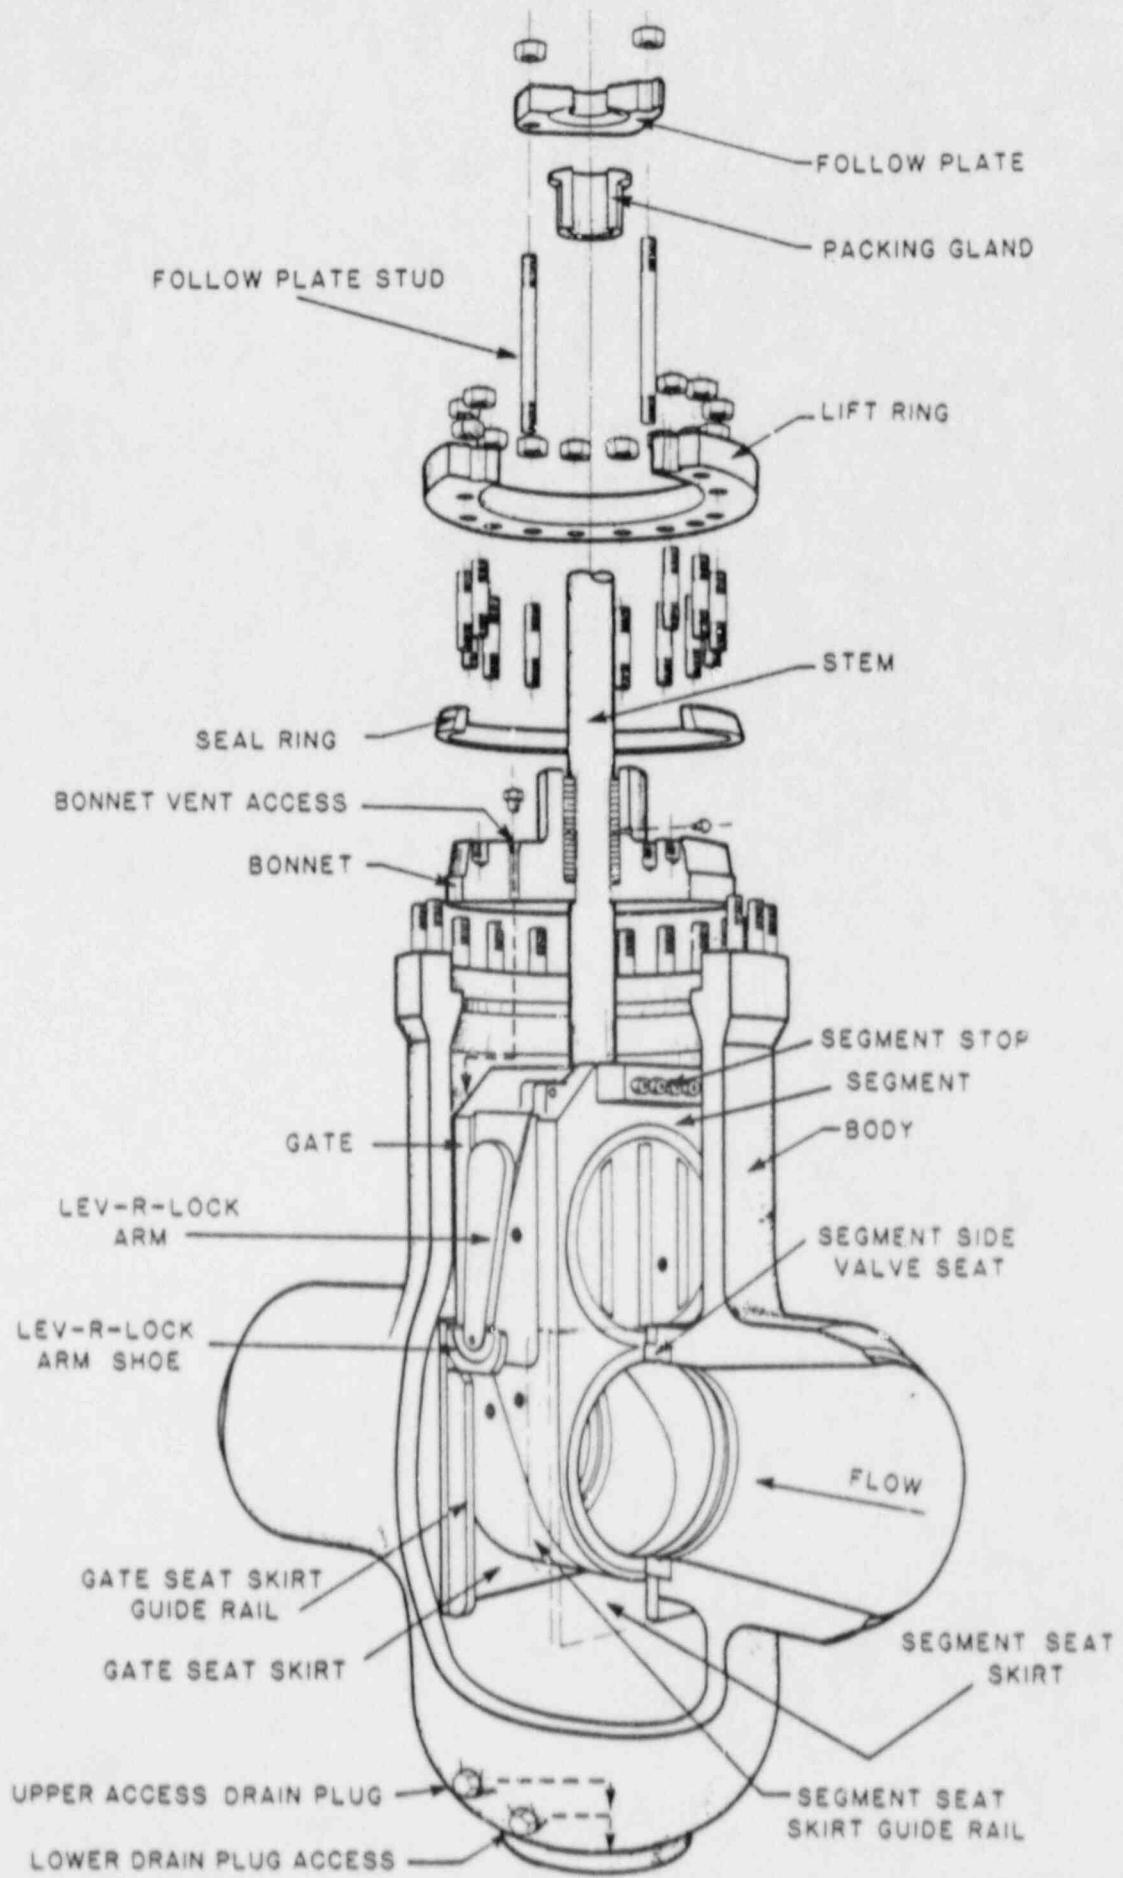
- (12) The shoes of both lev-r-lock arms were examined. Galling marks were found on the tops of both shoes (The shoe tops may contact the segment guide rails during the valve opening cycle). The shoe bottoms were smooth (The shoe bottoms may contact the gate guide rails during the valve closing cycle). Figures 10 and 11 are close-up views of the galling. Figure 12 is a distant view of the galling.

A Distant View of the Galling Marks on the Arm Shoes
