UNITED STATES  
**NUCLEAR REGULATORY COMMISSION**  
 REGION II  
 101 MARIETTA ST., N.W.  
 ATLANTA, GEORGIA 30323

Report Nos.: 50-327/88-34 and 50-328/88-34

Facility Name: Sequoyah 1 and 2

Inspection Conducted: June 6 - July 11, 1988

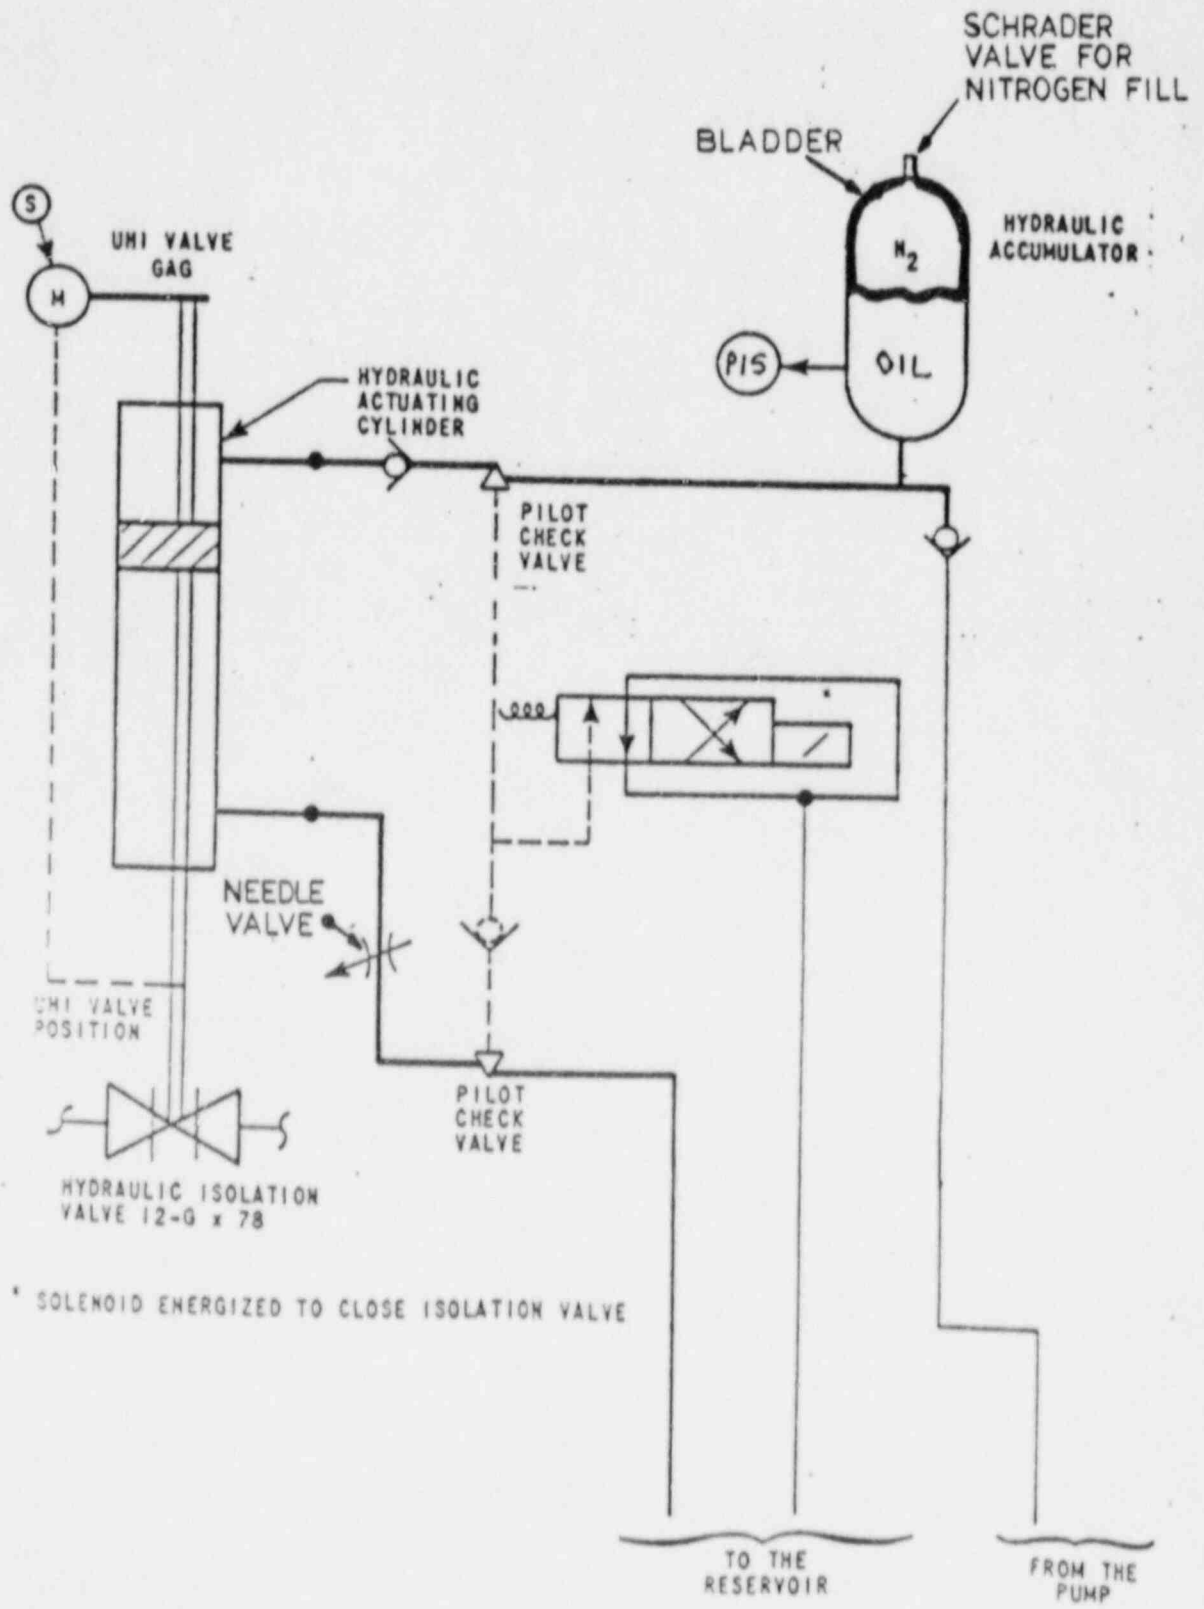
Upper Head Injection System Schematic

- 07/08/88 AT 1930 EDT AND AT 0450 EDT ON 07/09/88, HYDRAULIC ACCUMULATOR PRESSURE REACHED LOW SETPOINT (2970 psig) AND WAS RECHARGED BY OPERATIONS
- 07/09/88 AT 1100 EDT, SCHRADER VALVE N<sub>2</sub> BLADDER WAS CHECKED FOR LEAKS - SMALL LEAKAGE NOTED.

- 07/10/88 AT 0930 EDT, PORS TALKED WITH THE NRC TO INFORM THEM OF THE PROGRESS MADE AND THE ACTIONS REMAINING BEFORE VALVE REPAIR WAS COMPLETED.
- 07/10/88 AT 1231 EDT, ENTERED LCO 3.5.1.2 TO PERFORM PRECHARGE ON 2-FCV-87-21 AND PERFORM MAINTENANCE ON SCHRADER VALVE. NITROGEN PRESSURE WAS FOUND TO BE 1164.5 psig. LEAKAGE FROM THE SCHRADER VALVE WAS REPAIRED.

- THE LEAKING SCHRADER VALVE CAUSED THE LOW NITROGEN PRESSURE AND RESULTED IN SEVERAL RECHARGES PRIOR TO VERIFICATION OF PRECHARGE.
- MANAGEMENT DETERMINED THAT A NITROGEN PRECHARGE WAS THE MOST ACCURATE AND EFFICIENT WAY TO DETERMINE SYSTEM STATUS WITH RESPECT TO ACCUMULATOR HYDRAULIC PRESSURE.
