LICENSEE EVENT REPORT (LER)

TITLE (4) Leakage of Aluminum-Bronze Essential Cooling Water System

South Texas Project Electric Generating Station
Units 1 & 2
Docket Nos. STN 50-498 and STN 50-499
Leakage of Aluminum-Bronze Essential Cooling Water System

BECHTEL REPORT
ON
FAILURE ANALYSIS AND STRUCTURAL
INTEGRITY EVALUATION OF LEAKING
ALUMINUM - BRONZE CAST VALVE BODIES
AND FITTINGS IN THE ECW SYSTEM

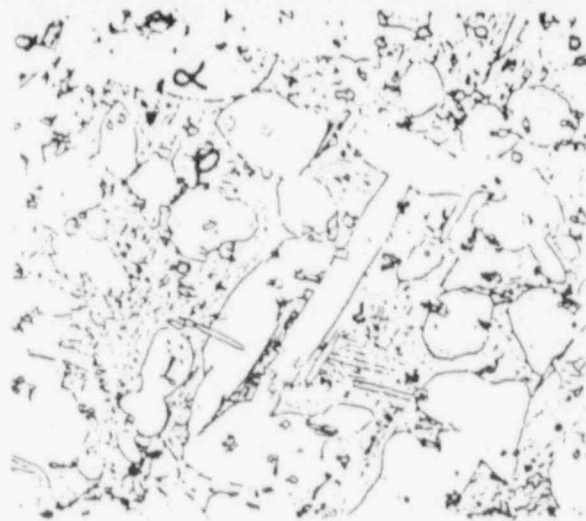
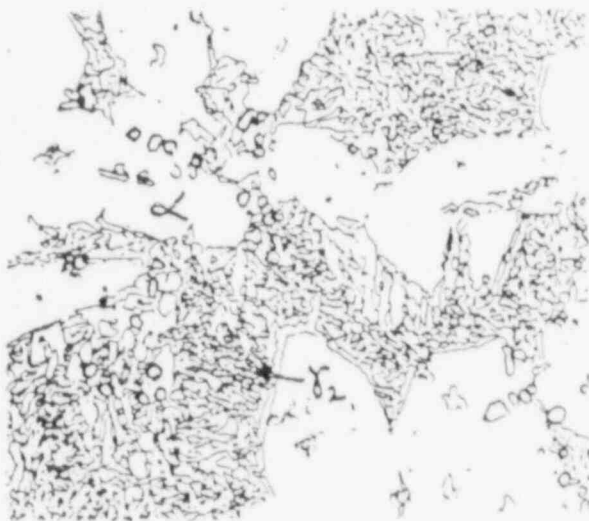
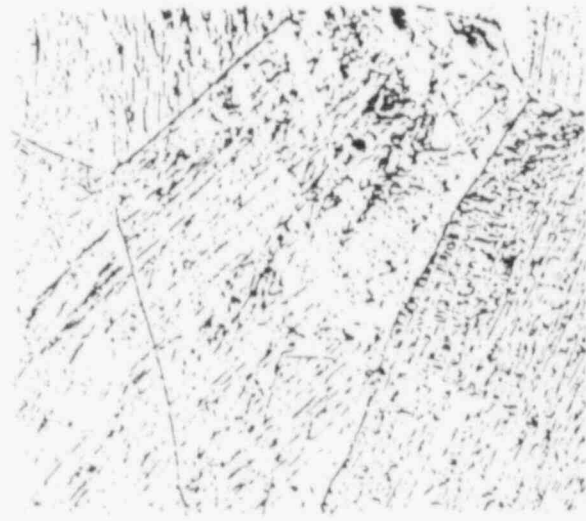
FIGURE 1.2a Typical Microstructures

- I. The identification of the phases (alpha, beta and gamma₂) is based on:
 - 1. Sample photomicrographs provided by the material supplier (see Figure 1.2a).

- B. In order to properly interpret the microstructure of Al-bronze, two actions were taken. The supplier of the raw castings was asked to send us photomicrographs of the typical microstructures of Al-bronze. Figure 1.2a is the information from them. Second, three small samples from Valve EW-0269 (serial No. 61-382) were heated above 1100°F for one hour. One sample was cooled in water, one in air and one was left in the furnace and slow cooled by turning off the power. Figure 1.2b shows the microstructure of the three specimens.

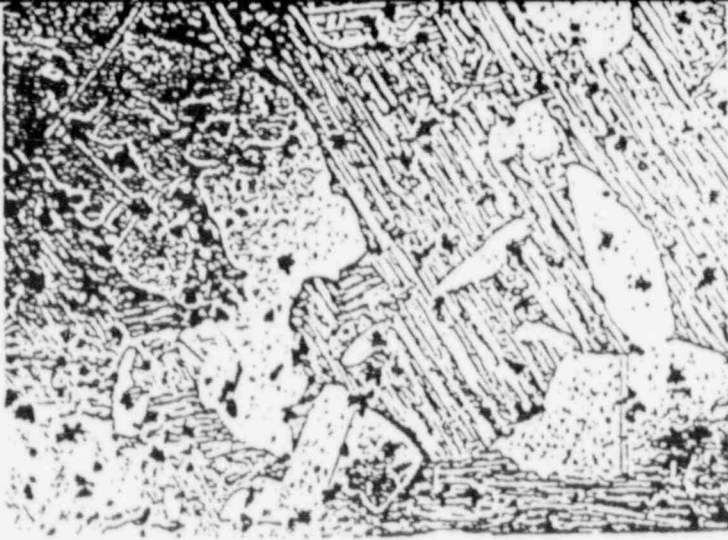
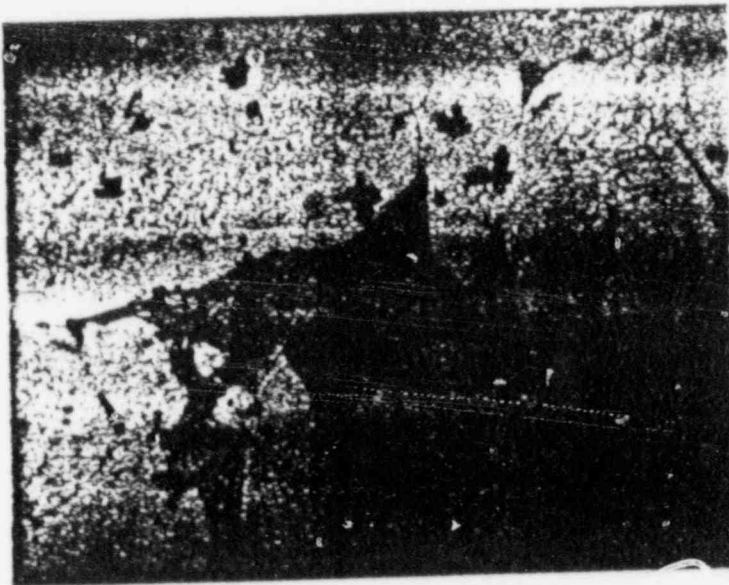
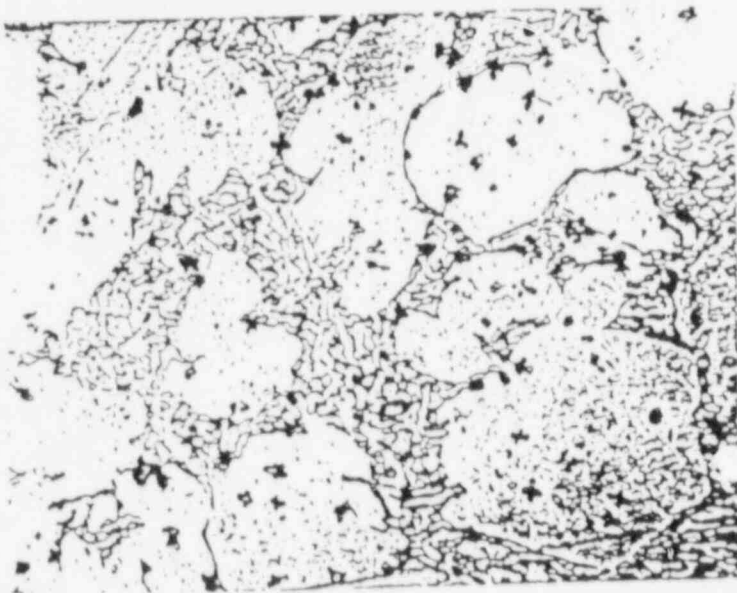
FIGURE 1.2b Typical Microstructures

Heat at 1150°F one hour
Water Quench

Heat at 1220°F one hour
Air Cool - Fan

Heat at 1250°F one hour
Furnace Cool

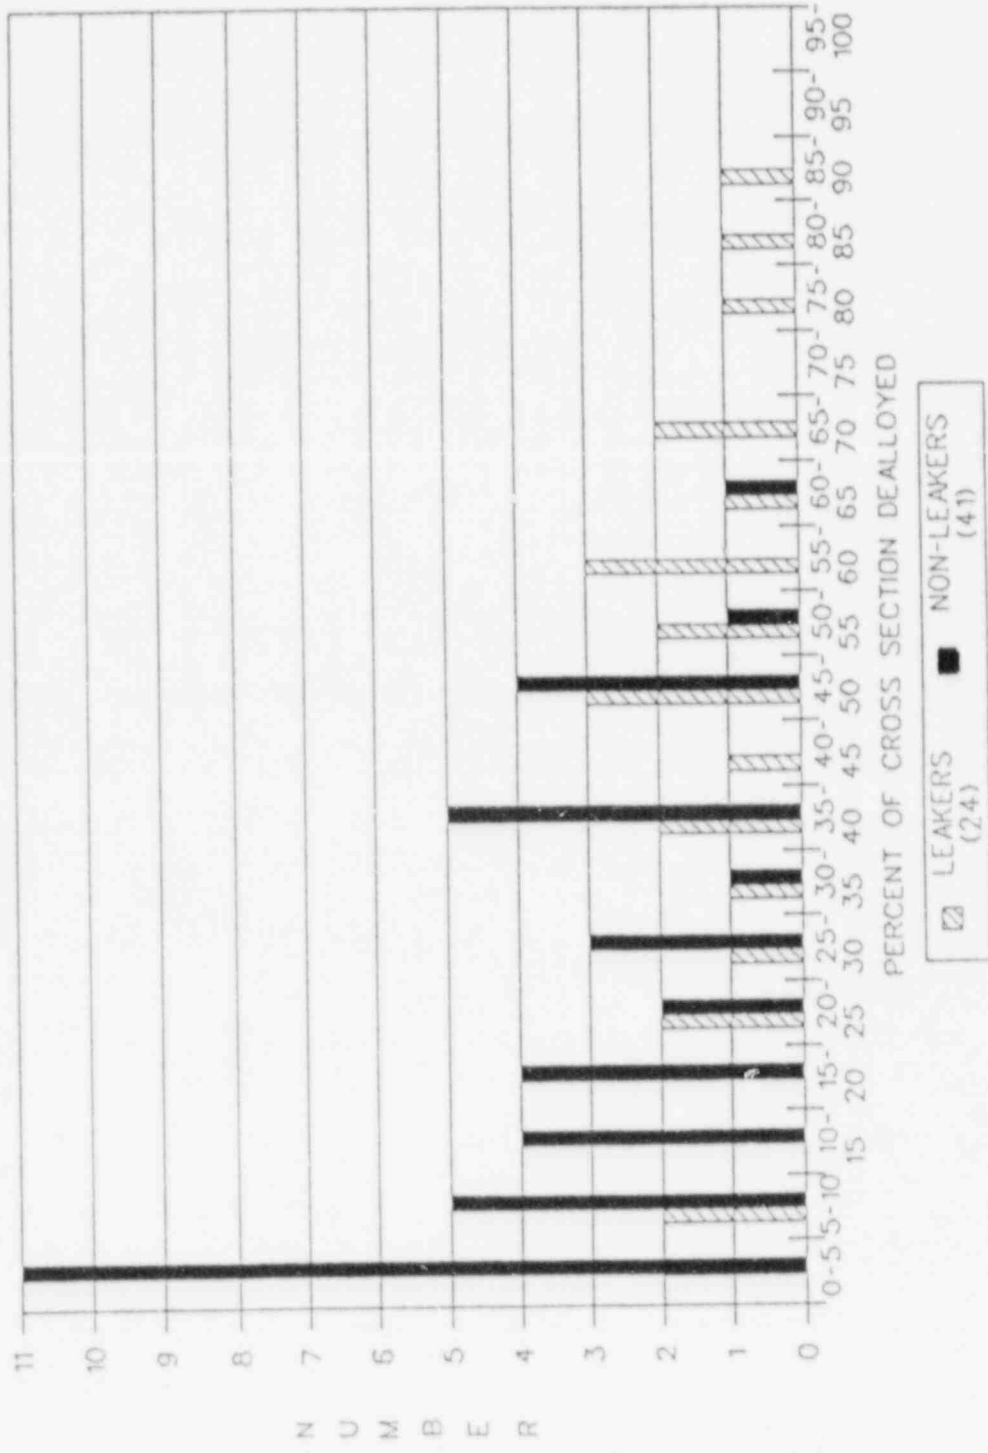
FIGURE 2.5

The above distribution functions were then used to determine the percentage of leaking socket ends that can be observed as a function of cross section dealloying as shown on Figure 2.5.

The original ASME Section III analysis was reviewed and stress values compared to allowable values for the original material. These results are shown in Figure 2.5. The stress ratios presented in the Figure 2.5 illustrate the fraction of the total allowable stress that exists in each fitting under the design conditions of sustained plus secondary loads.

It can be seen from these data that there are significant margins existing in the original design. The highest stress in the ECW small bore piping is about 77 percent of the code allowable stress. It can be seen from Figure 2.5 that in all cases these stress ratios show adequate stress margins.

STP UNIT 1 ALUMINUM/BRONZE ECWS
 DISTRIBUTION OF SAMPLED FITTINGS
