Detroit
Edison

Subject: Response to CAL on Reactor Recirculation
Pump B Discharge Valve

ACTION PLAN STATUS

VIEWGRAPHS FROM SEPTEMBER 27, 1988
PRESENTATION AT NRC REGION III HEADQUARTERS

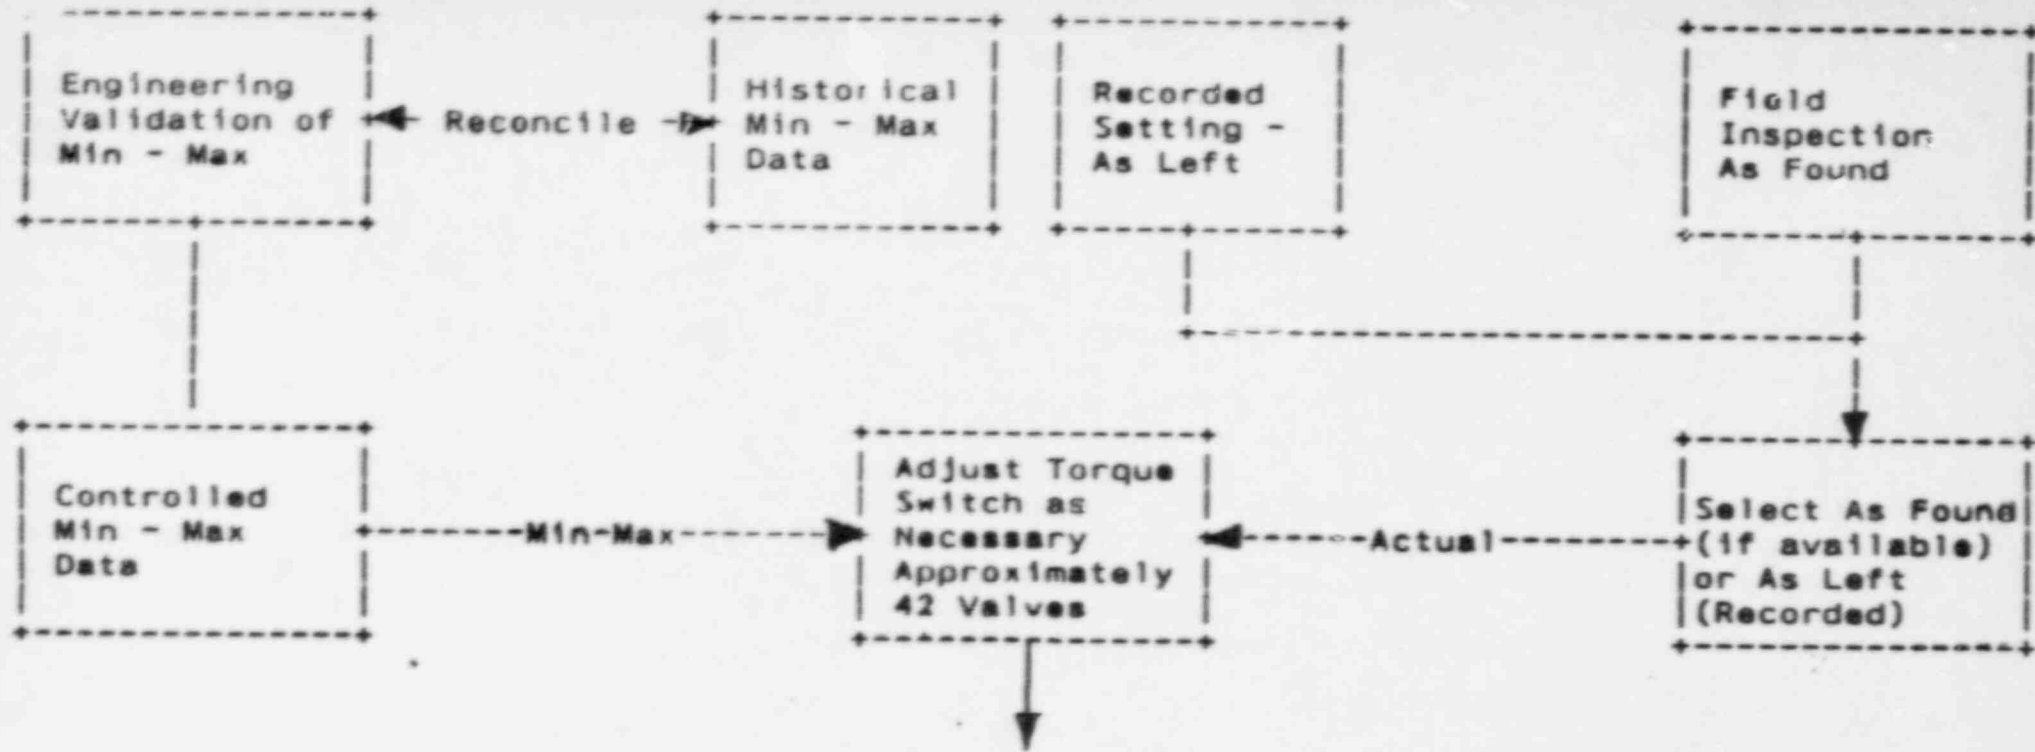
**As Found VS. Maintenance Recorded
Open and Close Torque Switch Settings
To Date**

- 1. Above count exclude 28 valves where
spring pack work was done**

- Field Inspection If
- a) Operator Replace
 - b) Sample Population
 - c) Spring Pack Work
 - d) MOVATS
 - e) Recorded Valve
Less Than 1 Division
Above Minimum
 - f) Other Work On MOV
