James A. FitzPatrick
Nuclear Power Plant
P.O. Box 41
Lycoming, New York 13093
315 342-3840

October 21, 1988
JAFF-88-0965

Subject: Additional Information on Internal Vessel Core Spray
Pipe Crack

TO: US NRC
FROM: R. J. CONVERSE
SUBJECT: ADDITIONAL INFORMATION ON
INTERNAL VESSEL CORE SPRAY
PIPE CRACK

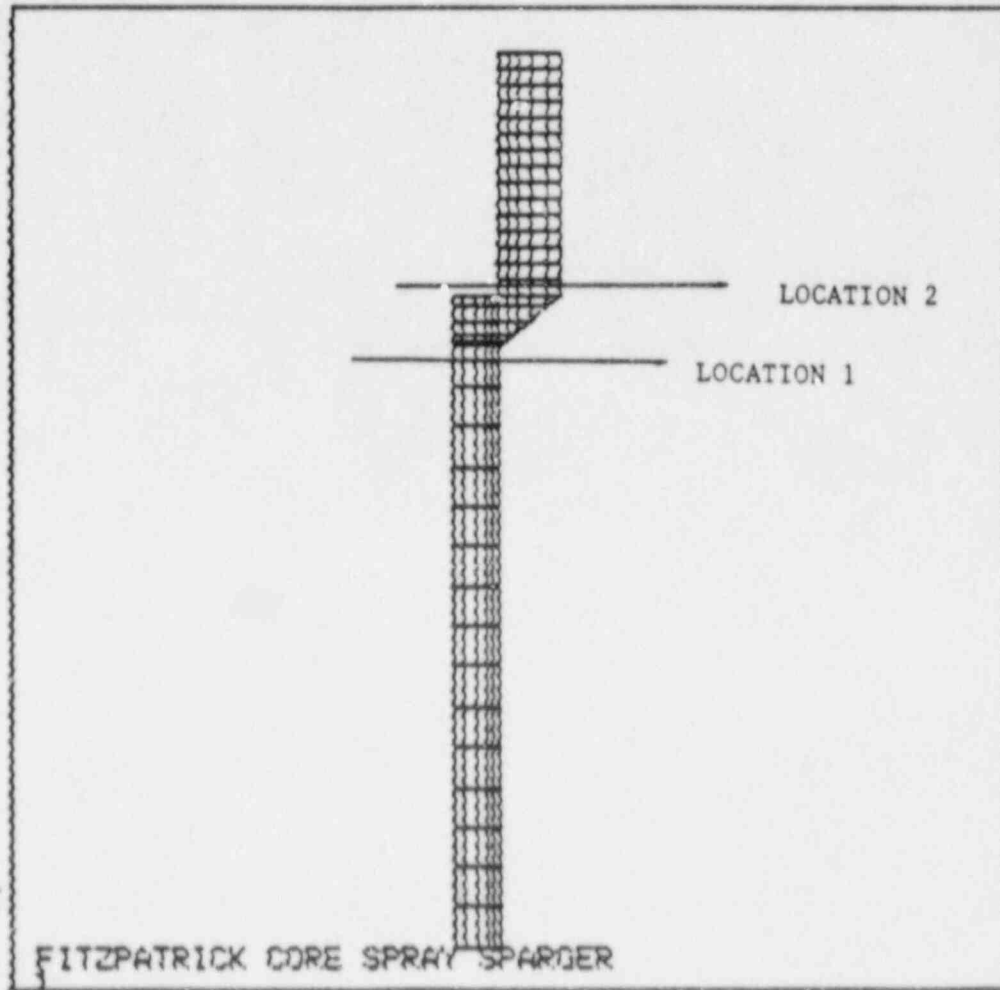
FIGURE 2 AXISYMMETRIC MODEL

The axisymmetric finite element model was used to determine the pressure and core spray flow operation induced stresses. Figure 2 shows the finite element model. Note that no credit is taken for any of the original core spray line pipe. The original pipe is removed and the entire load is assumed to be taken by the clam shell and the weld of clam shell to original pipe. Although the actual thickness of the clam shell is higher, the repair specification allowed a minimum thickness of 0.318 in. near the weld location. Furthermore, it was conservatively assumed that because of access limitations only 5/6th of the circumference would be welded. With this correction, the equivalent thickness for the clam shell was calculated as $(0.318 \times 5/6)$ or 0.265 inch.

The expected pressure difference during core spray operation was applied to all internal surfaces. In addition the injection load due to core spray flow was also applied as shown in Figure 2.
