APPENDIX R
MULTIPLE HIGH IMPEDANCE CABLE FAULT
FLAME TEST REPORT

MAY 27, 1988

PREPARED BY
PHILADELPHIA ELECTRIC COMPANY
PHILADELPHIA, PA. 19101
NUCLEAR ENGINEERING DEPARTMENT
ENGINEERING DIVISION
N2-1, 2301 MARKET STREET

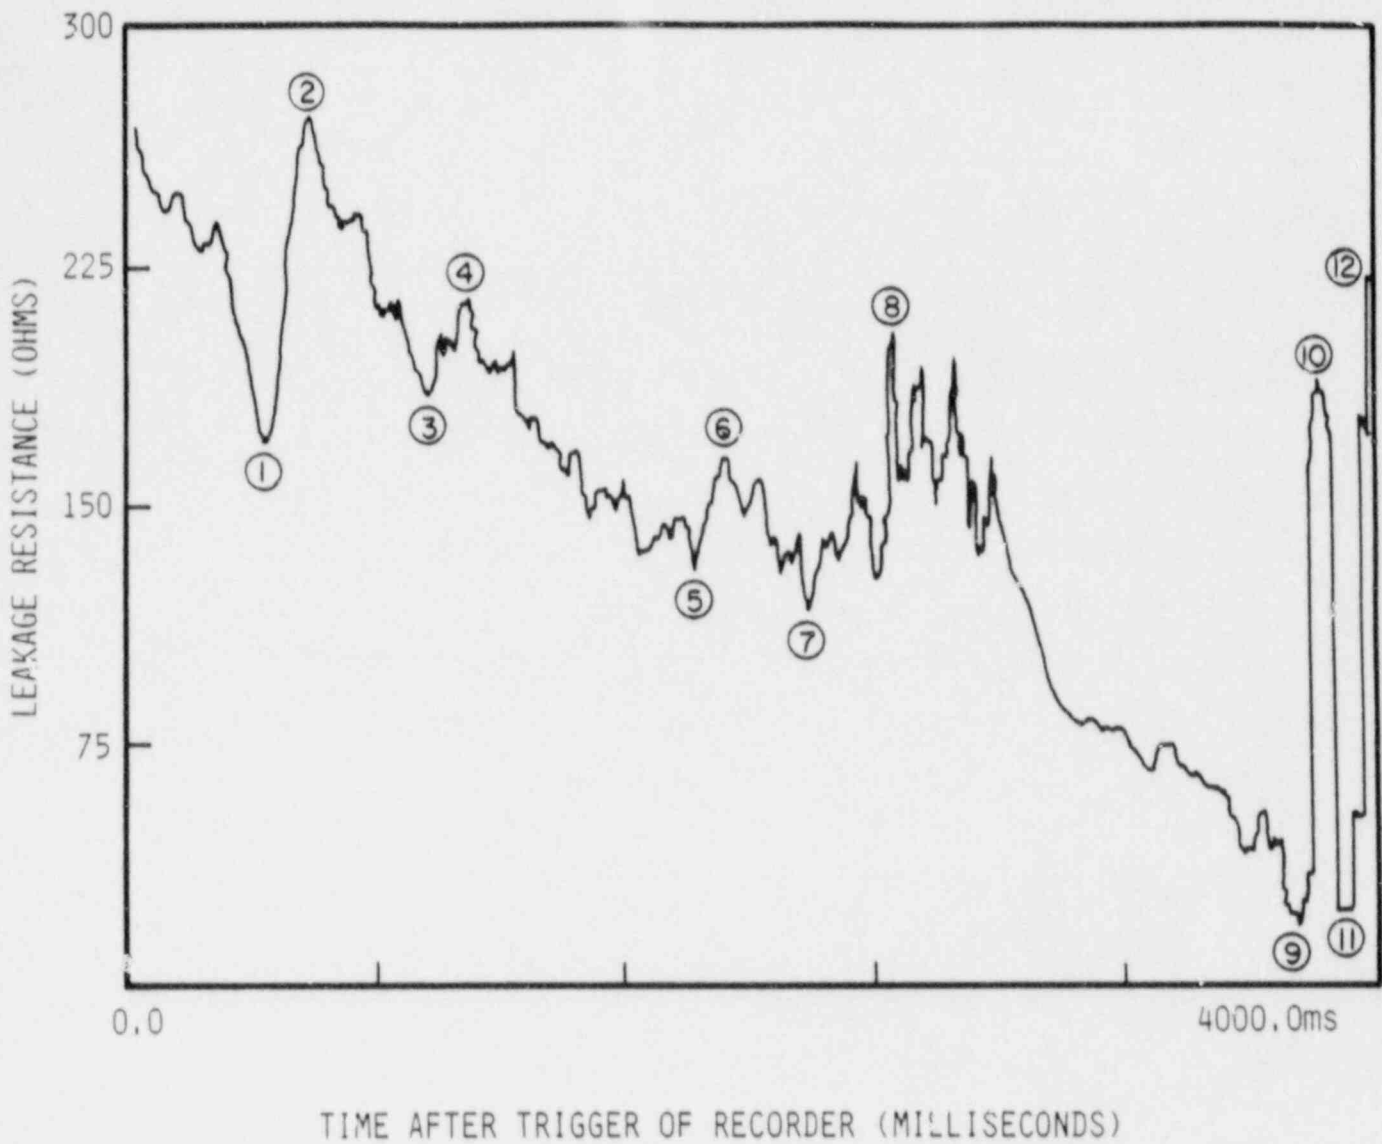
FIGURE NO. 6
 TEST NO. 1
 CABLE INSULATION LEAKAGE RESISTANCE
 VS. TIME (AFTER TRIGGER)

The analyzer triggered at 10 minutes from the start of the test. The analyzer was triggered at a cable insulation resistance value of 200 ohms between the energized conductors and neutral. Eight thousand data points were recorded during the four (4) second period. Figure 6 shows a graph of the cable insulation leakage resistance versus time for the recording period. The energized cable did not experience a short circuit. During the recorded period the maximum insulation leakage resistance between the energized conductor and neutral was 272 ohms which occurred at 601 MS and the minimum resistance was 18.57 ohms which occurred at 3752 MS. The maximum and minimum currents recorded were 5.508 Amps and 0.416 Amps. The following is a listing of various maximum and minimum points recorded.

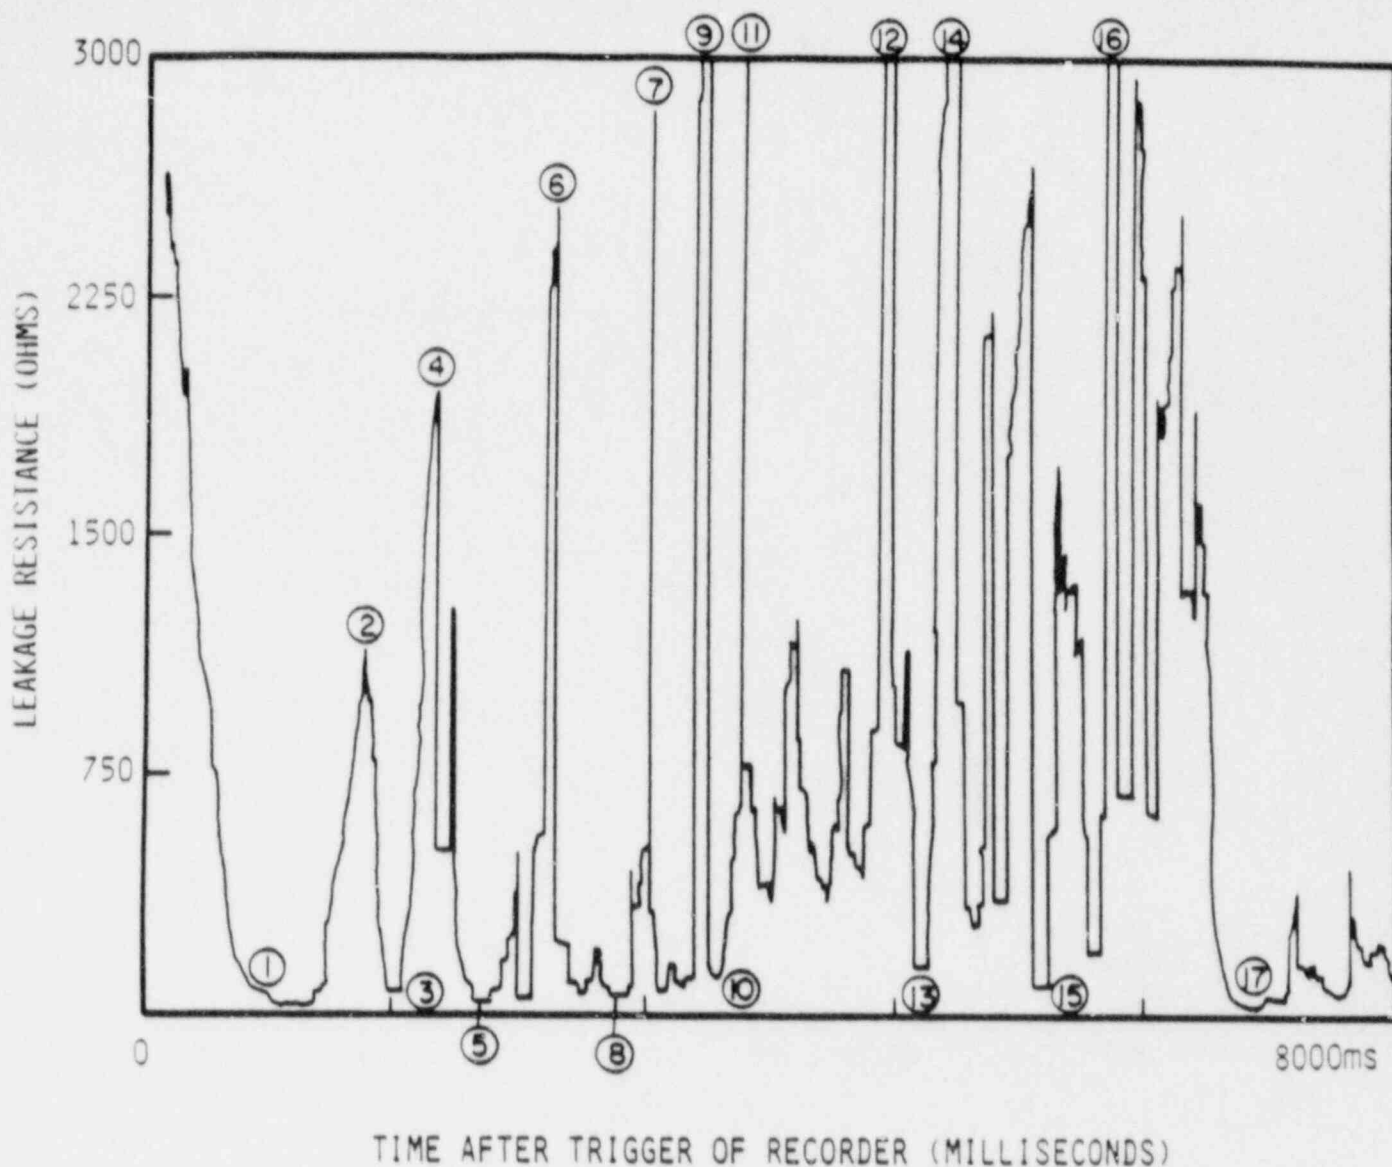
FIGURE NO. 8
 TEST NO. 2
 CABLE INSULATION LEAKAGE RESISTANCE
 VS. TIME (AFTER TRIGGER)

The analyzer triggered at 8 minutes and 5 seconds from the start of the test. Eight thousand data points were recorded during the eight (8) second interval after the analyzer triggered. Figure 8 is a graph of the cable insulation leakage resistance versus time. The energized cable did not experience a total short circuit.

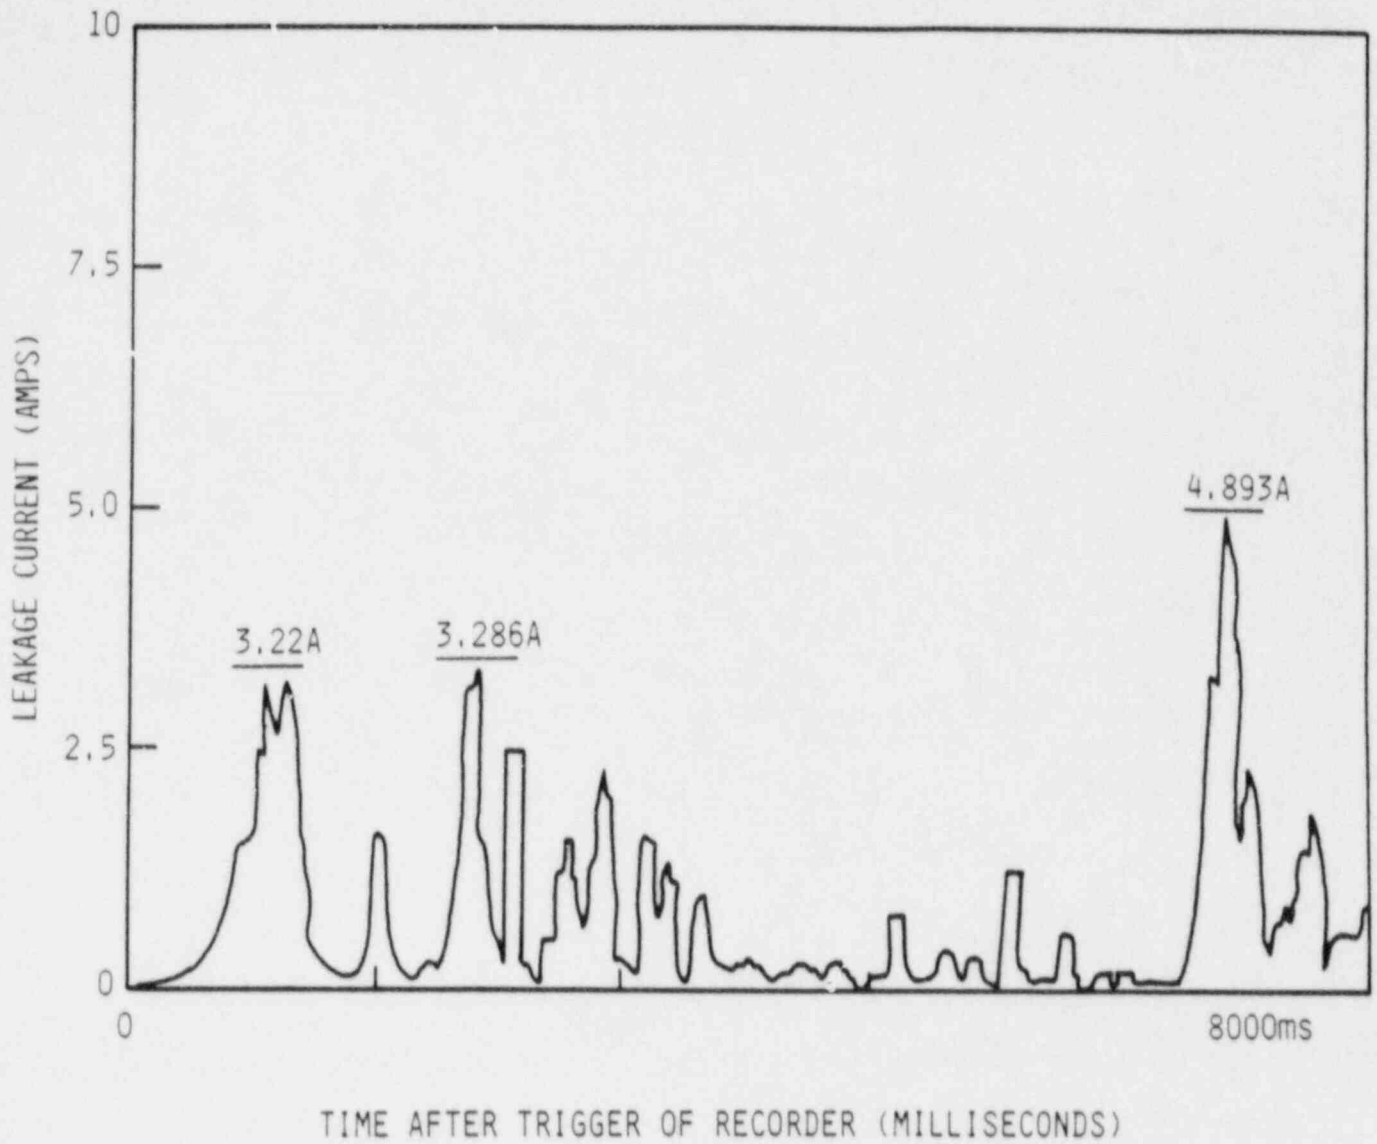
FIGURE NO. 9
TEST NO. 2
CABLE INSULATION LEAKAGE CURRENT
VS. TIME (AFTER TRIGGER)

Figure 9 is a graph of the insulation leakage current through the energized conductor into the high impedance fault as a result of the cable flame damage. For the recorded duration, the average current is 0.7525 amperes for the 8 second period. The maximum current is 4.893 amperes which occurs at 7085 MS.

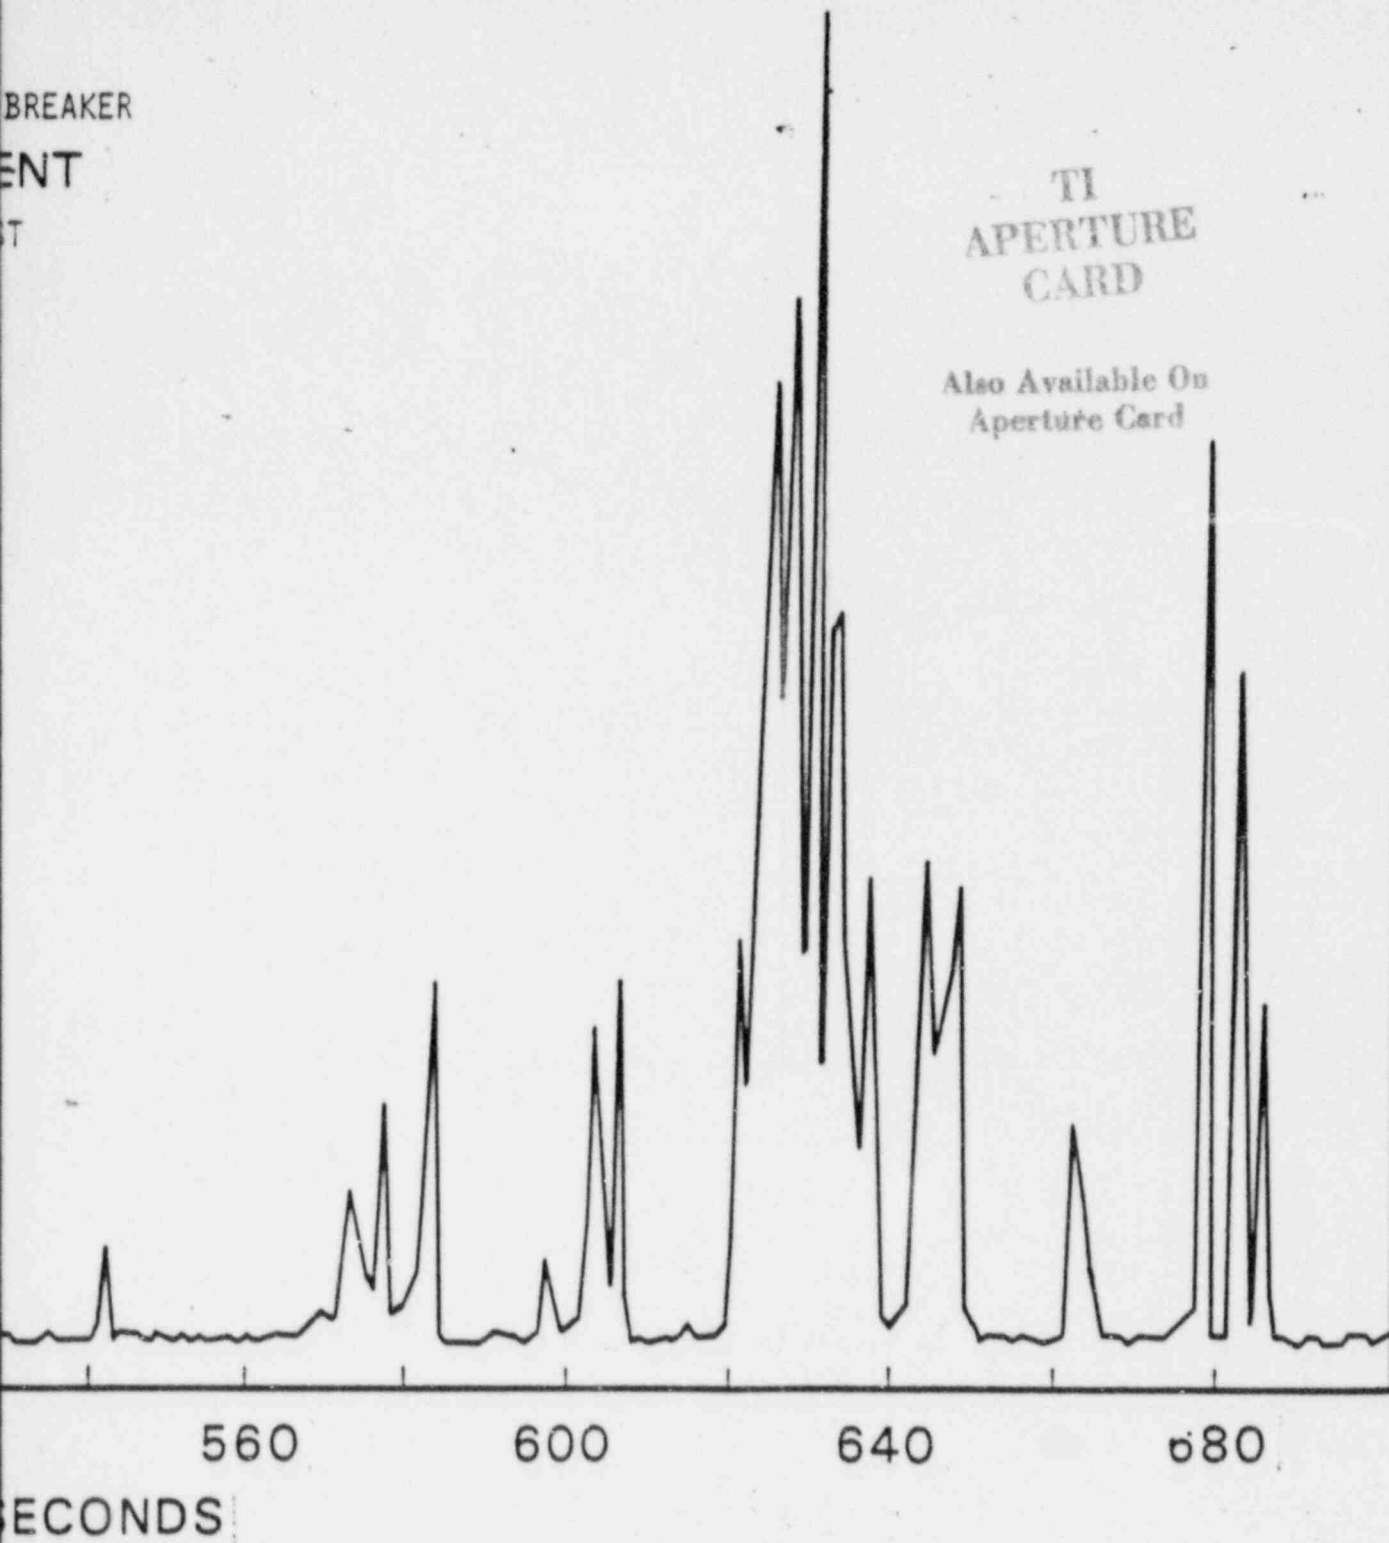
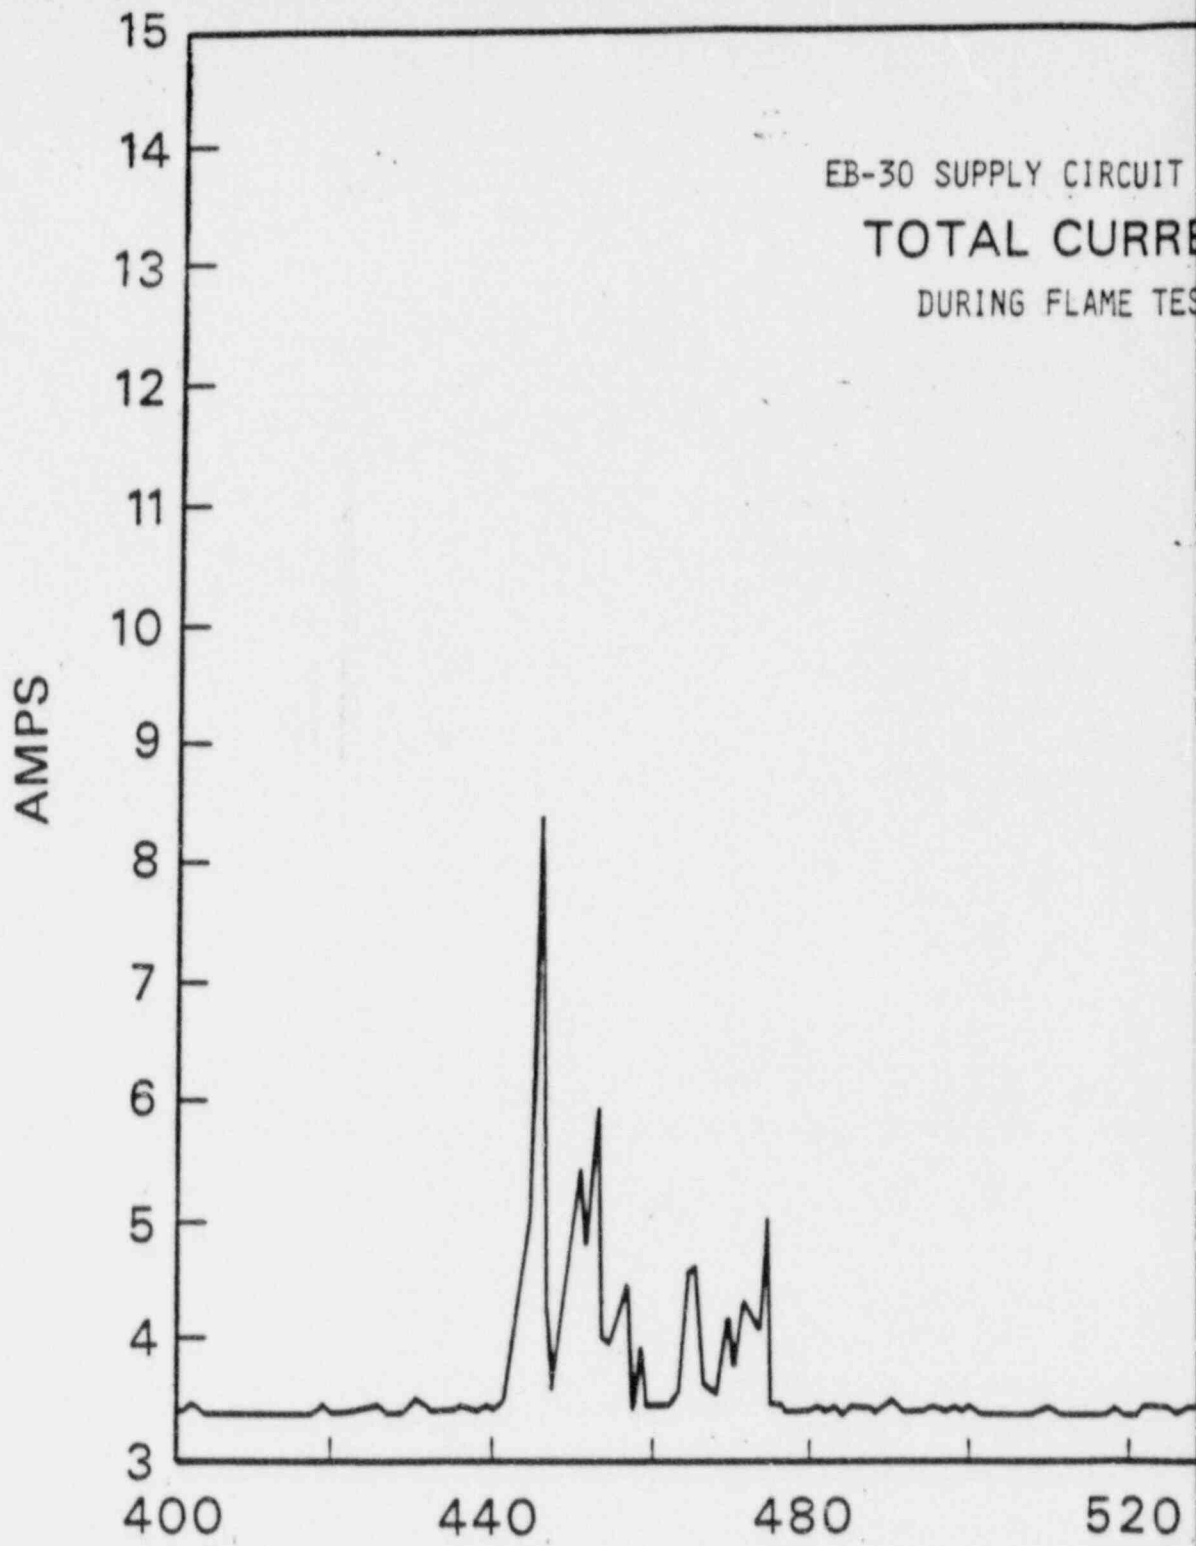
FIGURE NO 12
TEST NO 3
BREAKER CURRENT VS. TIME
ING FLAME TEST

As can be seen from Figure No. 12 "Total Supply Breaker Current Vs. Time During Flame Test" the circuit breaker was not in jeopardy of tripping due to cable fault high impedance short circuit currents. The current through the supply breaker was a combination of the fault current contributions from each of the energized cables.
