PDR-016
RESPONSE TO FREEDOM OF
INFORMATION ACT (FOIA) REQUEST

Perry MSIV Stroke Time Failure

ROOT CAUSE ANALYSIS

MSIV EG VALIDATION
TASK 3, SOLENOID VALVE
ENVIROMENTAL (THERMAL ENDURANCE) TEST PLAN
PERRY NUCLEAR POWER PLANT

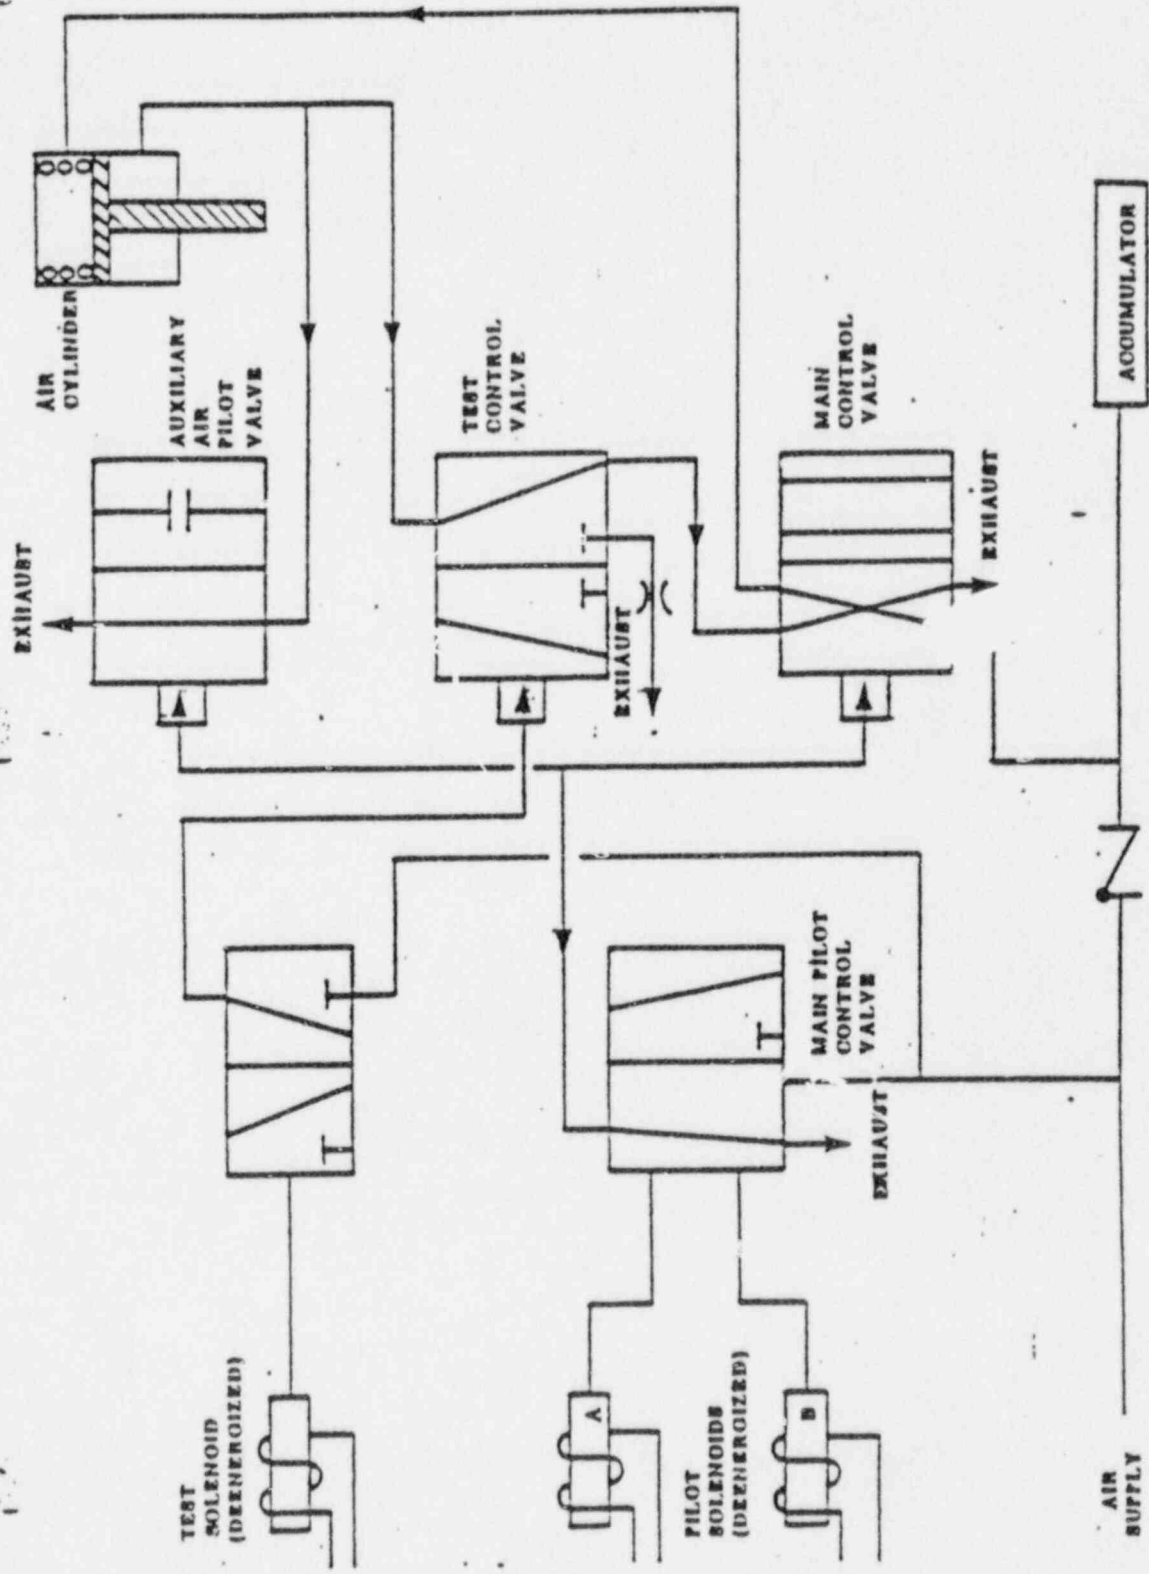
Figure B21-12B
M81V Pneumatic Control

Conclusion

This item was initially considered to have a high potential as root component failure. Inspections of the air lines and accumulators found no defect that could cause the observed operational pattern, however, so this potential cause is unlikely to be a root component failure.

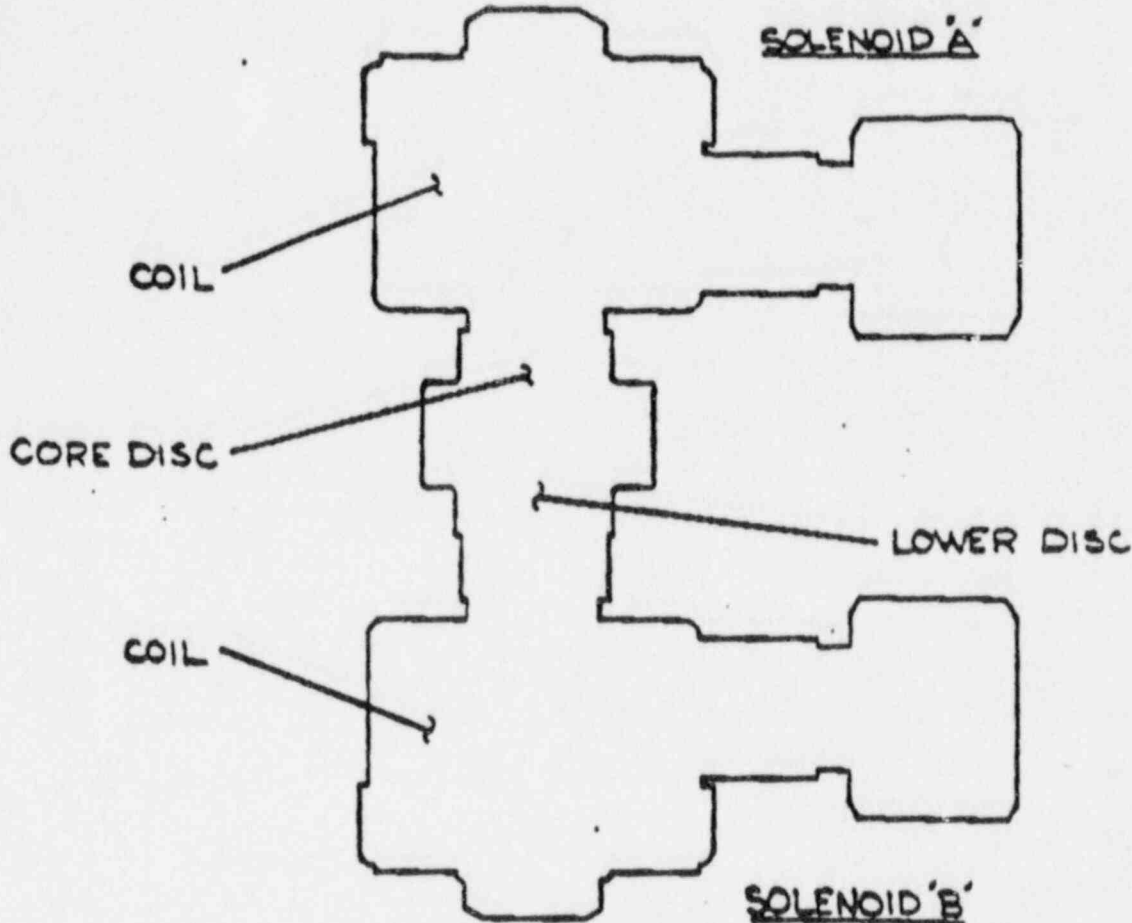
TITLE PLOT OF CORE DISC TEMP. VS. AMB. TEMP.

131°C	219°C	227°C	176°C	170°C
66°C	163°C	175°C	121°C	113°C
49°C	147°C	160°C	108°C	99°C
25°C	126°C	141°C	88°C	77°C
AMBIENT TEMP.	COIL-SOL. 'A'*	COIL-SOL. 'B'*	CORE DISC	LOWER DISC
MAXIMUM TEMPERATURE

ITEM	* 5°C ADDED FOR HOT SPOT			
MAXIMUM TEMPERATURES OF COIL AND CRITICAL ELASTOMERS WITH VALVE ENERGIZED AND NO FLOW				
BR NO.	BY	DATE	APP	D
