SUBJECT: DELUGE, PRE-ACTION AND FOAM-WATER DELUGE SPRINKLER
SYSTEMS: MODEL C DELUGE VALVES

IE INFORMATION NOTICE NO. 84-16: FAILURE OF AUTOMATIC SPRINKLER SYSTEM VALVES
TO OPERATE

**Subject: Nuclear Regulatory Commission Information Notice 84-16,
"Failure of Automatic Sprinkler System Valves to Operate"**

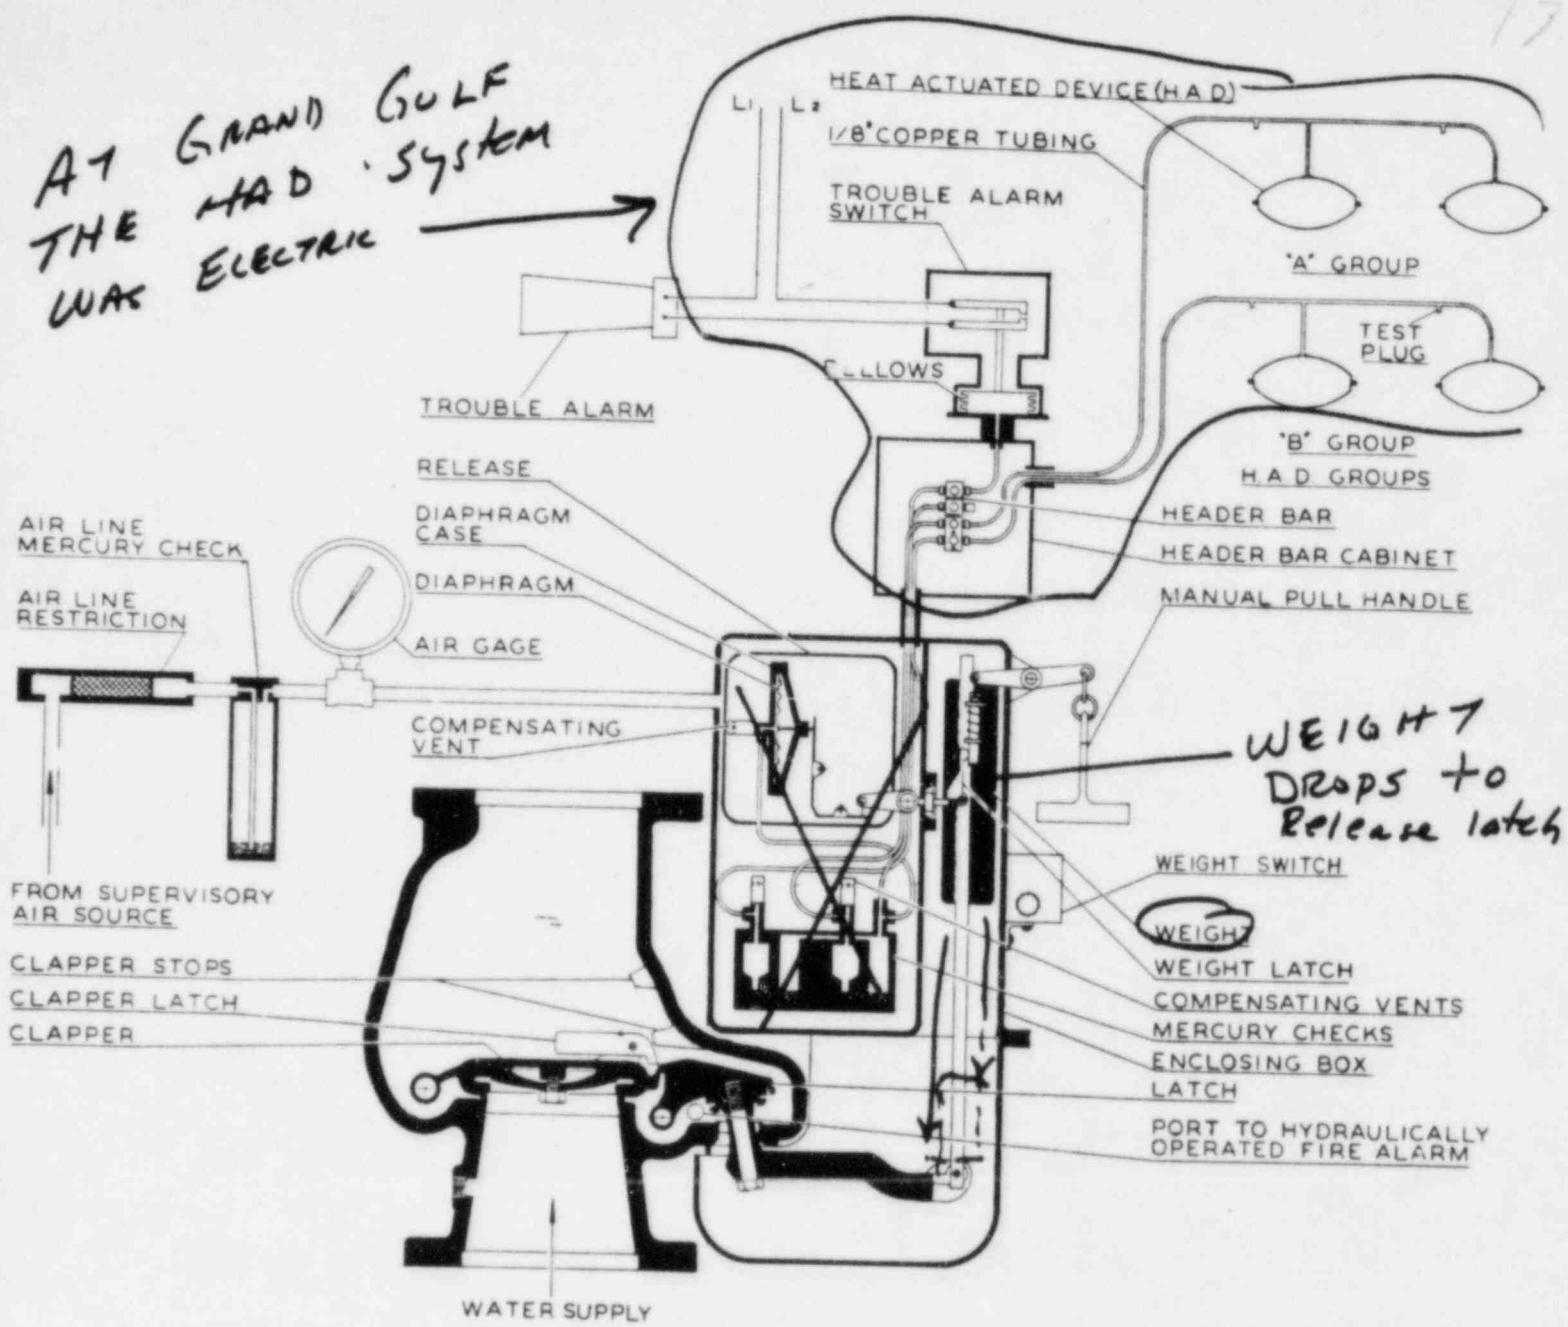
Dwg. No. SB-268

AT GRAND GULF THE HAD SYSTEM WAS ELECTRIC

Figure 2
Schematic Operating Diagram
of Standard Suprotex-Deluge
Valve

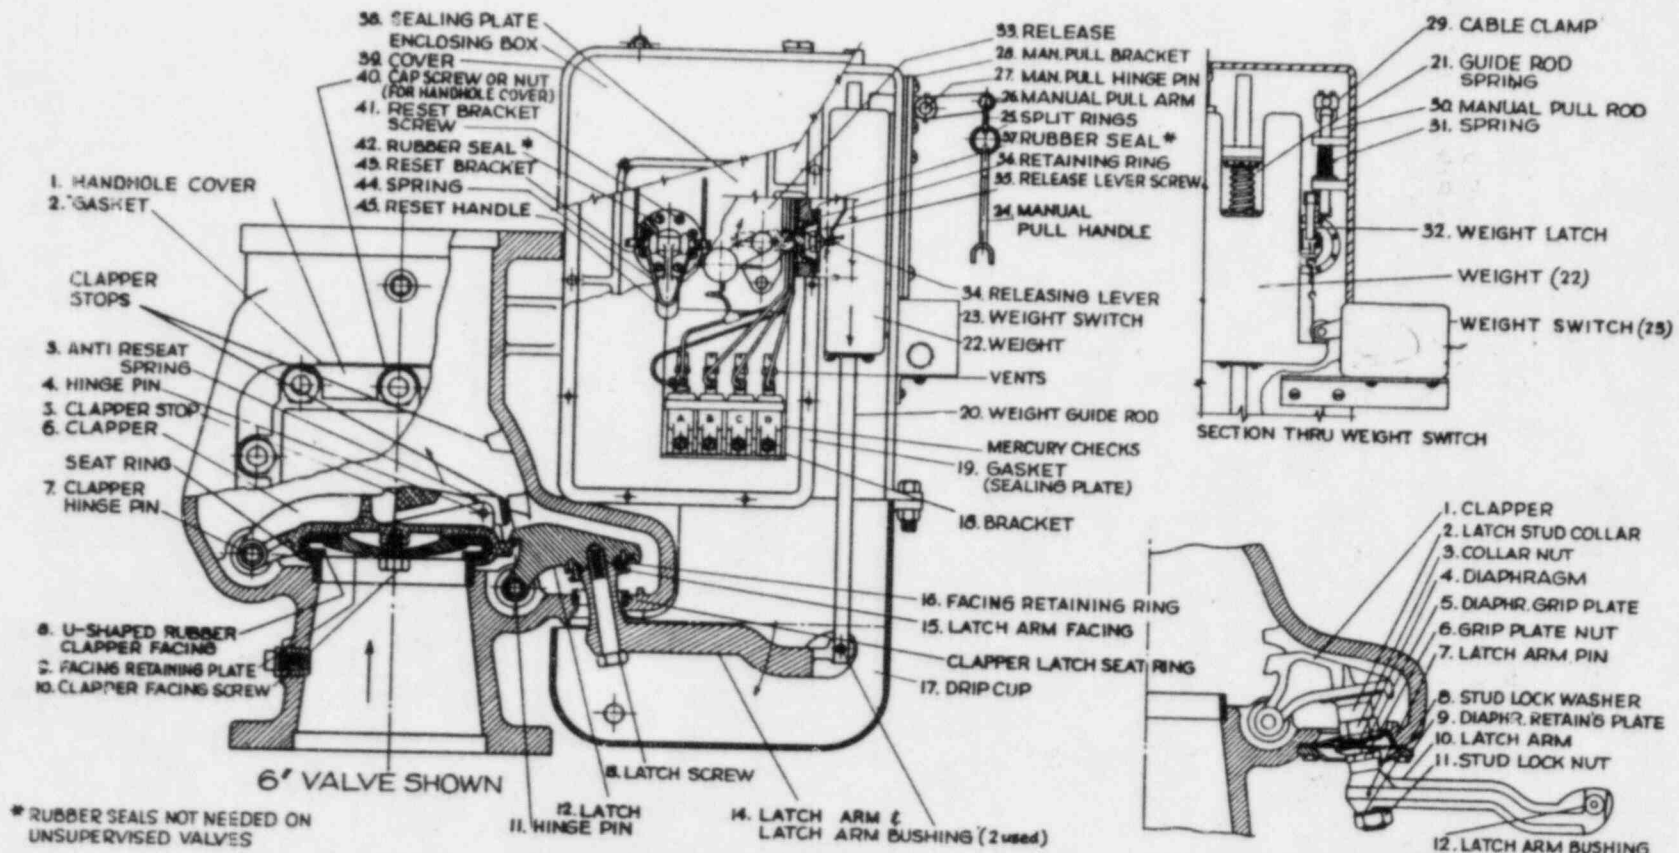
**REPLACEMENT PARTS
FOR ALL MODEL C VALVES**

* RUBBER SEALS NOT NEEDED ON UNSUPERVISED VALVES
