Subject: Augmented Inspection Team Report No. 50-219/87-29

Report No. 50-219/87-29

Facility Name: Oyster Creek Nuclear Station

Technical issues associated with the reported violation of Safety Limit 2.1.E on September 11, 1987 wherein a condition requiring at least two sets of suction and associated discharge valves in the five reactor recirculation loops to be in the full open position was not met.

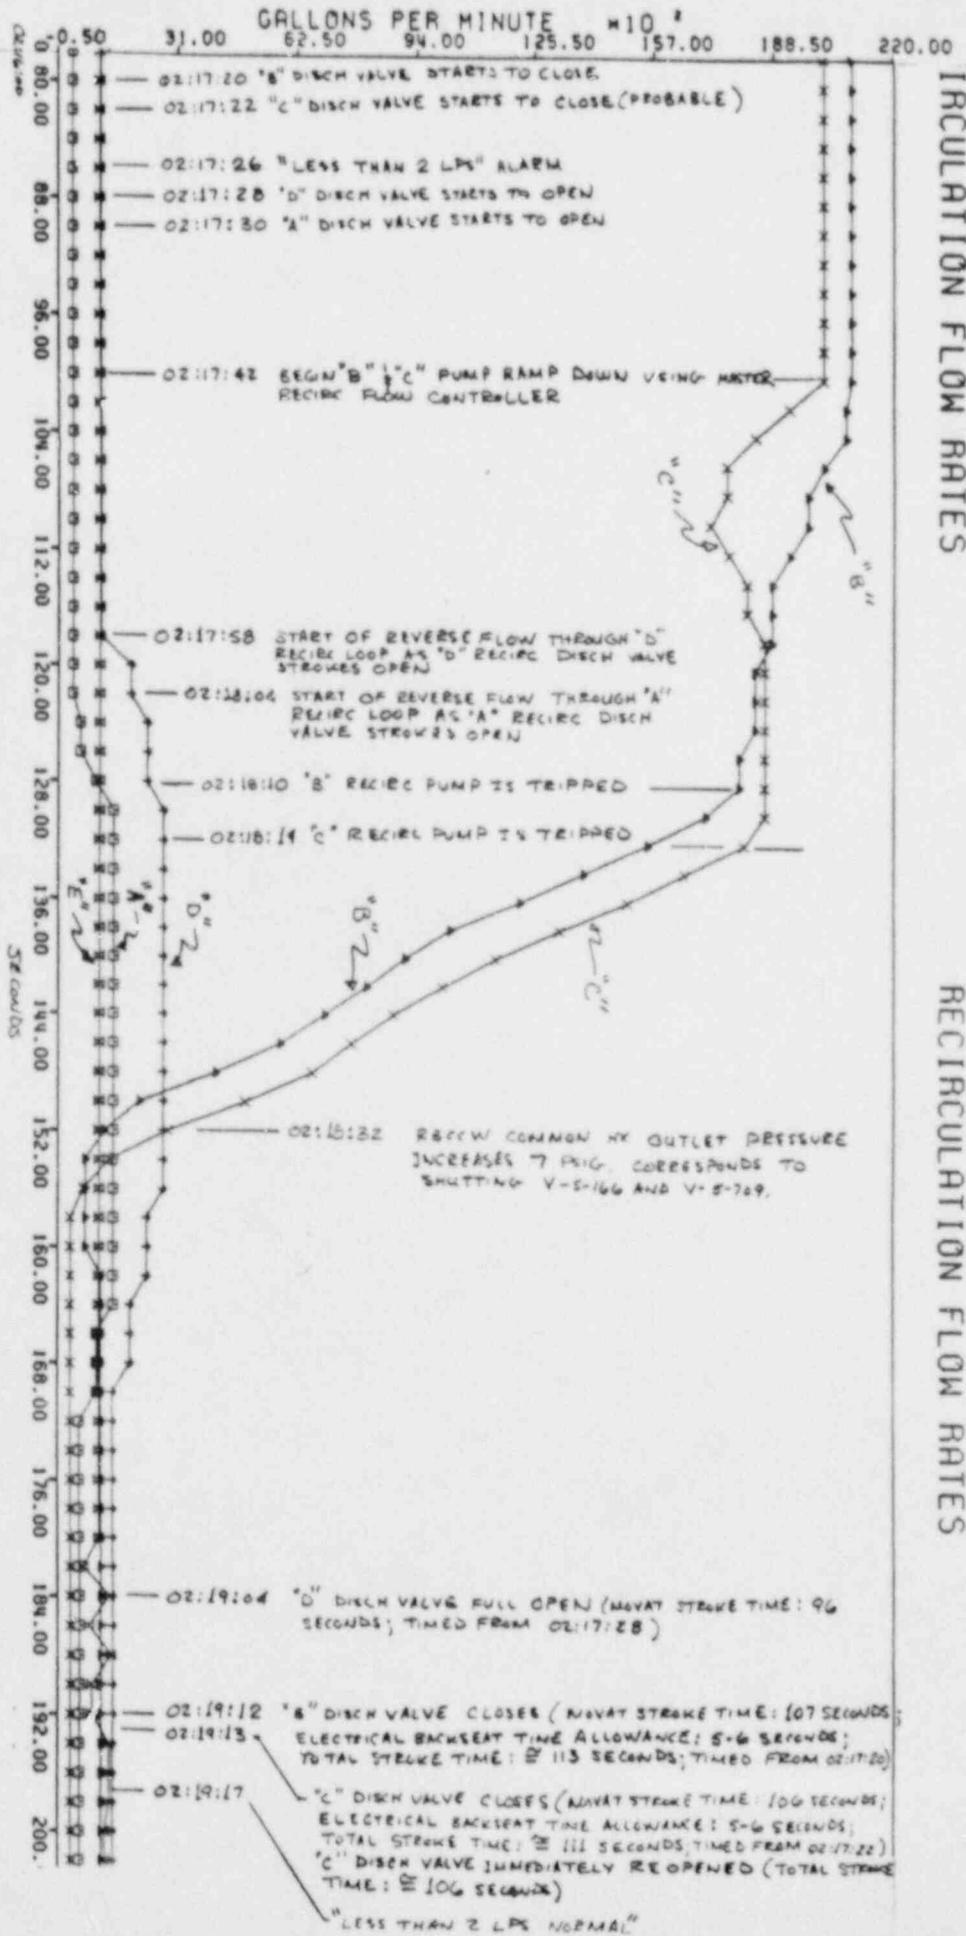
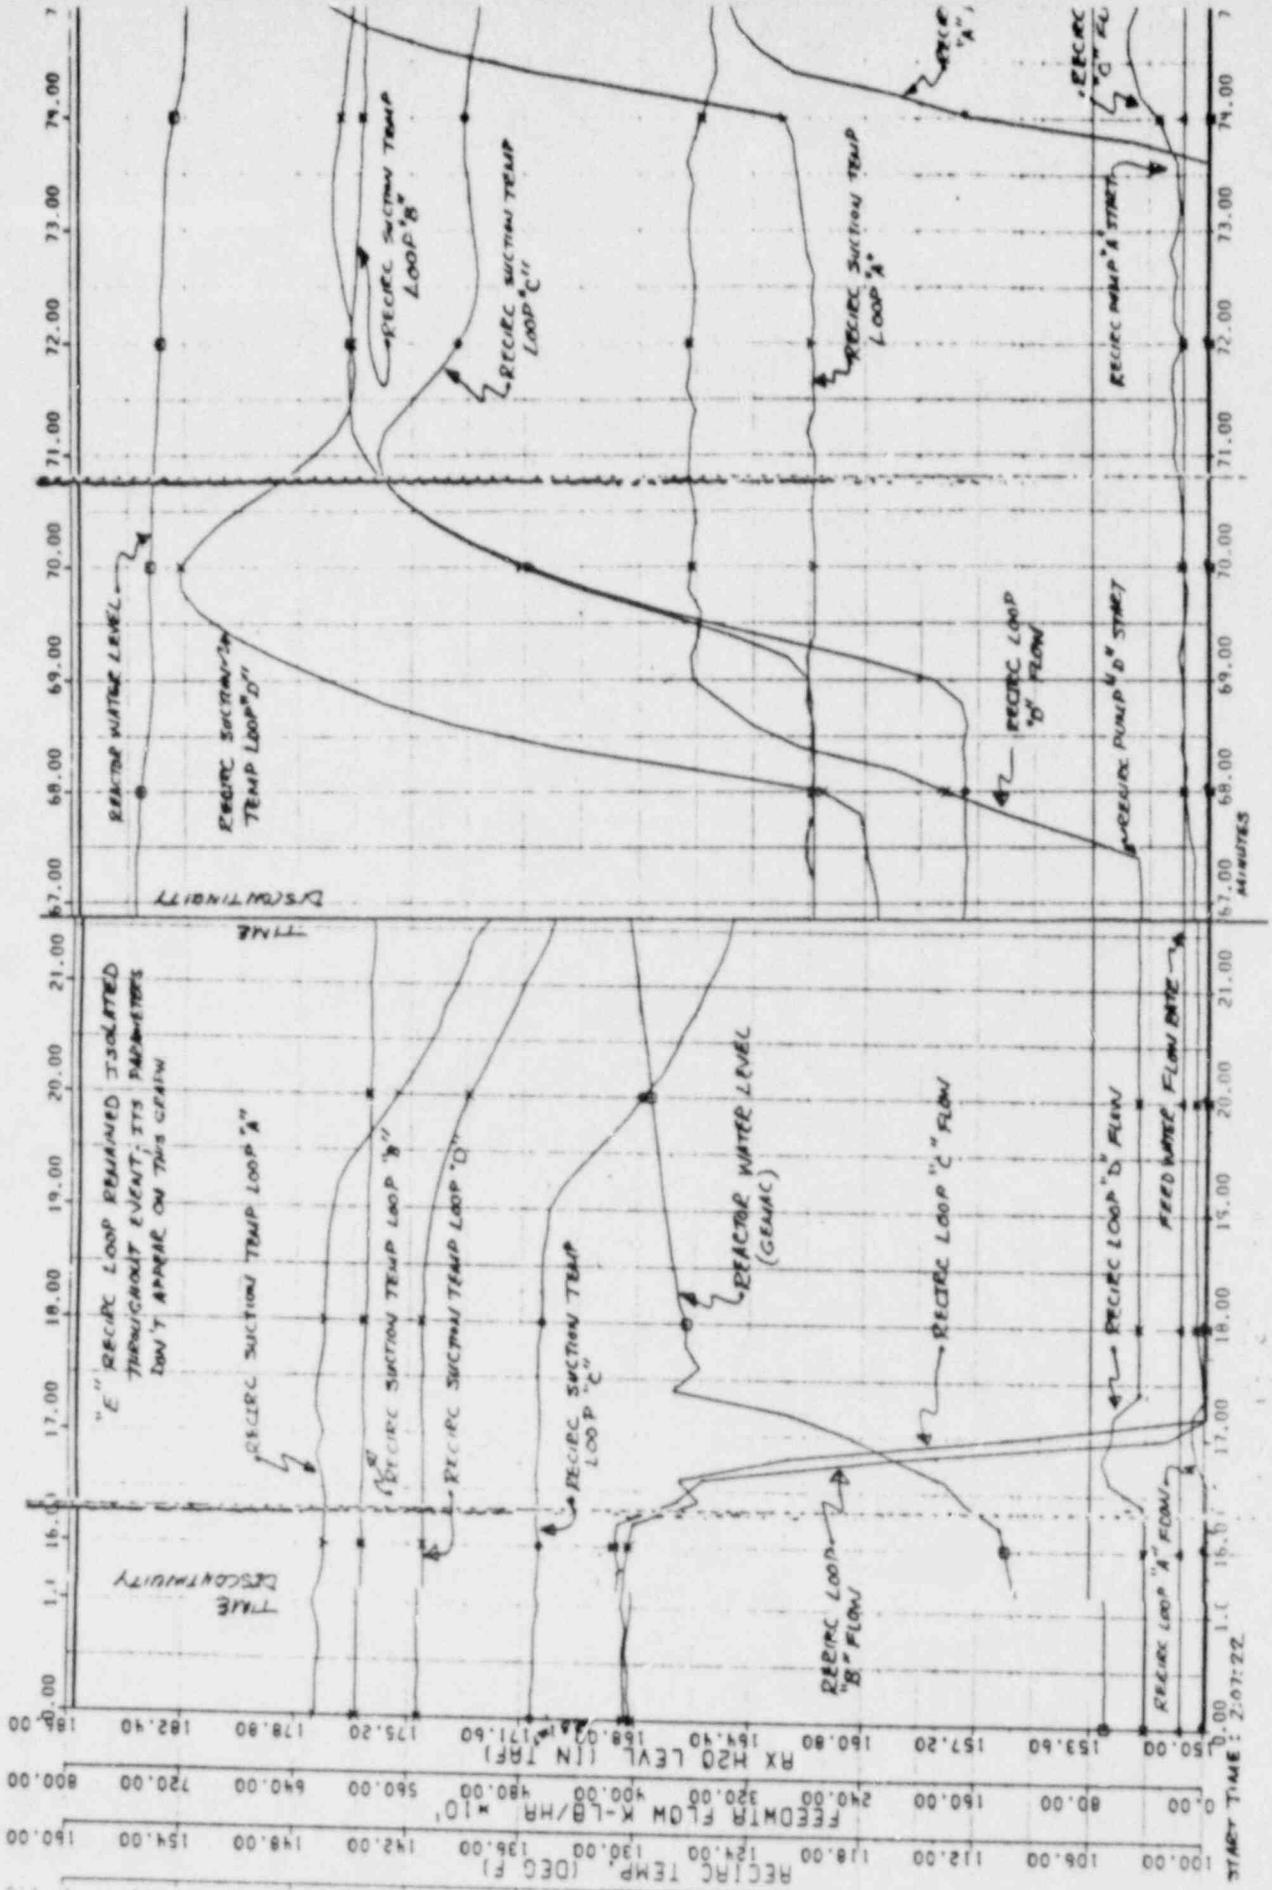
FIGURE 4

After the initial event and prior to starting recirculation pumps "A" and "D", the loop suction temperatures trended down for the open recirculation loops A, C, and D. This occurred prior to water level being raised to 185" inches above Top of Active Fuel (TAF) to facilitate natural circulation and shutdown cooling flow. Prior to this time, shutdown cooling flow likely was backflowing in the open recirculation loops to cause the suction temperature decline as indicated on Figure 4. Almost 40 minutes after the event, the "A" and "D" recirculation pumps were started causing increased reverse flow through unisolated loop "B" and "C" and increased core flow. The increased flow promoted uniform mixing of the reactor coolant and eliminated any stagnant water. As a result the loop suction temperature profiles responded as indicated in Figure 4. The maximum recirculation suction water temperature occurred at this time and was 155° F.
