# Rupture of Model 48Y UF<sub>6</sub> Cylinder and Release of Uranium Hexafluoride

Sequoyah Fuels Facility  
Gore, Oklahoma  
January 4, 1986

U.S. Nuclear Regulatory  
Commission

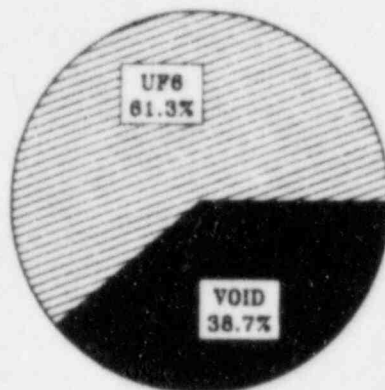
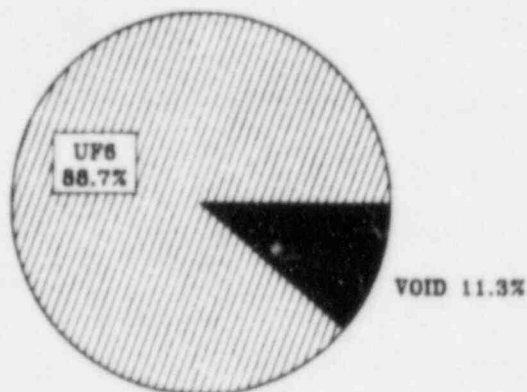
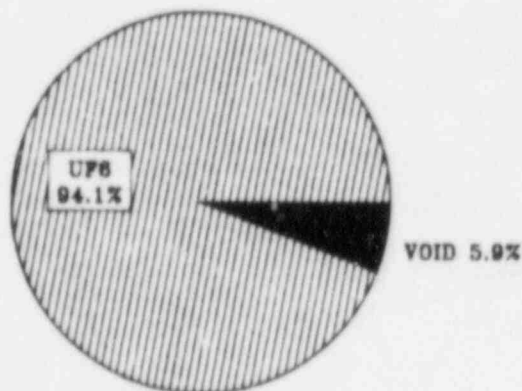
Figure 3.17  
Uranium Hexafluoride Cylinder  
Model 48Y Normally Filled  
Contents Weight: 27,560 pounds

Figure 3.17 graphically depicts the relative volumes occupied by  $\text{UF}_6$  in a normally filled cylinder when the  $\text{UF}_6$  is in the solid phase at 100°F and the liquid phase at 200°F and 250°F. The  $\text{UF}_6$  undergoes an increase in volume of about 36% when it changes from solid to liquid form at 147°F. Large internal pressures can be produced hydraulically when liquid contents expand to a volume greater than the volume of the vessel in which they are contained.
