# 1991 Annual Prelicensing Inspection of the Tuba City, Arizona, UMTRA Project Disposal Site

September 1992

U. S. Department of Energy  
Albuquerque Field Office  
Grand Junction Projects Office  
Grand Junction, Colorado

Prepared by  
Chem-Nuclear Geotech, Inc.  
Under DOE Contract No. DE-AC04-86ID12584  
U. S. Department of Energy  
Grand Junction Projects Office  
Grand Junction, Colorado

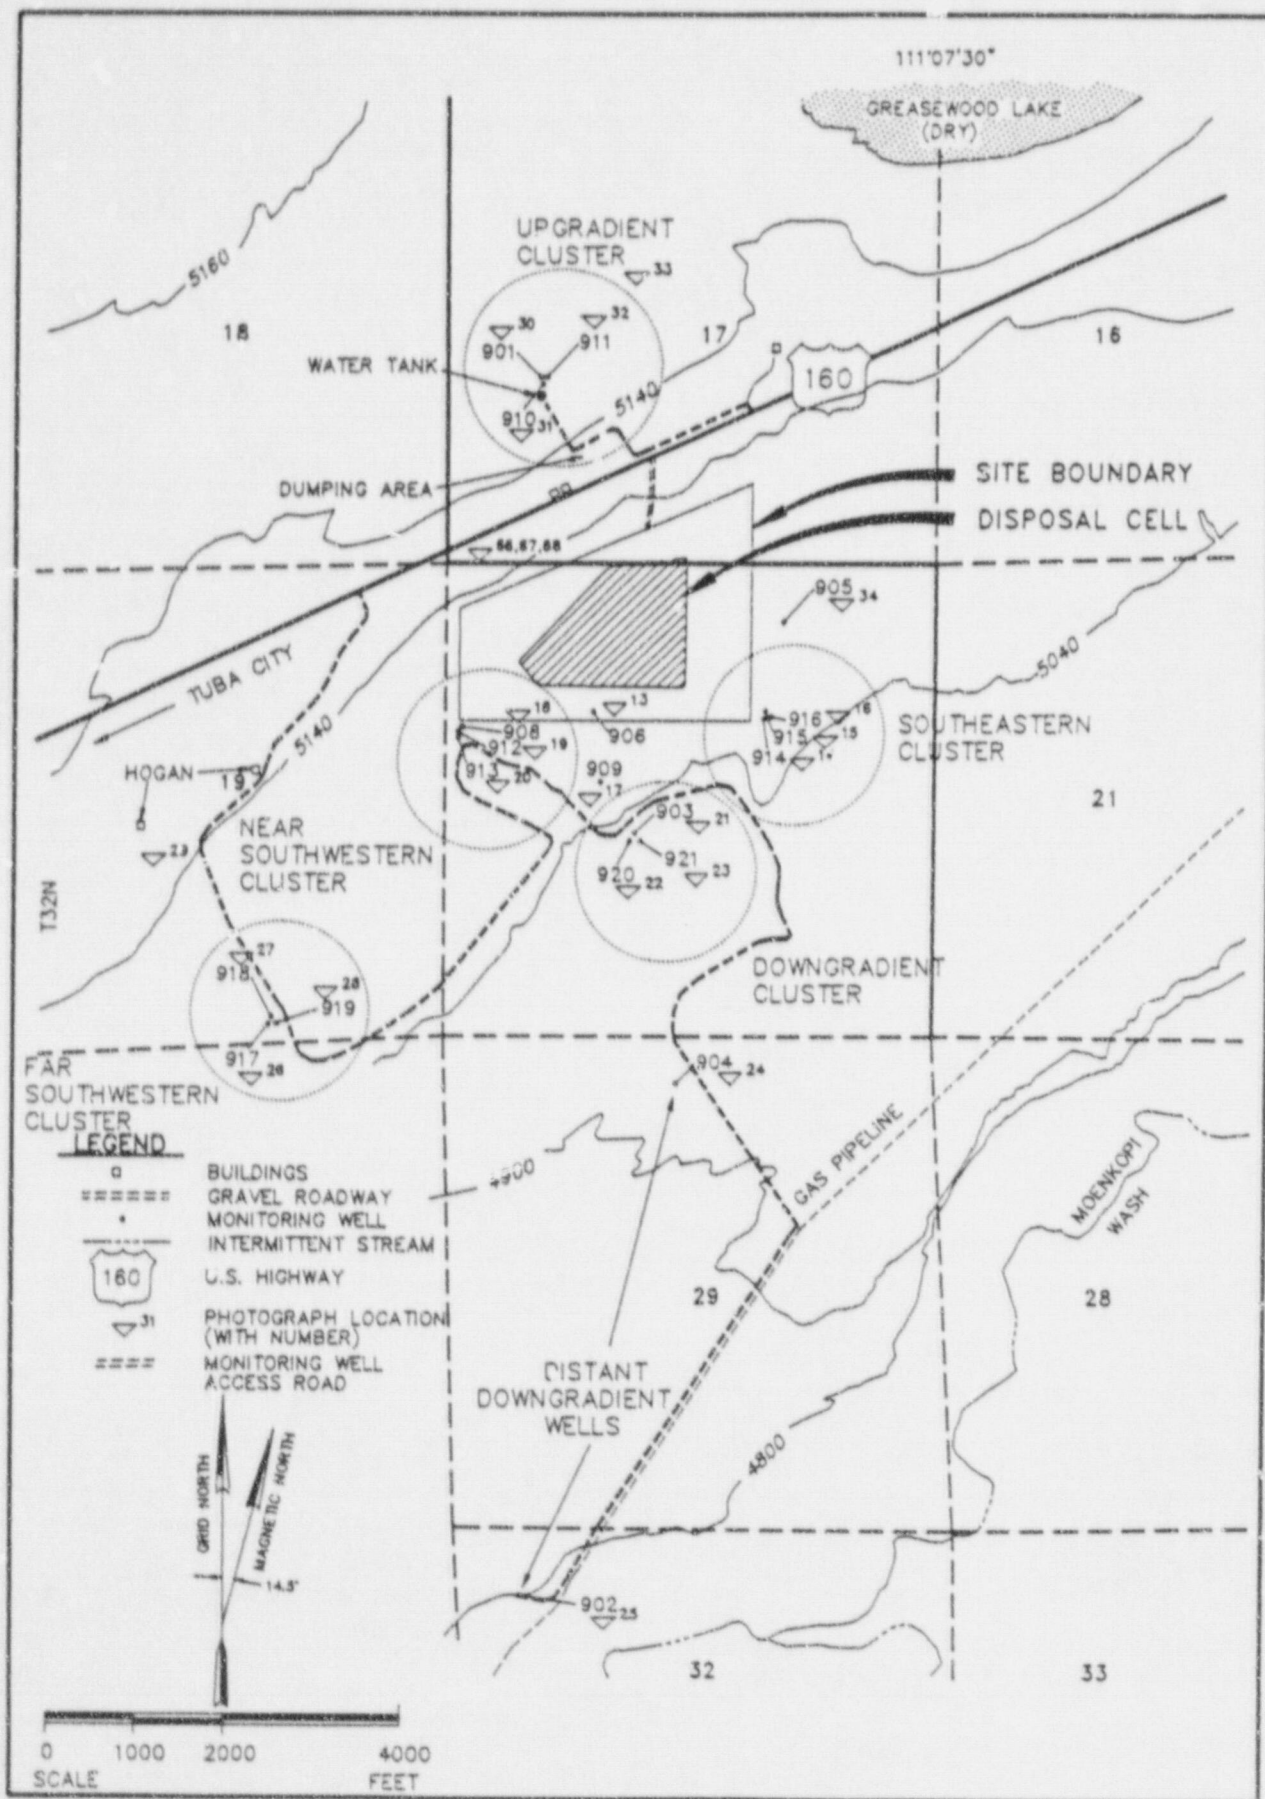
Figure 2-2. Groundwater Monitoring Wells for the Tuba City, Arizona, Disposal Site.

The area surrounding each well was inspected for signs of erosion, human activity, or other phenomena that might jeopardize the well. Nothing was seen at any of the wells to cause

concern. The only wells that appear to be in an area of noticeable or frequent human activity are the upgradient wells MW-901, MW-910, and MW-911. These wells appear to be in an area frequented by livestock (PL-29, PL-30, and PL-31), but there was no indication that the presence of livestock or their owners had an adverse affect on the wells.

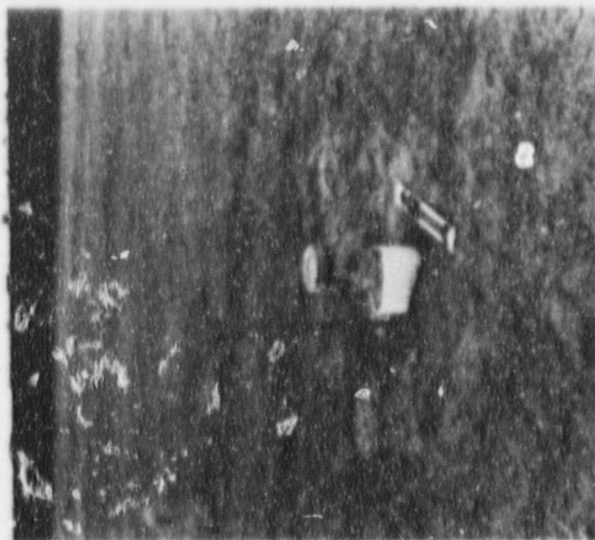
PL-12 TUB 7/91 MW-906

One monitoring well, MW-906, is within the disposal site (PL-12). The other wells are outside the site (Figure 2-2). Some of these wells are a considerable distance from the site. One well, MW-904, is approximately 1 mile from the site (PL-24); another well, MW-902, is approximately 2 miles away (PL-25). Some of the outlying wells are difficult to locate. A number of roads and tracks were used to reach the outlying wells. Some of these roads are steep where they cross arroyos and old terrace escarpments. Soft, loose sand is present on most, if not all, of the roads. A high-clearance, four-wheel drive vehicle is an advantage, if not a necessity, in reaching these wells. (An attempt will be made during the 1992 inspection to map the various roads and tracks used to reach the monitoring wells.)
