SUBJECT: POTENTIAL GENERIC ISSUE CONCERNING RING SETTINGS OF
 CROSBY SAFETY VALVES

SUBJECT: IE NOTICE REGARDING MAIN STEAM SAFETY
VALVE TEST FAILURES AT WYLE LABORATORIES

IE Information Notice No.: 85-xx MAIN STEAM SAFETY VALVE TEST FAILURES AND RING SETTING ADJUSTMENTS

IE INFORMATION NOTICE NO. 86-05: MAIN STEAM SAFETY VALVE TEST FAILURES AND RING SETTING ADJUSTMENTS

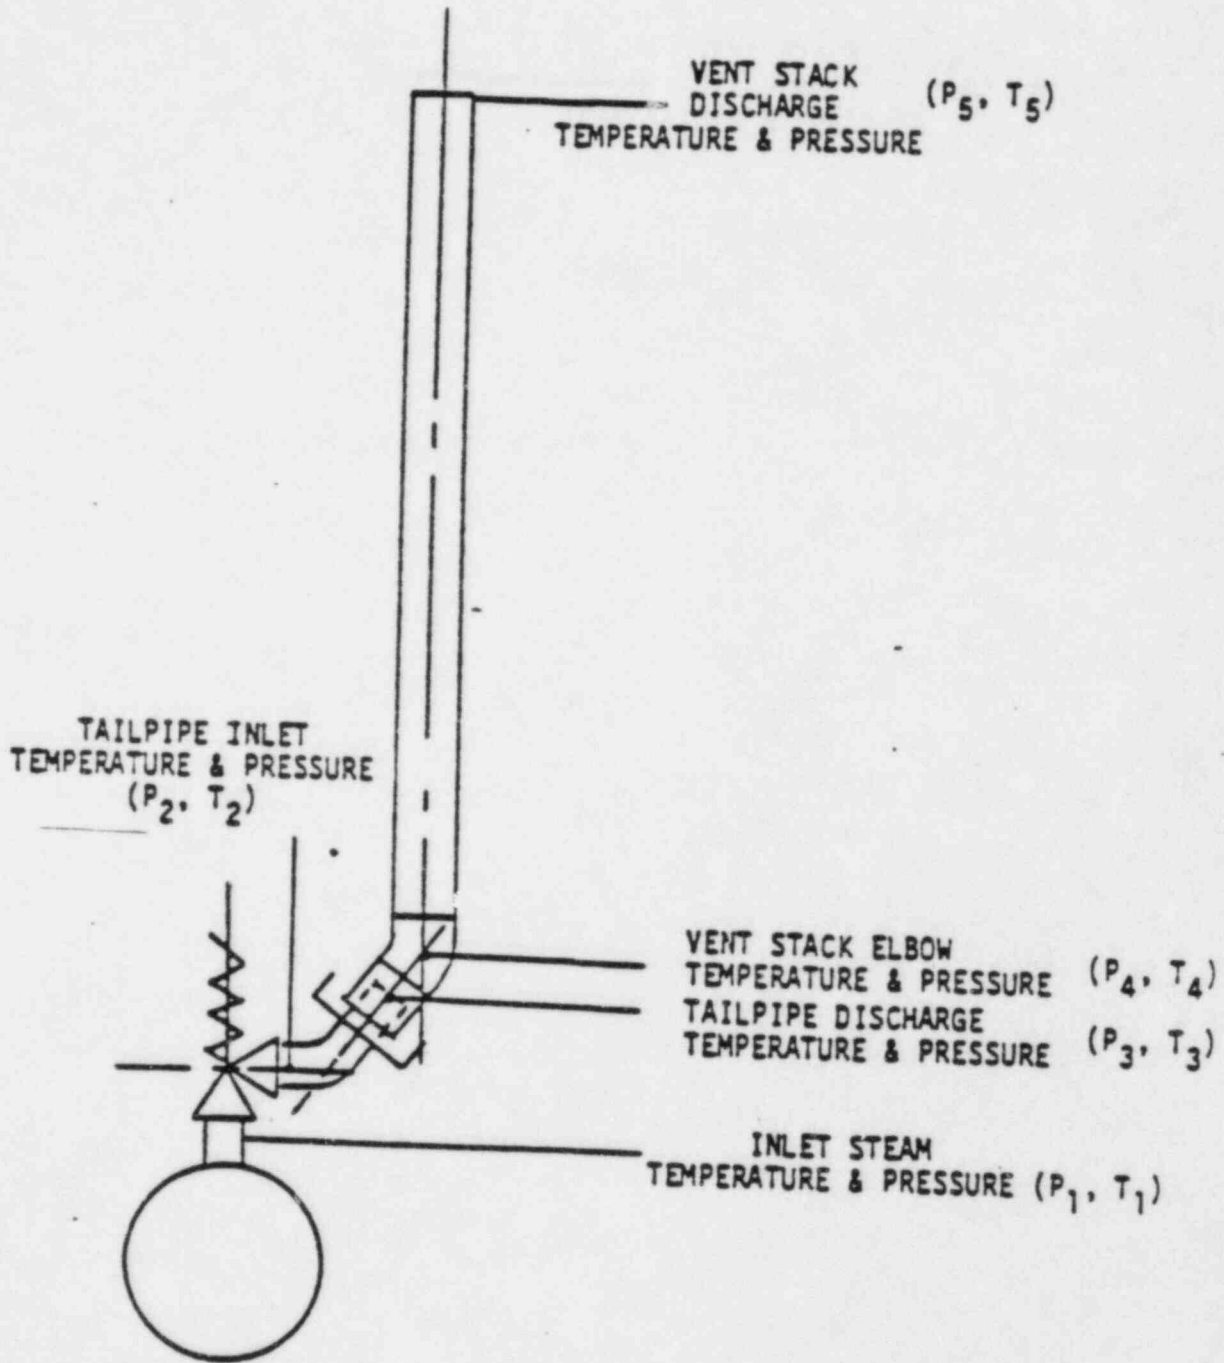
FIGURE 1. INSTRUMENTATION LOCATIONS (16, 18, AND 20-INCH VENT STACKS)

- PROBLEM - FULL FLOW TEST RESULTS INDICATE SPRING-ACTUATED MAIN STEAM SAFETY VALVES MAY NOT ACHIEVE RATED FLOW CAPACITY.
- SAFETY SIGNIFICANCE - POSSIBLE INADEQUATE OVERPRESSURE PROTECTION OF SECONDARY SYSTEM IN PWRs USING THESE VALVES
- WYLE LAB TEST RESULTS: INADEQUATE LIFT OF VALVE DISK (ABOUT 50%) WITH THE VENDOR (CROSBY) RECOMMENDED RING SETTING ADJUSTMENTS. TESTS WERE CONDUCTED TO DETERMINE ADEQUACY OF DISCHARGE PIPING.
- CORRECTIVE ACTION - RINGS READJUSTED. OBTAINED FULL LIFT ON SEABROOK VALVES
- GENERIC IMPLICATION - SEABROOK VALVES AND DISCHARGE PIPING SIMILAR TO OTHER PWRs. FULL FLOW TESTS NOT NORMALLY RUN TO ADJUST RINGS.
- NRC FOLLOWUP ACTION: -
 - (1) DEVELOPING IE INFORMATION NOTICE
 - (2) STAFF MAY PURSUE AS A GENERIC ISSUE
 - (3) DISCUSSIONS WITH CROSBY BY REGION 1 AND NRR REGARDING ADEQUACY OF VENDOR GUIDANCE AND SRV RING SETTINGS.

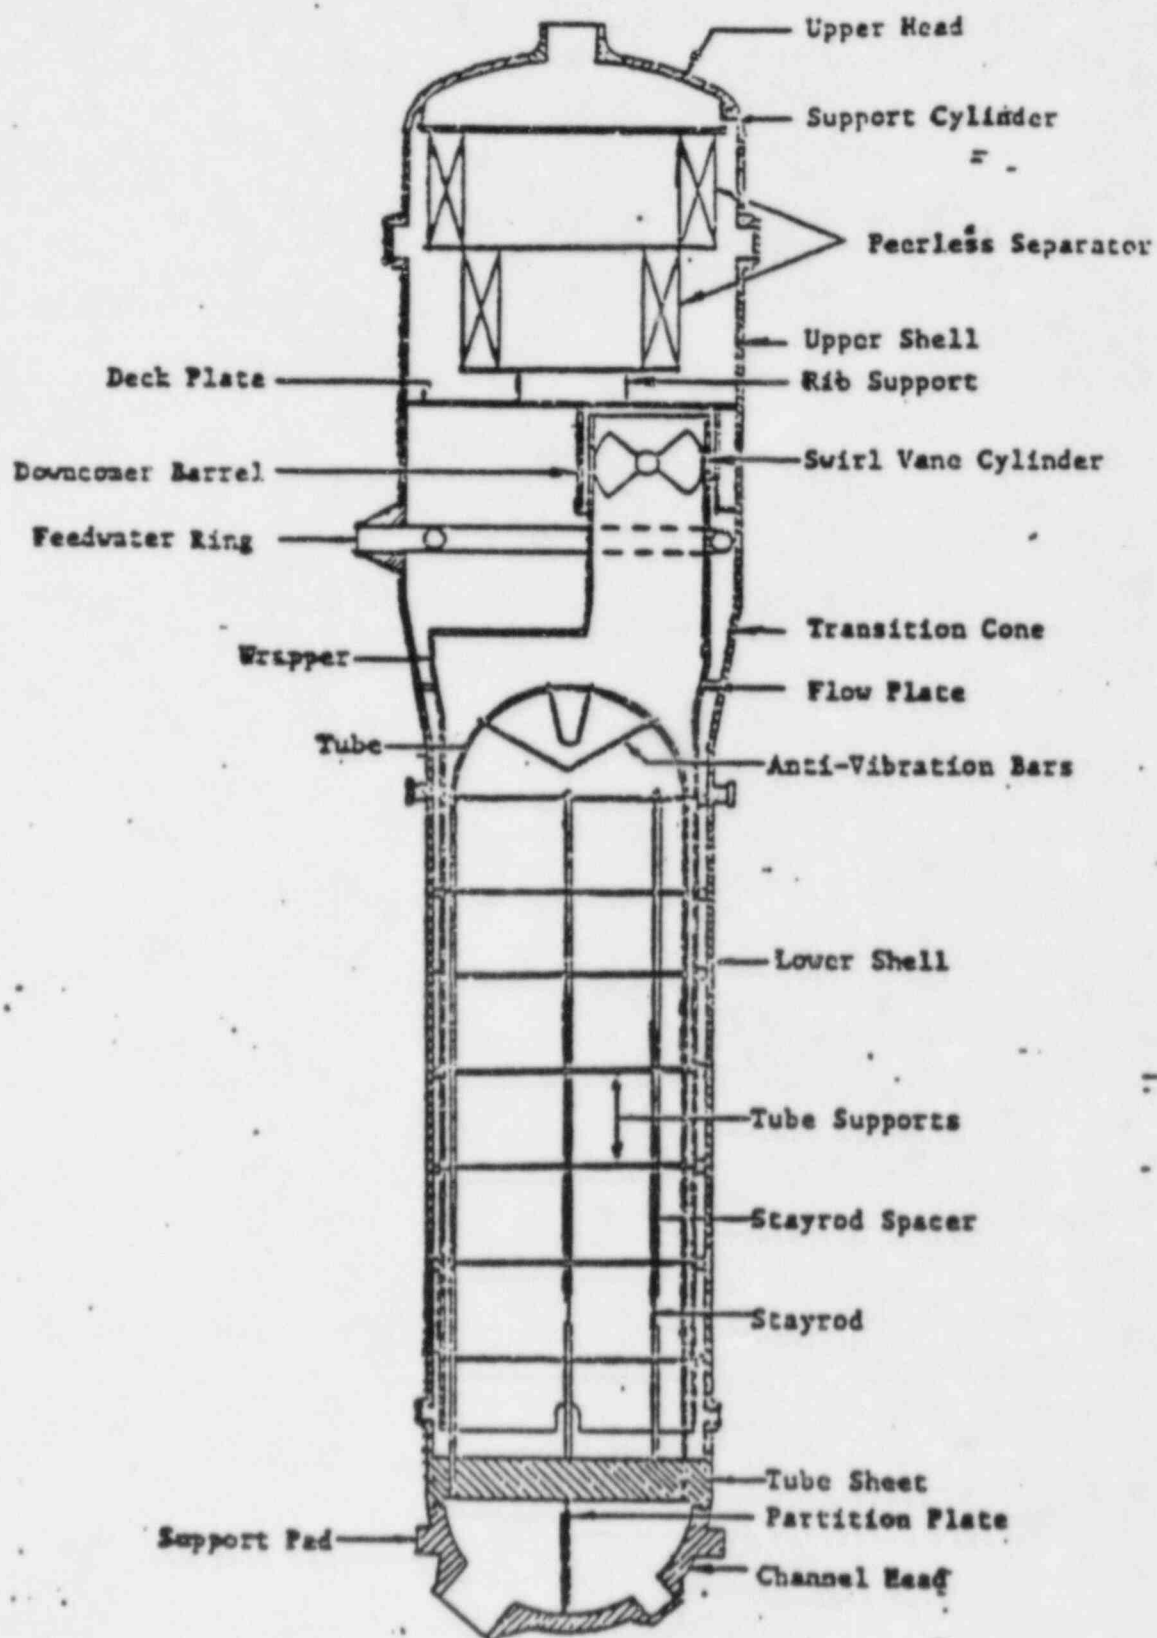
FIGURE 2.3-1
 SERIES 51 STEAM GENERATOR

- PLANT IN REFUELING STATUS
- T.S. REQUIRES INSPECTIONS OF SG TRANSITION ZONE UPPER GIRTH WELDS
- INDICATIONS FOUND BY UT:
 - SG 31 - 1
 - SG 32 - 2
 - SG 33 - 0
 - SG 34 - 23
- SG-34 HAD WELD REPAIR OF LEAK FOUND IN 1983
- MT ON SG-34 SHOWED CLEAN ON 16 OF 23 INDICATIONS
- REMAINING 7 WELD INDICATIONS ON 34, AND 3 ON 31 AND 32 WERE FOUND TO BE CODE ACCEPTABLE BY VIRTUE OF SIZE OR BY FRACTURE MECHANICS ANALYSIS
- LICENSEE STILL EVALUATING
- NRR HAS LEAD (SINCE 7/15/85)
- NRR & IE DEVELOPING GENERIC CORRESPONDENCE

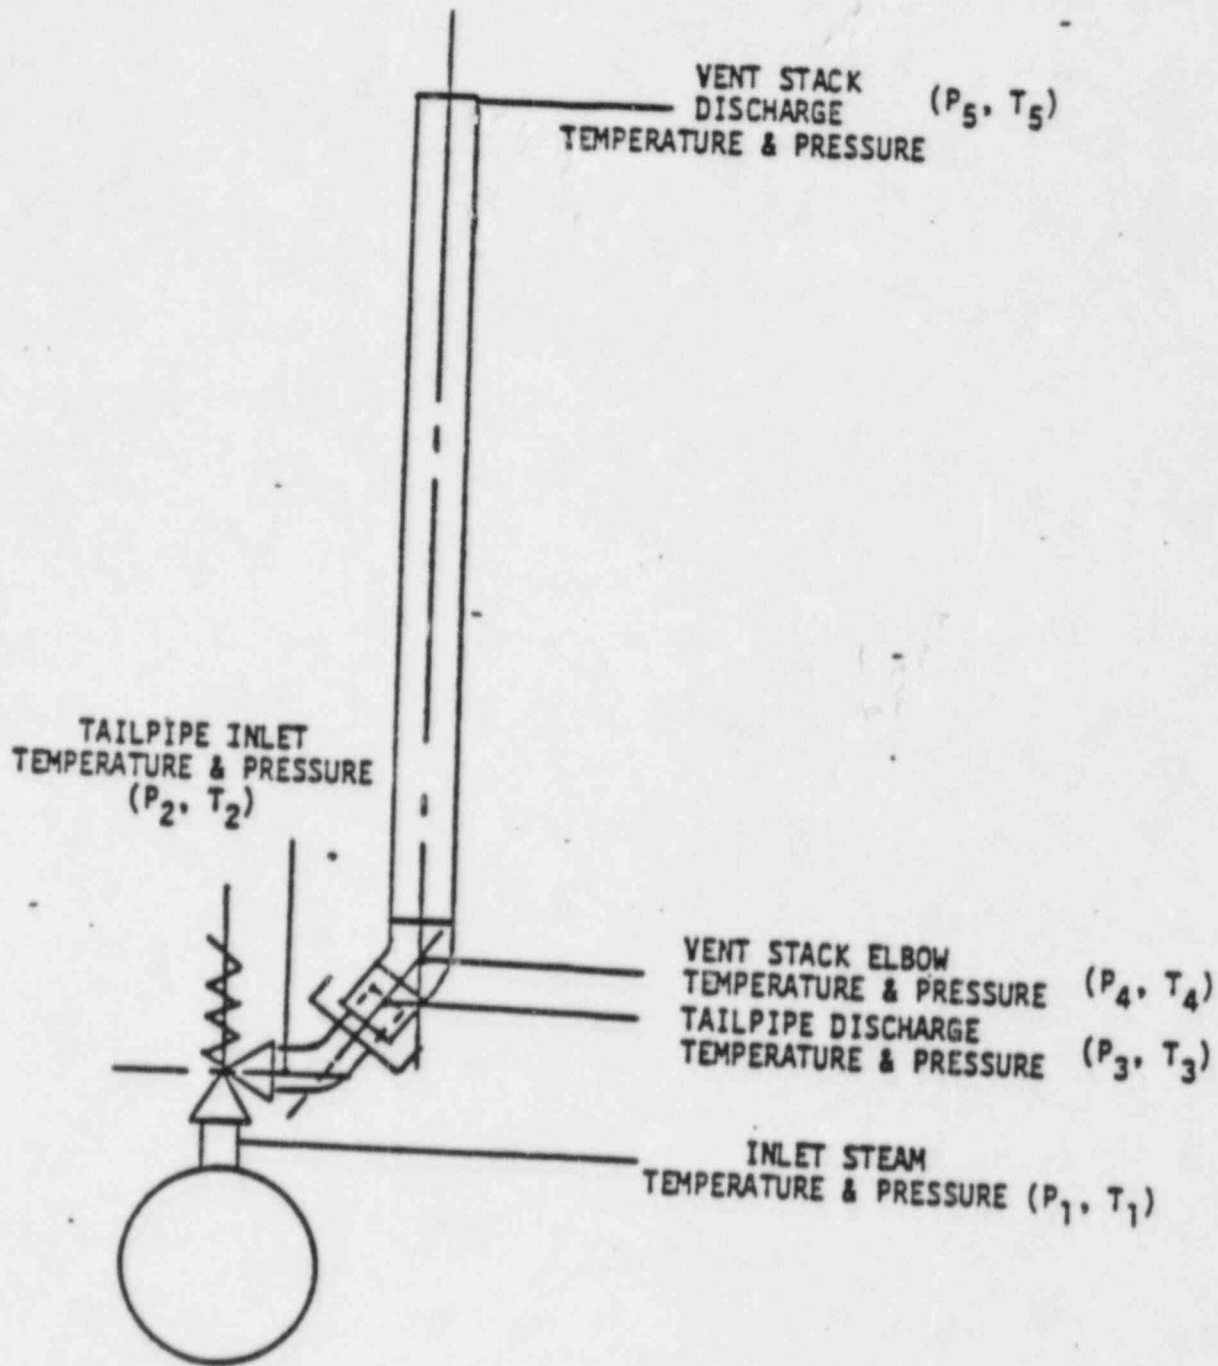
FIGURE 1. INSTRUMENTATION LOCATIONS (16, 18, AND 20-INCH VENT STACKS)

- GENERIC IMPLICATION - SEABROOK VALVES AND DISCHARGE PIPING SIMILAR TO OTHER PWRs. FULL FLOW TESTS NOT NORMALLY RUN TO ADJUST RINGS.

- NRC FOLLOWUP ACTION: -
 - (1) DEVELOPING IE INFORMATION NOTICE
 - (2) STAFF MAY PURSUE AS A GENERIC ISSUE
 - (3) DISCUSSIONS WITH CROSBY BY REGION 1 AND NRR REGARDING ADEQUACY OF VENDOR GUIDANCE AND SRV RING SETTINGS.
