UNITED STATES
NUCLEAR REGULATORY COMMISSION
REGION II
101 MARIETTA STREET, N.W.
ATLANTA, GEORGIA 30323

Report Nos.: 50-369/85-38 and 50-370/85-39

Facility Name: McGuire 1 and 2

Scope: This routine, unannounced inspection was in the area of Nuclear Service Water System Operability.

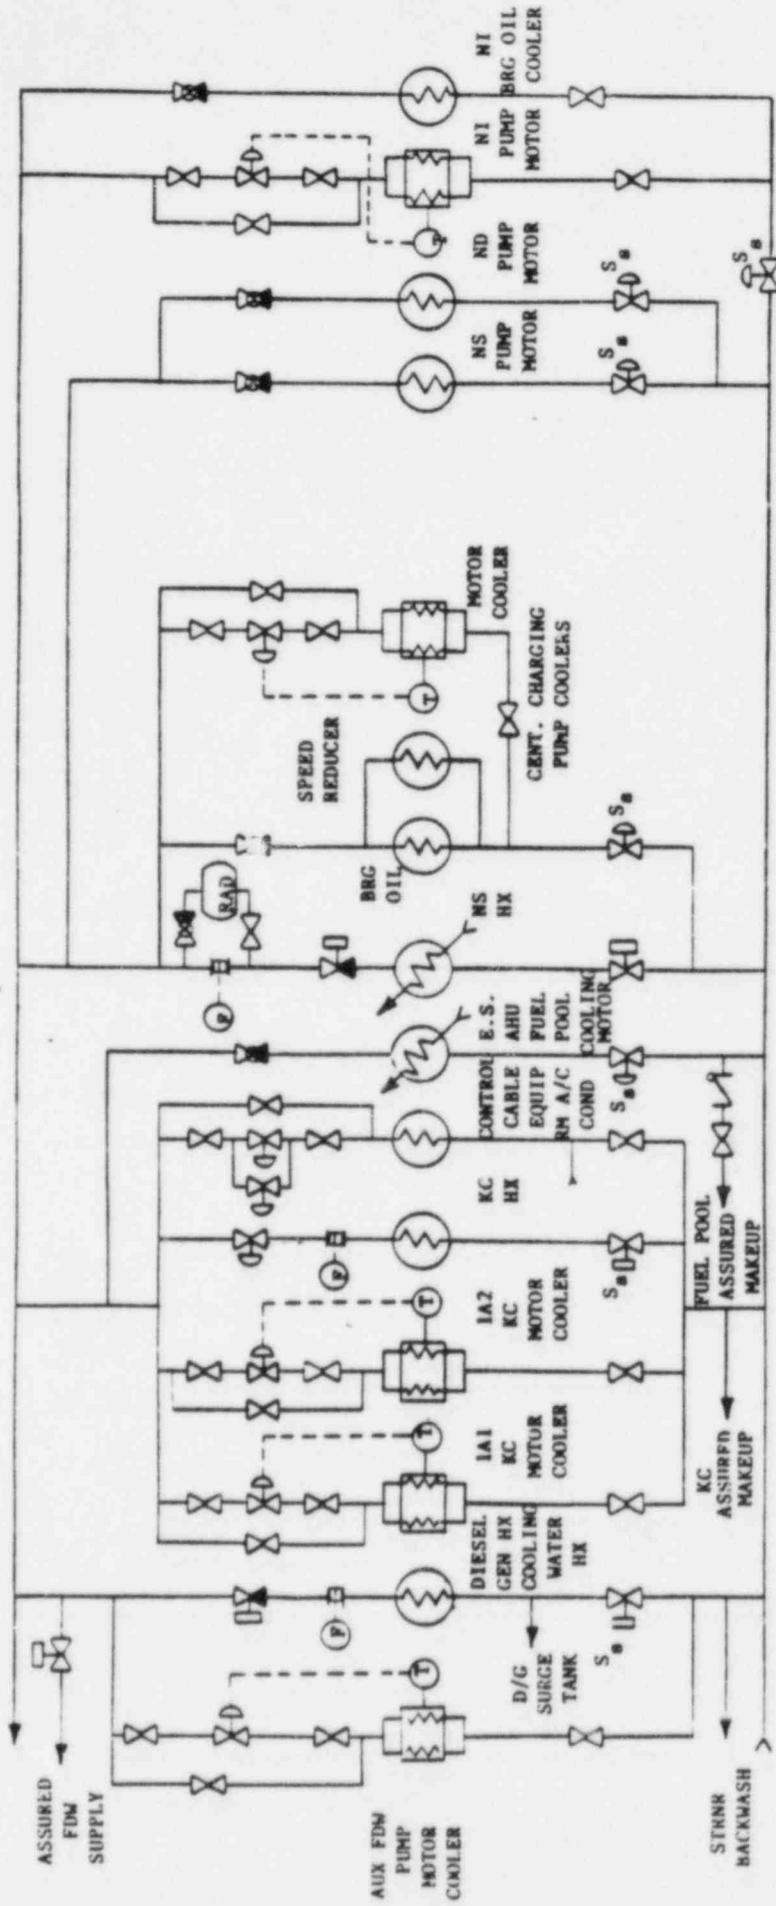
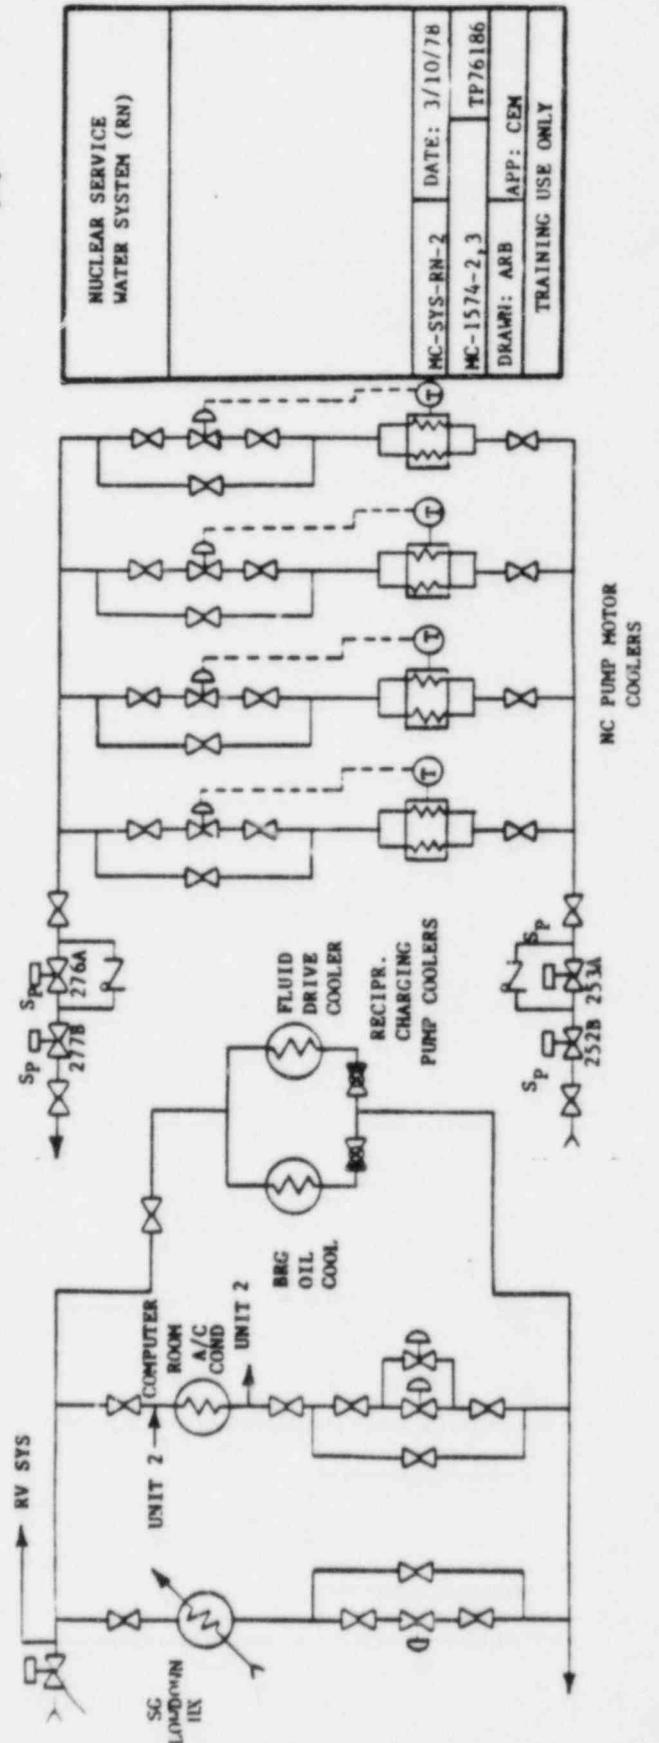
NUCLEAR SERVICE WATER SYSTEM (RN)	
MC-SYS-RN-2	DATE: 3/10/78
MC-1574-2,3	TP76186
DRAWN: ARB	APP: CEM
TRAINING USE ONLY

The inspector noted slight inaccuracies in the system piping diagrams, in that relief valve 1RN-295 is located upstream of flow element 5360 as opposed to downstream as indicated on DWG MC-1574-2.0 and vent valve 1RN141 is located upstream of flow element 5930 as opposed to downstream of the flow element as indicated on DWG MC-1574-2.0. The licensee made arrangements to correct these inaccuracies prior to the inspectors leaving the site.
