BOSTON EDISON COMPANY  
800 BOYLSTON STREET  
BOSTON, MASSACHUSETTS 02199

June 16, 1986  
BECO Ltr #86-079

Subject: Second Response to NRC Confirmatory Action  
Letter #86-10, Regarding the Events Which  
Occurred on April 4, 11-12, 1986 at Pilgrim  
Nuclear Power Station

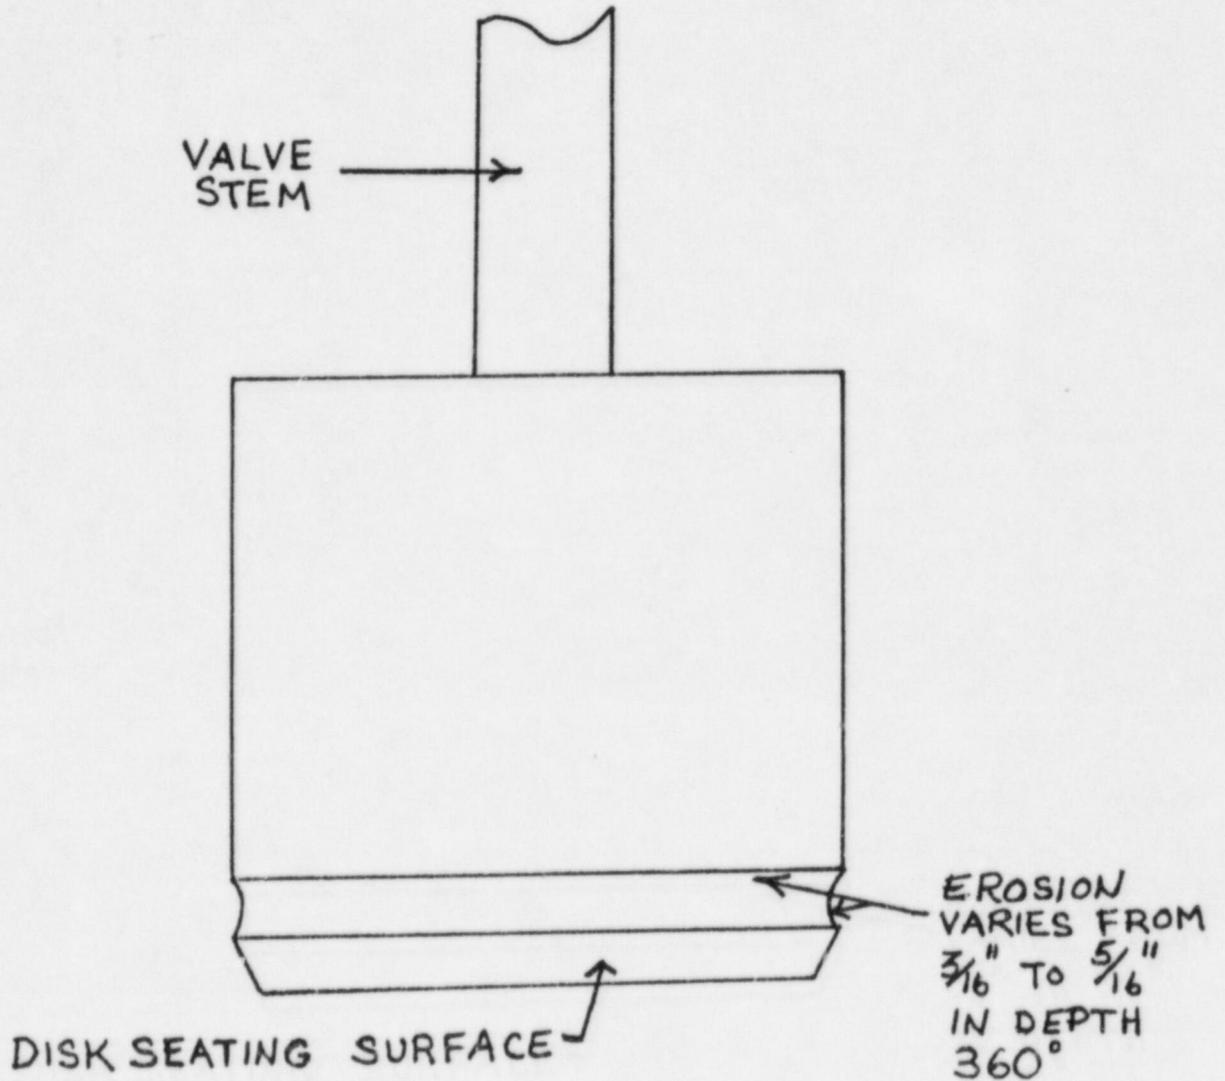
NED has responded that the root cause of the observed volumetric wear on the disk is attributed to cavitation (erosion) pitting followed by concentration cell corrosion attack. Specifically, cavitation pitting occurs initially while throttling during extended shutdown cooling service. Concentration cell corrosion attack in the resultant pits subsequently follows. The failure of the locking nut tack welds was attributed to poor weld technique during manufacture.

The wear noted is acceptable by analysis for interim operation as has been evaluated by NED to ASME III NB-3000 criteria. NED concludes that the remaining metal significantly exceeds the minimum acceptable disk thickness for postulated loads including design, emergency and faulted conditions. The wear rate will not result in an unacceptable reduction in disk thickness prior to refueling outage #7 (January 1987). This disk (for MO 1001-28B) will be removed and evaluated or restored during RFO-7 to confirm the wear rate. Disk deterioration in the form of a gross metal removal is not considered related to seat leakage. The MO 1001-28B valve will not have a motor operator torque setting in excess of 3 5/8 (as it is presently set). As a consequence of the findings on the MO 1001-28B valve, NED has concluded that similar wear may have occurred in the MO 1001-28A valve and recommends that the 1001-28A valve be disassembled and inspected at this time. This is to ascertain whether comparable disk deterioration has occurred. The valve disassembly is in progress in response to the recommendation.

Comments: SEVERE EROSION NOTED ON VALVE DISC - SEE ATTACHED SKETCH
