ROCHESTER GAS AND ELECTRIC CORPORATION . 89 EAST AVENUE, ROCHESTER, N.Y. 14649-0001

March 6, 1987

Subject: Inspection 87-03 - Environmental Qualification of Electrical Equipment 10CFR50.49 R.E. Ginna Nuclear Power Plant Docket No. 50-244

VICTOREEN HIGH-RANGE RADIATION MONITOR (PACKAGE #36)

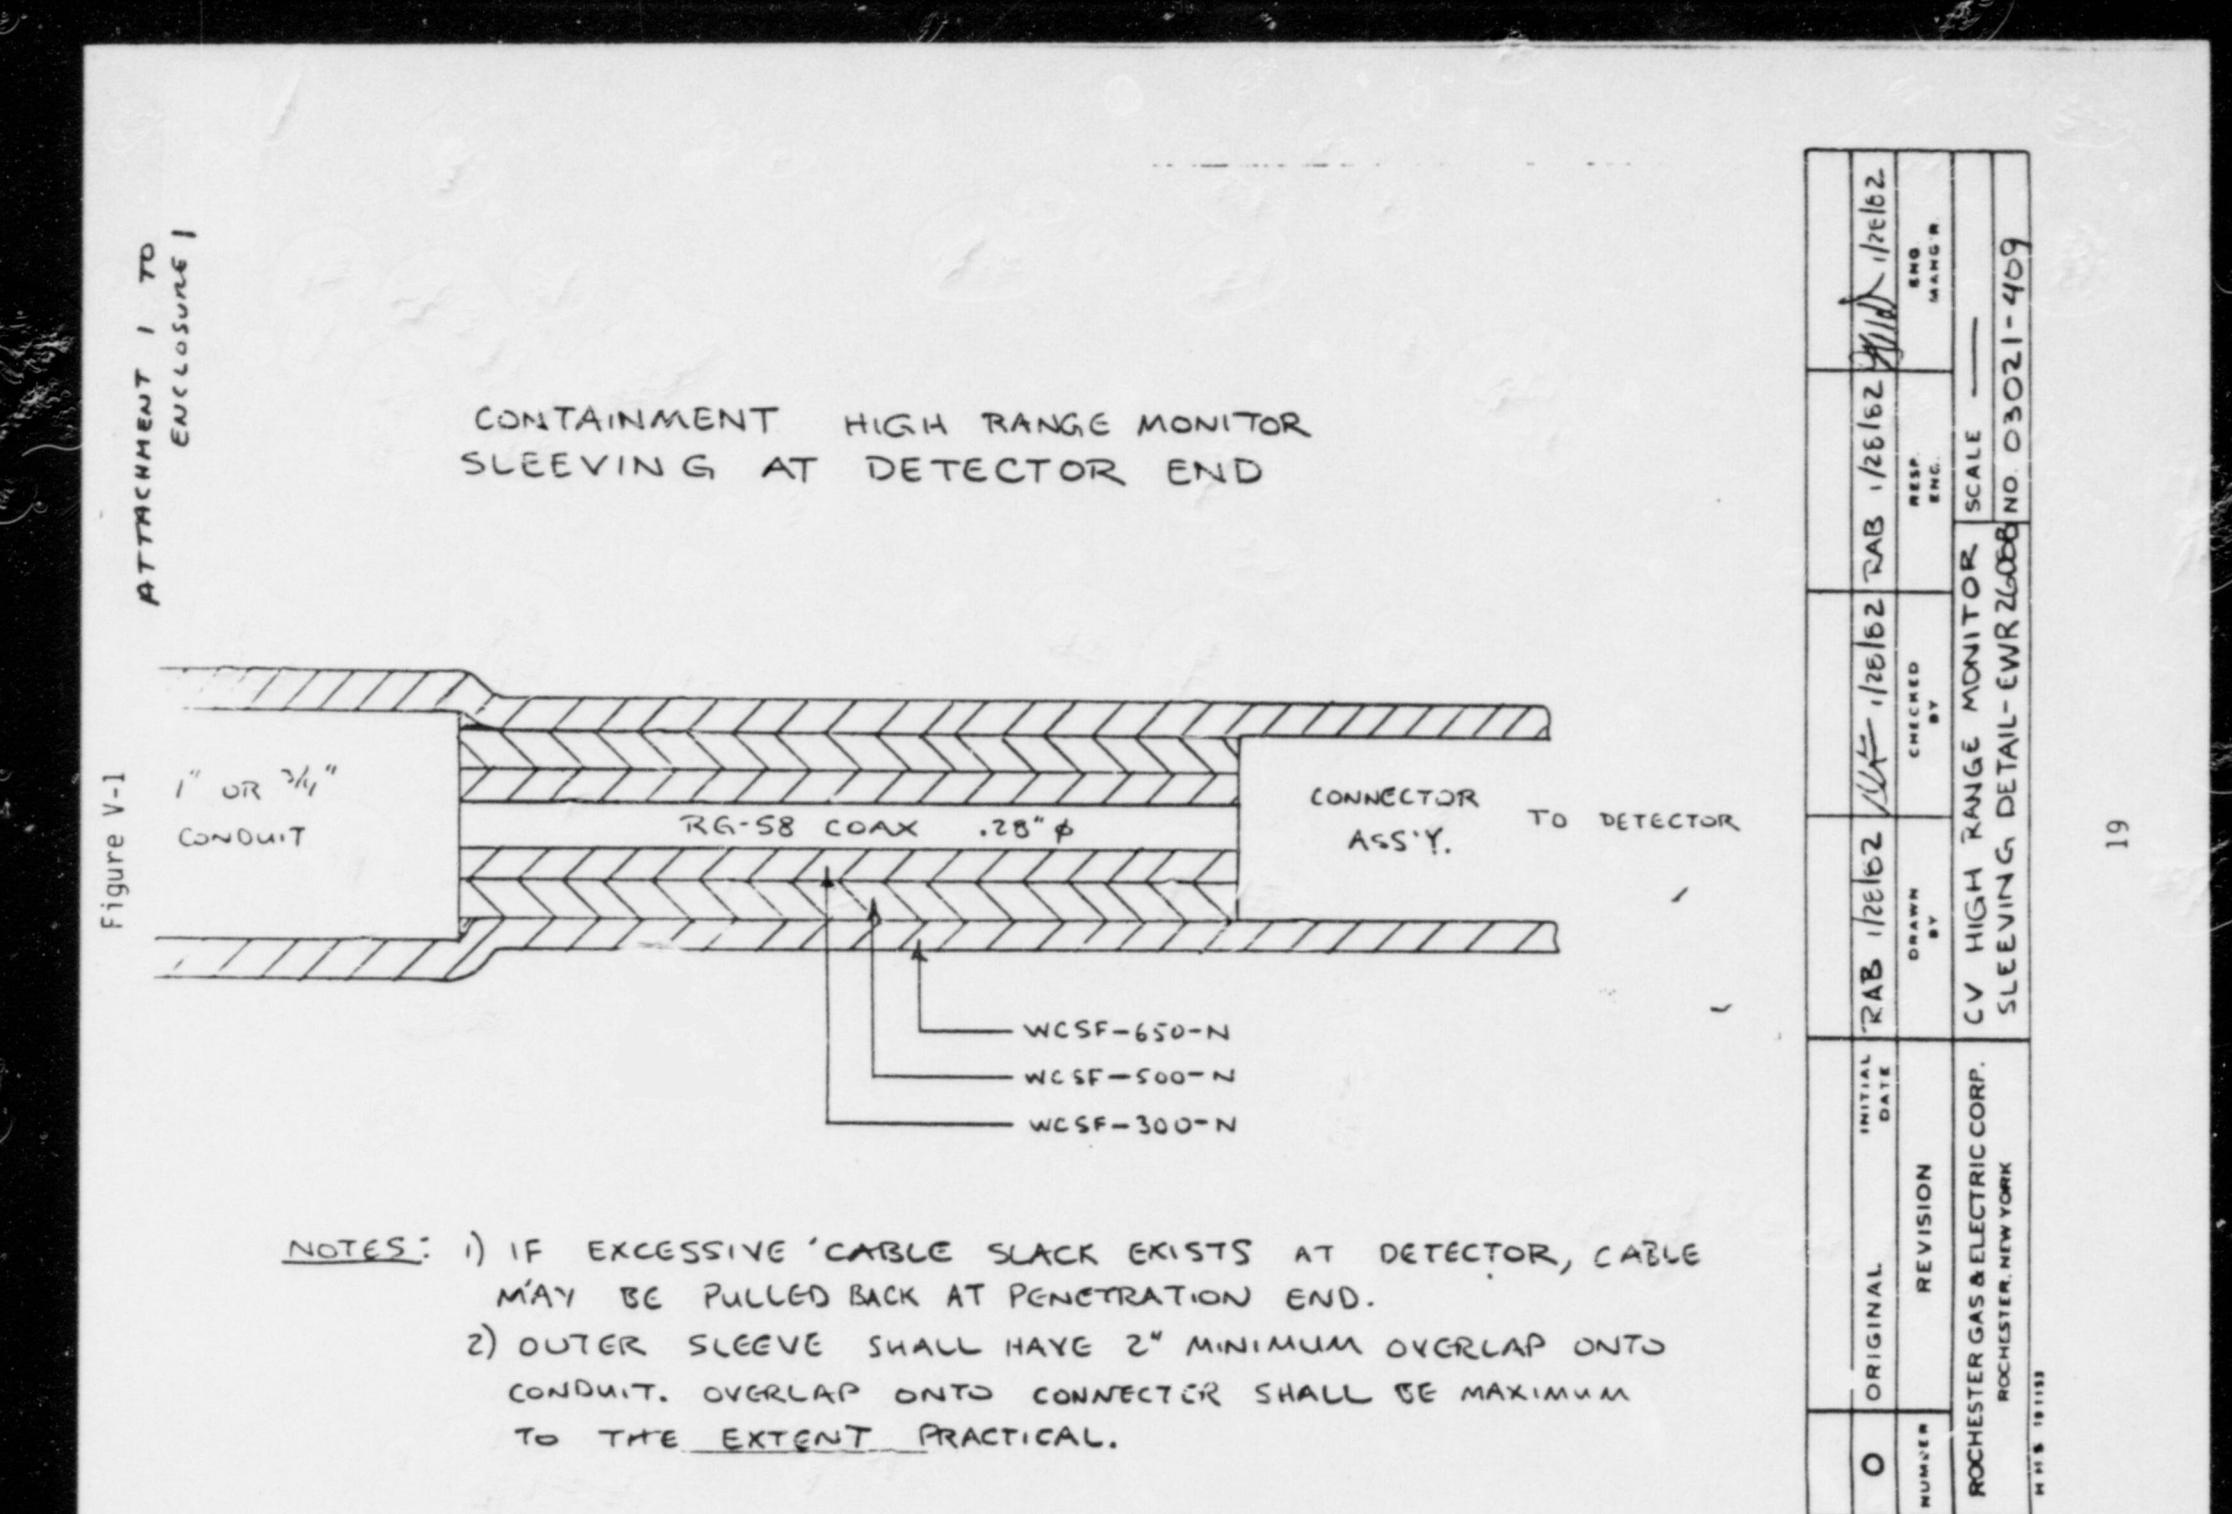
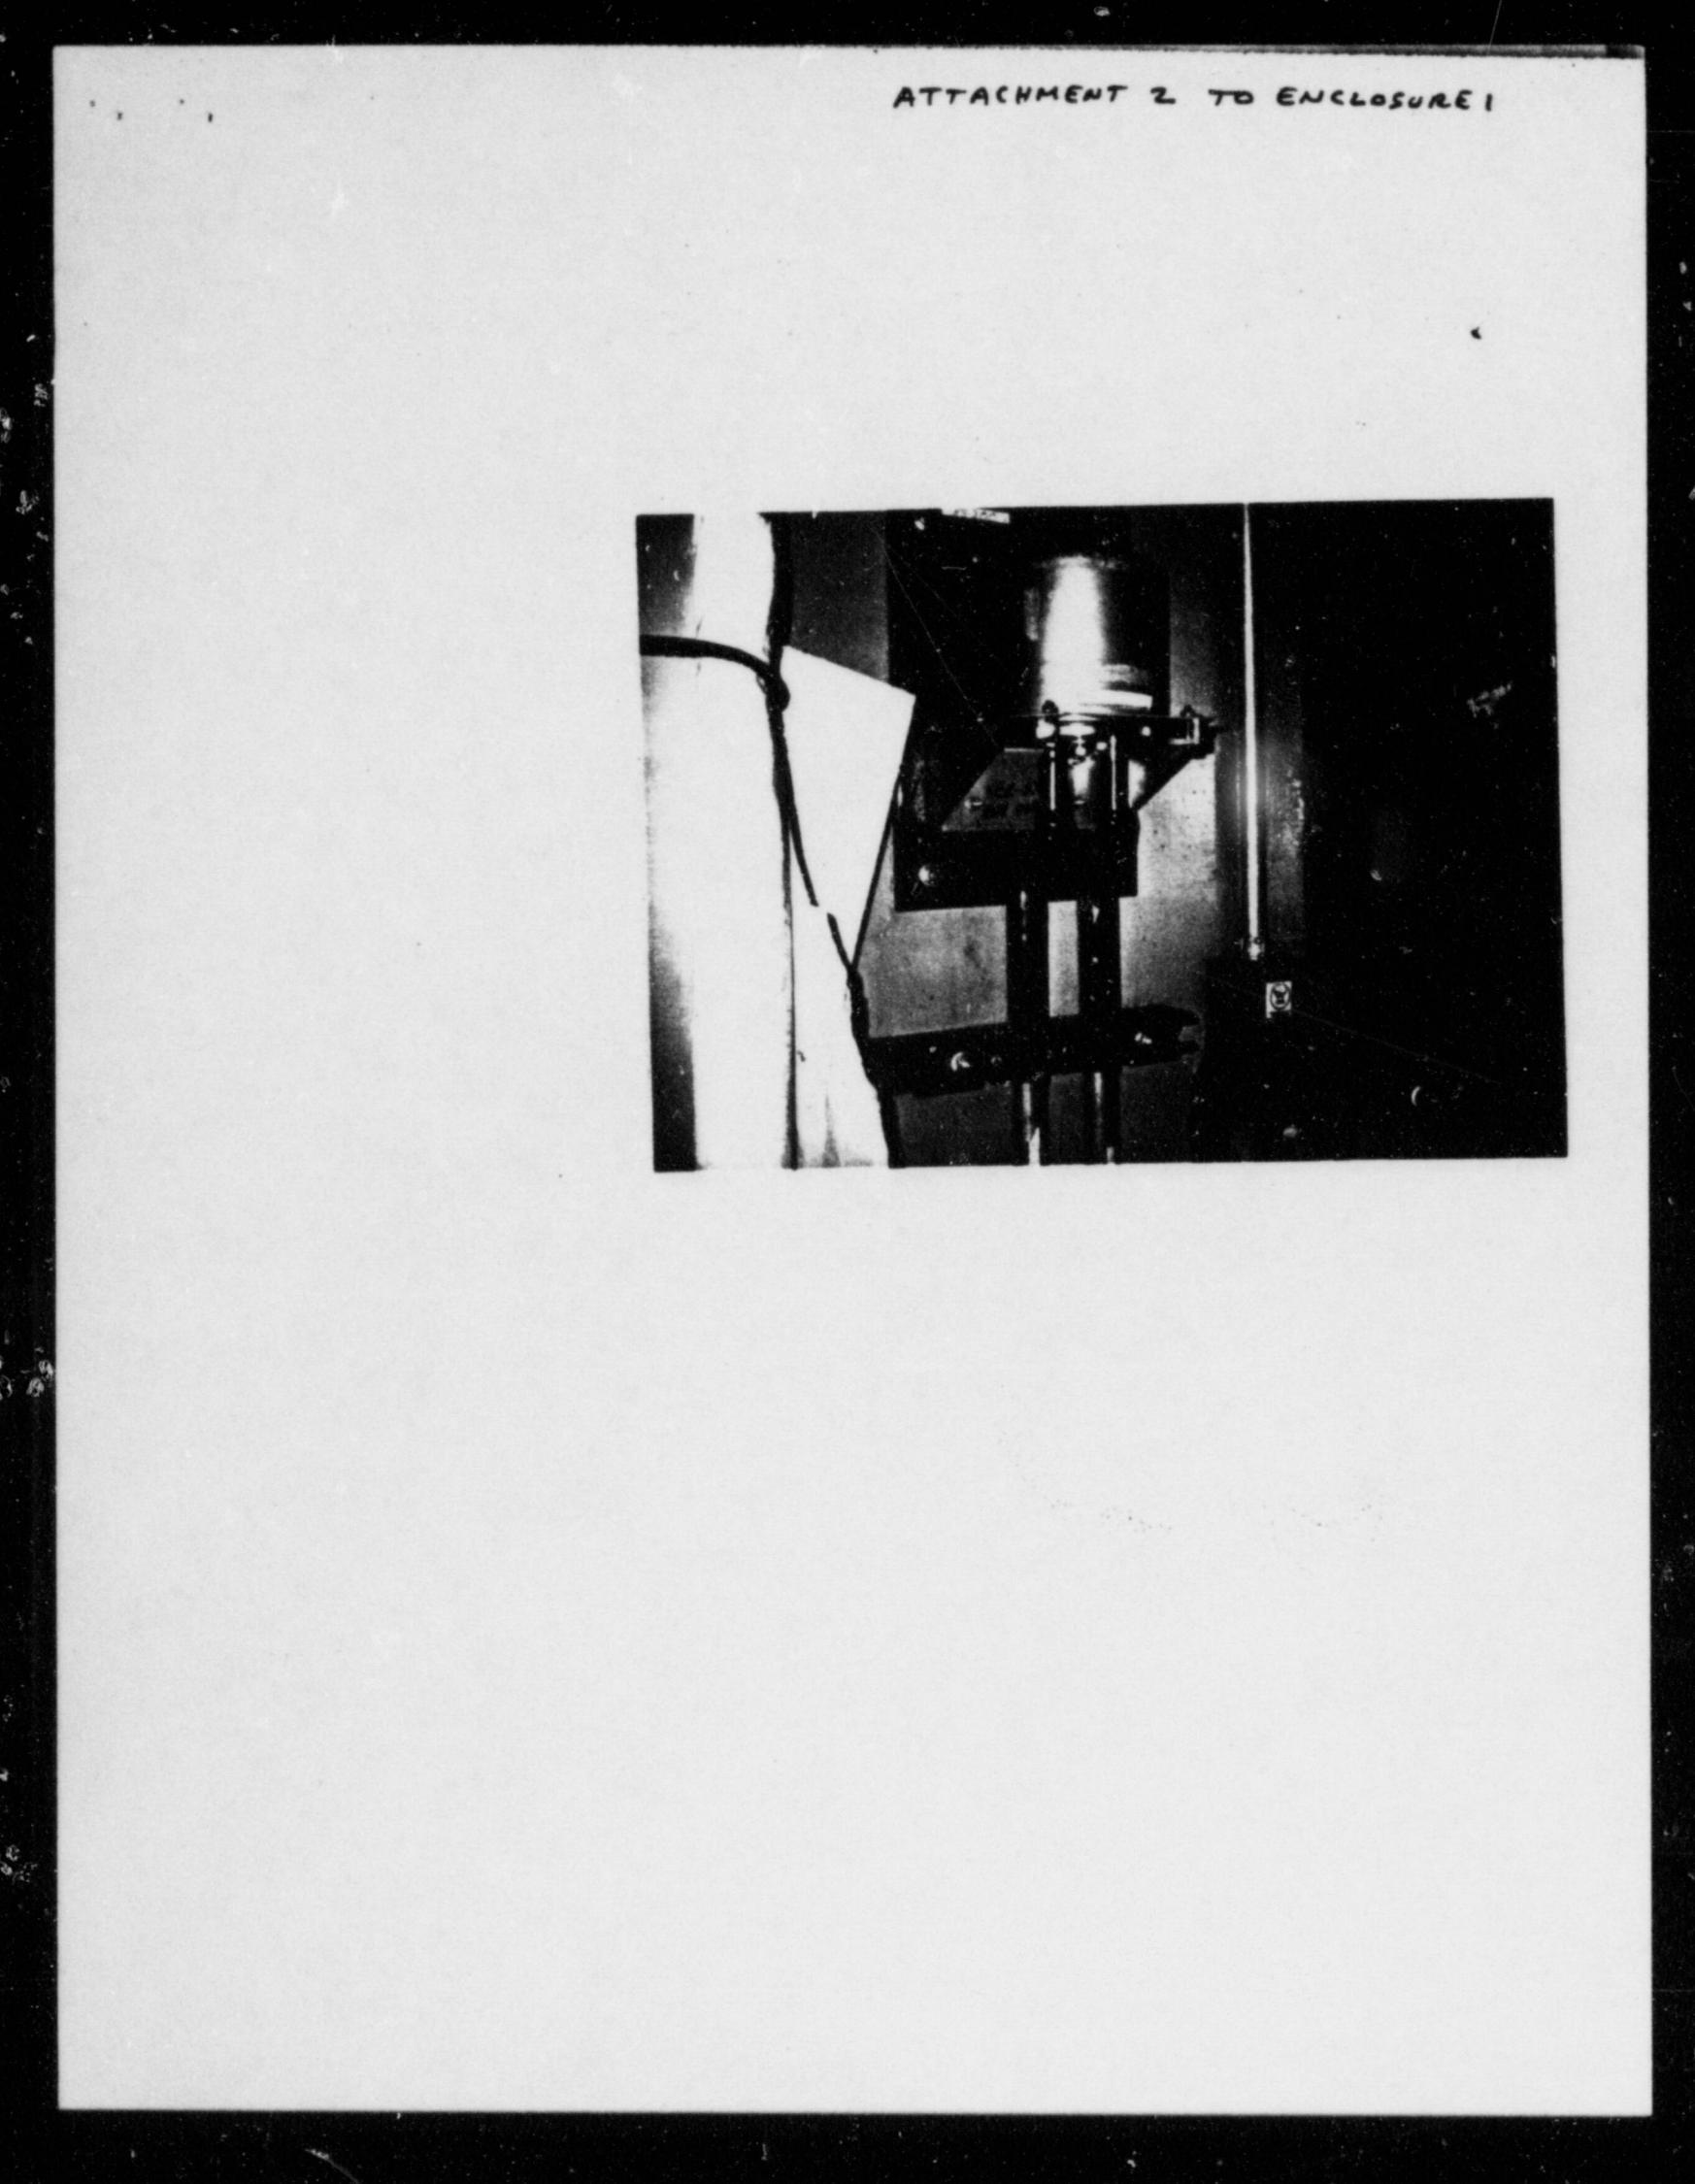
Victoreen Test Report 950.301, Section V, pages 60 and 61 (Attachment 3) lists the failure mechanisms which occurred during the unsuccessful attempts at qualification. Attachment 4 is a set of 3 drawings which show a) a detailed representation of the detector-connector cable assembly (this is an enhanced version of Figure 2, Section VI, page 51 of Victoreen Test Report 950.301), b) a representation of the failure leakage paths described in Attachment 3, and c) a comparative representation of RG&E's installed configuration. There were no failures attributed to the connection at the base of the detector.

RG&E believed then, and believes now, that the system installed is qualified to 10CFR50.49, and that the documentation in the EEQ files at RG&E at the time of the inspection properly supported this qualification basis (the only new item in this response is the photograph). Therefore, RG&E does not believe that this issue should be considered a "potential enforcement item".

As a result of the NRC inspection, RG&E has evaluated the feasibility of adding a potting material at the connector-detector interface. Even though no leakage paths were iden if ed in this area in the Victoreen test report, the effort resided to seal this area with RTV7403 is minimal. Therefore, although RG&E does not believe any safety requirement for this potting installation exists, the simplicity and minimal expense of this change is such that RG&E has added the RTV7403 (see Attachment 8). The installation of RTV7403 is identical to its application as noted in EEQ Package #36, Reference 3.b.3 (see Attachment 9 drawing, which is from that report). The adhesion of the RTV to the detector metal is demonstrated in that qualification report. RG&E takes credit only for this metal sealing and adhesion, not for the additional RTV7403 filet which overlaps the Raycnem sleeve.

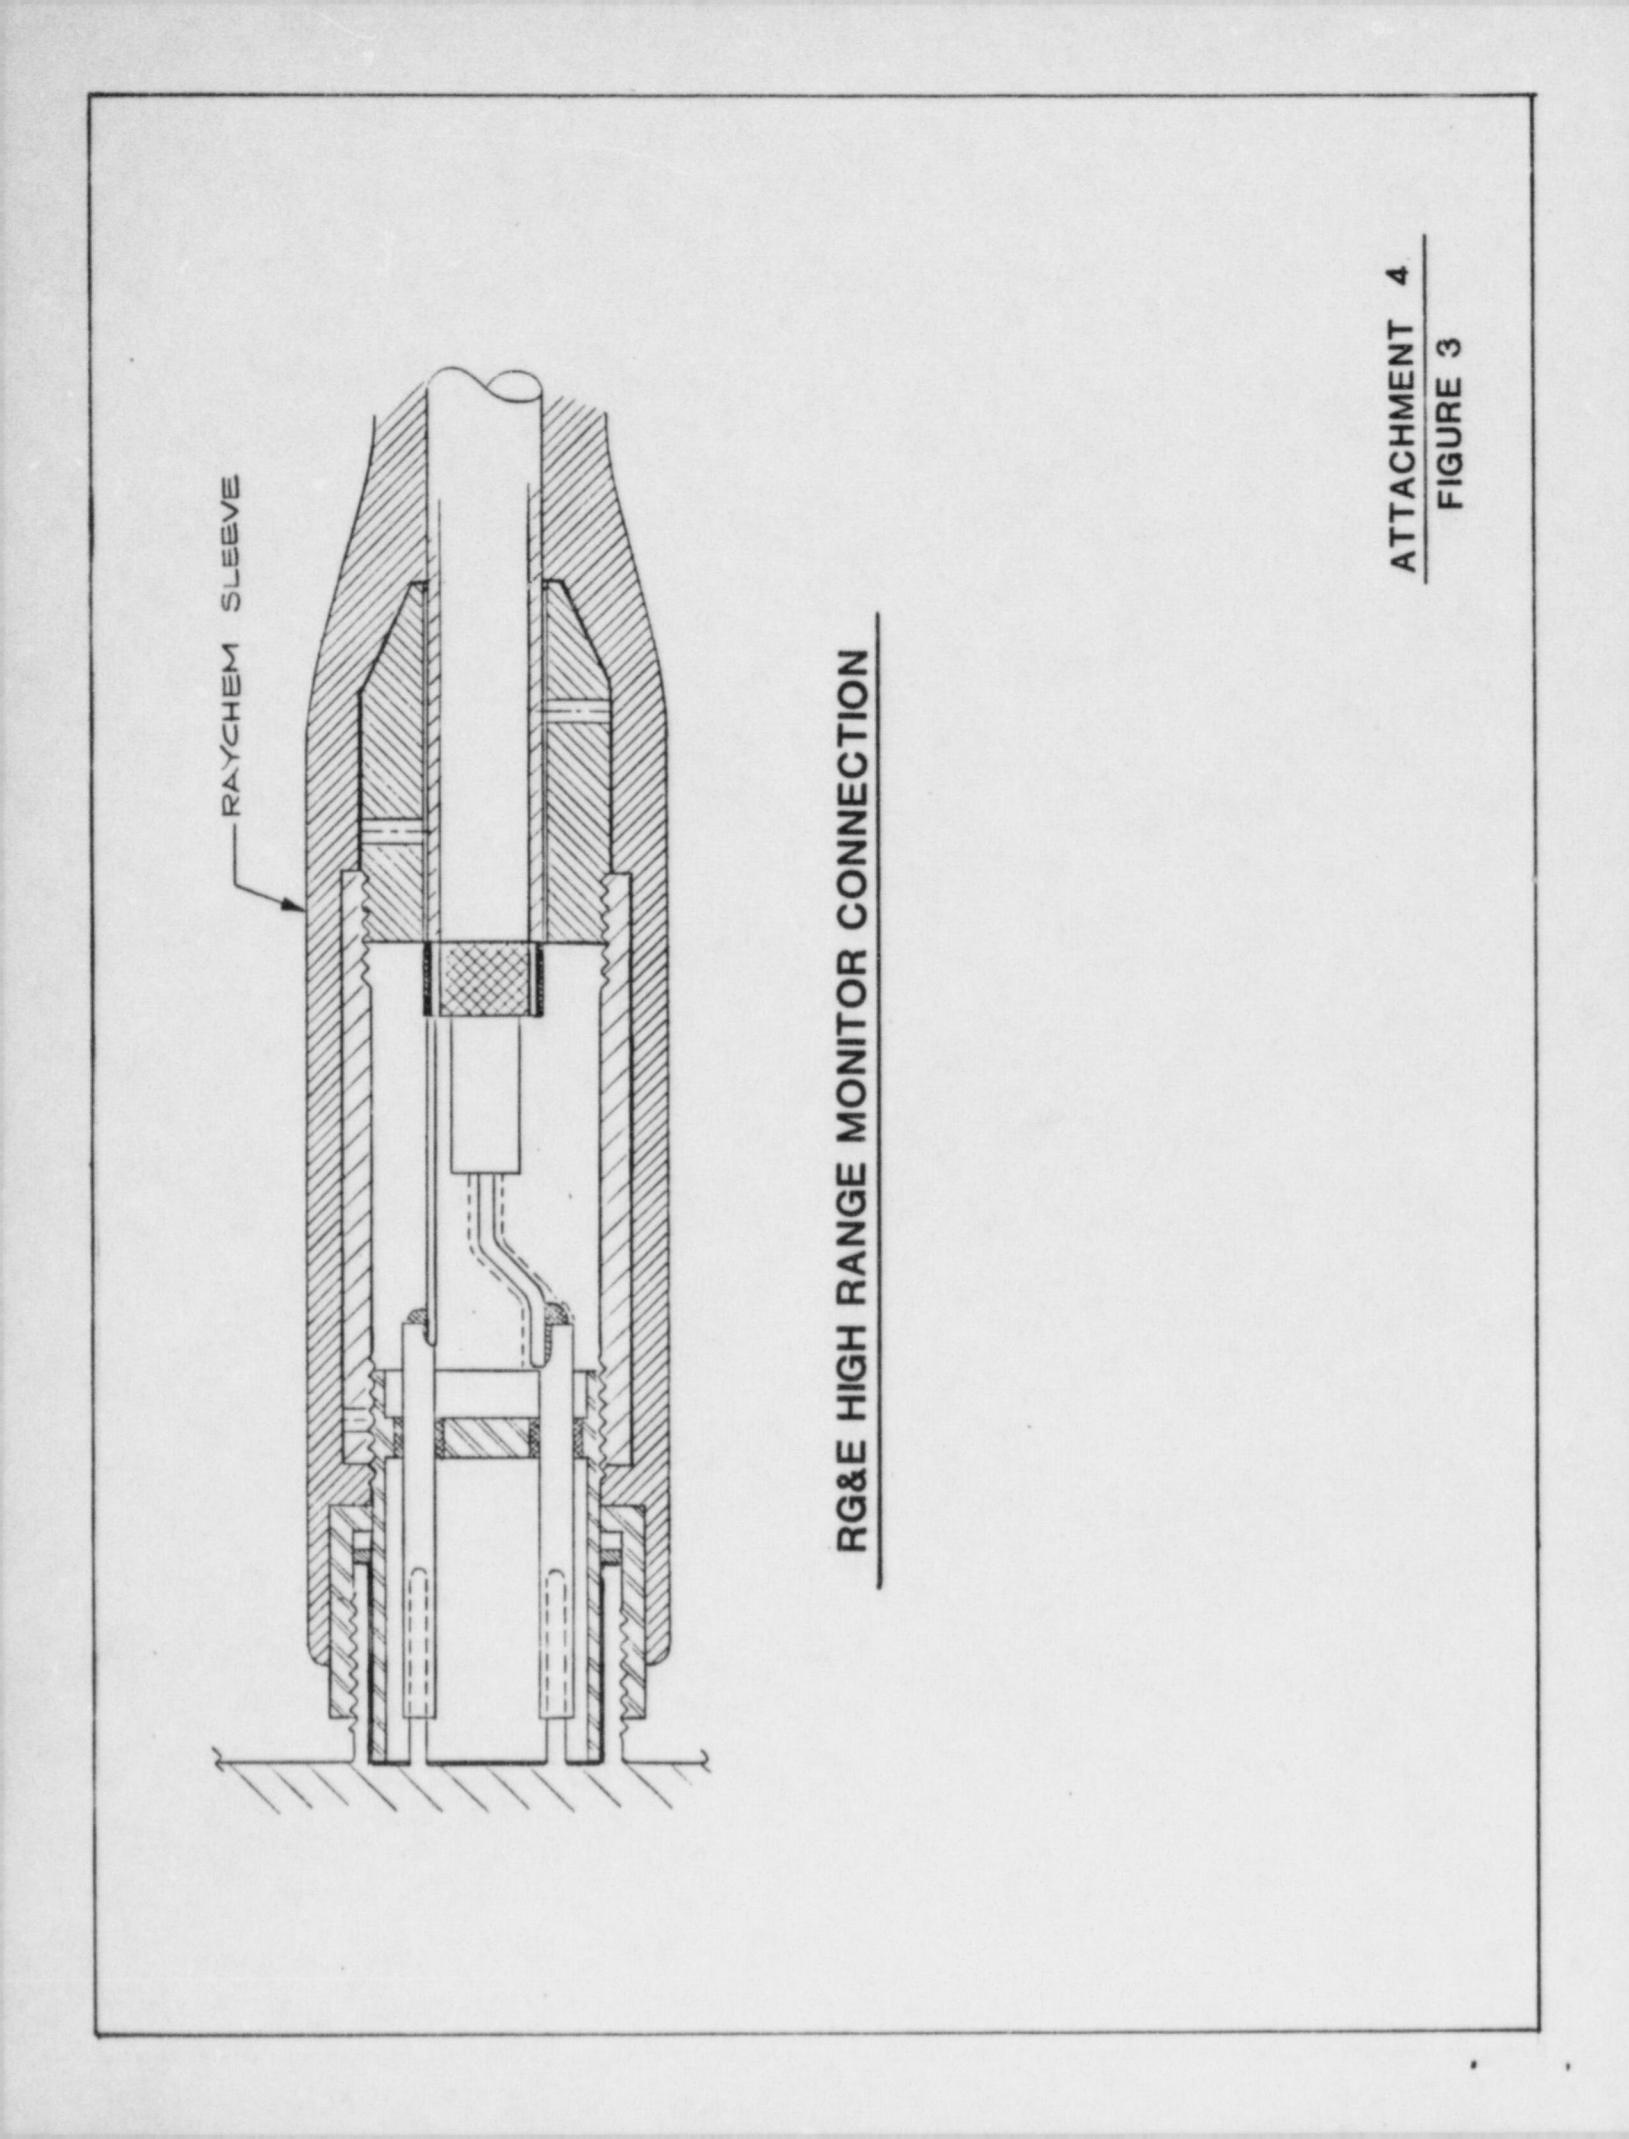
ATTACHMENT 4 FIGURE 2

Failures were traced to one or more of the following:

- Moisture penetrating to the center conductor of the cables:
 - a.) leakage of the seal at the connector threads to the back shell
 - b.) leakage of the seal into the back shell at the set screw threads of the back shell
 - c.) leakage through the outer insulating jacket of the cable, thence along the inner insulation surface (between the inner insulation and shield) into the back shell, and reaching the inner termination of the cable to the connector.

- Electrical shorts occurring between the center conductor and the shield at the termination area inside the back shell of the connector.
- Open or broken connection of the center conductor of the cable at the termination inside the back shell of the connector.
- Open or broken connection of the shield at the termination inside the back shell of the connector.
- Leakage of the stainless steel welds or compression seals of the stainless steel cable enclosures (see deviation to test plan 907351).
- Loss of control of the LOCA environmental chamber used to conduct the test.

FAILURE MECHANISMS IDENTIFIED

IN VICTOREEN TEST REPORT NO. 950.301
