FINAL REPORT

RHR PUMP WEAR RING
SURVEILLANCE EXAMINATION RESULTS
PIGGRIM NUCLEAR POWER STATION

WORK PERFORMED FOR
BOSTON EDISON COMPANY

January 23, 1987

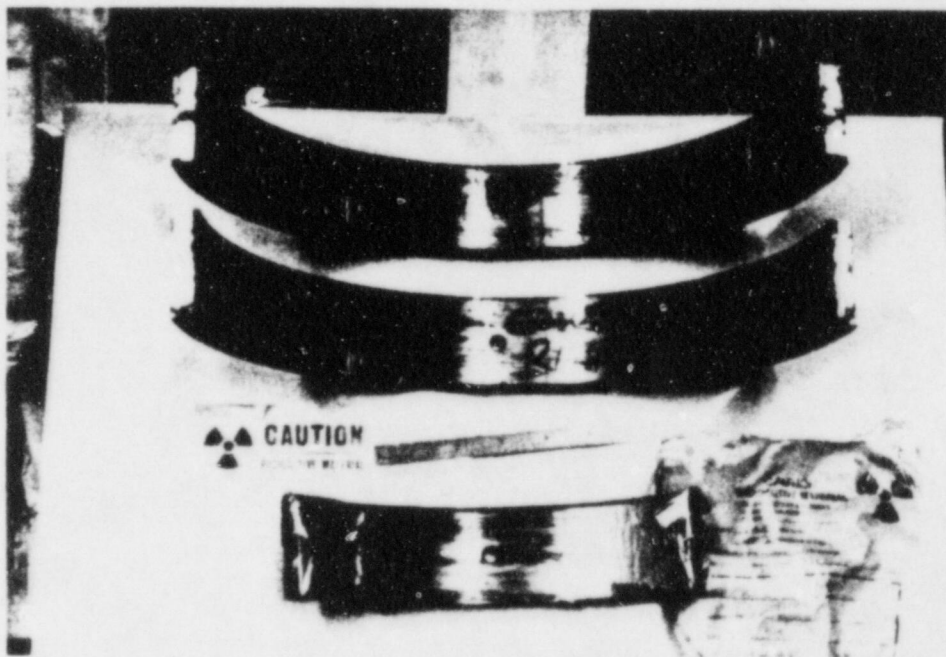
RHR pump impeller wear ring samples were removed from two Pilgrim pumps and sent to GENERAL ELECTRIC'S VALLECITOS NUCLEAR CENTER for metallurgical evaluation (Figure 2). This report presents the results of the metallurgical evaluation performed on the Pilgrim wear ring samples.

Figure 2. Photo of Pilgrim RHR pump wear ring sent to VNC for metallurgical evaluation.

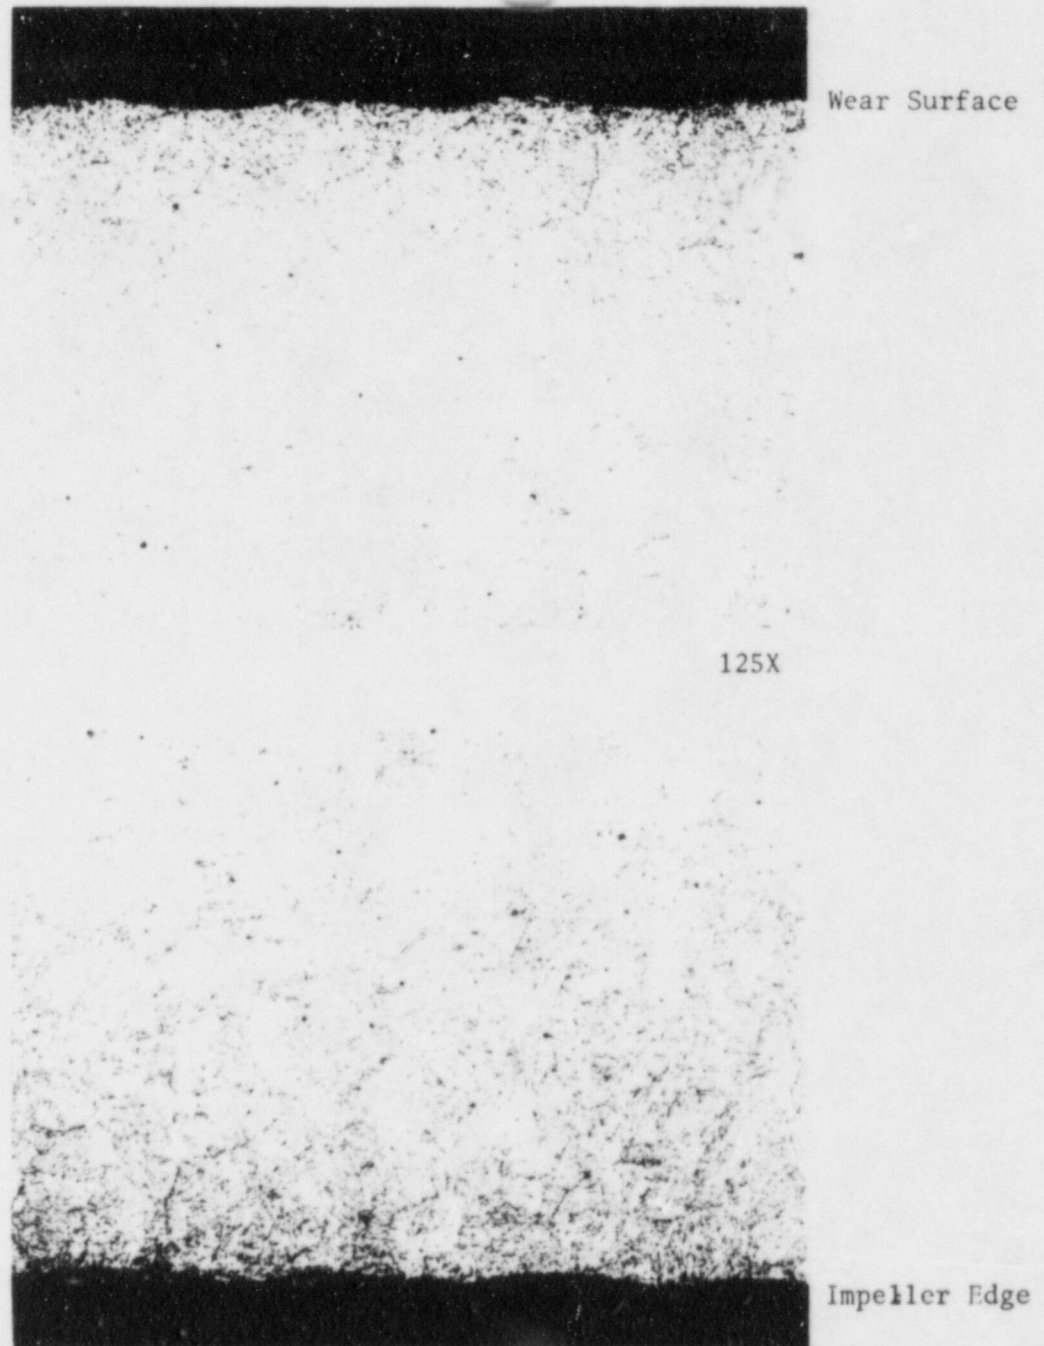
Figure 6. Typical edge views of section 1 removed from RHR pump "A" wear ring segment. The edge in the upper photo was adjacent to the wear surface, and the edge in the lower photo was adjacent to the impeller.

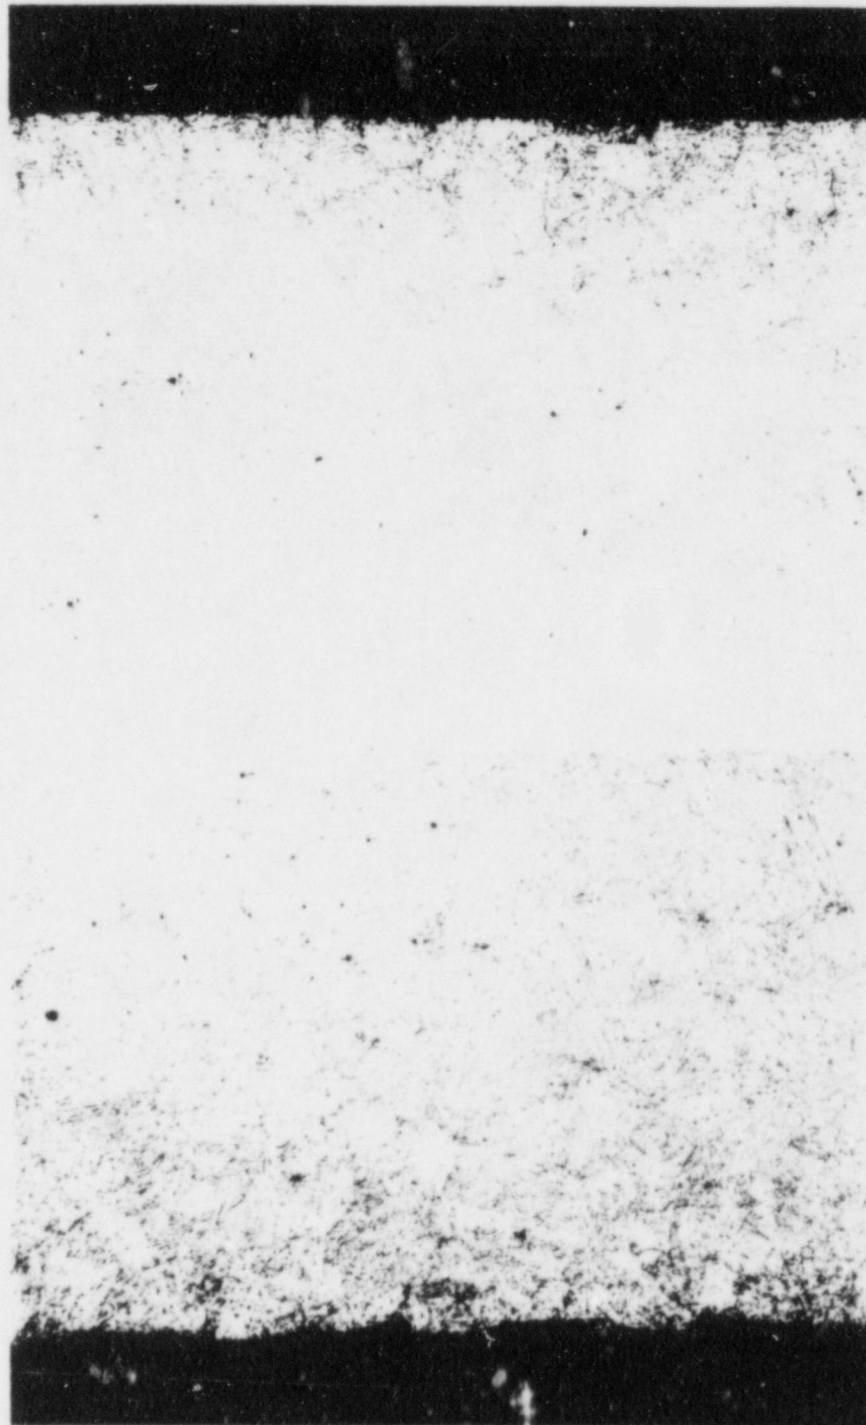
Figure 7. Typical edge view of section 2 removed from RHR pump "A" wear ring segment. The edge in the upper photo was adjacent to the wear surface and the edge in the lower photo was adjacent to the impeller.

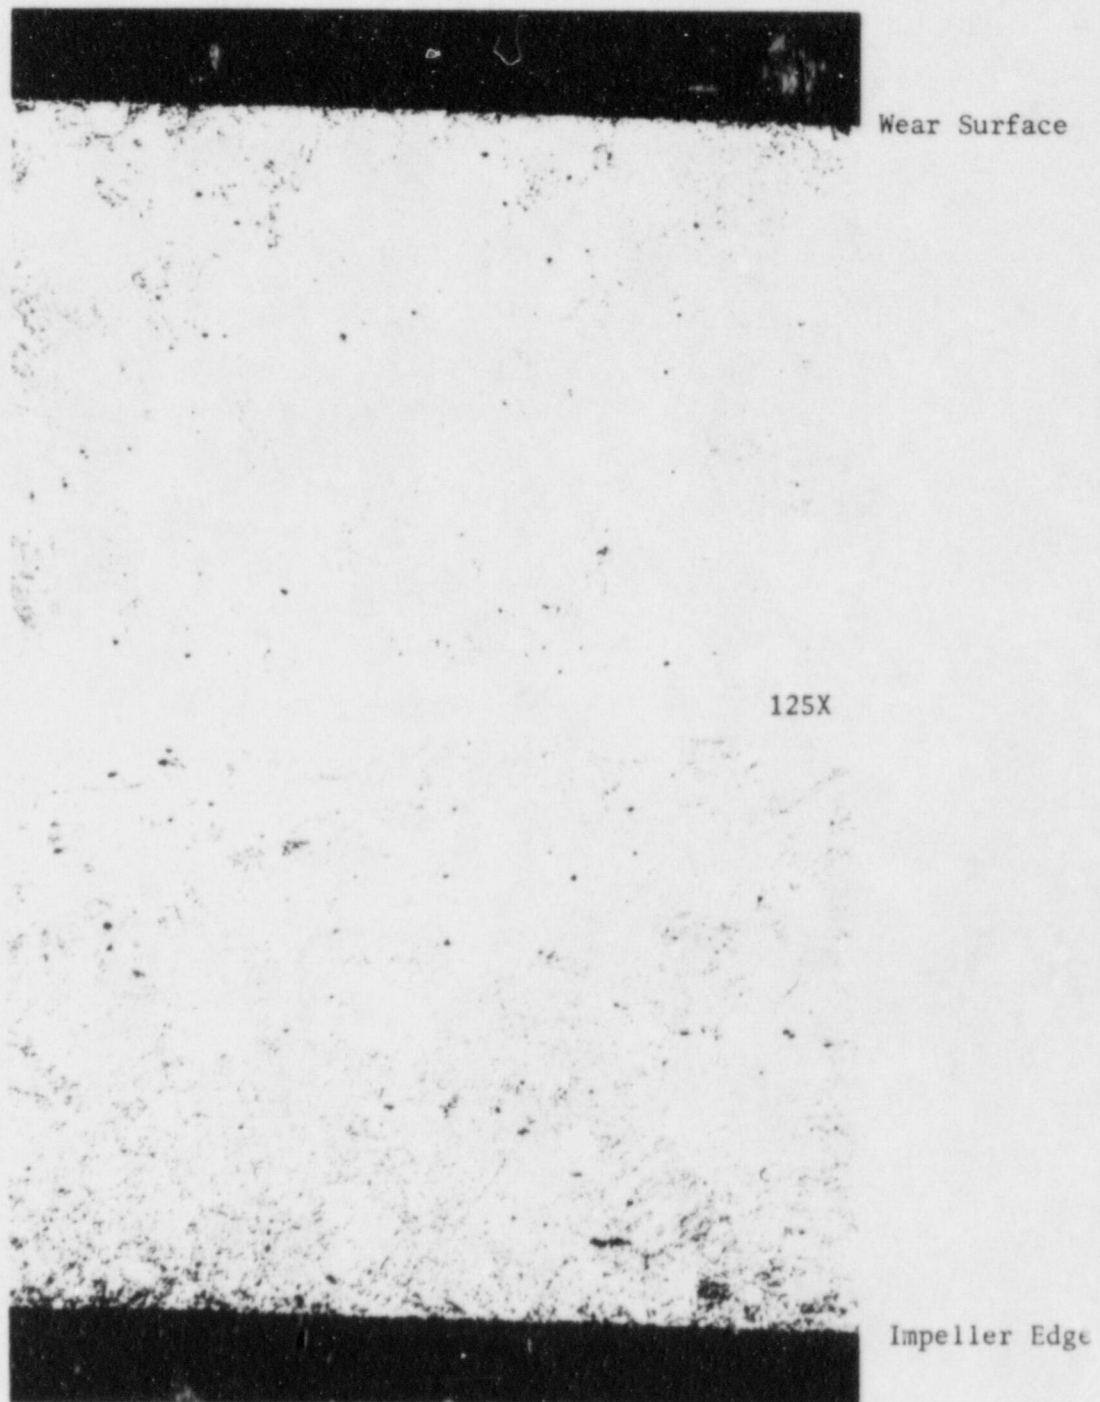
Figure 9. Typical edge views of section 4 removed from RHR Pump "A" wear ring segment. The edge in the upper photo was adjacent to the wear surface and the edge in the lower photo was adjacent to the impeller.

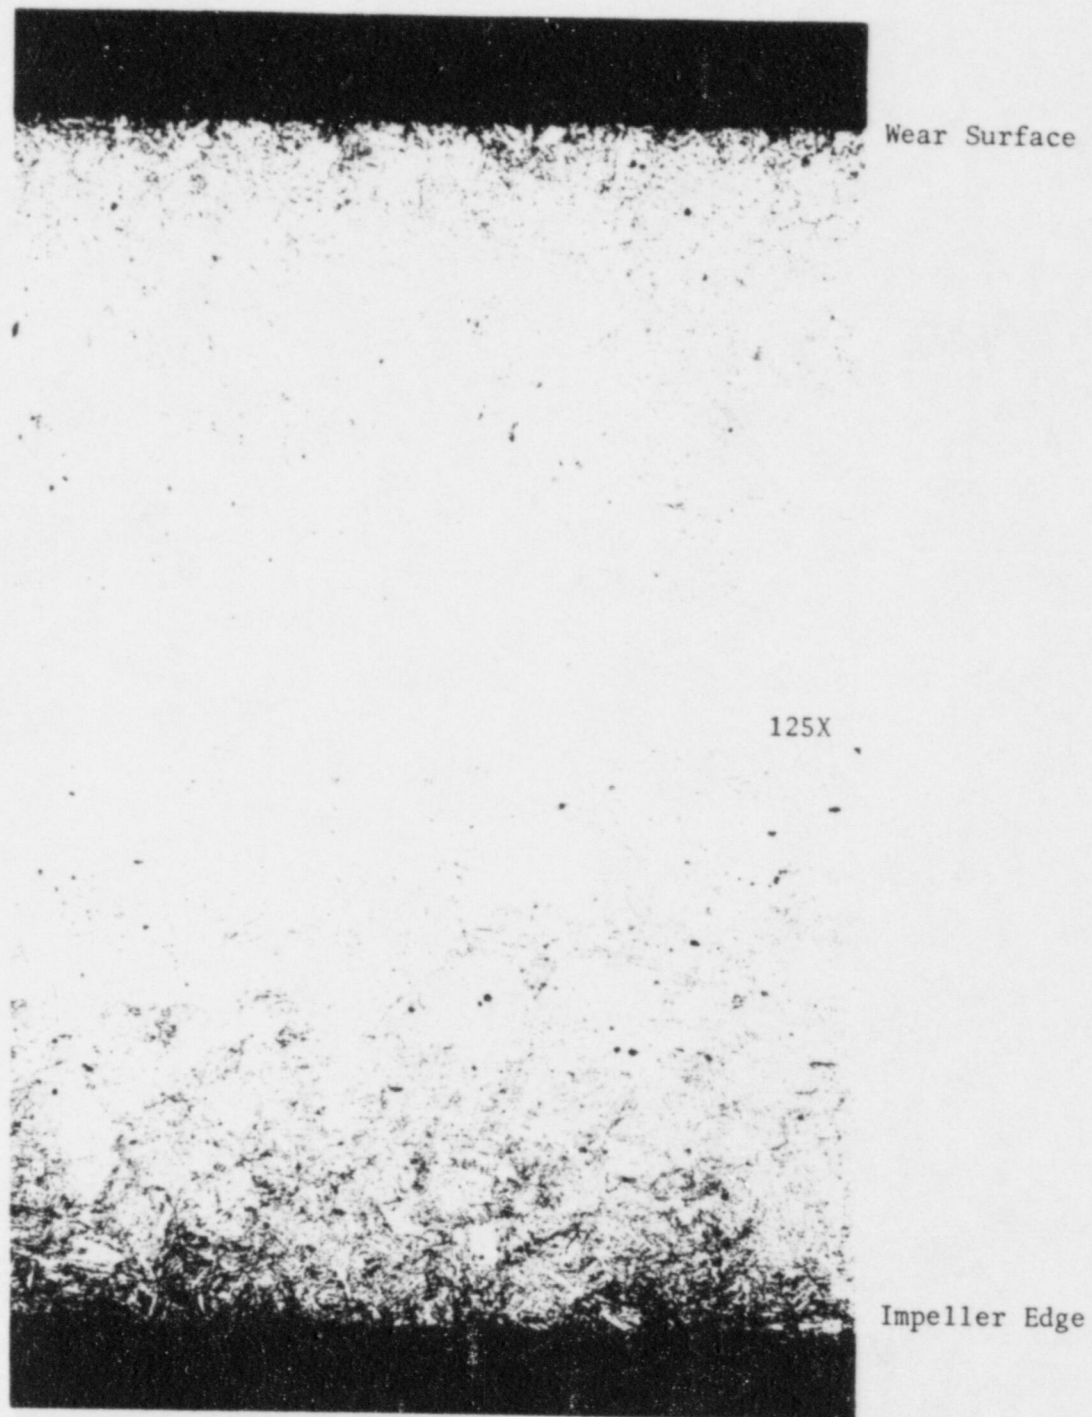
Figure 10. Typical edge views of section 5 removed from RHR pump "A" wear ring segment. The edge in the upper photo was adjacent to the wear surface and the edge in the lower photo was adjacent to the impeller.

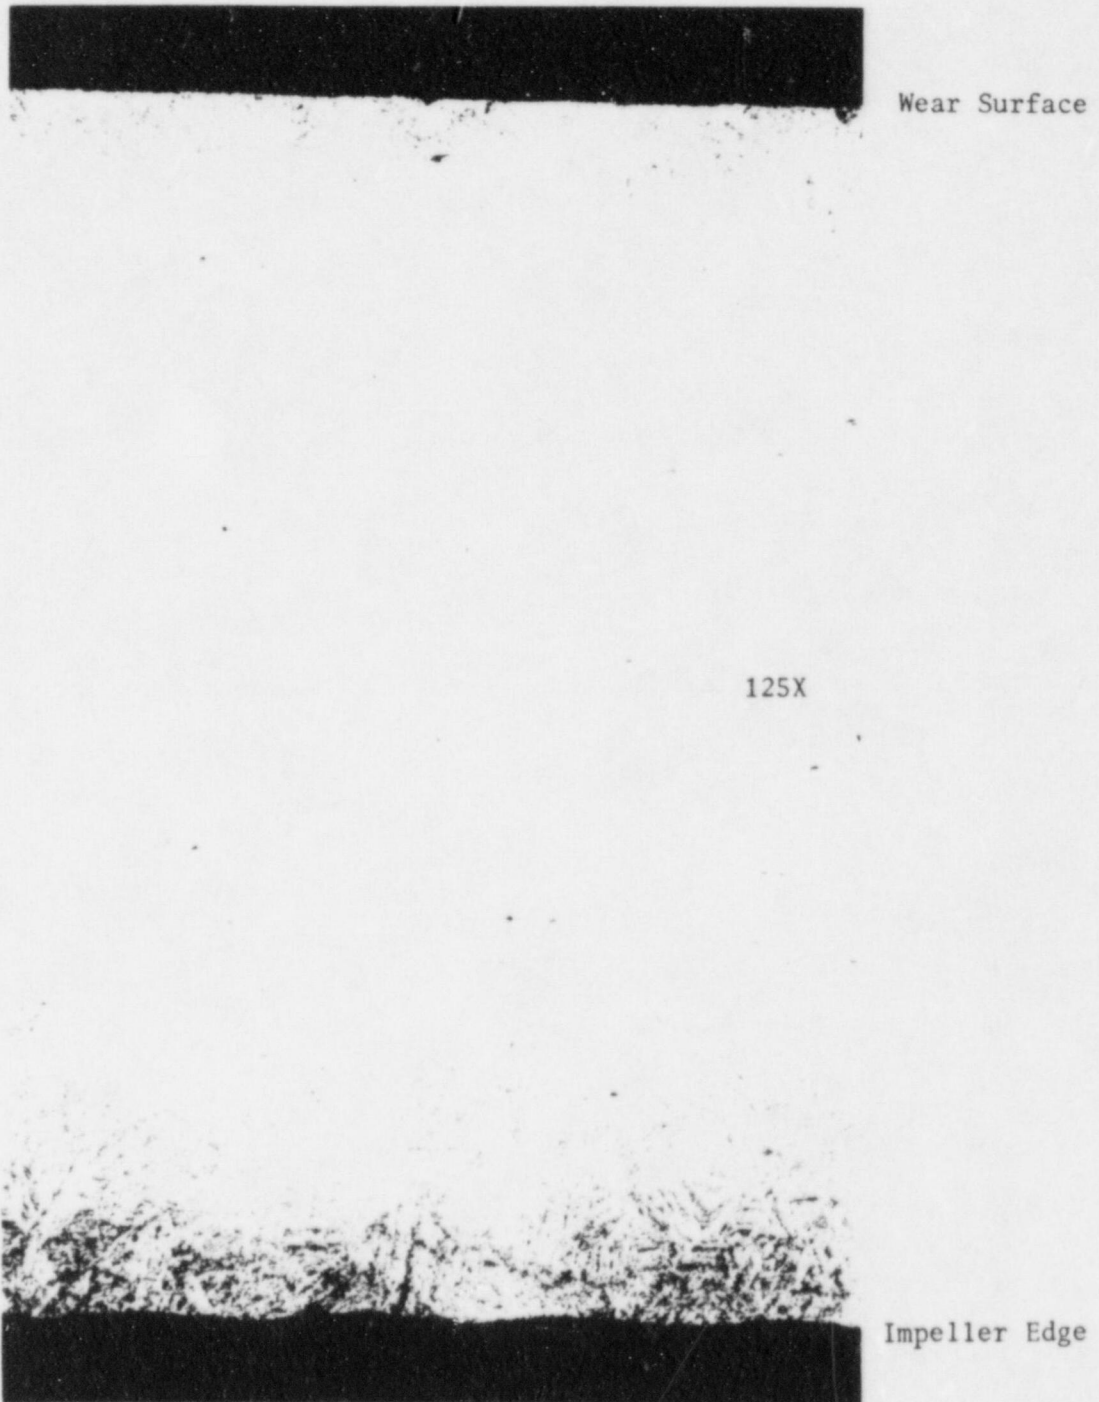
Figure 13. Typical edge view of section 1 removed from RHR pump "B" wear ring. The edge in the upper photo was adjacent to the wear surface and the edge in the lower photo was adjacent to the impeller.

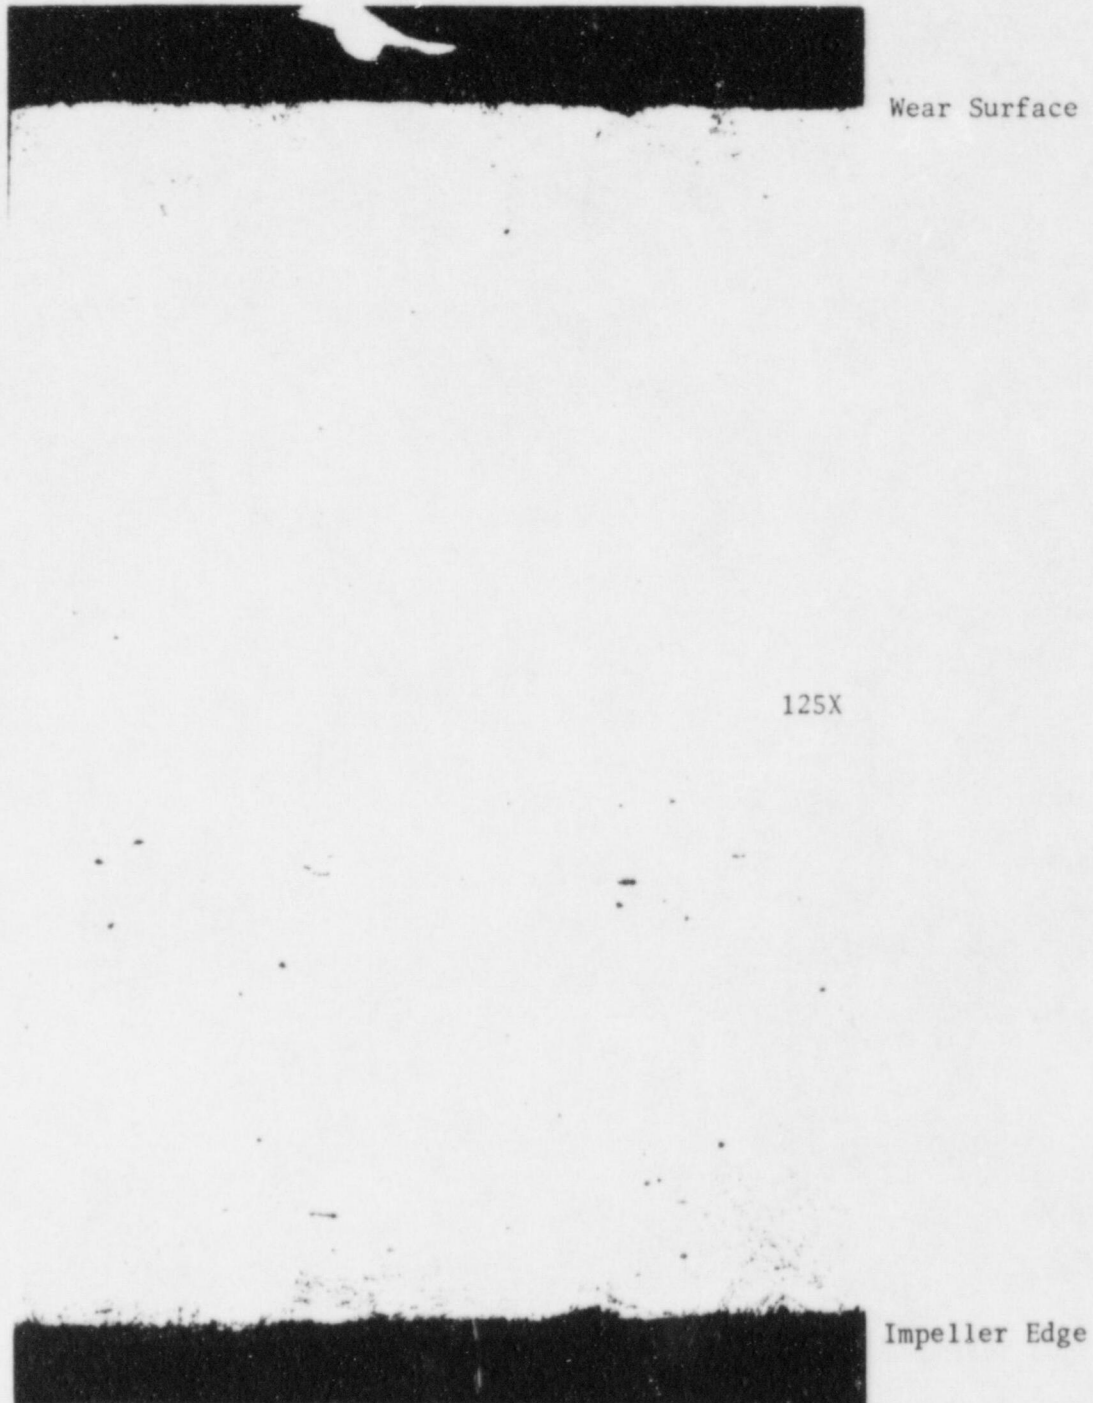
Figure 14. Typical edge view of section 2 removed from RHR pump "B" wear ring. The edge in the upper photo was adjacent to the wear surface and the edge in lower photo was adjacent to the impeller.

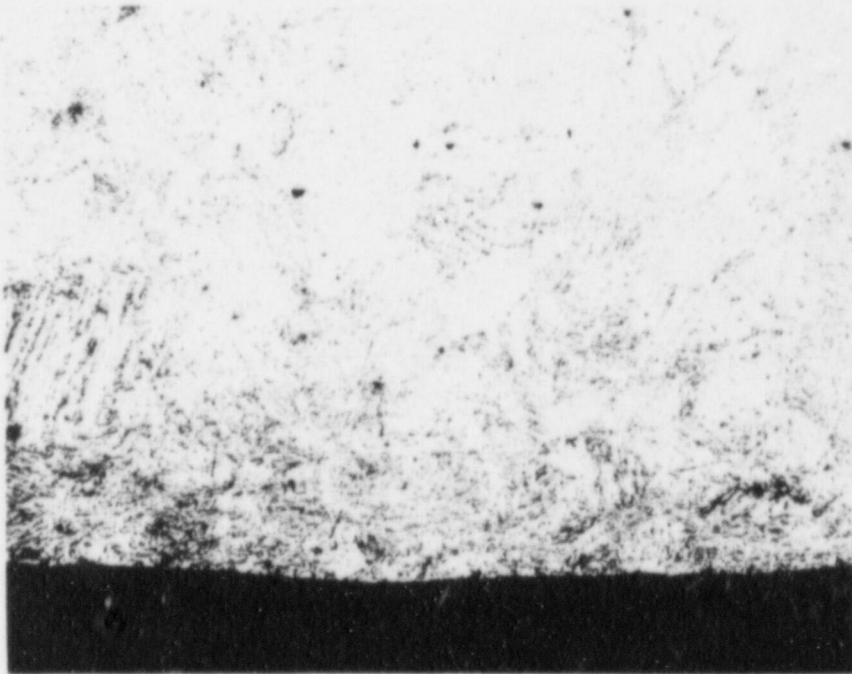
Figure 17. Typical edge views of section 5 removed from RHR pump "B" wear ring. The edge in the upper photo was adjacent to the wear surface and the edge in lower photo was adjacent to the impeller.
