Long-Term Surveillance and Monitoring Program

**Annual Site Inspection and Monitoring Report
for
Uranium Mill Tailings Radiation Control Act
Slick Rock, Colorado, Site**

1998 Annual Report

February 1999

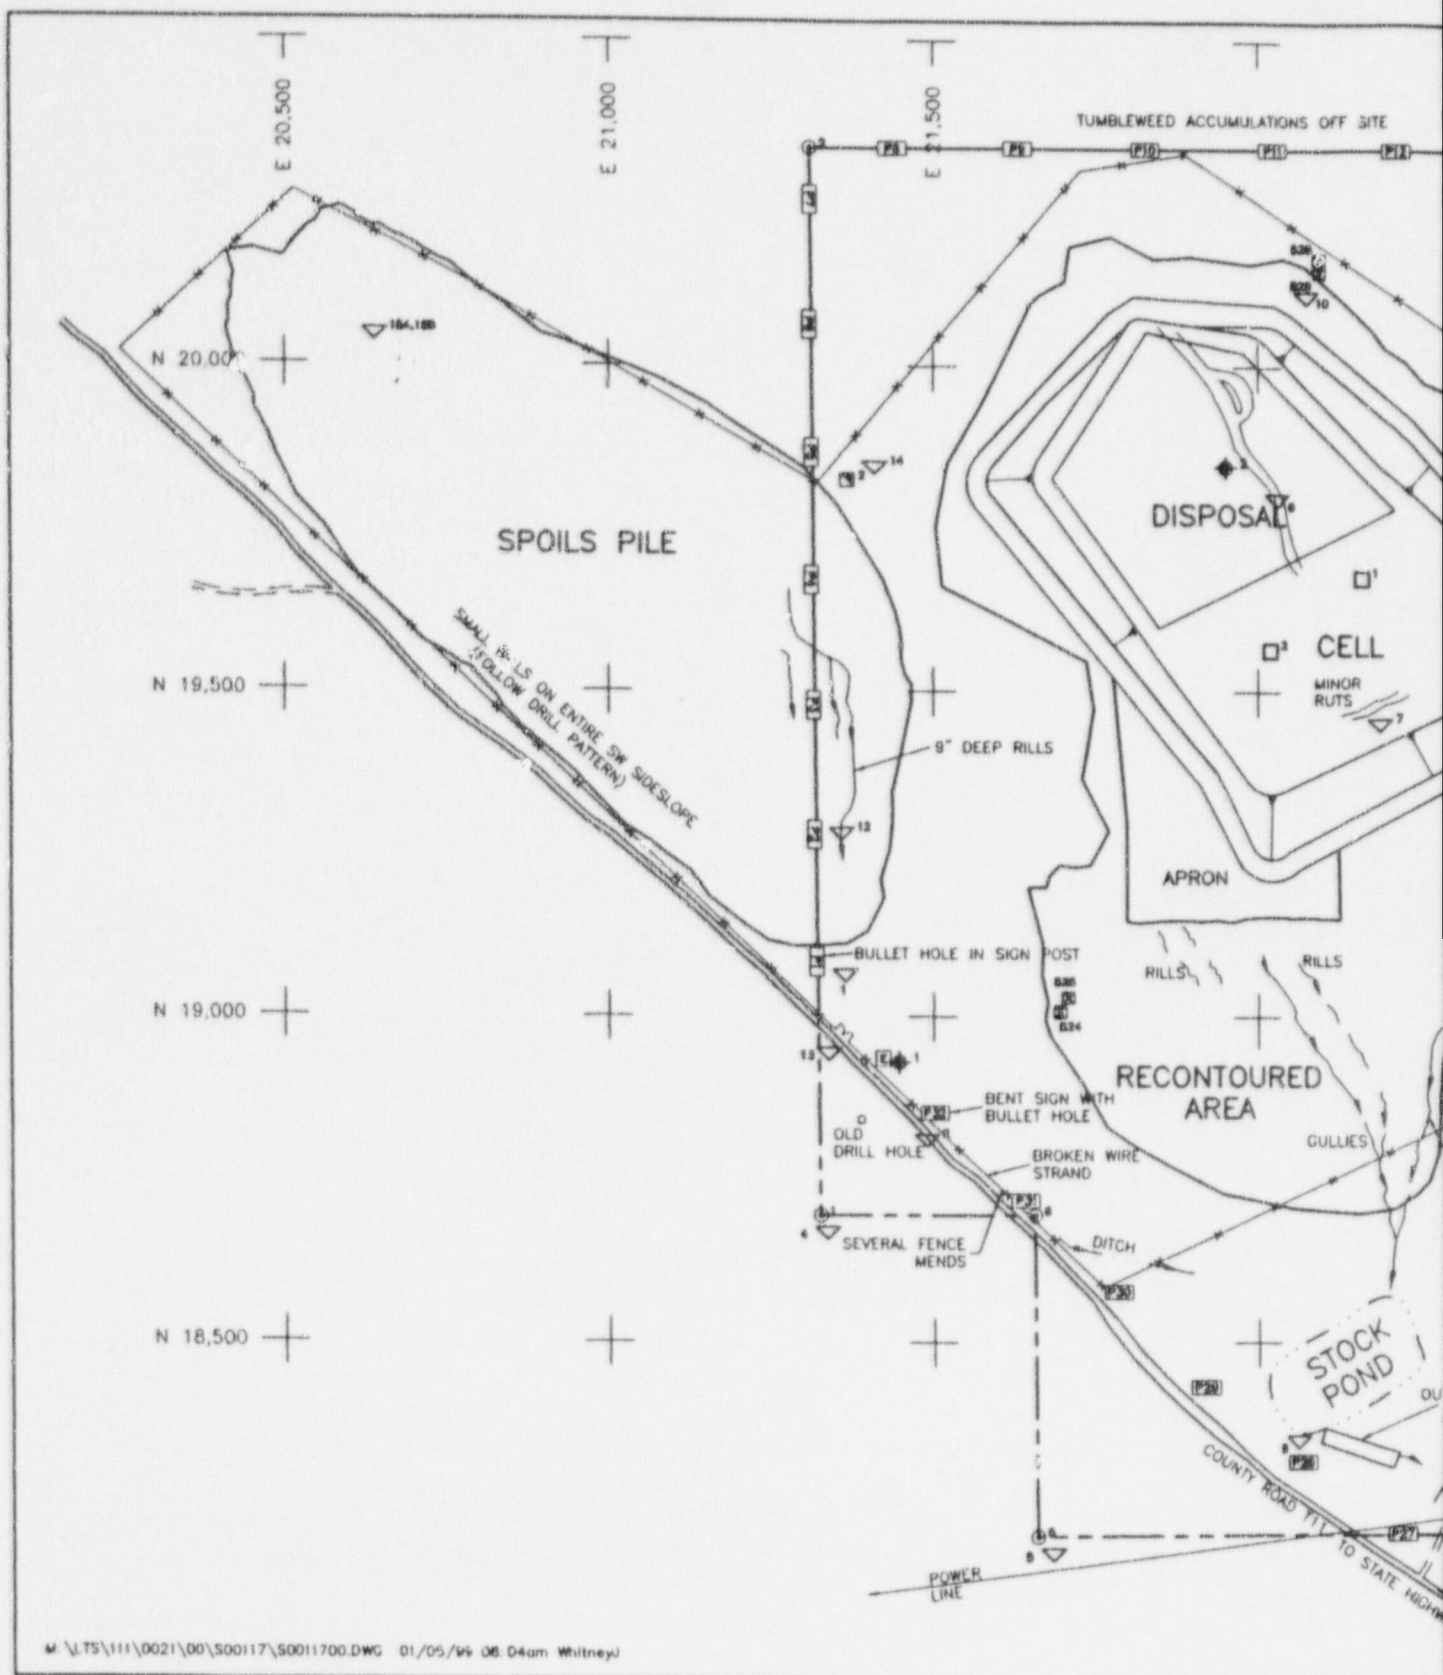
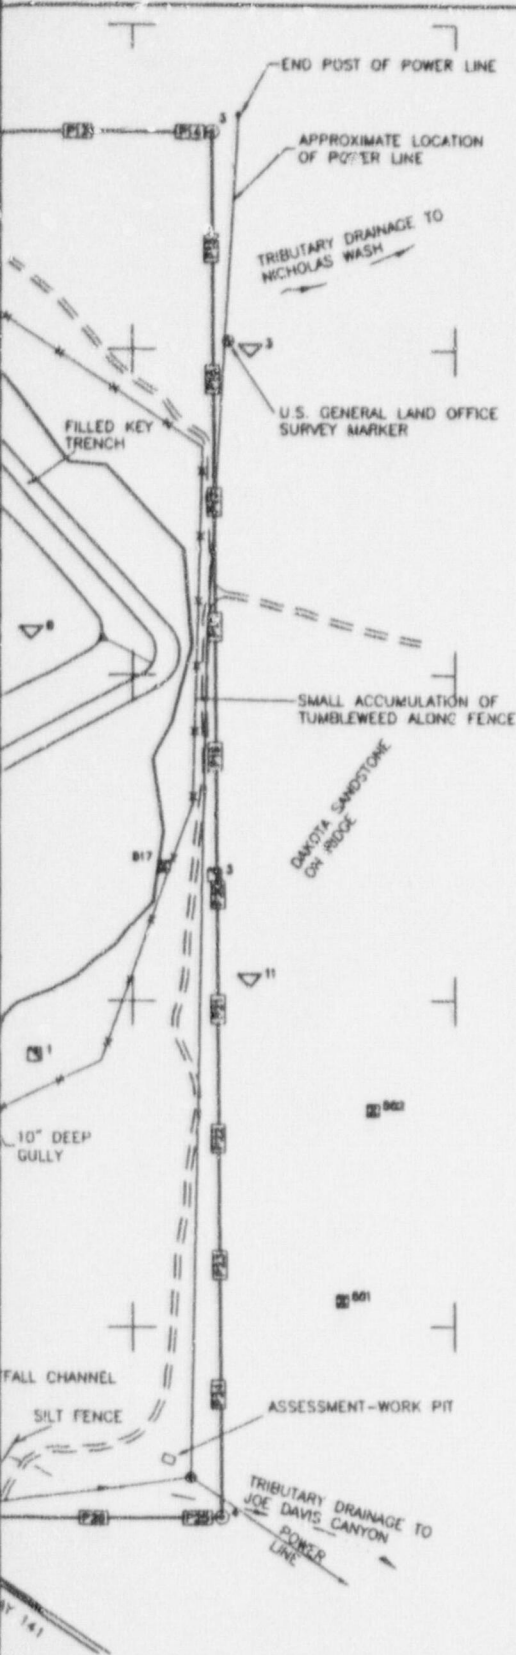
A stock fence of sorts surrounds the disposal cell, most of the reseeded areas, and the spoils pile west of the disposal cell. The approximate location of the fence is shown on Figure SRK-1. The fence, such as it is, is in excellent condition except between perimeter signs P31 and P32 where a strand of wire is broken, and west of the entrance gate, where several wires are slack (SRK PL-13).

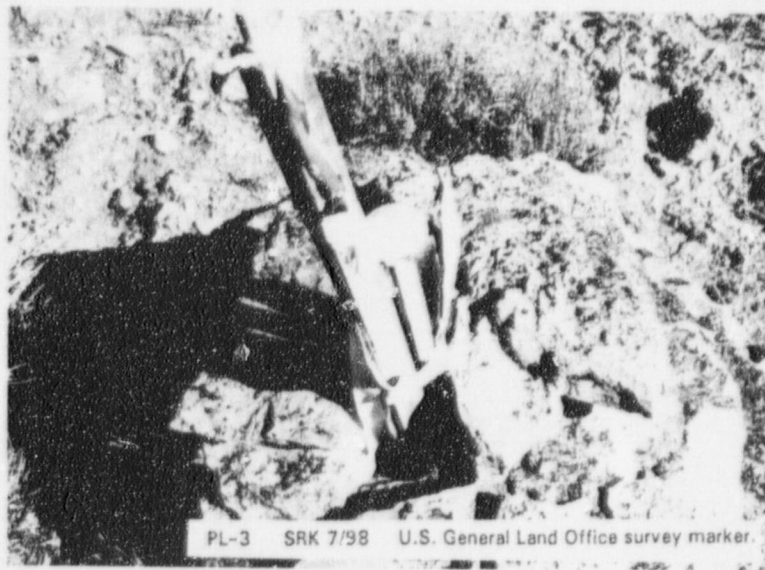
PL-3 SRK 7/98 U.S. General Land Office survey marker.
