Radiological and Engineering Assessment

Vicinity Property No. DUR 028

FINAL
THE RADIOLOGICAL AND ENGINEERING ASSESSMENT
AND FINAL DESIGN

DU-028

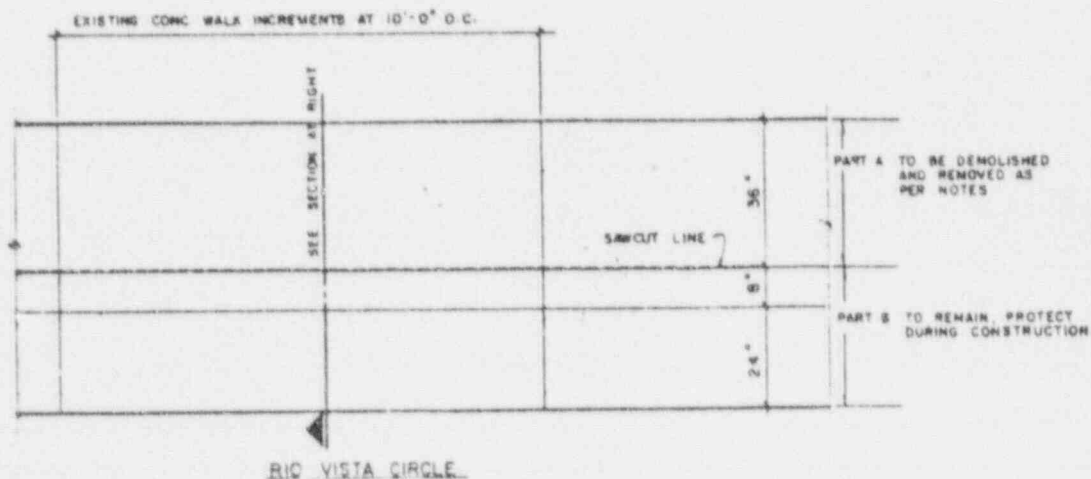
PLOT PLAN

DESIGNATES AREA TO BE DEMOLISHED AND REPLACED

- DEMOLISH AND REMOVE CONCRETE DRIVEWAY, SIDEWALK AND FRONT STOOP. SHORE CARPORT ROOF AS NECESSARY FOR REMOVAL OF THE SHED AND DRIVEWAY.
- REMOVE HEDGES LOCATED SOUTH OF THE DRIVEWAY. REPLACE HEDGES WITH SIMILAR TYPE AND SIZE.

- HAND EXCAVATE AROUND THE TWO SPRUCE TREES TO A DEPTH OF 24 INCHES TAKING EXTREME CARE SO AS NOT TO DAMAGE THE TREES OR THE ROOT SYSTEM. AFTER INITIAL EXCAVATION, THE CONTRACTORS' REPRESENTATIVE WILL RESURVEY AND NOTIFY THE SUBCONTRACTOR IF FURTHER EXCAVATION AND/OR TREE REMOVAL IS REQUIRED. IF TREES ARE TO BE REMOVED, REPLACE WITH SIMILAR TYPE AND SIZE AS PRACTICAL.

- EXCAVATE REMAINING PORTION OF AREA "A" TO A DEPTH OF 24 INCHES.
- REPLACE PLANTER AREA WITH PLANTS OF SIMILAR TYPE AND SIZE.
- BACKFILL ALL CONCRETE AREAS WITH 14 INCHES OF COMMON FILL AND TOP WITH 6 INCHES OF STRUCTURAL FILL.

- BACKFILL REMAINING PORTION OF AREA "A" WITH 24 INCHES OF COMMON FILL AND TOP WITH 3 INCHES OF GRAVEL.
- REPLACE SHED AND ROOF SUPPORTS IN CARPORT AREA.

- DEMOLISH AND REMOVE ENTIRE CONCRETE SIDEWALK.
- REMOVE AND SALVAGE CLOTHES LINE AND POLES. REPLACE IN ORIGINAL LOCATION AND ELEVATION.
- REMOVE BUSHES IN REAR YARD. REPLACE BUSHES WITH SIMILAR TYPE AND SIZE.
- PROTECT 4 INCH PVC PIPE IN PLACE DURING EXCAVATION.
- EXCAVATE AREA "B" WITHIN THE BOUNDARIES SHOWN TO A DEPTH OF 6 INCHES AT THE CONCRETE RETAINING WALL AND SLOPING DOWN TO A DEPTH OF 30 INCHES AT THE HOUSE.
- BACKFILL EXCAVATED AREA WITH COMMON FILL AND TOP WITH 6 INCHES OF TOP SOIL AND 500. IN SIDEWALK AREA TOP WITH 6 INCHES STRUCTURAL FILL AND CONSTRUCT NEW 4 INCH THICK CONCRETE SIDEWALK TO THE SAME SIZE AND ELEVATION OF THAT REMOVED.
