Draft Radiological and Engineering Assessment

Vicinity Property No. DUR 202

THE RADIOLOGICAL AND ENGINEERING ASSESSMENT
AND FINAL DESIGN

DU-202

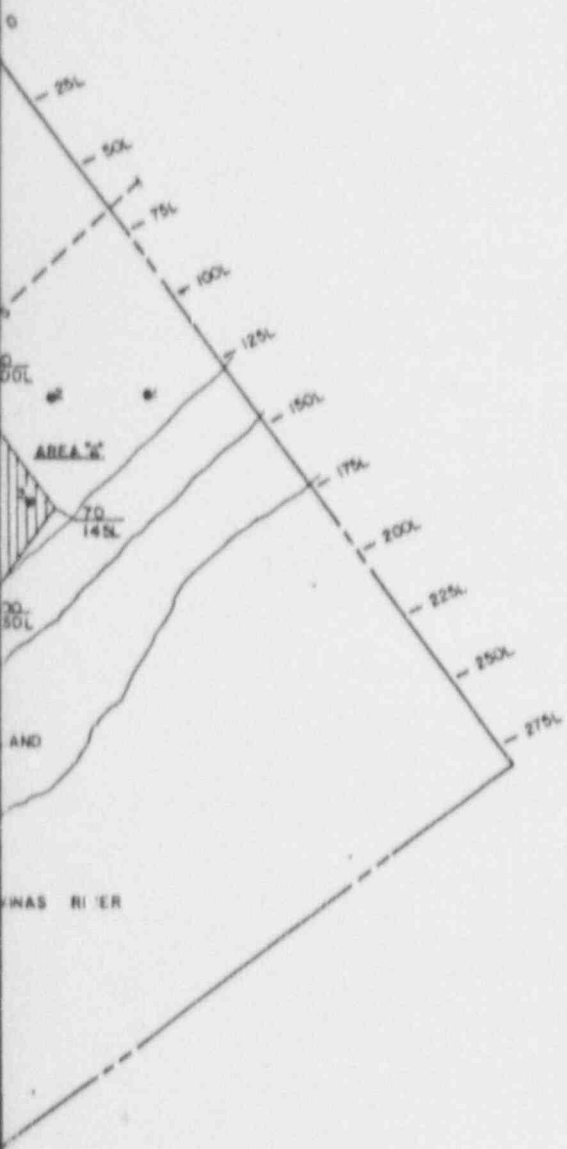
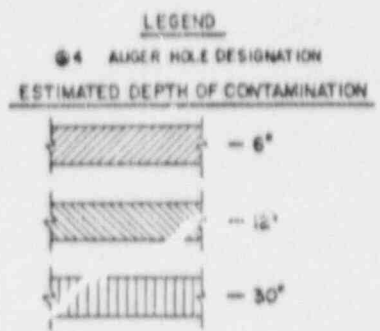
Contamination was found in 9 of the 21 holes augered. The location and depth of the contamination is described in Table 3.1 and is shown in Figure 3.1.

HOLE	CONTAMINATION DEPTH
1	None
2	None
3	0-36"+*
4	0-24"+*
5	None
6	12-30"+*
7	0-12"+*
8	None
9	None
10	None
11	12-24"
12	0-18"
13	None
14	0-12"
15	0-12"
16	0-18"
17	None
18	None
19	None
20	None
21	None
