Re: License No. 37-17860-01

PermaGrain Products is pleased to report that we returned to full production operation at 6:00 a.m. on June 4. There was no release during this period of time of chemical contaminants or radioactive material to the environment. Per the request of your Inspector, Mr. Frank Costello, the following will summarize the incident.

At 8:05 on the evening of May 31, the Quehanna production facilities were subjected to the forces of a wide group of tornadoes. To ease the explanation, I will first refer to Figure 4.1. The group of the tornadoes were flowing from west to east. The swath pattern was approximately 1.5 miles wide. The northern edge of the swath was approximately 300 yards from the lobby entrance on the far side of the home of the resident Vice President of Manufacturing, Mr. Larry Griest. As indicated previously, the tornado direction is west to east. On the west end of the building, the wall near the word "open" was torn off with an area of approximately 8 feet wide, 30 feet high. The roof over this entire process area was damaged so that it was leaking. The wall in the conference room on the west end, and the woodworking shop wall were penetrated.

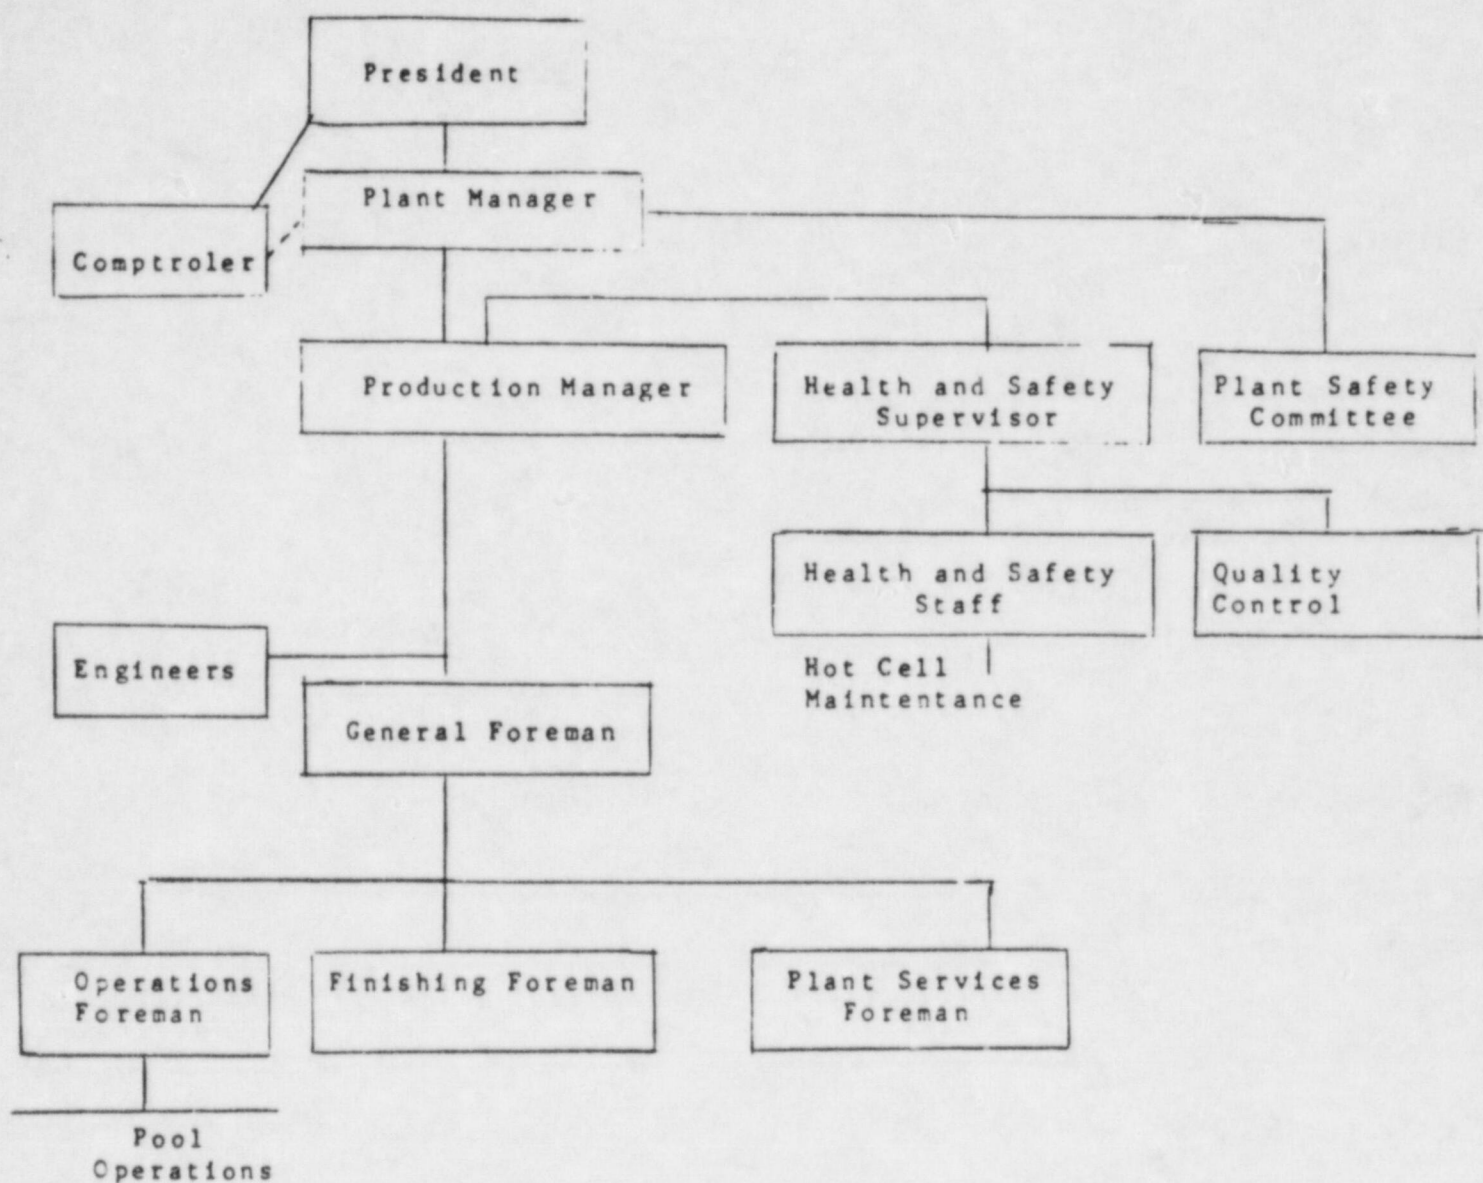
Mr. Costello requested information on our organization which is given on Figure 3.1 (attached) from our license. The key person, the Plant Manager, who is actually the Vice President of Production, is Mr. Larry Griest. Immediately after the accident, Mr. Griest, who was onsite in his trailer, communicated with his two operating personnel in the plant and instructed them to immediately do a perimeter damage check. At this point in time, the plant was on emergency power, and no radiation alarms had activated. Mr. Griest then contacted me via telephone. At
