KKL IN-SERVICE EXPERIENCE WITH

EPG - BALL VALVES

(NIAGARA MOHAWK TASK NO. GE-1)

OCTOBER 1986

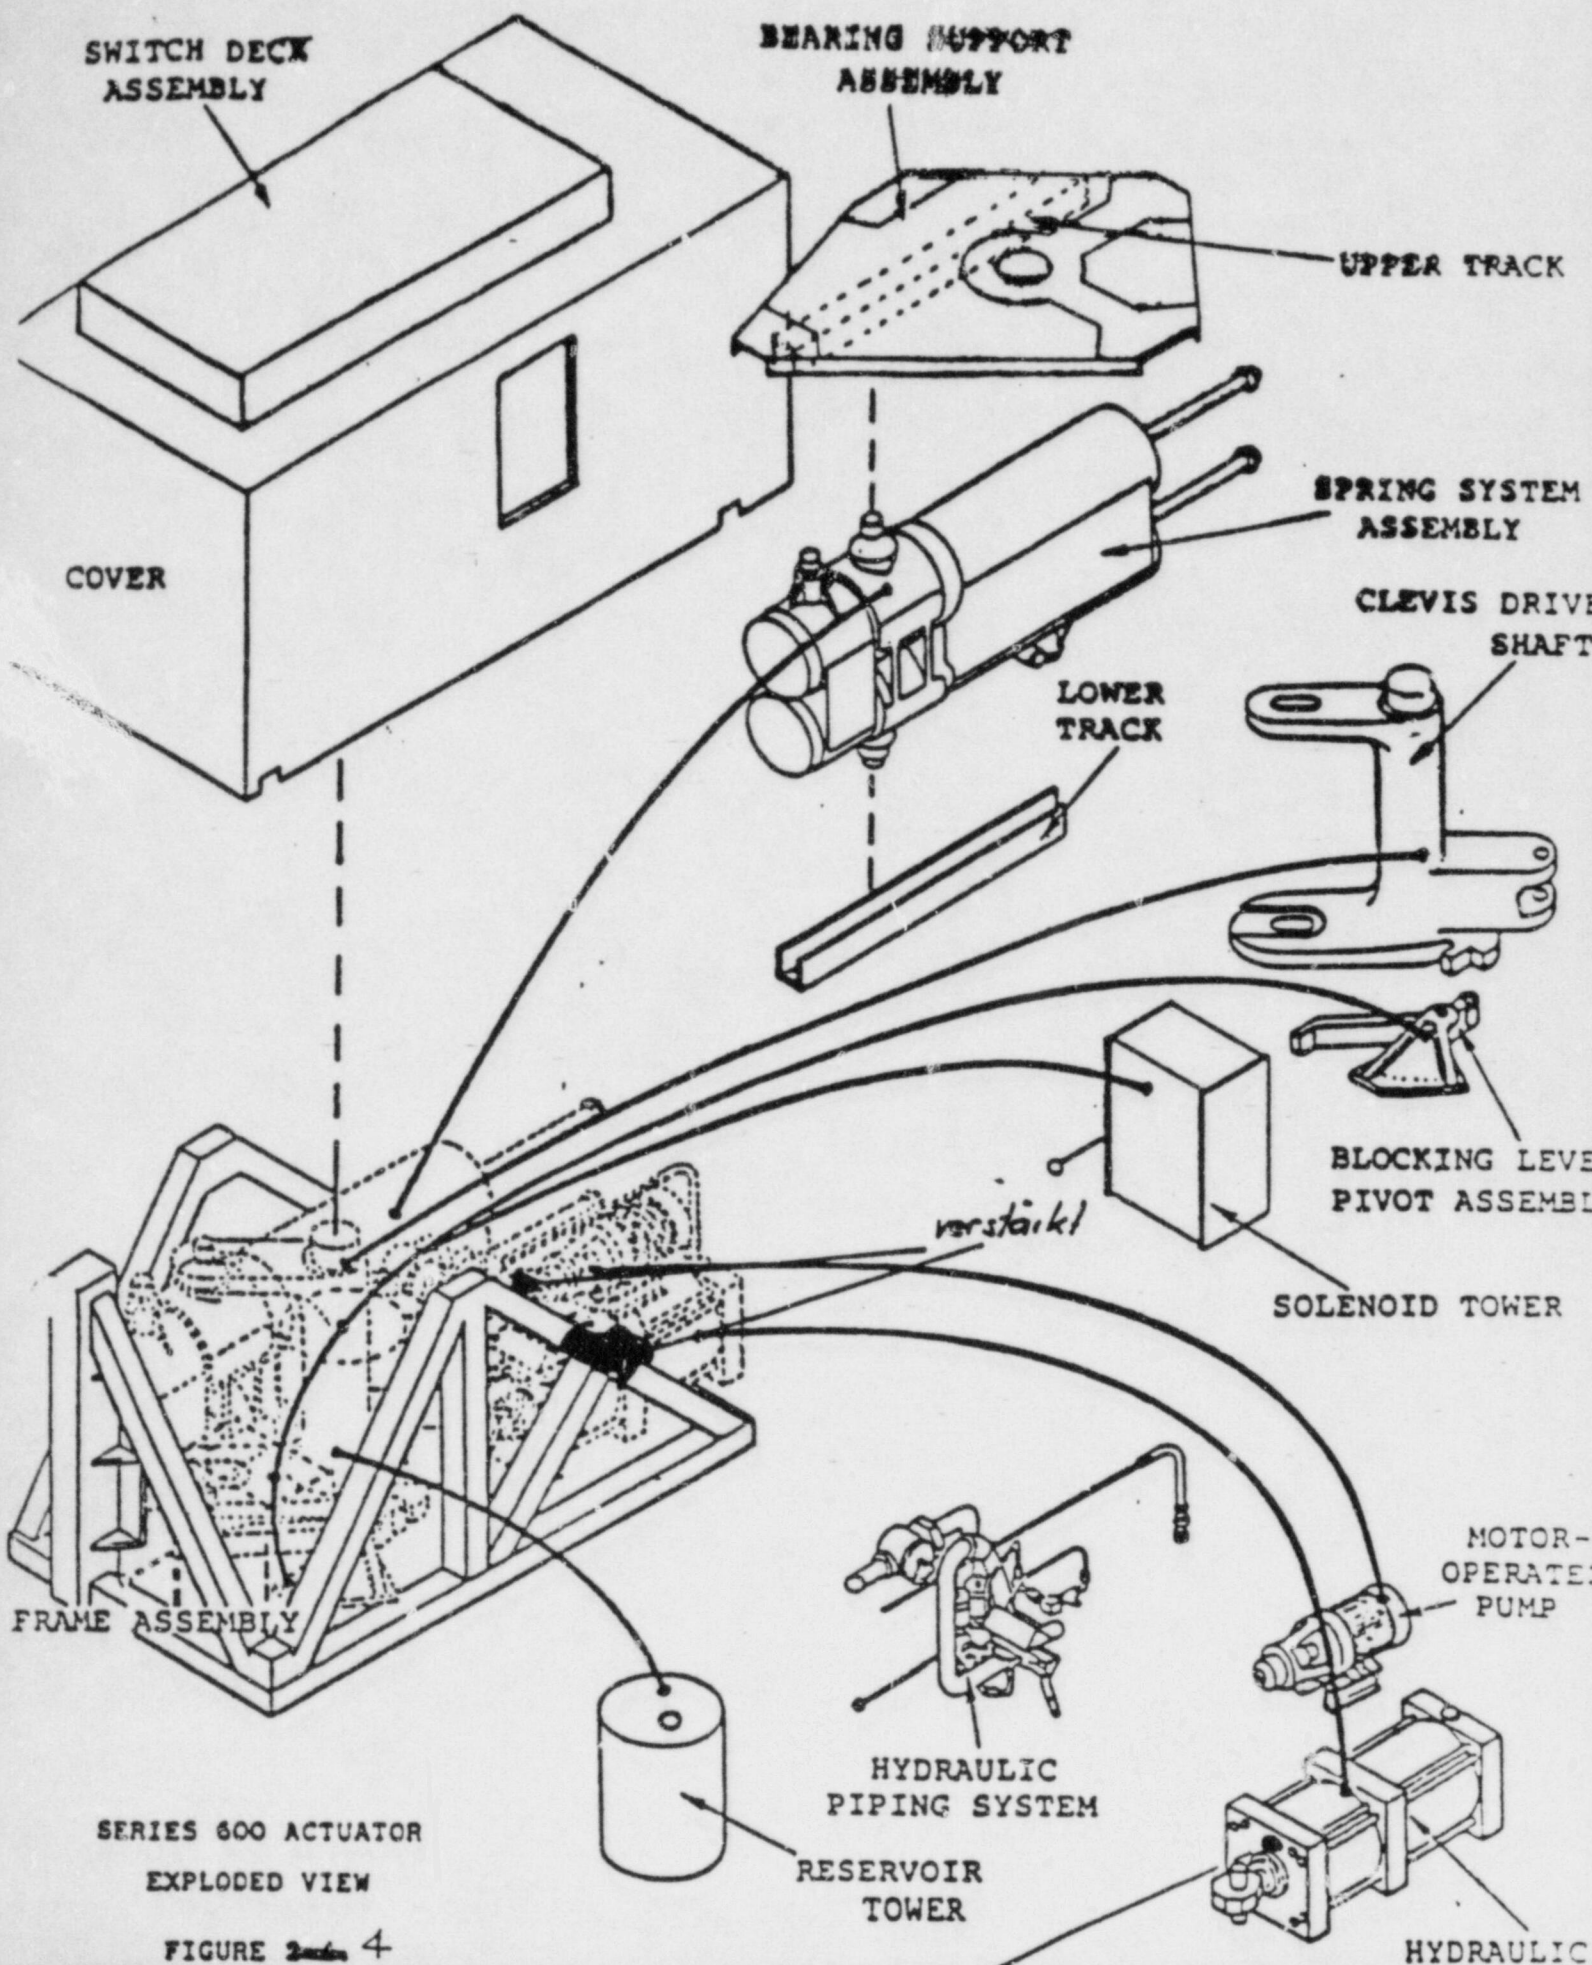
FIGURE 2-3

7.1 KKL identified that numerous problems were experienced with the EFCOMATIC Series 600 actuator. The problem areas experience are highlighted on the attached figures 2 and 3. The types of problems ranged from leaking seals, broken bracket, cracked roller bearing to misalignment of parts. Due to the short time schedule for the visit, specific details were not discussed for each problem area. Essentially, KKL replaced or repaired parts or re-aligned features depending upon the cause. Modification efforts were limited to beefing up the bracket and changing the mechanical manual trip lever.

LATCH ARM AND SOLENOID TOWER
