Subject: Arkansas Nuclear One - Unit 1
Docket No. 50-313
License No. DPR-51
ANO-1 Relief Request For LPI/DHR Pump Casing Repair

**ARKANSAS NUCLEAR ONE – UNIT 1
3rd TEN YEAR INTERVAL
REQUEST NO. 99-1-001, Revision 0**

**Stress Analysis for
Decay Heat Removal Pump**

**Evaluation of Flaw Remaining After Repair of
Decay Heat Removal Pump P-34B**

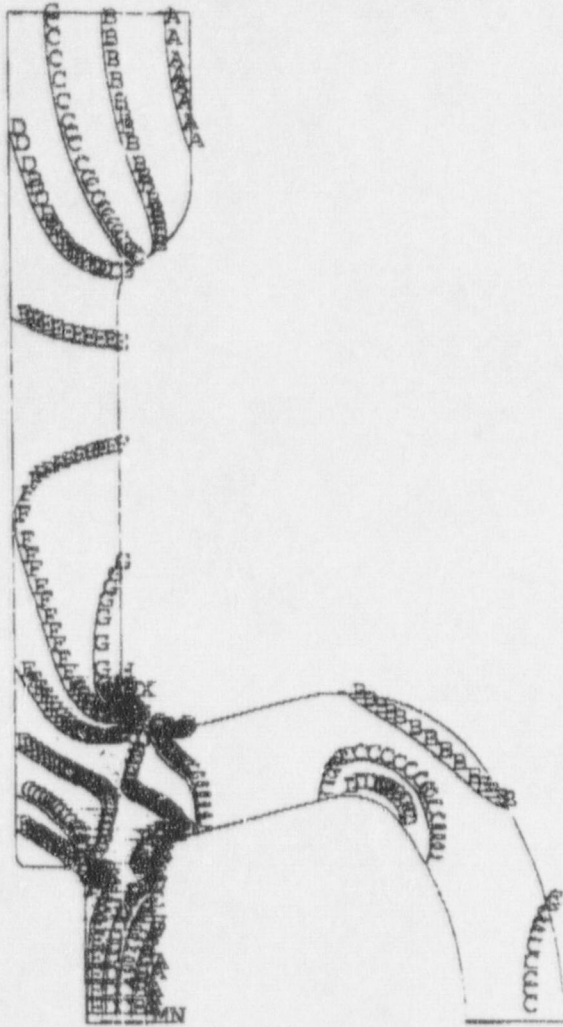
Figure 2. Finite Element Model

A two dimensional axisymmetric finite element model, depicted in Figure 2, was constructed using the ANSYS finite element program (Version 5.3). Based on the available information, the model was contoured to match the arrangement drawing. The model assumed symmetry about the center of the pump impeller since the main interest was in the region of the intersection of the volute and the cylindrical pump casing. The boundary conditions allowed free radial movement at the symmetry line.
