Radiological and Engineering Assessment

Vicinity Property No. CAN-133

THE RADIOLOGICAL AND ENGINEERING ASSESSMENT
AND FINAL DESIGN

June 25, 1984

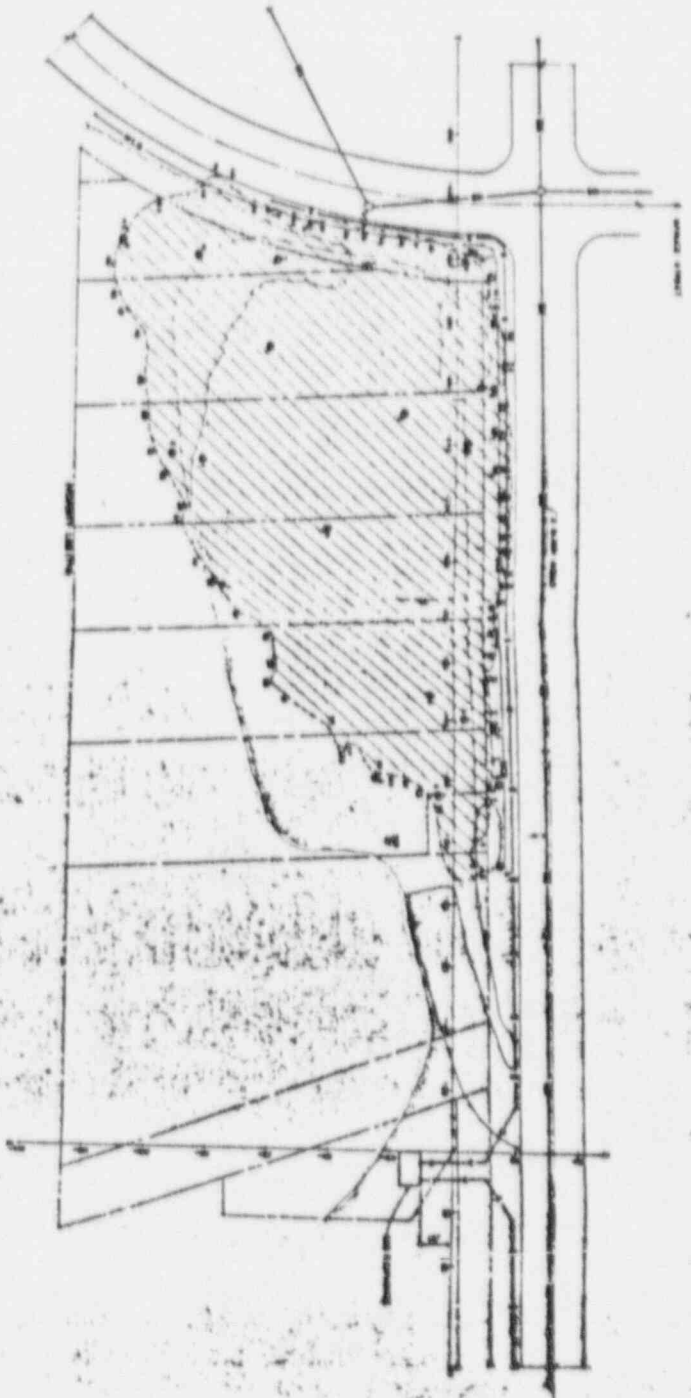
Contamination, as defined in RAC-018, was found in 10 of the 26 holes augered. The location and depth of the contamination is shown in Table 3.2. Three supplemental boreholes were drilled subsequent to the original survey. No contamination was found in these holes.

A	(-200.0,40.0)	None
B	(-175.0,40.0)	None
C	(-120.0,40.0)	None

Option 2 includes excavation of contaminated soil designated on Drawing CA-133-100 and replacement with clean fill and topsoil. Seeding is required, rather than sodding, because the property is vacant and normal vegetation should be re-established within one growing season. The area to be excavated is approximately 15,500 square feet. See Figure 4.1. The depths of excavation vary across the area from 1 to 9 feet, with the average depth being approximately 3 feet. There are no utilities within the excavation area and there are no safety hazards to contractor for performing the work. The work area is directly accessible from Glenn Avenue.
