SUBJECT: CRACKED REACTOR COOLANT INLET NOZZLE ON A LETDOWN HEAT EXCHANGER AT PALO VERDE 3

Reference: Palo Verde Nuclear Generating Station - Unit 3 Letdown Heat Exchanger - Cracked Reactor Coolant Inlet Nozzle RECO Mfg. Serial No. N-2376 Bechtel Deficiency Report # 86-29

Subject: Final Report - DER 86-29 A 50.55(e) Condition Relating to Letdown Heat Exchanger Nozzle Crack File: 87-006-216

Records Center Institute of Nuclear Power Operations 1100 Circle 75 Parkway - Suite 1500 Atlanta, Georgia 30339 FINAL REPORT - DER 86-29 DEFICIENCY EVALUATION 50.55(e) ARIZONA NUCLEAR POWER PROJECT (ANPP) PVNGS UNITS 1, 2, 3

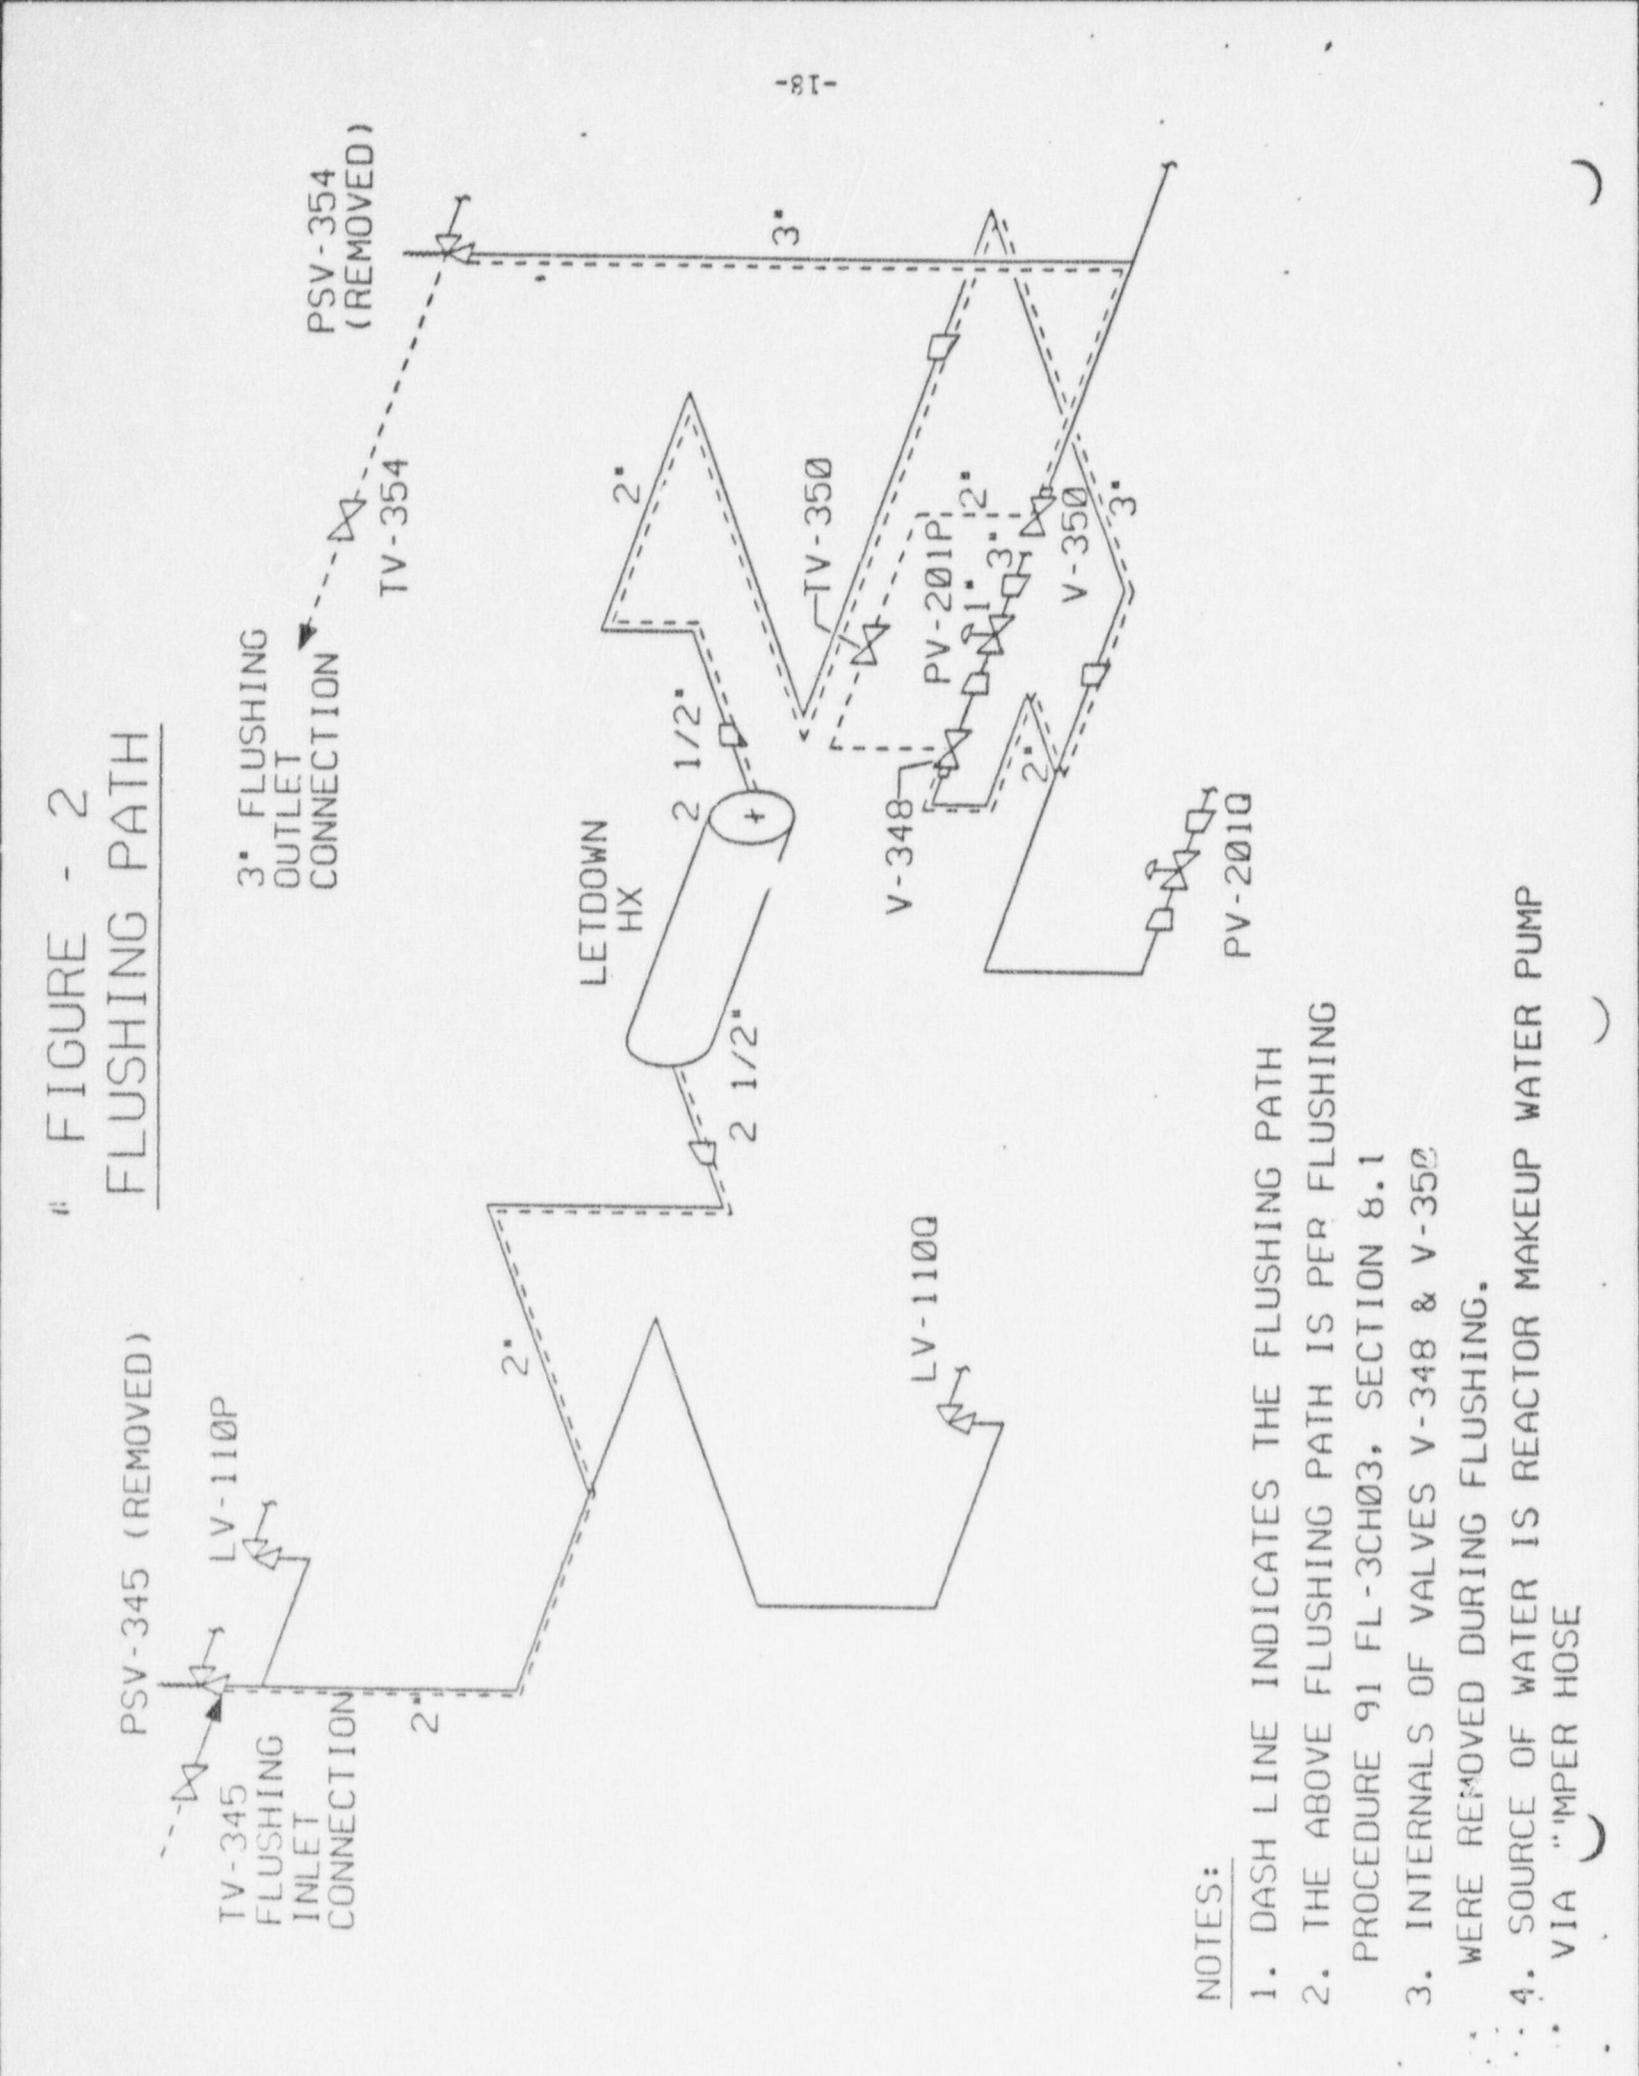
## TABLE 1 - SURAART OF STRESS EVALUATIONS OF THE FAILURE OF THE UNIT 3 LETDOWN MEAT EXCHANGER NOZZLE (DER 86-23)

15101108	IANULYSIS PERFORMED	INPUT DESCRIPTION	(RESULTS (NOTE 1)	CONCLUSIONS
11.2.1 IOPERATION 1 1	EVALUATION OF POST REPAIR ROZZLE HYIBRATION DATA ('NORBAL OPERATING FLOW RATES) I	ISTRIP CHART DATA DURING NORMAL IOPERATING FLOWRATES FOLLOWING REPAIR I I	ISTRESS: 0.4 Kai IFORCE: 20 LBSI ICYCLES: RORE THAN 1.026 IDISPLACEMENT: .036 MIL I	ISTRESSES REMAIN WELL BELOW CRACK IPROPADATION TERESHOLD - NOTELE INTEGRITY AS NOT AFFECTED. I

11.2.2 IFL05N145 I I	FVALUATION OF FLOW INDUCED VIBRATION IOUE TO STISTER FLUSHING I I I I	IDURATION: 44 CUMULATIVE HOURS ITEAPERATORE: 60 - 80 DEG F ESTIMATED IRRESSURE: 140 PSI ESTIMATED I(ACTUAL PLANT DATA NOT AVAILABLE) IESTIMATED FLOW RATE 200 GPM	INCOMENTATES USED DURING FLUSEING ICOULD INDUCE STRESSES IN THE RANGE OF 13.5 TO 4.0 KAI FOR APPROXIMATELY 1.0E6 ICTCLES - IESTIMATED DISPLACEMENT RANGE 0.2 - 10.6 BIL	ISTRESSES ELECTED LOWER RAXOE OF ICRACK PROPAGATION TERESHOLD - IPRESERVE OF PRE-ELISTING FLAN COUL IRESULT IN NOZZE FAILURE. 7 - 3.5 K si

BURCHURSTER, VIOLA				
12.1 PTNERAAL PTRAASIERTS 1	IFATICUE EVALUATION OF THERMAL ITRAMSIENTS DUBING BUT PRIOR TO FAILURE I I I	<ul> <li>PLAKT DATA:</li> <li>FLOW AND TEXP VS. TIKE Ø 2 BIKUTE</li> <li>INTERVALS FROM 10/23 TO 10/27</li> <li>NUZZLE CONFIGURATION (FIGURE 1)</li> <li>STRESS INDICES (NB-3683)</li> </ul>	IUSAGE FACTOR: LESS THAN 0.07 I I I	I I ITRE TOTAL USAGE FACTOR(UF) FROM ALL ILOW CTCLE / HIGH STRESS POTENTIAL

12.2 IPRESSURE ITRANSIENTS	FATIGUE EVALUATION OF PRESSURE "YRANSIENTS DURING HIT PRIOR TO FAILURE	PLAKT DATA:     FLOW AND PRESS VS. TISE @ 3 BINUT;     INTERVALS FROM 10/23 TO 10/27     NOZZLE CONFIGURATION (FIGURE 1)	REGLIGIBLE CONTRIBUTION TO USAGE FACTOR	-ICONTRIBUTING FACTORS WAS CALCULATED ITO BE LESS TRAN 0.1 USING ICONSERVATIVE STRESS INDICES TO IACCOUNT FOR THE FRESERCE IOF THE GROOVE.
