# Geologic and Seismologic Study of Bodega Head

BY  
Pierre Saint-Amand

This report is Dr. Saint-Amand's analysis and conclusions concerning the hazards posed by the Pacific Gas and Electric Company's anticipated construction of a 325 megawatt nuclear reactor at Campbell Cove on Bodega Head.

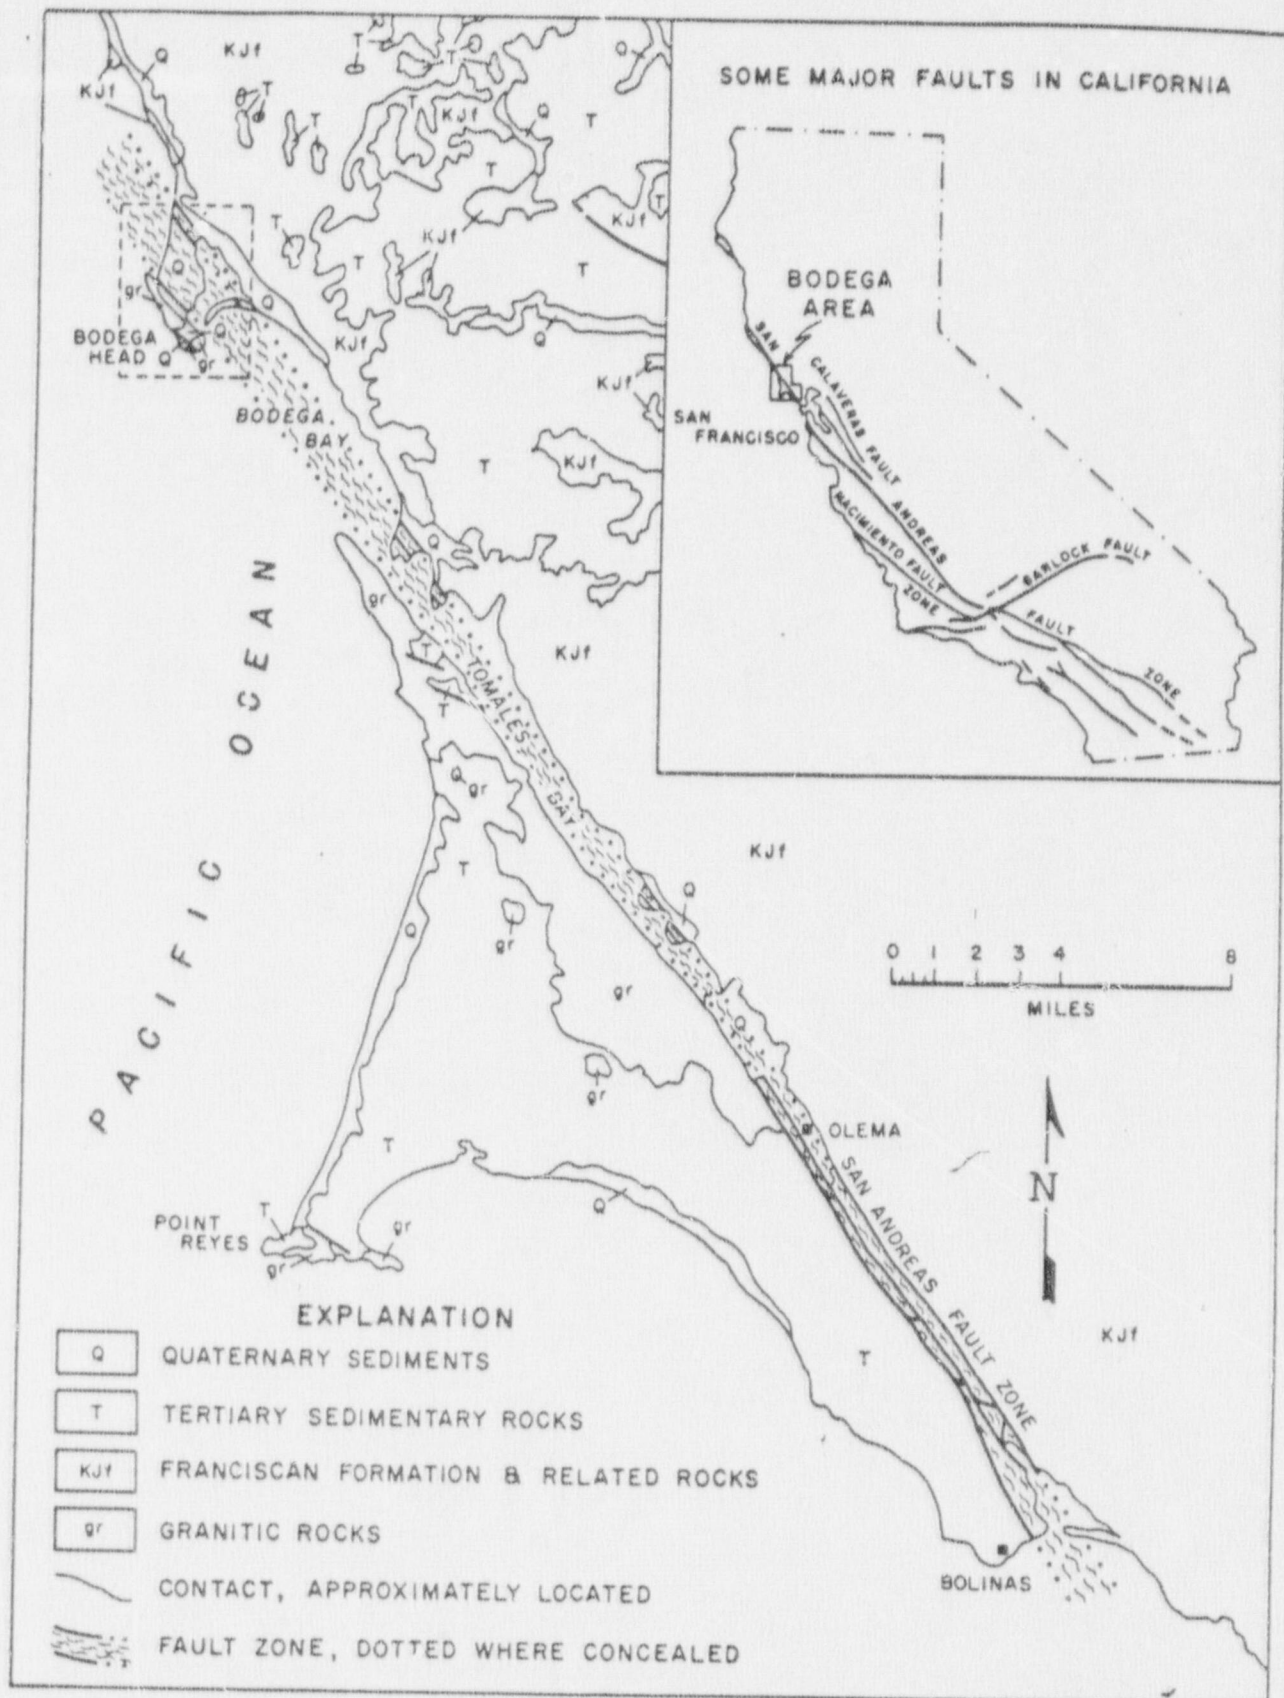
Generalized geologic map of Bodega Head and Pt. Reyes (after San Francisco and Santa Rosa sheets of the Geologic Map of California). The area shown in dashed lines is the area shown on next page.

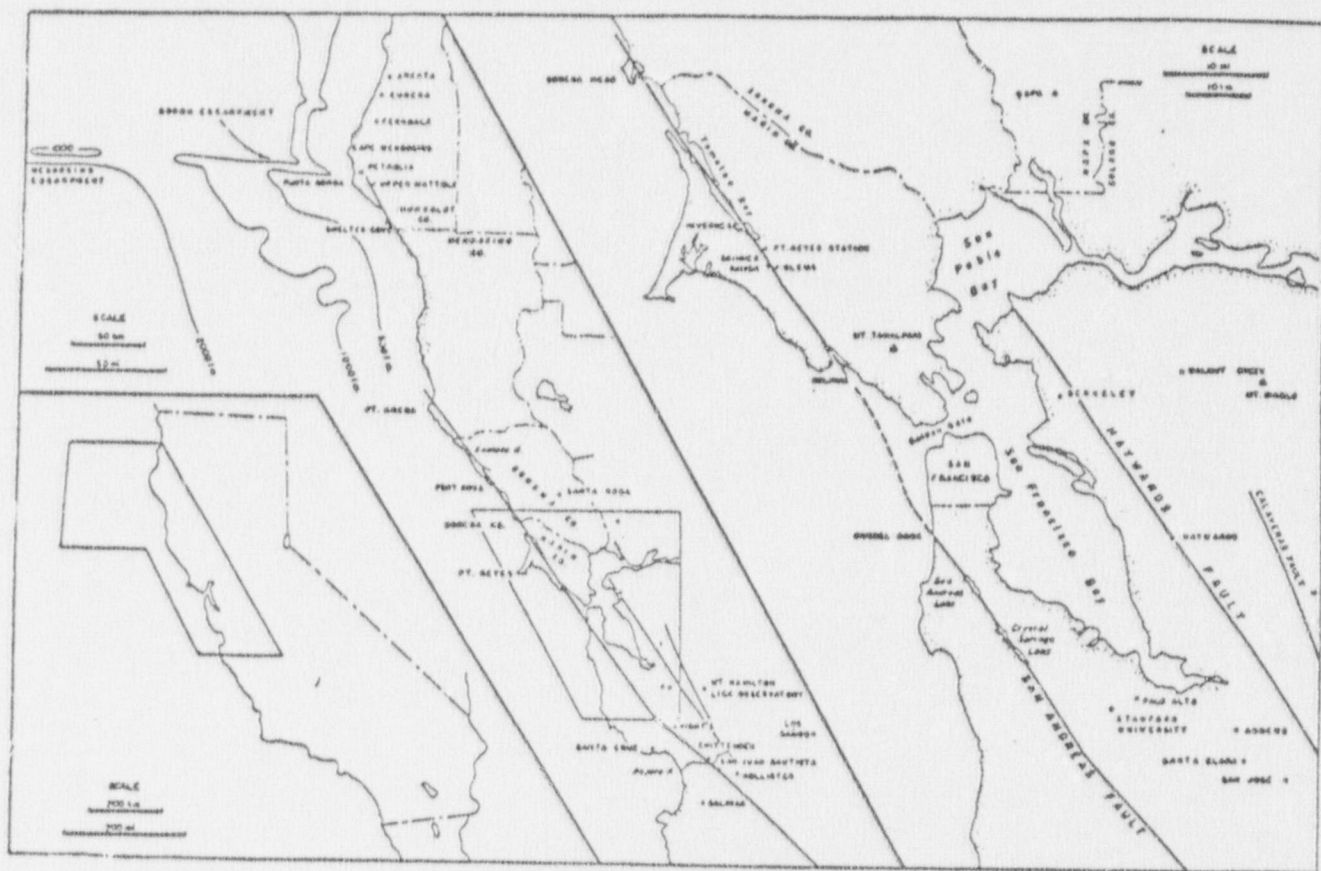
FIG. 11. Locality Map for 1906 Earthquake.  
Taken from Richter 1958.

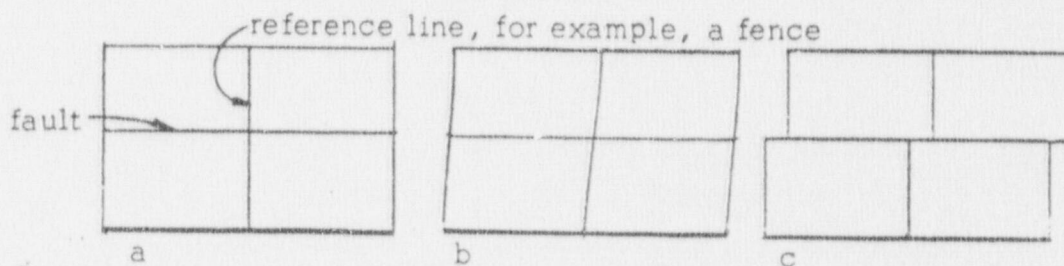
The gradual drift of the land deforms the blocks (see Fig. 12) bending the rocks and storing energy in them in the form of elastic strain. The strain accumulates until the forces generated in the rock are great enough to overcome the frictional forces on the surfaces of a fault that prevent slippage. When this happens the rock on either side suddenly snaps back into its unstrained straightened condition.

FIG. 12. Process of Strain Accumulation and Release (not to scale)  
 a. Field cut by a strike slip fault, before strain accumulation.  
 b. During strained condition and before an earthquake.  
 c. After an earthquake.
