NOTICE OF VIOLATION

Duke Power Company
Catawba Unit 1

Docket No. 50-413
License No. NPF-35

ENFORCEMENT CONFERENCE SUMMARY

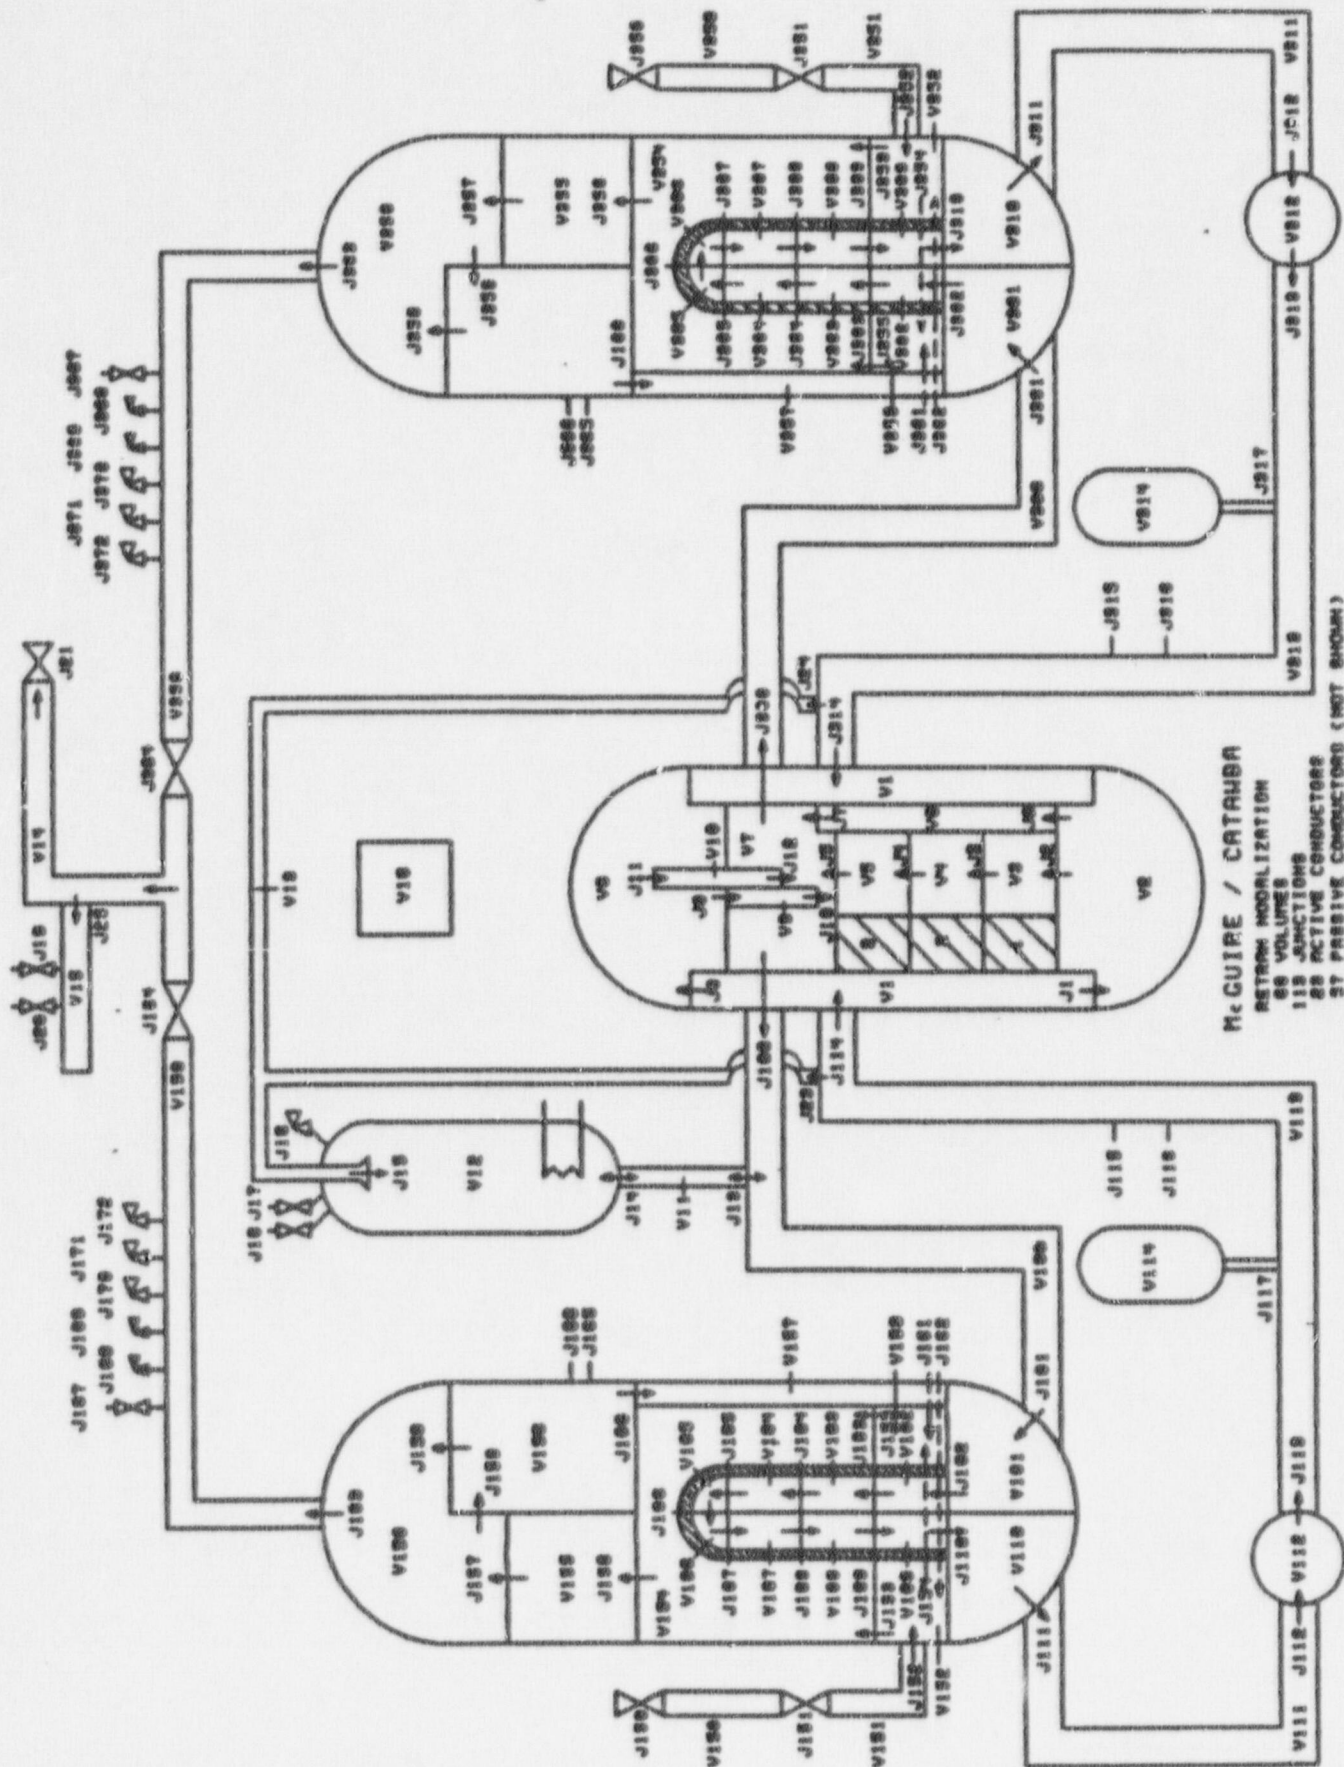
- PLANT SPECIFIC SIMULATION OF THE WORST CASE SCENARIO USING A THREE-LOOP CATAWBA UNIT 1 RETRAN-02 MODEL

- BOUNDARY CONDITIONS
 - MAIN FEEDWATER LINE BREAK AT STEAM GENERATOR A
 - MINIMUM AUXILIARY FEEDWATER DELIVERED TO STEAM GENERATOR D
 - DECAY HEAT CORRESPONDING TO CONTINUOUS OPERATION OF CYCLE 2 AT FULL POWER UNTIL JULY 6, 1987 (195 EFPD).
 - NO CREDIT FOR HEAT TRANSFER DUE TO AUXILIARY FEEDWATER SUPPLIED TO THE RUPTURED STEAM GENERATOR (SIGNIFICANT CONSERVATISM)
 - SCENARIO SIMULATED FOR 30 MINUTES AT WHICH TIME OPERATOR INTERVENTION CAN BE CREDITED

McGUIRE / CATAUBA
 RETURN NO. 100
 88 VOLUMES
 113 JUNCTIONS
 28 ACTIVE CONDUCTORS
 37 PASSIVE CONDUCTORS (NOT SHOWN)
