McGuire Nuclear Station Unit 2
Review of Susceptibility to an Event like the
McGuire Unit 1 Tube R18C25 Rupture
and Justification for Return to Power

Addendum to McGuire Unit 1 Justification for Return to Power

August 1989

Duke Power Company

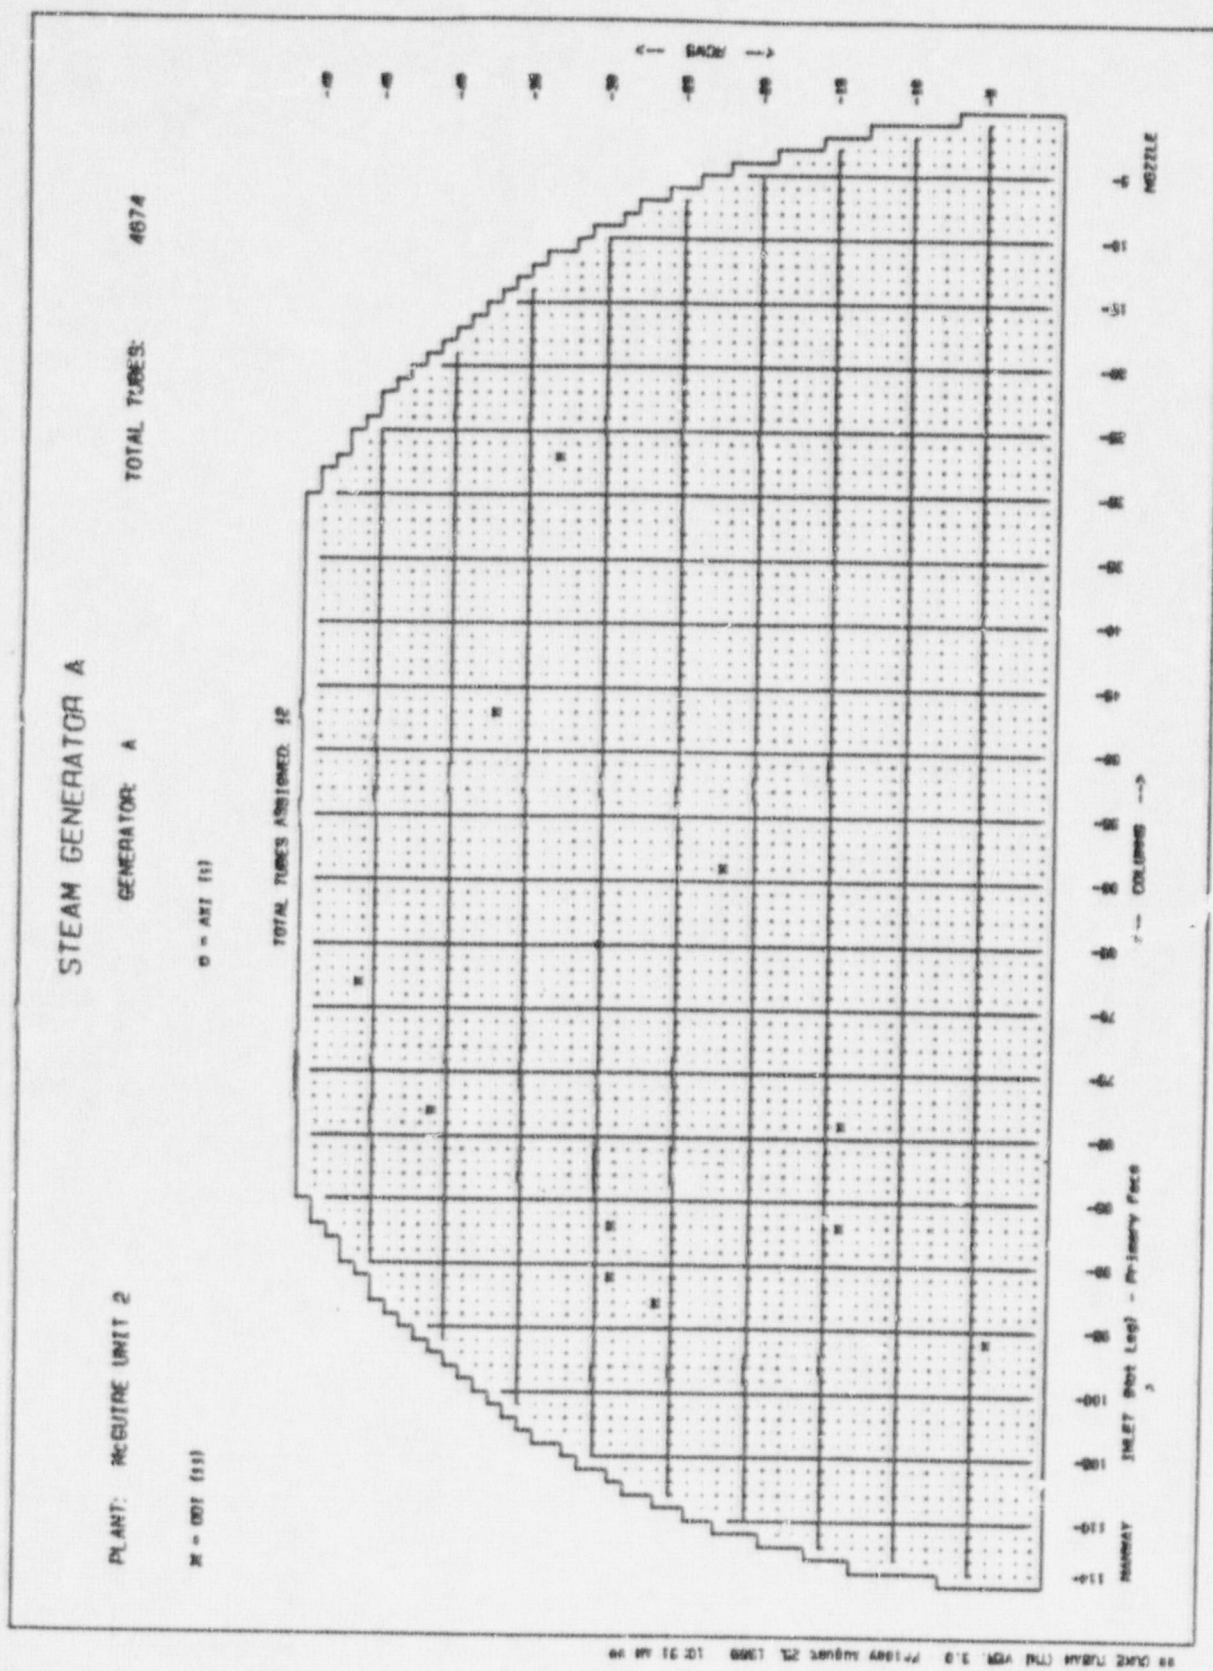
Figure 5-9. Steam Generator A Inlet - Free Span Indications

Tubesheet maps for "free-span" indications are shown in Figures 5-9 through 5-16. These maps include localized tube "buff marks" and axial indications which exhibit some significant length. All of the axial indications were plugged; SG D had the highest population of these indications.
