SOUTHERN CALIFORNIA
EDISON

Subject: Docket Numbers 50-361 and 50-362
Response to Inspection Report 98-05 Regarding Linestarters
San Onofre Nuclear Generating Station, Units 2 and 3

Licensee Event Report (LER) 1998-003 (References 2 and 3), described the discovery on February 5, 1998, of a Unit 2 jammed reversing linestarter mechanical interlock associated with valve 2HV9305. The discovery was made during a planned replacement of the interlock. Based on the condition of the interlock when it was removed, SCE assumed that the valve would not have opened upon demand.

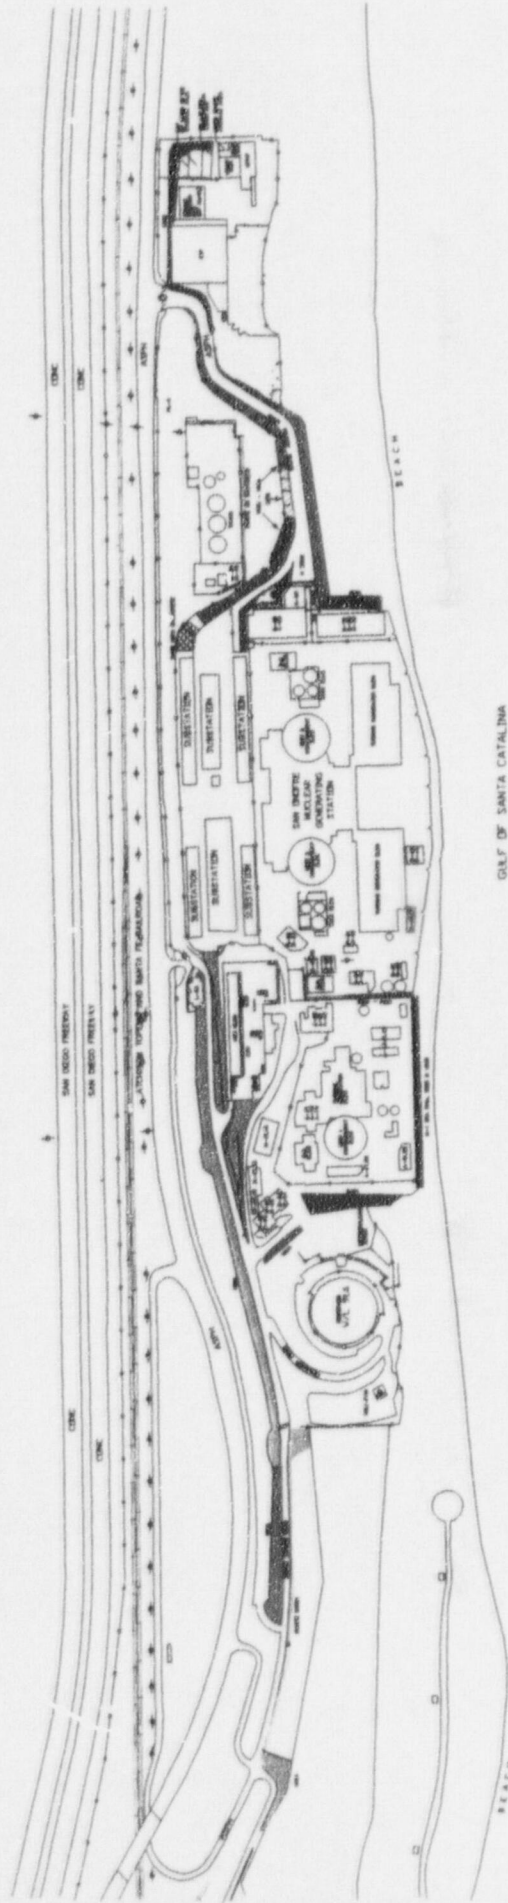
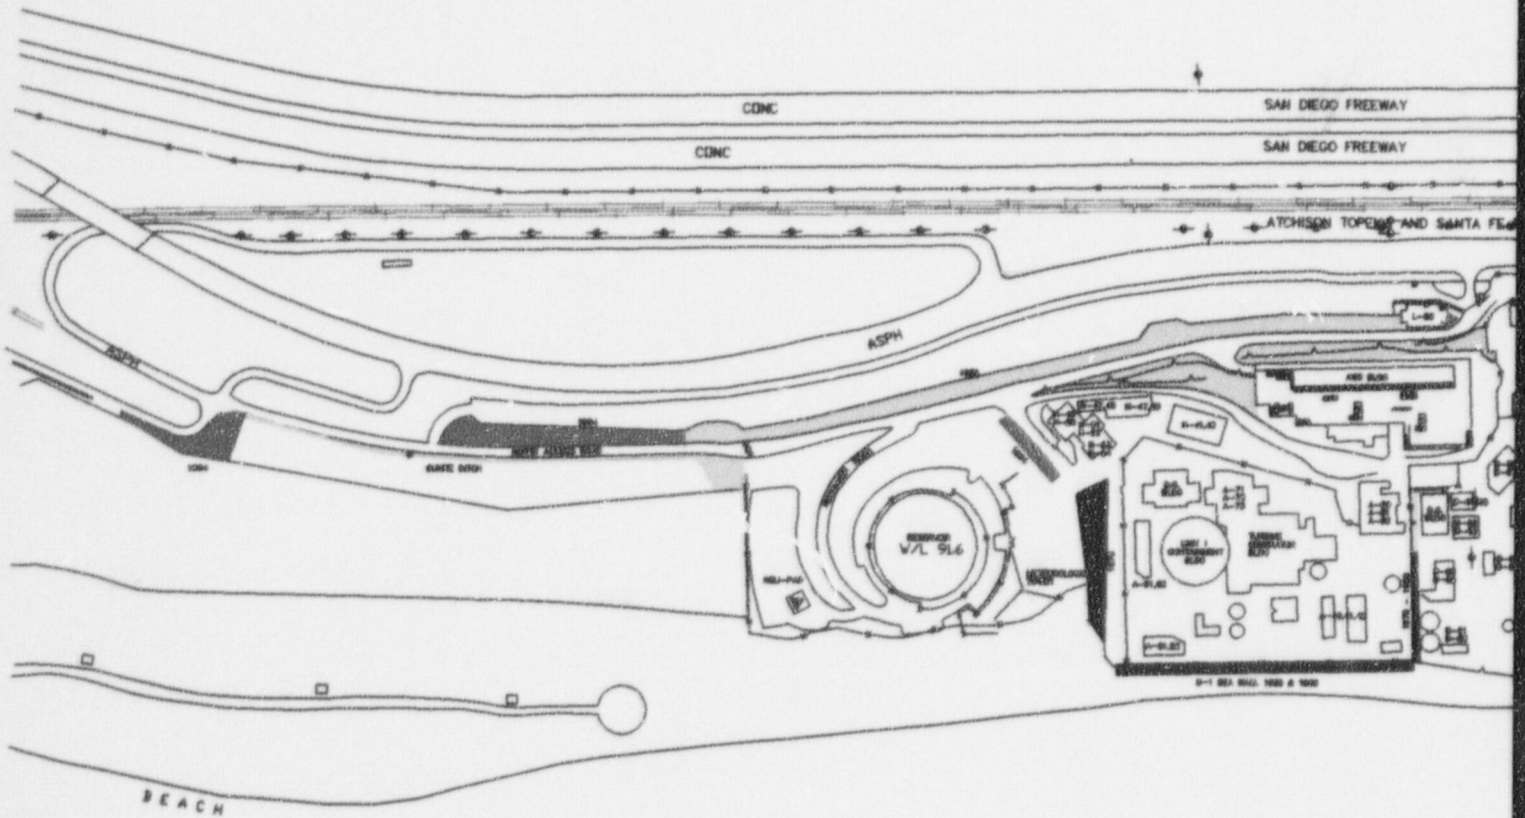
ATTACHMENT 1
FIGURE 1
SHOTCRETE & GUNTING ACTIVITY MAP

Figure 1 represents the obtained information relative to when specific guniting activities took place. The guniting activities were at various locations surrounding the plant. Individual guniting activities are relatively short in duration. Recollections of additional guniting activities, early in construction, could not be confirmed.
