Dominion Energy Nuclear Connecticut, Inc. 5000 Dominion Boulevard, Glen Allen, VA 23060 DominionEnergy.com

October 8, 2020

DOMINION ENERGY NUCLEAR CONNECTICUT, INC. MILLSTONE POWER STATION UNIT 2 PROPOSED LICENSE AMENDMENT REQUEST TO REVISE THE MILLSTONE UNIT 2 TECHINCAL SPECIFICATIONS FOR STEAM GENERATOR INSPECTION FREQUENCY

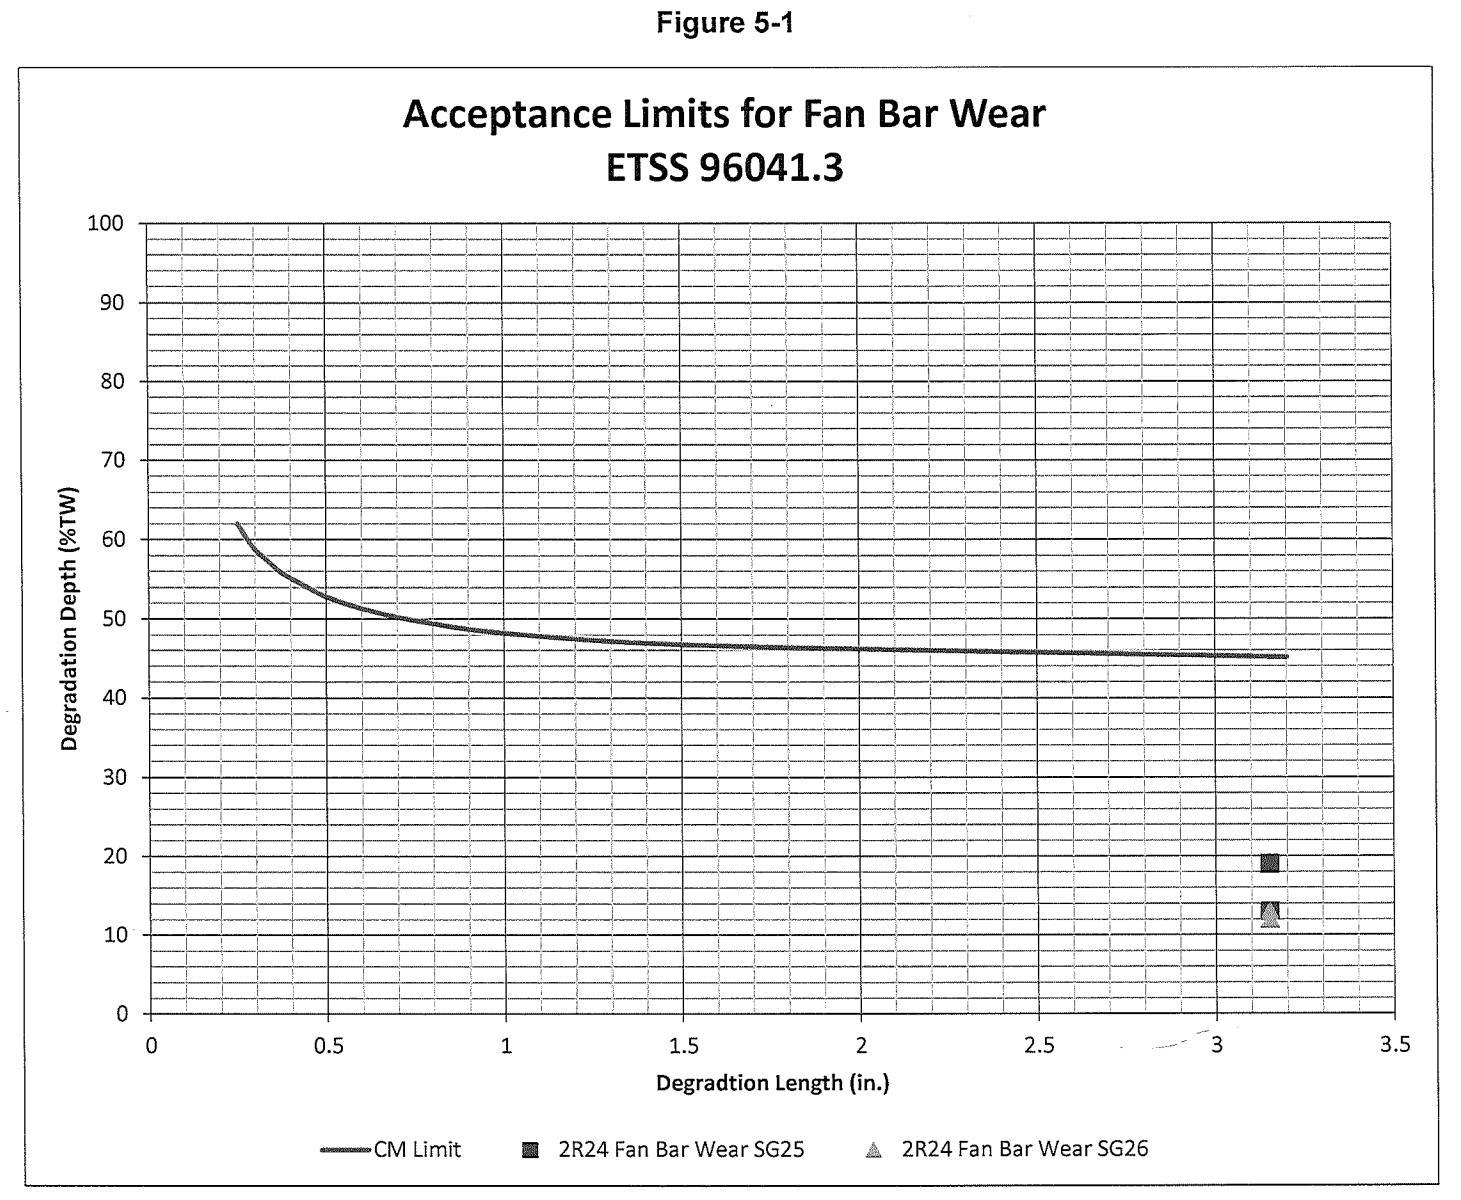
The figures also display the length and depth of each flaw. Because each flaw plotted in Figures 5-1 through 5-4 lies below the CM limit curve, it is concluded that the structural performance criteria set forth in the MP2 Technical Specifications was not exceeded by any of the evaluated flaws. This also provides reasonable assurance that none of these flaws would have leaked under accident conditions.
