PRECURSOR DESCRIPTION AND DATA

NSIC Accession Number: 109295

Title: Borated Water Storage Tank Level Indication Fails at Oconee

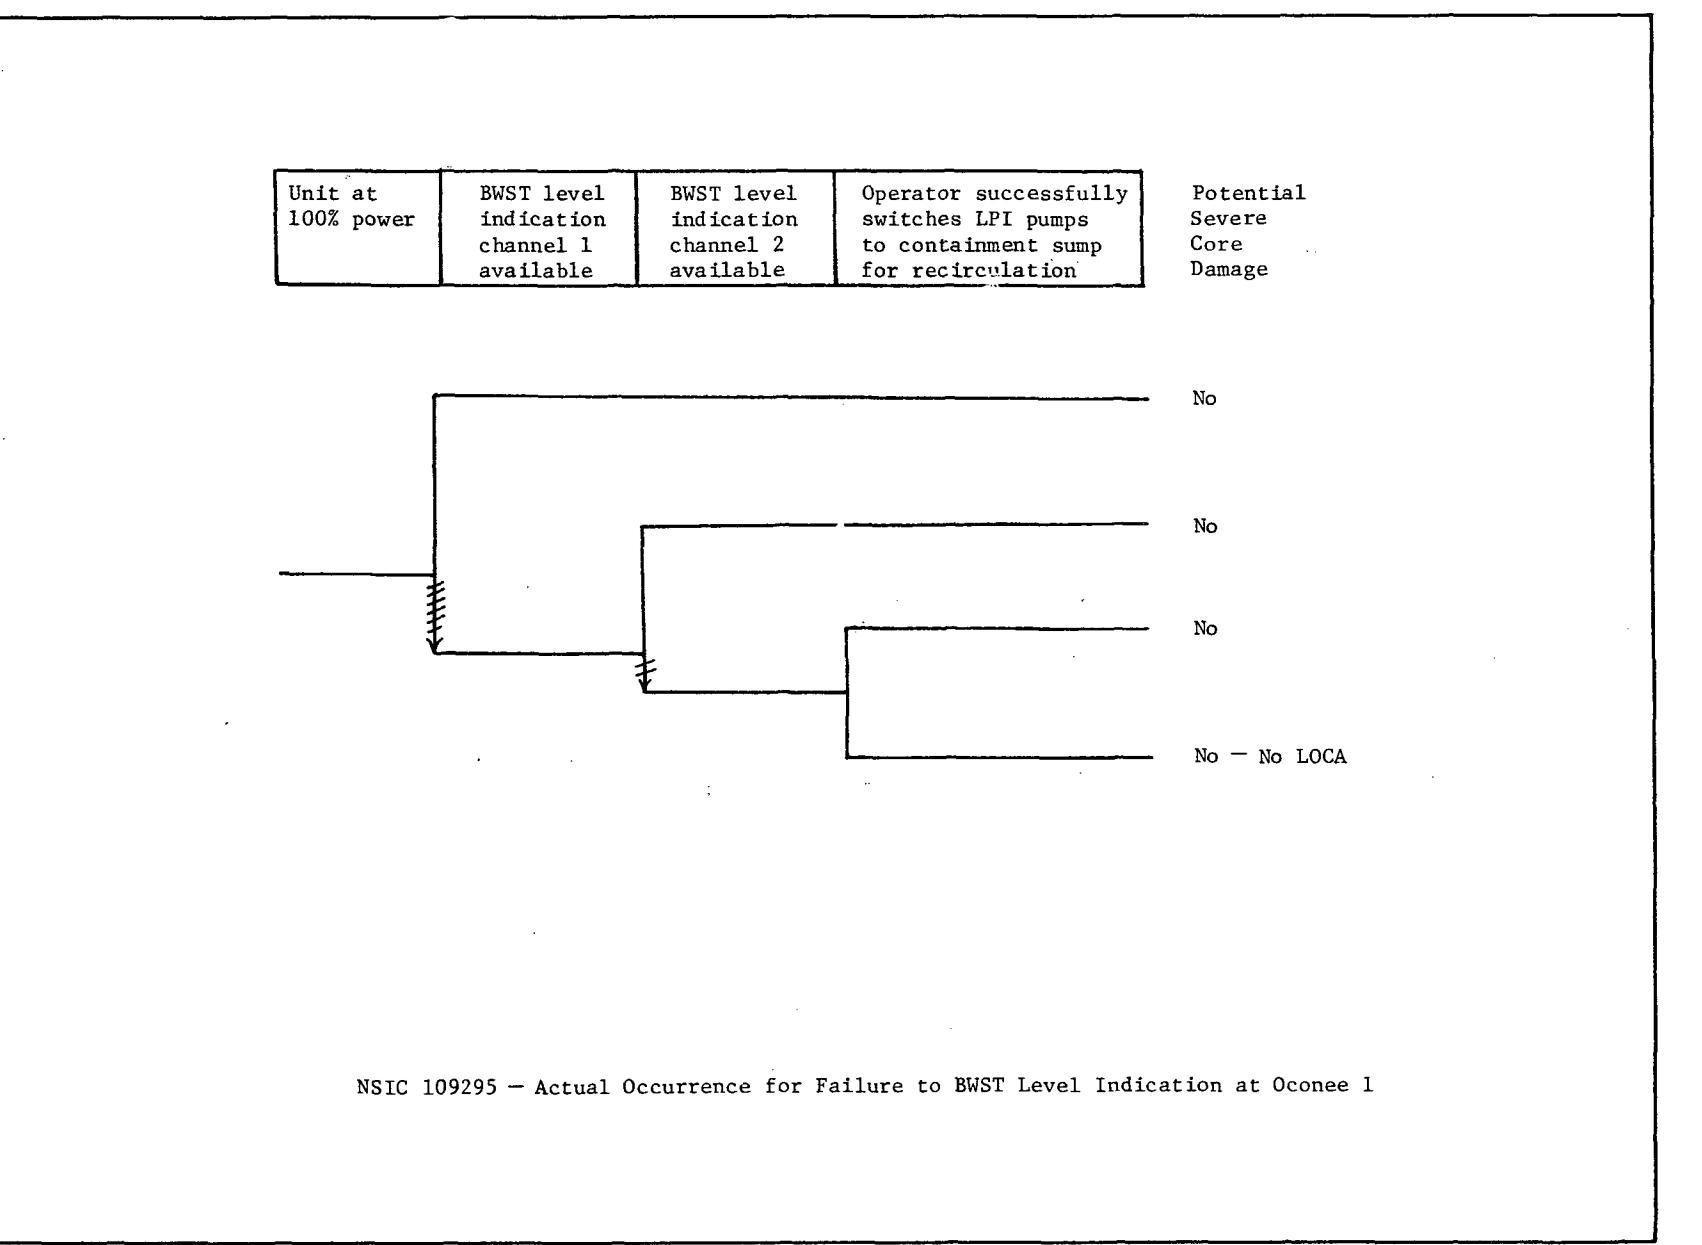
NSIC 109295 - Sequence of Interest for Failure to BWST Level Indication at Oconee 1

Both channels of BWST level indication failed due to freezing of moisture in the 1 vel transmitter impulse lines. This was caused by a failure in the trace heating for the instrument air lines to the transmitters.

Small LOCA	Reactor Trip	Auxiliary Feedwater and Secondary Heat Removal	High Pressure Injection	Low Pressure Recirculation and LPR/HPI Cross-Connect	Potential Severe Core Damage	Sequence No.
- 1				1

* success requires the operator to switch to recirculation without BWST indication after sufficient water has been injected for LP pump NPSH and before the BWST is emptied, and without level indication.

- 1. Reactor shutdown was initiated.
- 2. Independent power sources were provided for each heat tracing circuit, resulting in redundant heat tracing.
