# Turkey Point Unit 3 ICW Pipe Leak Repair Plan Potential Relief Request

NRC NRR Turkey Point PM and Tech Staff Briefing  
August 25, 2021

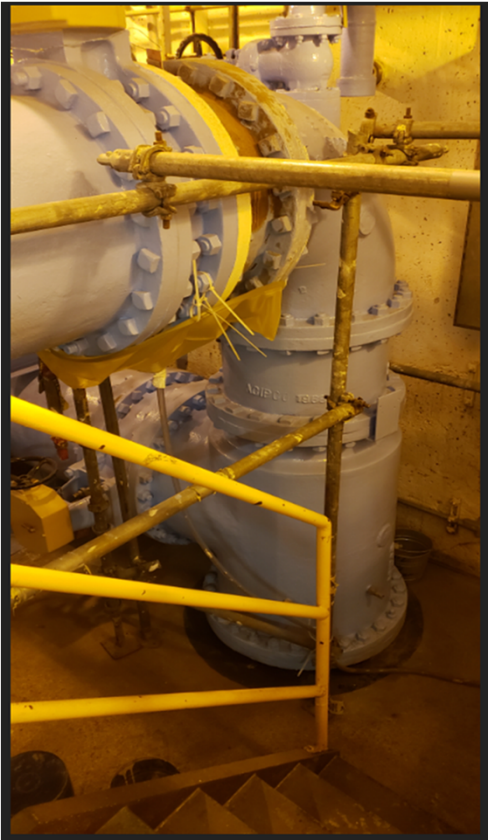
See 11-1/8 inch-Long spool piece Directly Downstream of Valve 3-50-406 (5613-P-820-S, Sheet 1 of 2)

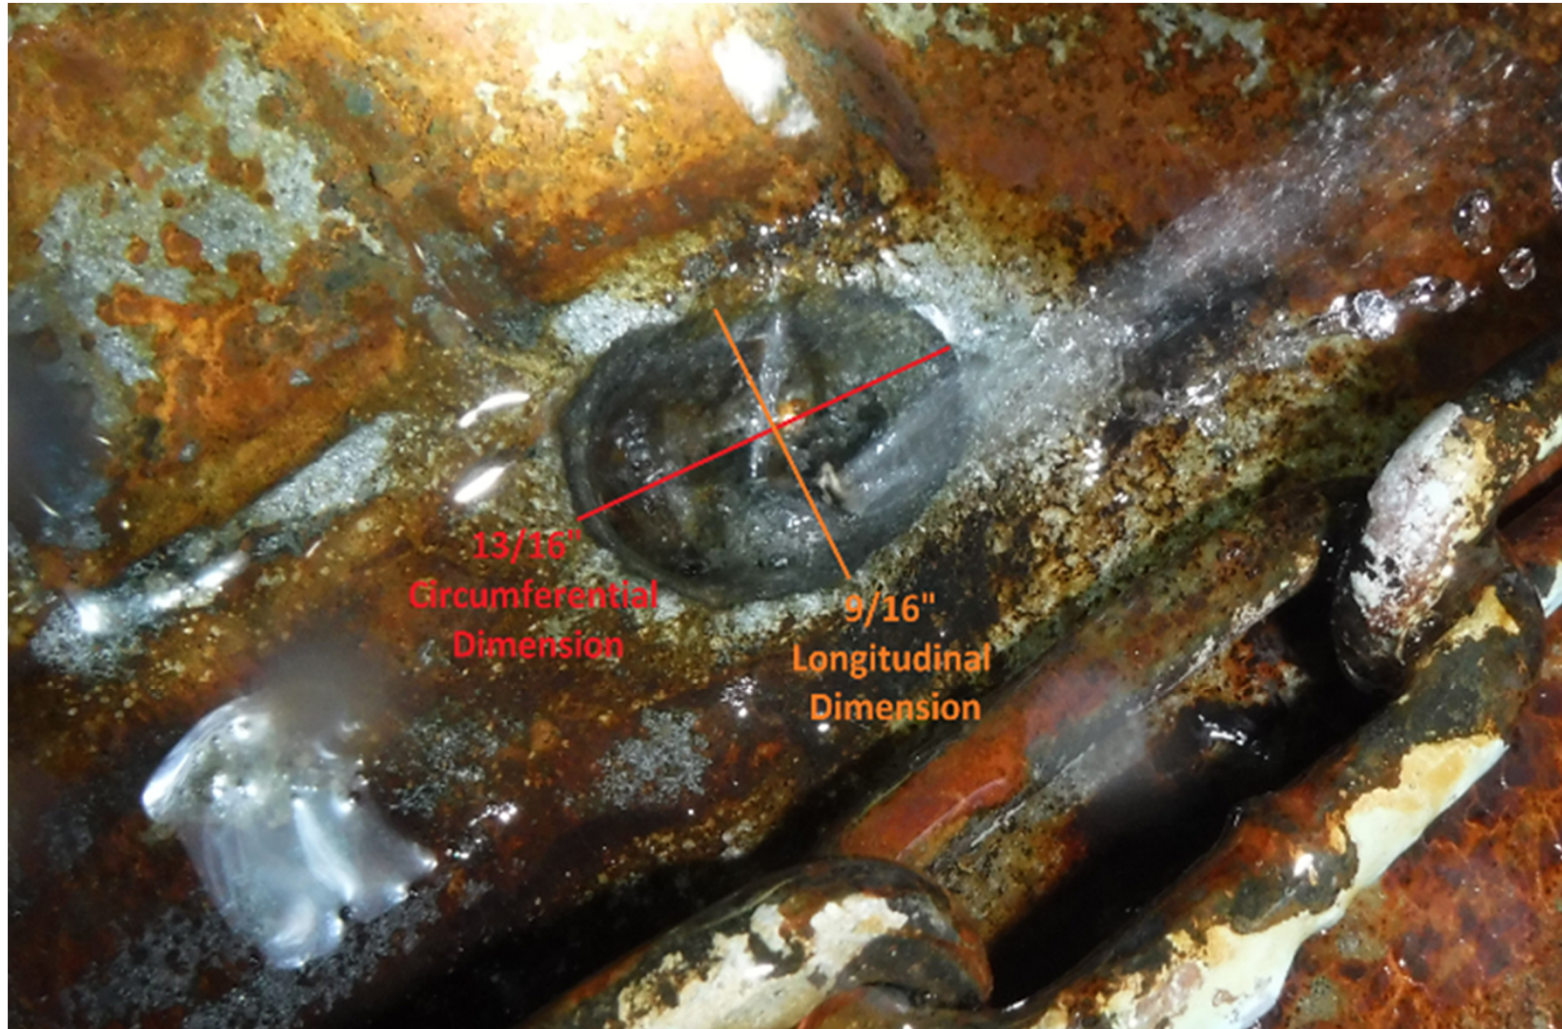
- The ICW safety related piping affected is classified as Quality Group C and treated as ASME Section XI Class 3 piping
- The ICW piping section of concern is 24" nominal diameter, with a specified nominal wall thickness of 0.73".
- The pipe is Cast Iron ASA 21.6, Class 150, Cement Lined ASA 21.4 with .25" thickness.
- Maximum operating parameters are  $T = 120 \text{ degF}$  and  $P = 25 \text{ psig}$ .
