**PERRY NUCLEAR POWER PLANT**

Geologic Map of Tunnel Excavations

Figure 2D-2 (Sheet 1 of 24)

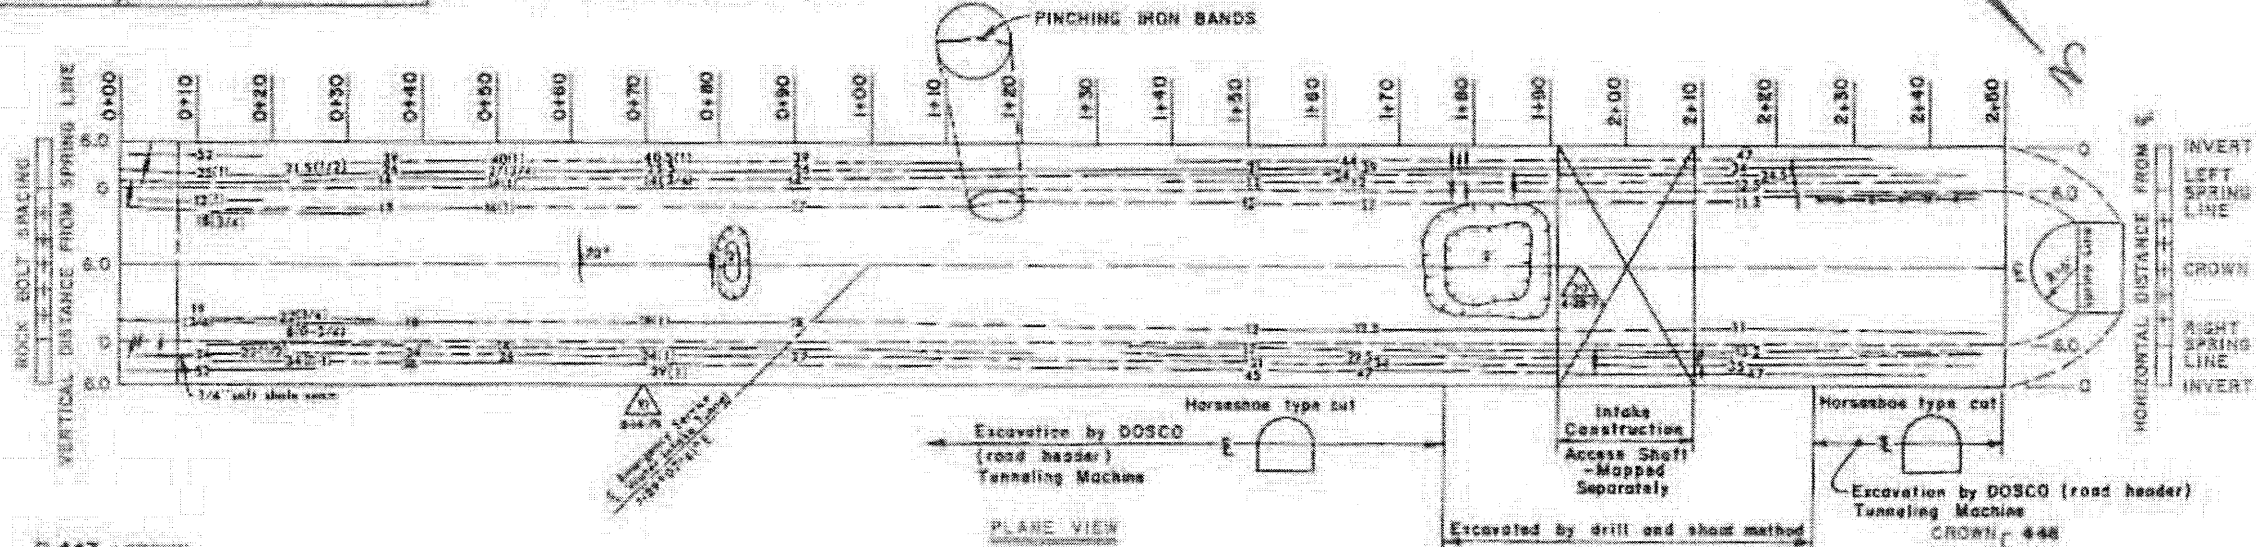
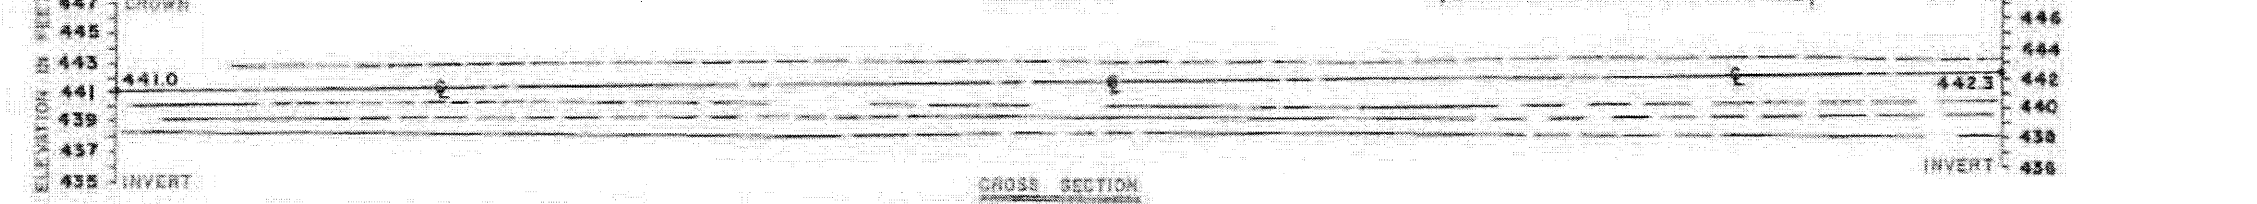
no. 1-5	no. 4	no. 5 at crown	no. 4	no. 5 at crown
5 Rock bolts in steel ribs with wire mesh between, roof surface coated vermiculite slurry		5 Rock bolts in steel ribs, covered by wire mesh	Roof bolts 1-5'	Roof 5 Rock bolts in steel ribs at 15'-4' centers, covered by wire mesh
3'-8"	3'-7"	3'-8"	3'-8"	3'-5"
Bedding fractures only		Very widely spaced	non-persistent 1'-3'	non-persistent 1'-10'
No inflow				No inflow
approx. 24' of horizon, approx. 35' of ground (11) 2 1/2' of shale				approx. 24' of horizon, approx. 25' of ground (11) 2 1/2' of shale

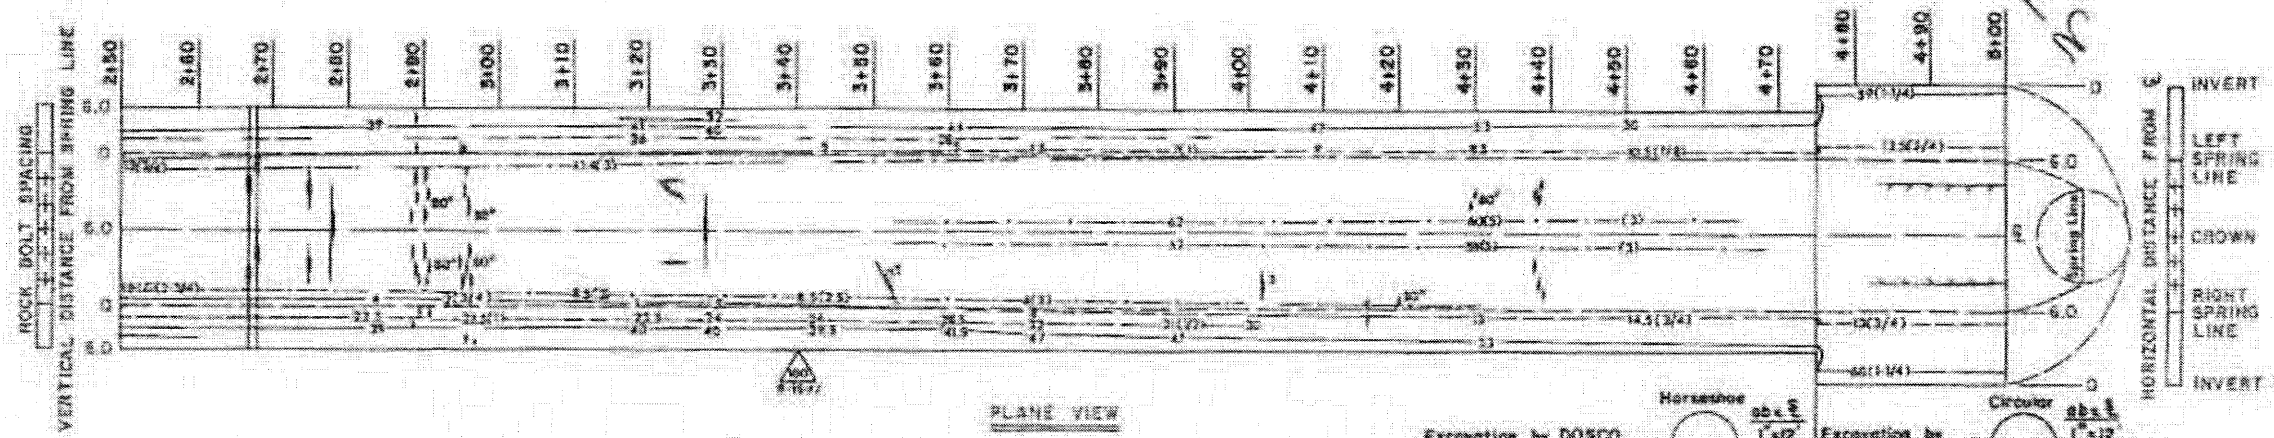
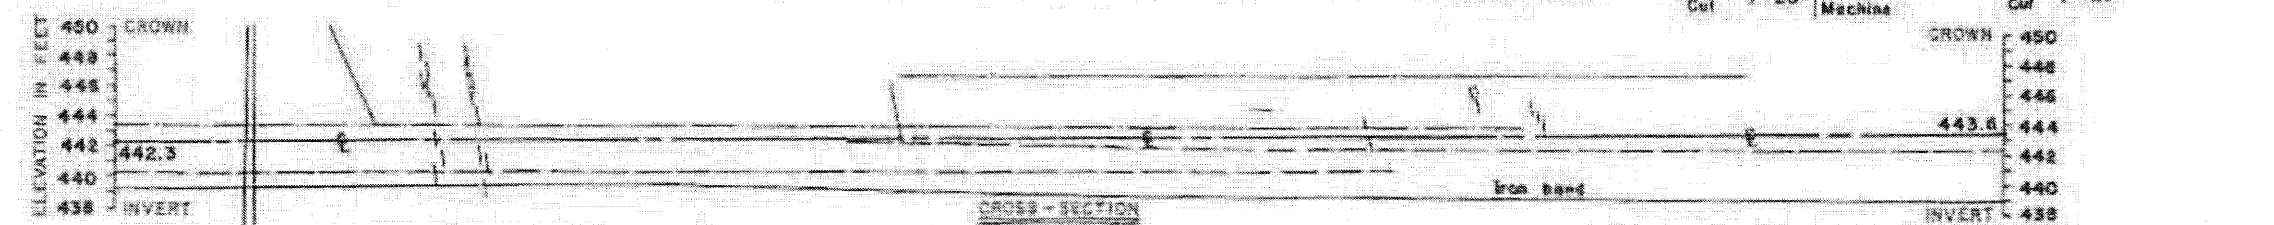
Figure 20-2 (Sheet 2 of 24)

STATION	2+70	2+80	2+90	3+00	3+10	3+20	3+30	3+40	3+50	3+60	3+70	3+80	3+90	4+00	4+10	4+20	4+30	4+40	4+50	4+60	4+70	4+80	4+90	5+00
Excavation Progress																								
ESTIMATED ROCK CONDITION (TERZAGHI NO.)																								
TEMPORARY SUPPORT SYSTEM																								
BEDDING SPACING	1'-5"	1/2'-5"	1'-5"	2'-5"	1'-4"	1/2'-4"	3/4'-4"	1'-3"	1'-4"	1'-4"	1'-4"	1'-4"	1'-4"	1'-4"	1'-4"	1'-4"	1'-4"	1'-4"	1'-4"	1'-4"	1'-4"	1'-4"	1'-4"	1'-4"
FRACTURE SPACING	1'-10"	1'-10"	2'-10"	1/2'-10"	10'																			
WATER CONDITION																								
DEPTH OF COVER

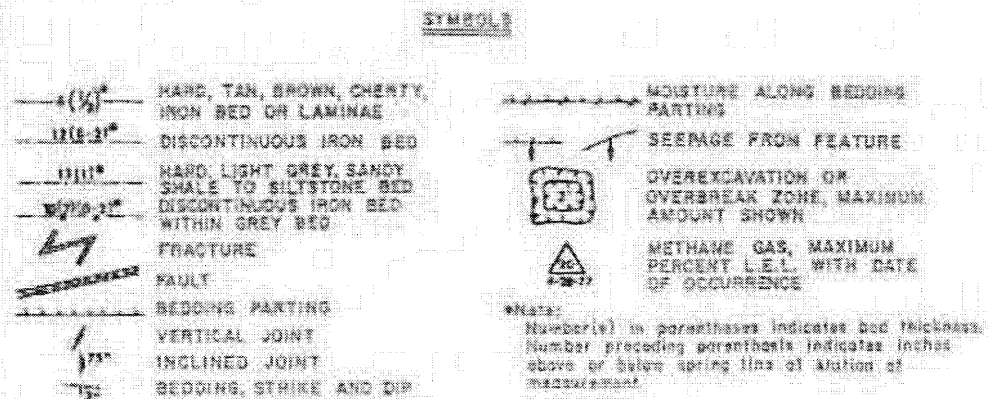
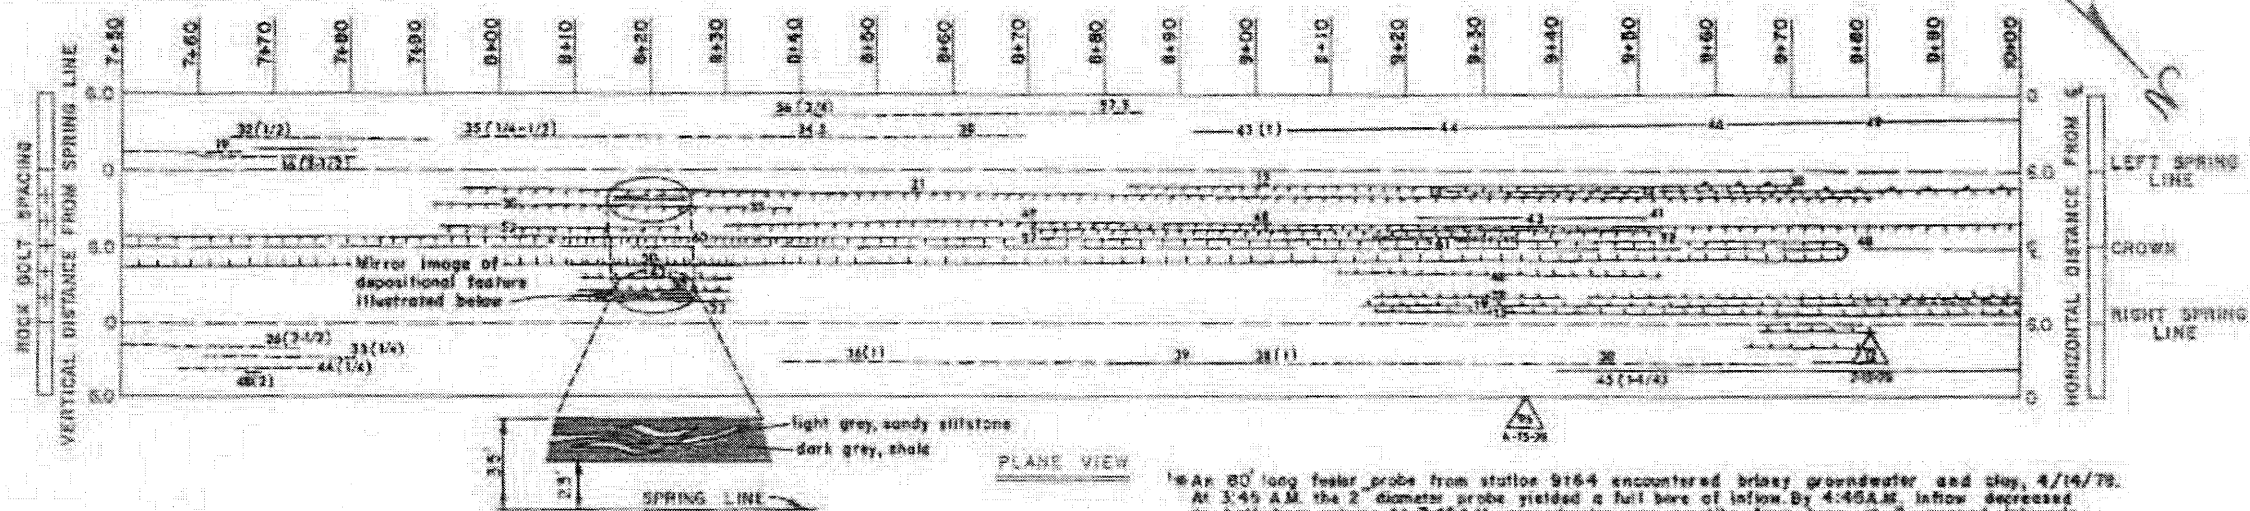
Geologic Map of
 Tunnel Excavations
 Figure 2D-2 (Sheet 4 of 24)

At 80' long test probe from station 9164 encountered brassy groundwater and clay, 4/16/79. At 3:45 A.M. the 2" diameter probe yielded a full bore of inflow. By 4:45 A.M. inflow decreased to half bore volume. At 7:45 A.M. groundwater was spurting from bore at 3 second intervals.

3'-0"	3'-0"	3'-0"	3'-0"	3'-0"	3'-0"
3'-0" Careful spalling along bedding fracture near crown 3 Rock bolts @ 2' centers in ribs spaced 2-1/2' apart, spaced by wire mesh					
1'-4"	1'-7"	1'-8"	1'-10"		
bedding fracture only					
Moisture along bedding fracture near crown			Moisture along bedding fracture near crown Seepage out of rock bolts w/ iron staining		Slight moisture along 20% of bedding fractures and rock bolts
5.4' water			10.5' water		11.8' water (plate)
ONLY subsurface (thick)

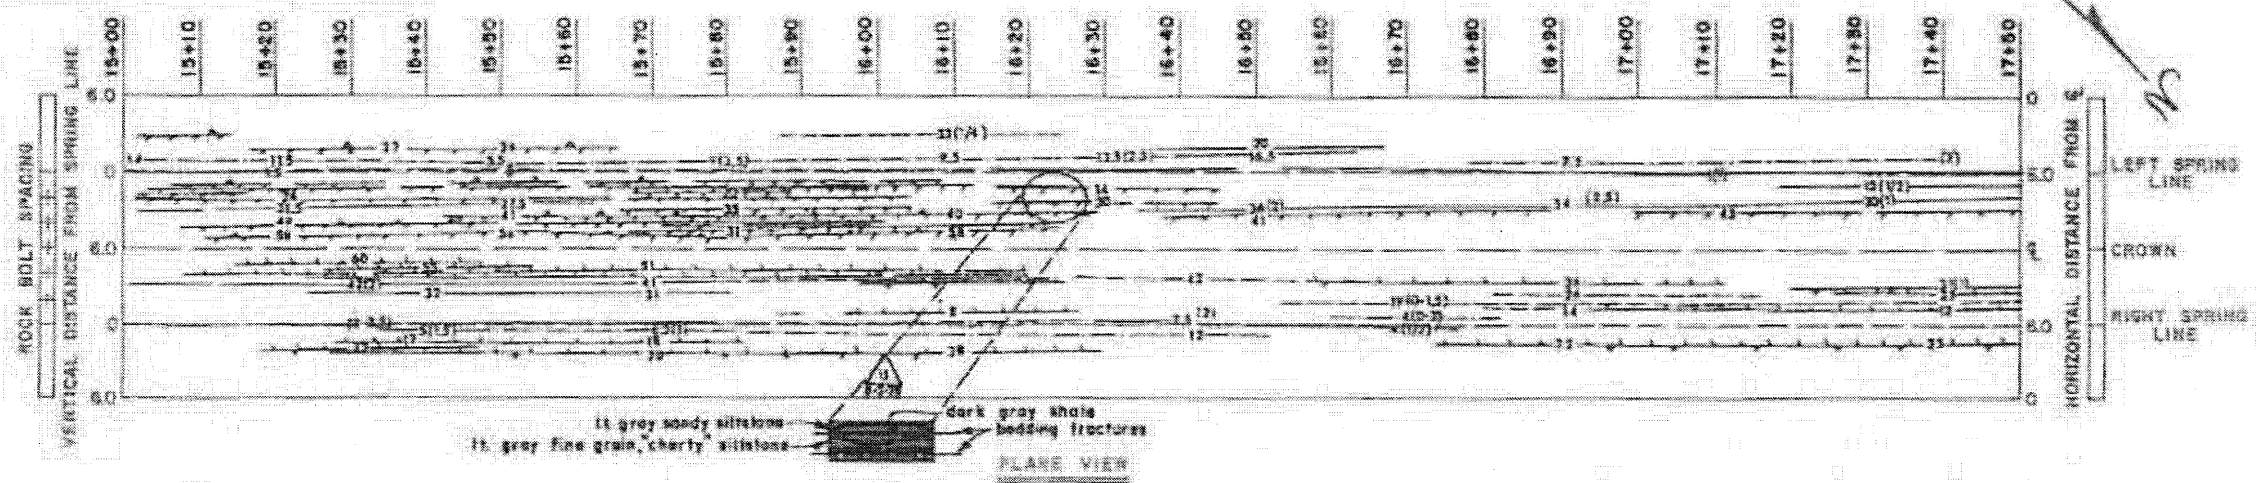
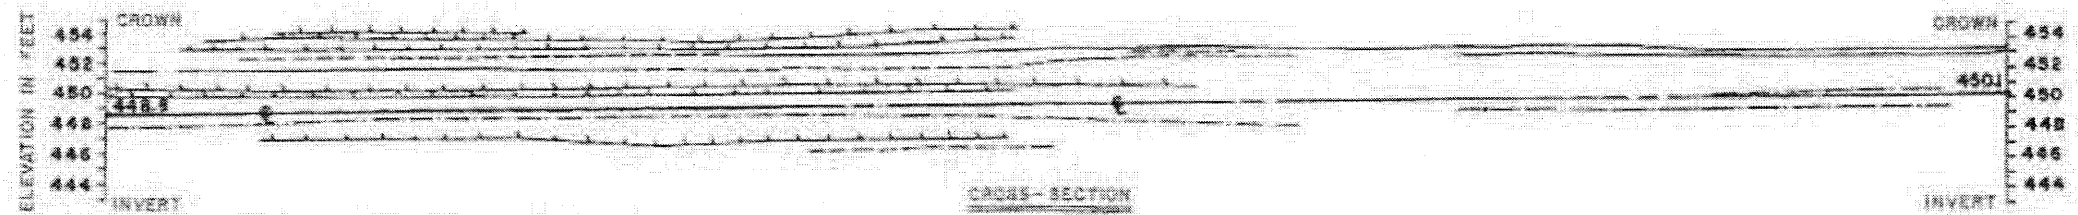
Figure 2D-2 (Sheet 7 of 24)

15+10	15+30	15+50	15+70	15+90	16+10	16+30	16+50	16+70	16+90	17+10	17+30	17+50
<p>EXCAVATION PROGRESS</p> <p>ESTIMATED ROCK CONDITION (TERZAGHI NO.)</p> <p>TEMPORARY SUPPORT SYSTEM</p> <p>BEDDING SPACING</p> <p>FRACTURE SPACING</p> <p>WATER CONDITION</p> <p>DEPTH OF COVER</p>												
<p>Approx. 6"-10"</p> <p>Approx. 20% of bedding fractures show minimal moisture</p>												
<p>10.5' water</p> <p>101.7' subsurface (shale)</p>

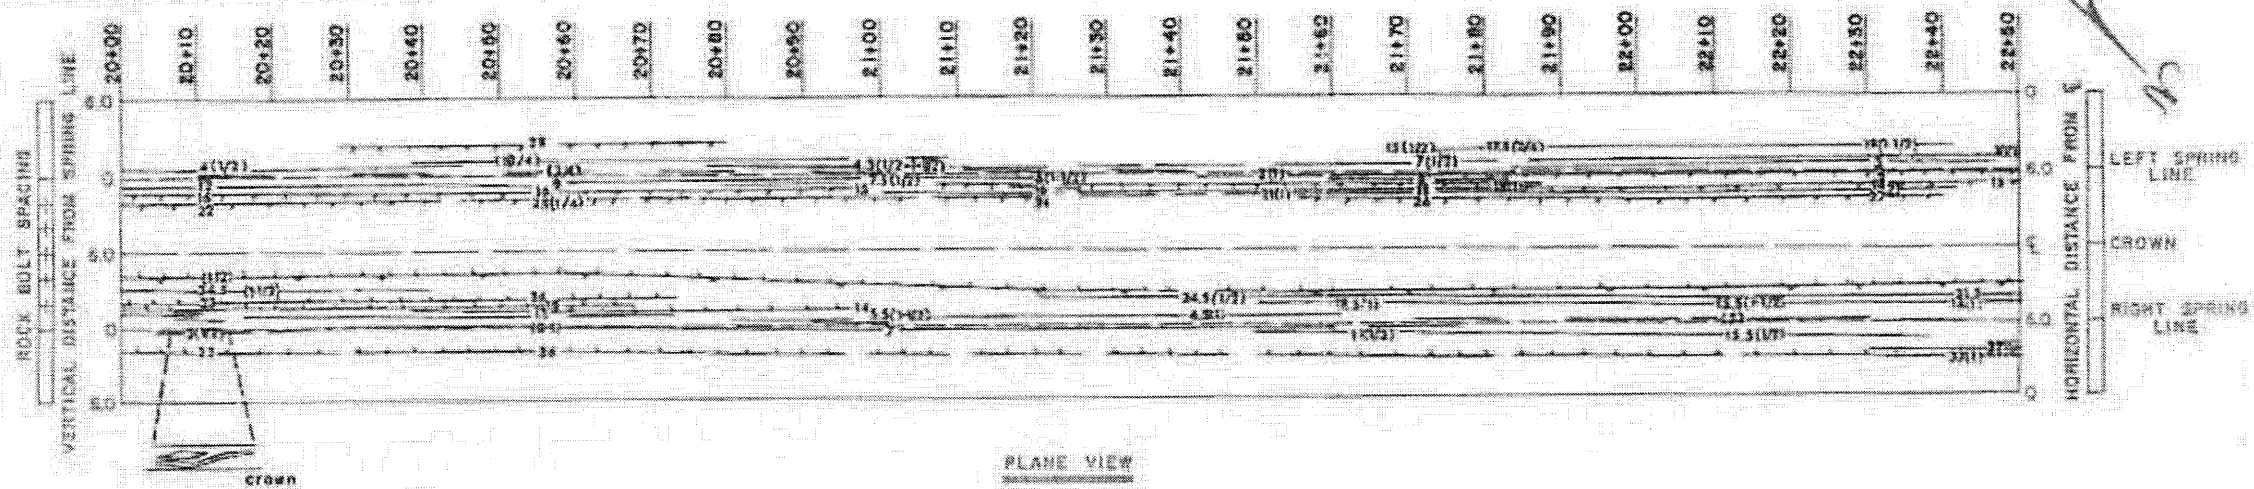
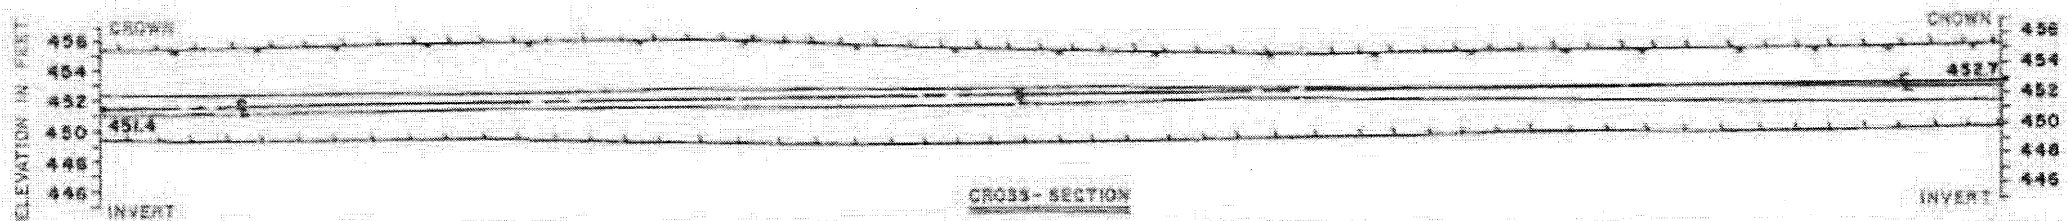
Geologic Map of
Tunnel Excavations
Figure 2B-2 (Sheet 9 of 24)

2'-0"	4'-0"	4'-0"	4'-0"	2'-0"
3 rock bolts at 2' centers in steel ribs at 4' centers spanned by wire mesh		3 rock bolts at 2' centers in steel ribs at 2.5'-4.0' centers spanned by wire mesh		
3'-8"		4'-8"		
Bedding fractures only				
Slight moisture from open parting along west wall for entire length				
17.5 water		17.5 water		
M1.8 substructure (shale)		M1.8 substructure (shale)

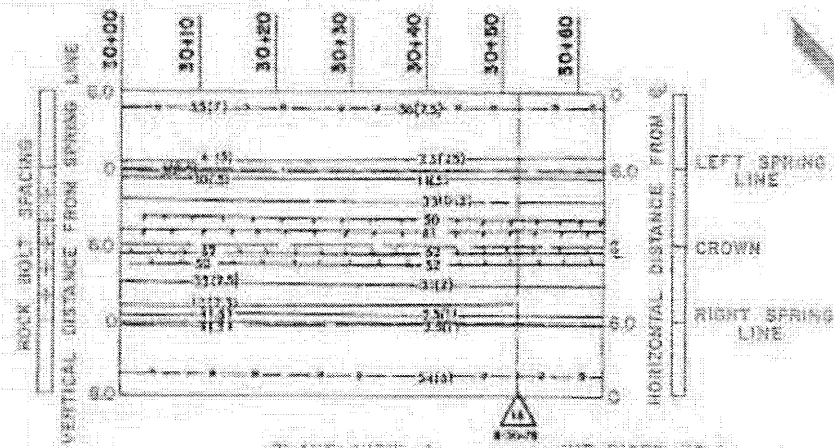
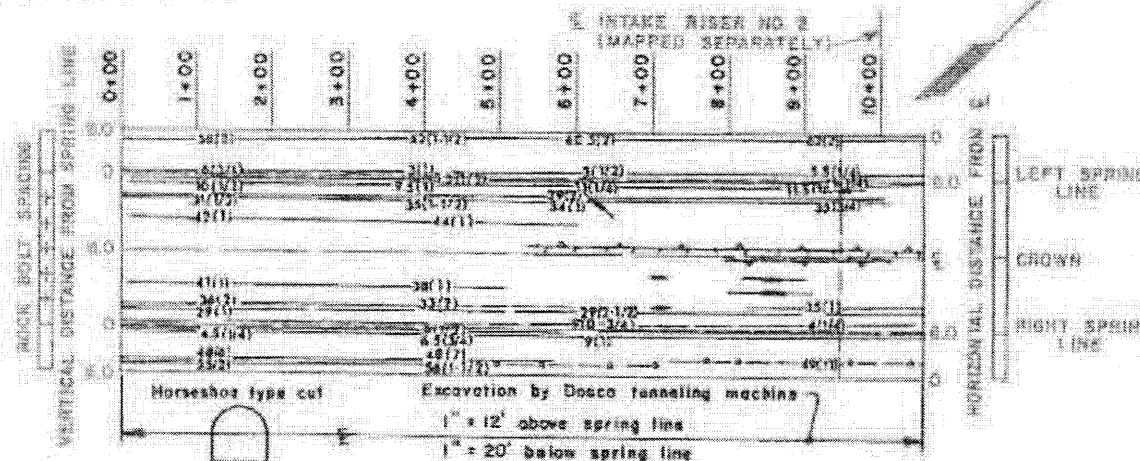
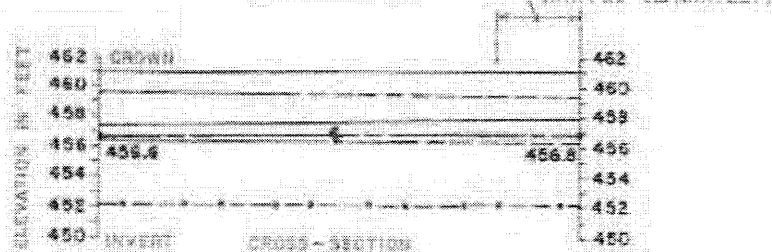
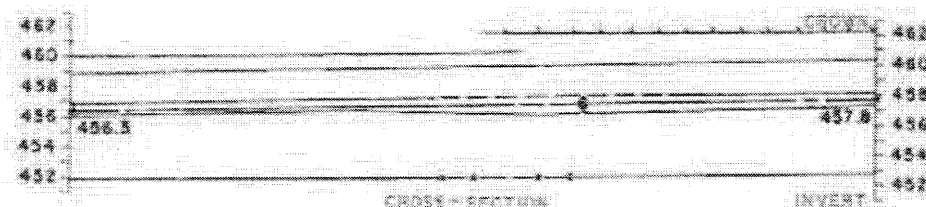
Figure 20-2 (Sheet 13 of 24)

EXCAVATION PROGRESS	ESTIMATED ROCK CONDITION (TERZAGHI NO.)	TEMPORARY SUPPORT SYSTEM	BEDDING SPACING	FRACTURE SPACING	WATER CONDITION	DEPTH OF COVER
Excavation progress	ESTIMATED ROCK CONDITION (TERZAGHI NO.)	TEMPORARY SUPPORT SYSTEM	BEDDING SPACING	FRACTURE SPACING	WATER CONDITION	DEPTH OF COVER
Slight overbreak along entire section		3 rock bolts at 2' centers in steel ribs at 4' centers spanned by wire mesh	4'-6"	Bedding fractures only, spaced as above	Slight moisture along all bedding fractures	27.5' top water 91.5' subsurface (shale)

EXCAVATION PROGRESS	ESTIMATED ROCK CONDITION (TERZAGHI NO.)	TEMPORARY SUPPORT SYSTEM	BEDDING SPACING	FRACTURE SPACING	WATER CONDITION	DEPTH OF COVER
Excavation progress	ESTIMATED ROCK CONDITION (TERZAGHI NO.)	TEMPORARY SUPPORT SYSTEM	BEDDING SPACING	FRACTURE SPACING	WATER CONDITION	DEPTH OF COVER
Slight overbreak along entire section		3 rock bolts at 2' centers in steel ribs at 4'-4.5' centers, spanned by wire mesh	3'-8"	Bedding fractures only, spaced as above	No seepage	21.5' water 91.7' subsurface (shale)

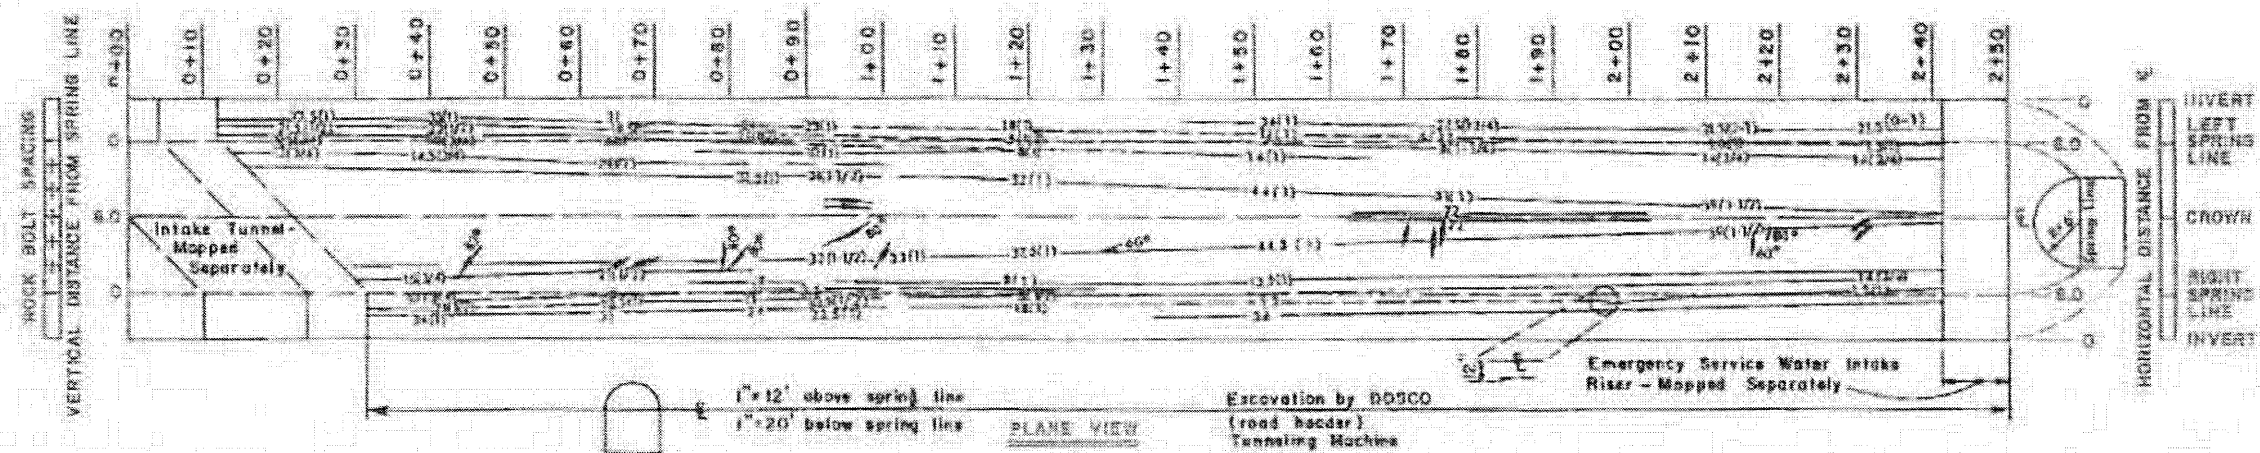
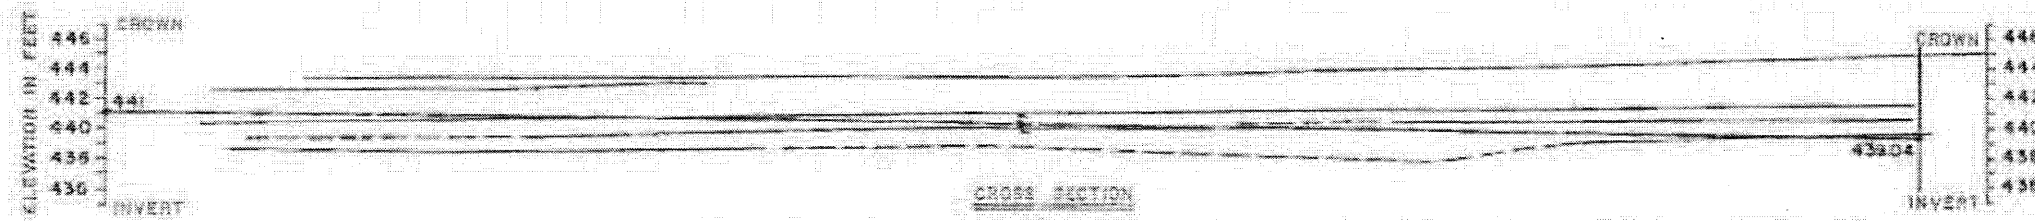
Figure 2D-2 (Sheet 14 of 24)

STATION	0+00	0+10	0+20	0+30	0+40	0+50	0+60	0+70	0+80	0+90	1+00	1+10	1+20	1+30	1+40	1+50	1+60	1+70	1+80	1+90	2+00	2+10	2+20	2+30	2+40	2+50	
ESTIMATED ROCK CONDITION (OVERBREAK NO.)	3																										
TEMPORARY SUPPORT SYSTEM	None																										
BEDDING SPACING	3'-4"																										
FRACTURE SPACING	Widely spaced 10'-20'																										
WATER CONDITION	No seepage																										
DEPTH OF COVER	33.5' at intake and 27.5' at end of 112.5' of shaft

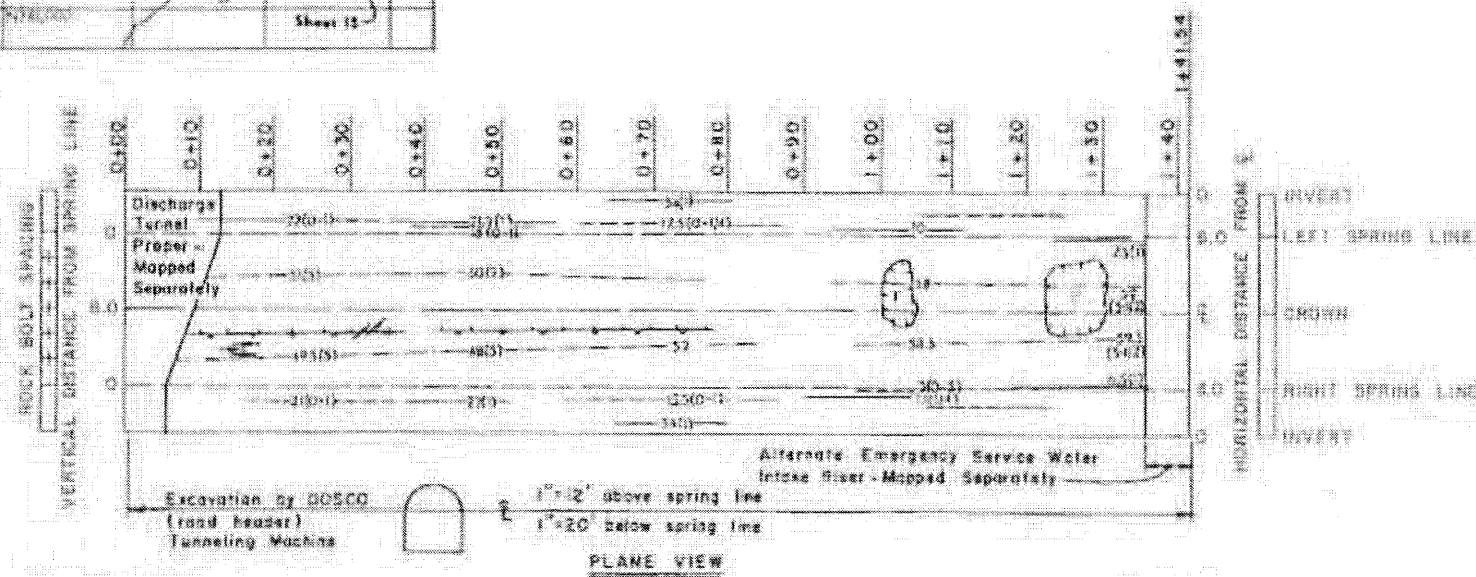
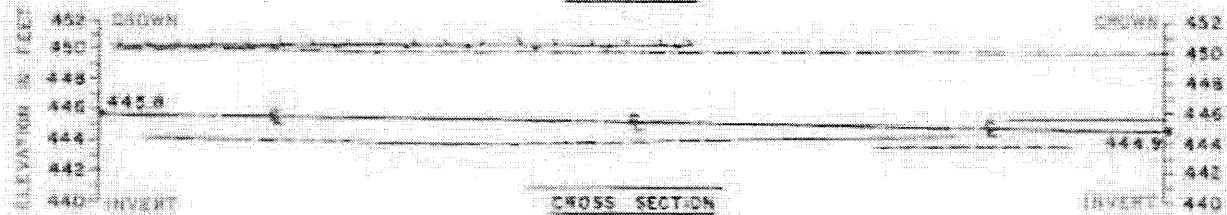
Figure 2D-2 (Sheet 15 of 24)

2'	2'	2'	2'
re =			
3 rock bolts at 2' centers in steel ribs at 10'-11' centers, spanned by wire mesh.			
1/2"x2"	2"x2"	2"x2"	Approx. 1"-1 1/2" openings
3"x2"	Bedding fractures only, spaced as above		
Slight seepage from bedding parting along west wall			No inflows
Approx. 115' limestone 275' gravel fill 11.7' above		Approx. 215' limestone 275' gravel fill 112.7' above

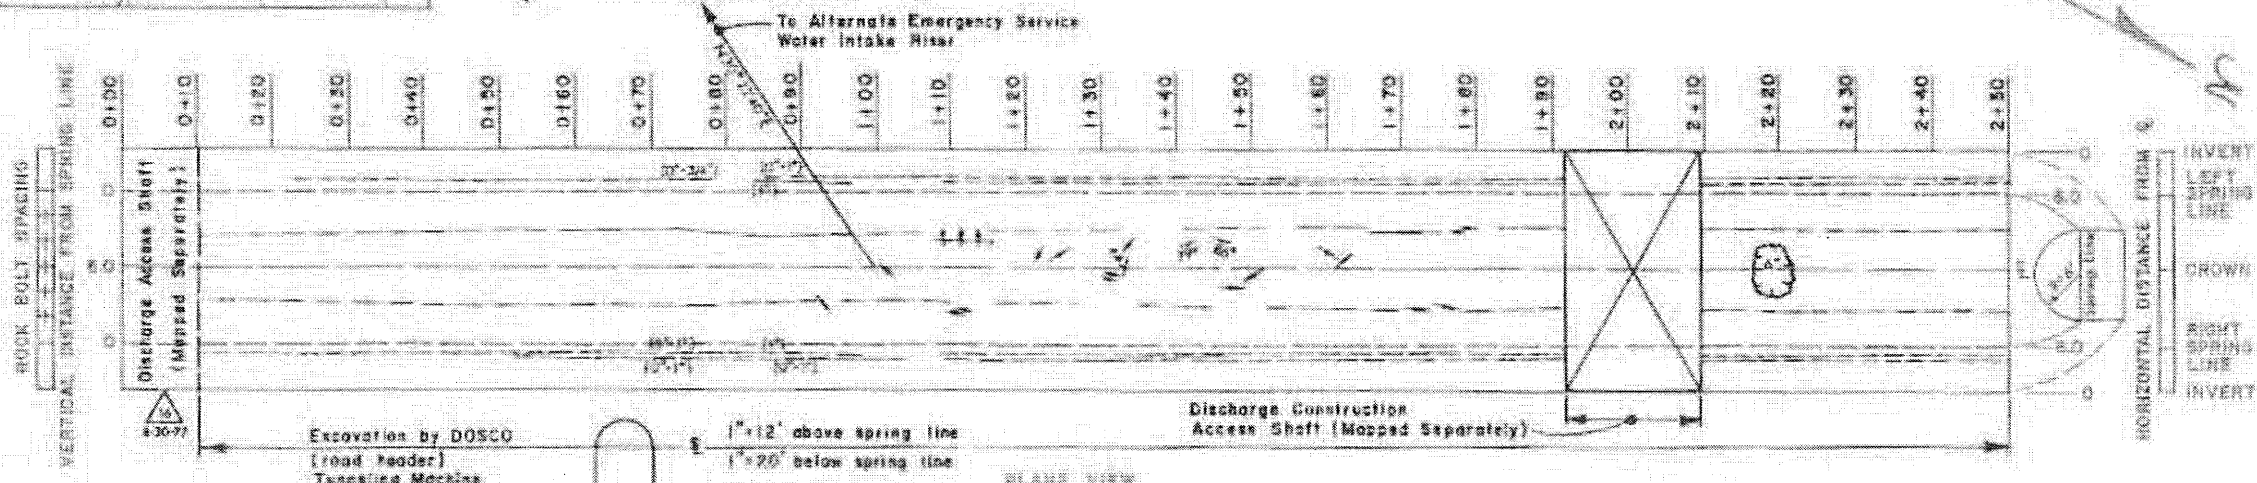
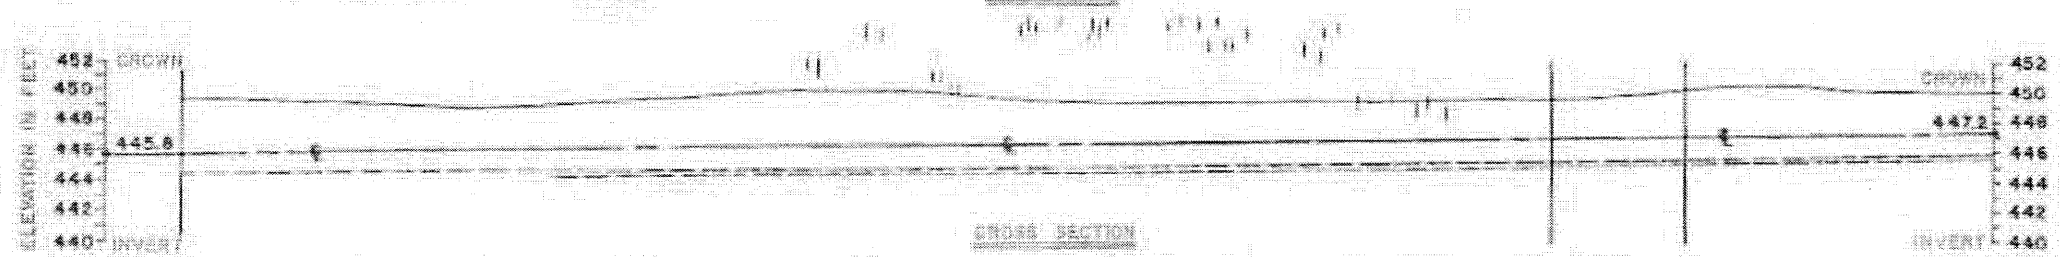
Figure 20-2 (Sheet 15 of 24)

STATION	0+00	0+10	0+20	0+30	0+40	0+50	0+60	0+70	0+80	0+90	1+00	1+10	1+20	1+30	1+40	1+50	1+60	1+70	1+80	1+90	2+00	2+10	2+20	2+30	2+40	2+50
Excavation Progress																										
Estimated Rock Condition (Terzaghi No.)																										
Temporary Support System																										
Bedding Spacing																										
Fracture Spacing																										
Water Condition																										
Depth of Cover

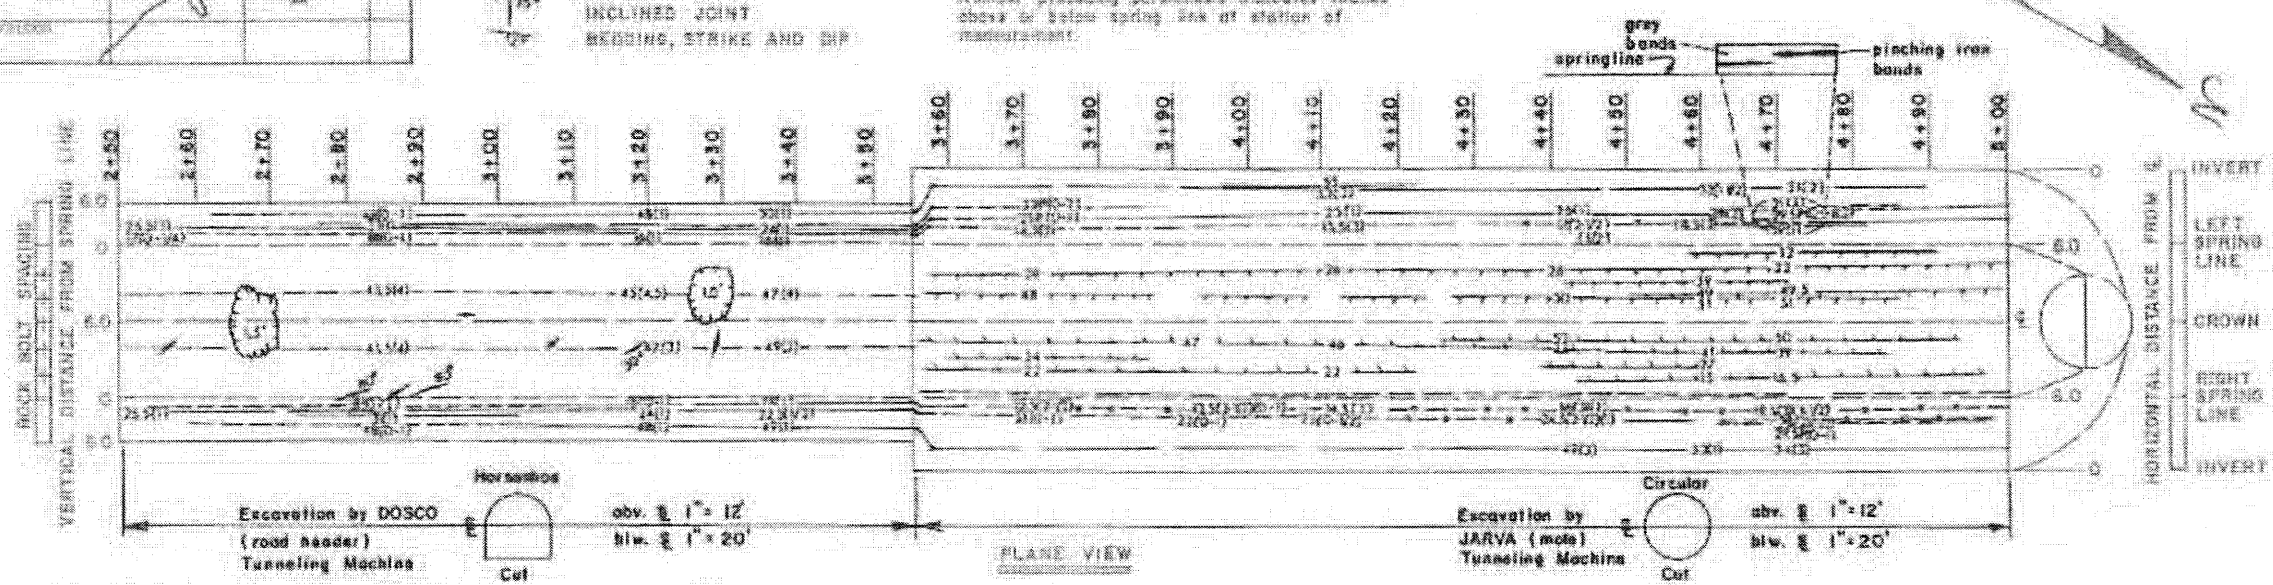
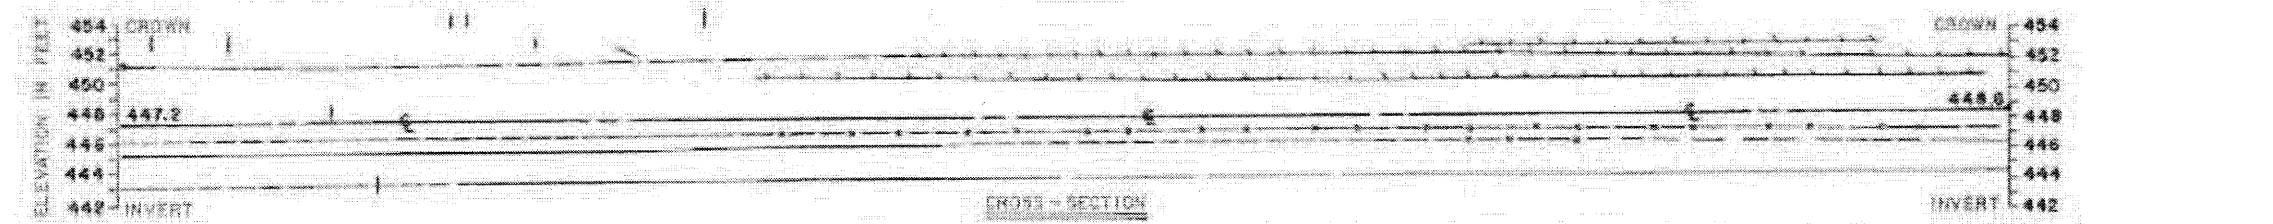
Figure 2D-2 (Sheet 17 of 24)

No. 4					
5 inch bolts at 2' centers in steel ribs at 30'-35' centers, spanned by wire mesh					
1'-4"	1'-5"	1'-6"	1'-9"	1'-11"	2'-11"
Approx. 5'-10"	Approx. 8'	Approx. 11'	Jointing less apparent in smooth circular bore excavation		Bedding fractures only, spaced as above
No inflow					
Approx. 24' lagging & 14' glocal 141 11x8' shale				Approx. 1' of bench & 13' of shale

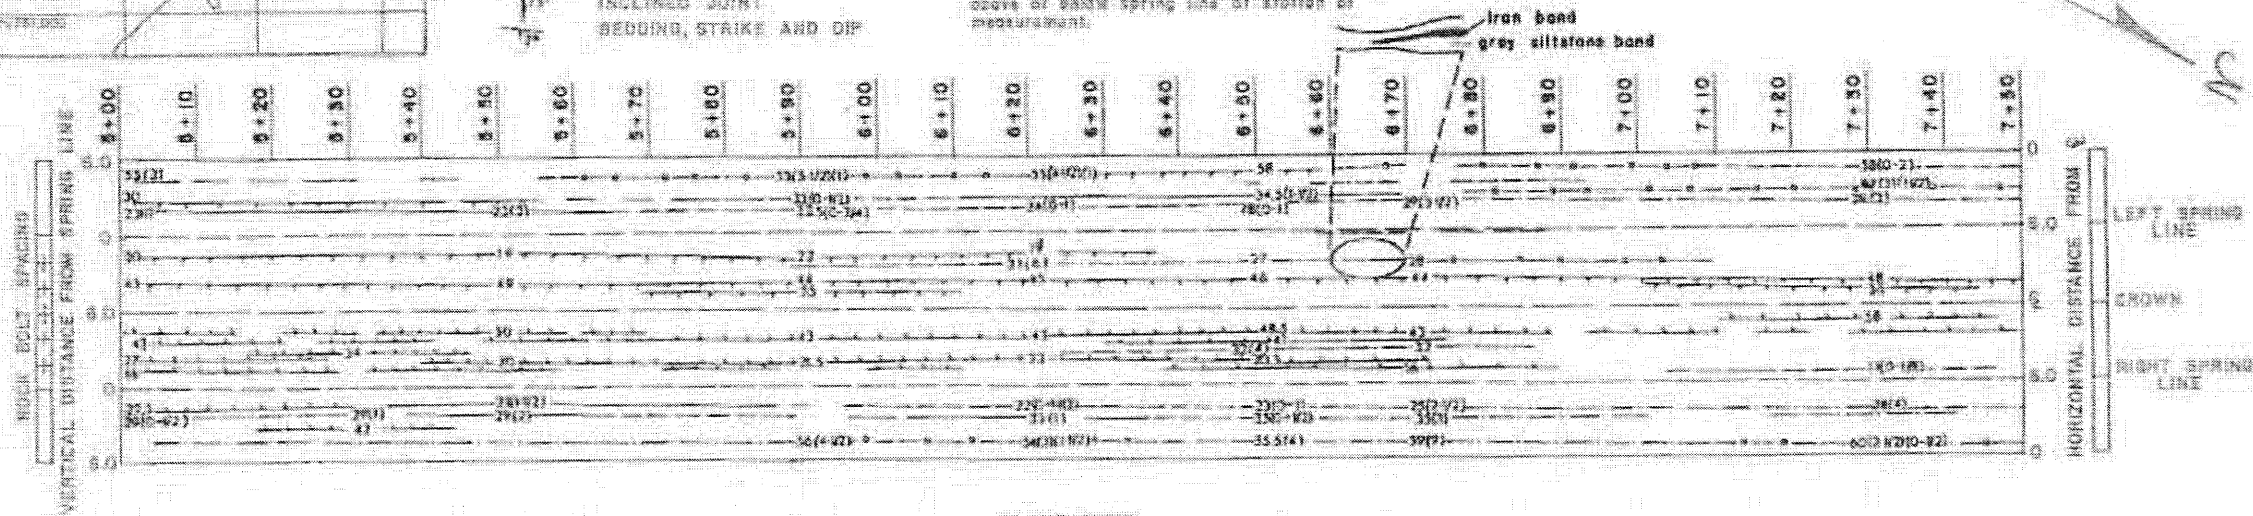
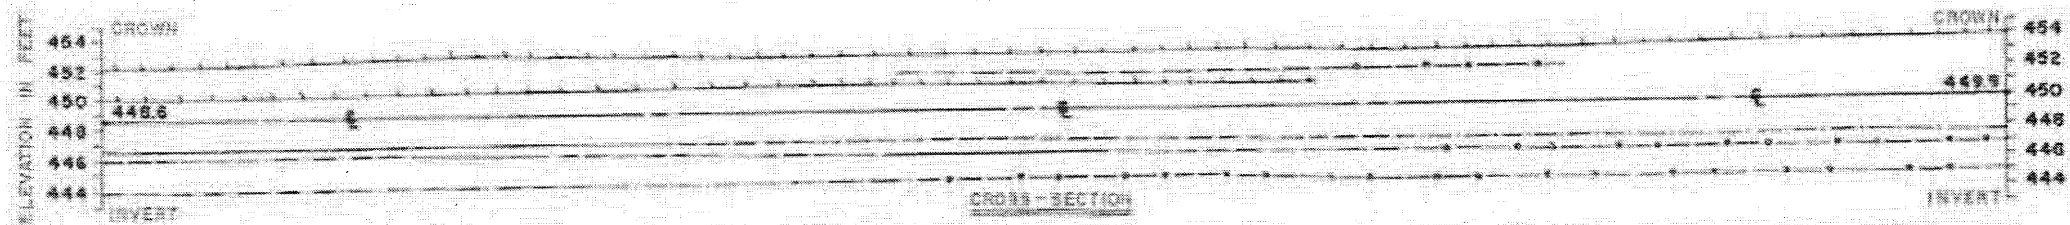
Geologic Map of Tunnel Excavations
Figure 2D-2 (Sheet 18 of 24)

STATION	8+00	8+20	8+40	8+60	8+80	9+00	9+20	9+40	9+60	9+80	10+00	10+20	10+40	10+60	10+80	11+00	11+20	11+40	11+60	11+80	12+00	
Excavation Progress	No. 4												Steel ribs at 3.0' - 4.0' centers									
Estimated Rock Condition (Terzaghi No.)	3' - 11"												7' - 12"									
Temporary Support System	Bedding fractures only, spaced as above												Bedding fractures only, spaced as above									
Bedding Spacing	No inflows																					
Fracture Spacing																						
Water Condition																						
Depth of Cover													2.5' minimum + 1.0' subsurface (chase)

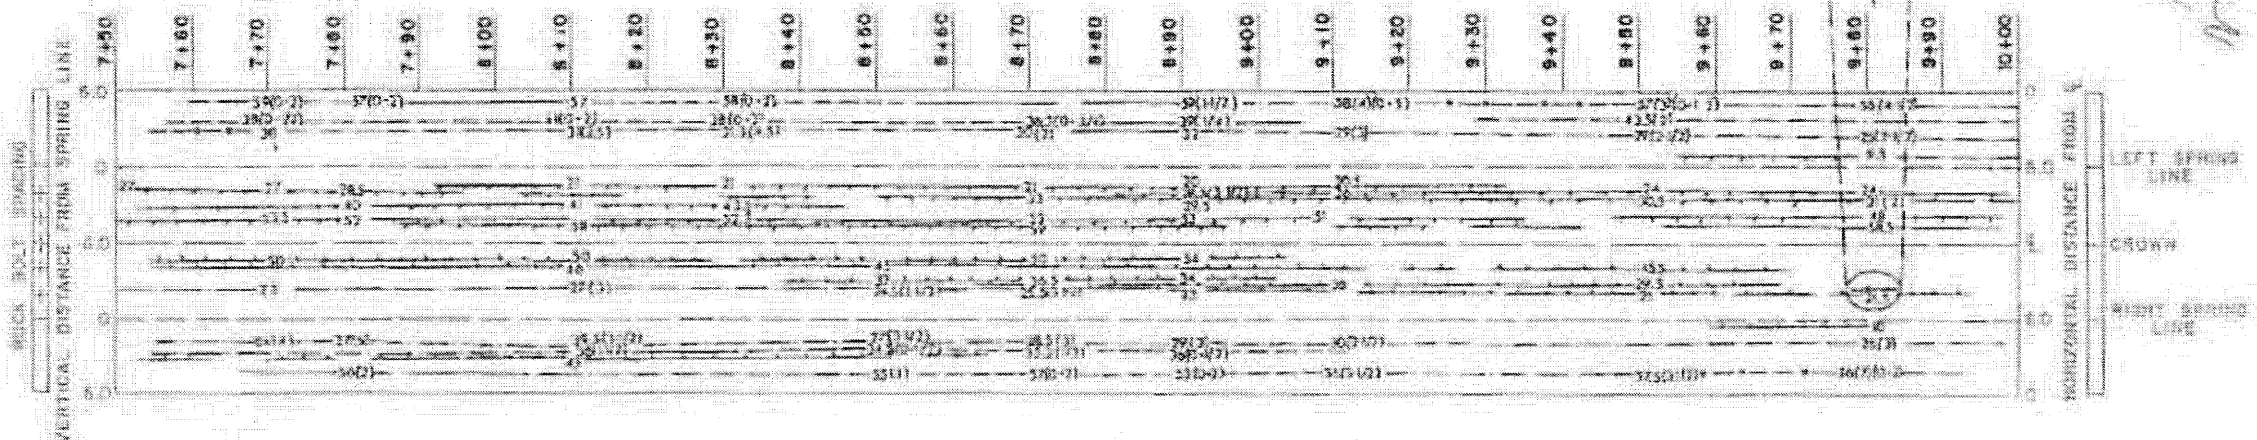
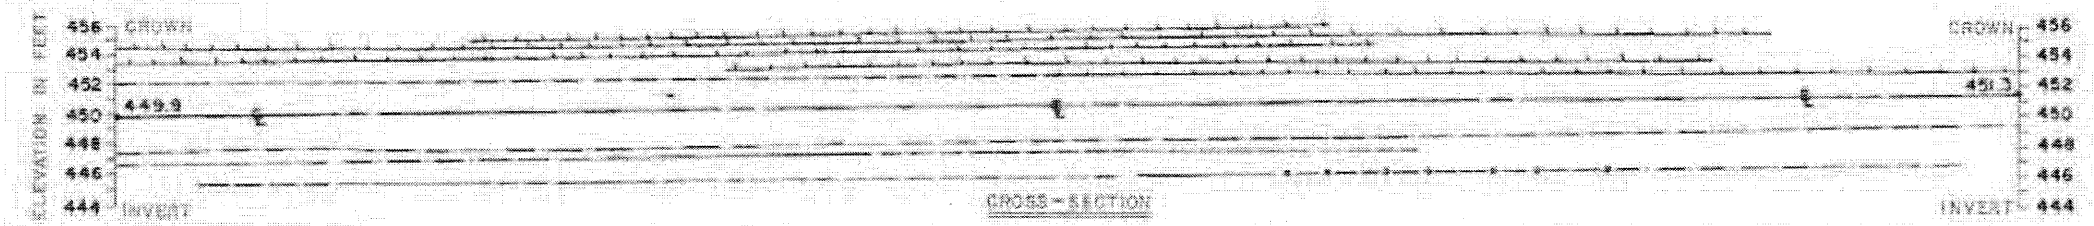
Figure 2D-2 (Sheet 19 of 24)

No. 4	
stack bolts at 2' centers in steel ribs at 2'-6" centers, spanned by wire mesh	
4" x 12"	
Bedding fractures only, spaced as above	
No rillows	
4.5' max water 1 ft. 1" subsurface (hole)	7.5' max water 111.7" subsurface (hole)

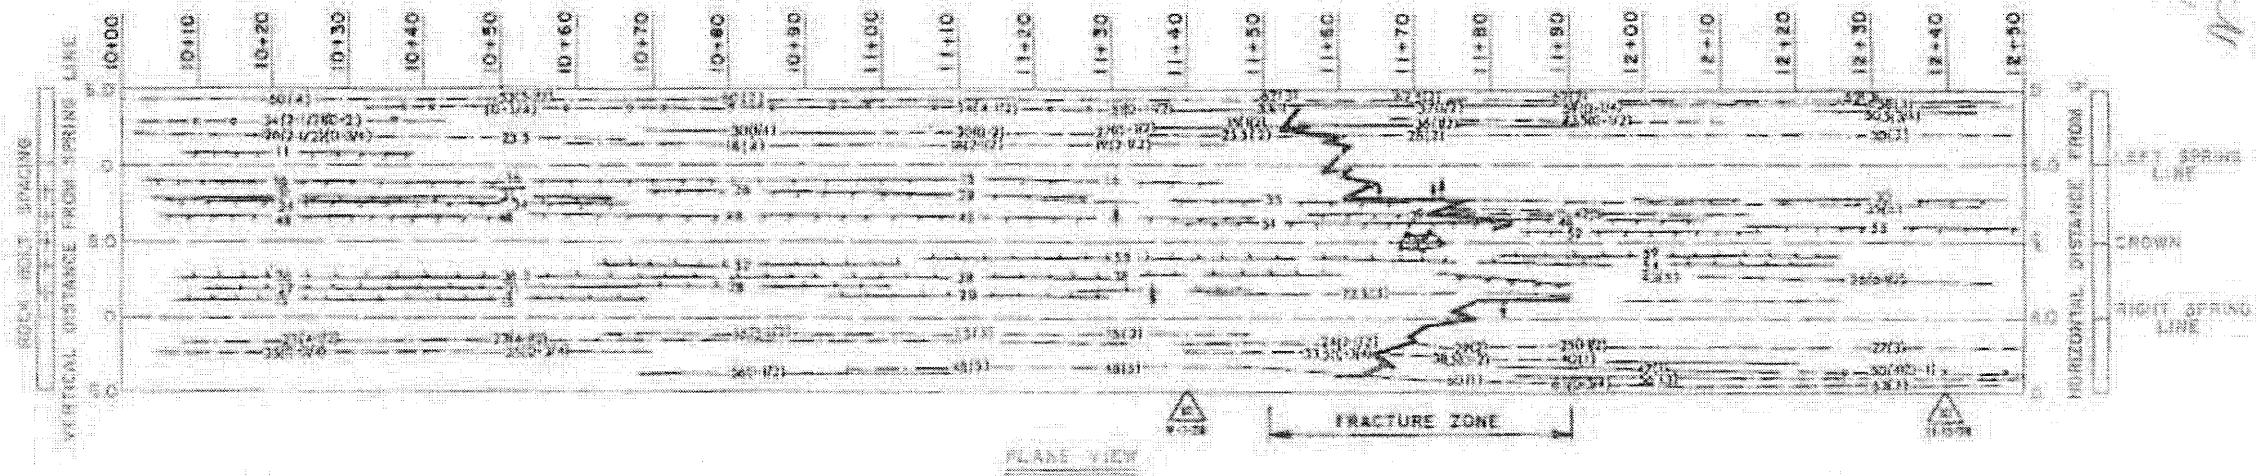
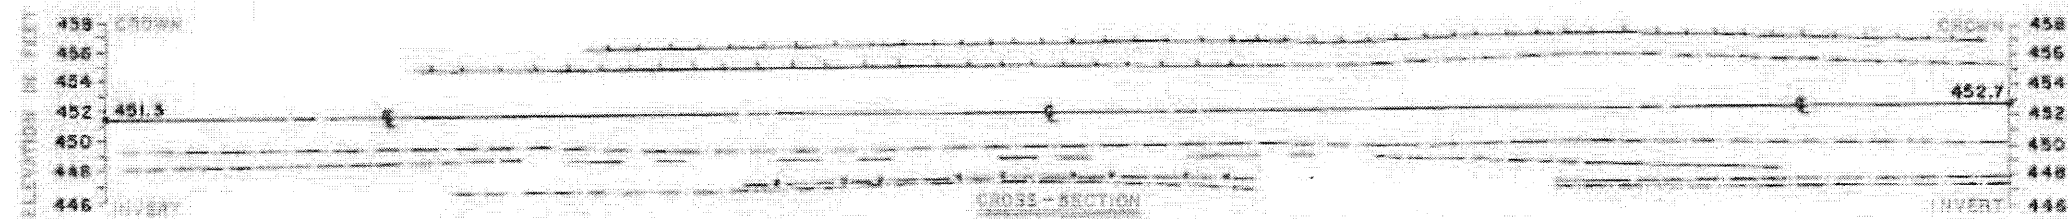
Figure 2D-2 (Sheet 20 of 24)

EXCAVATION PROGRESS ESTIMATED ROCK CONDITION (TERZAGHI NO.) TEMPORARY SUPPORT SYSTEM			
BEDDING SPACING FRACTURE SPACING WATER CONDITION DEPTH OF COVER			
Bedding fractures only, spaced as above No inflow		Zone of fractures in chevron pattern cutting excavation at low angle Seepage from rock bolts Seepage from bedding partings in fracture zone	
3 rock bolts at 2' centers in steel ribs at 4.0' A.S. centers, spanned by wire mesh		0.5' x 1.0' mesh back casting from crown	
3' x 10'		6' x 6'	
No inflow		No inflow	
7.5' water 111.7' subsidence (holes)		8.5' water 109.7' subsidence (holes)

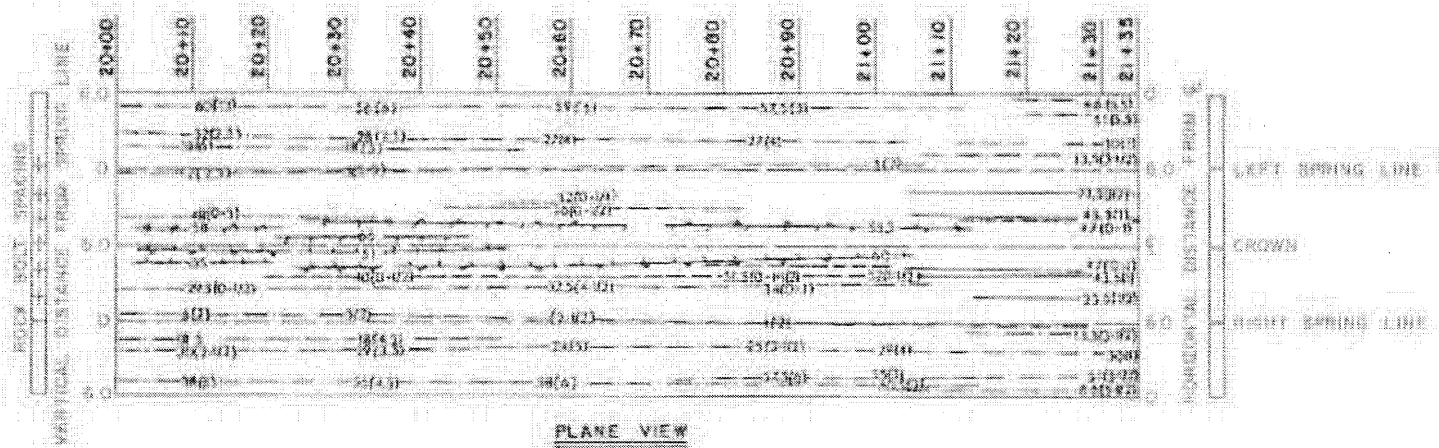
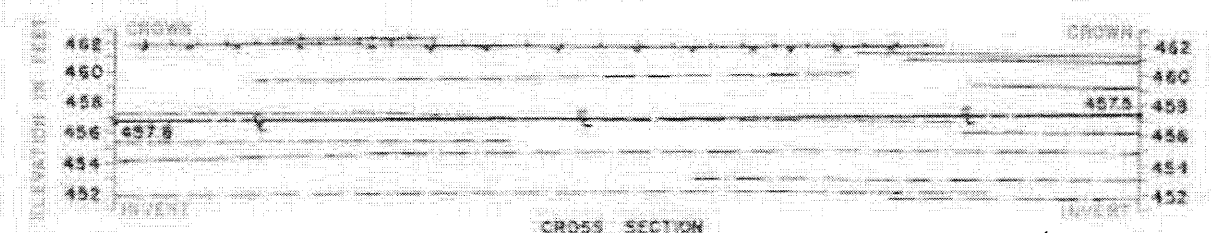
Figure 20-2 (Sheet 24 of 24)

<p>Excavation Progress</p> <p>ESTIMATED ROCK CONDITION (PERMANENT) NO. 1</p> <p>TEMPORARY SUPPORT SYSTEM</p> <p>BEDDING SPACING</p> <p>FRACTURE SPACING</p> <p>WATER CONDITION</p> <p>DEPTH OF COVER</p>	
<p>Slight overbreak along entire excavation (8'-1')</p>	
<p>1/2" rock bolts of 2" centers, in steel ribs at 4'-2' centers, spaced by wire mesh</p>	
<p>2'-1" Bedding partings only, spaced as above</p>	
<p>Slight moisture along bedding partings, where indicated</p>	
<p>18.5' water + 2.5' subsurface (shale)</p>	<p>2.5' water + 2.5' subsurface (shale)</p>
