**U.S. DEPARTMENT OF
ENERGY**

2021 Annual Site Inspection and Monitoring Report for Uranium Mill Tailings Radiation Control Act Title I Disposal Sites

March 2022

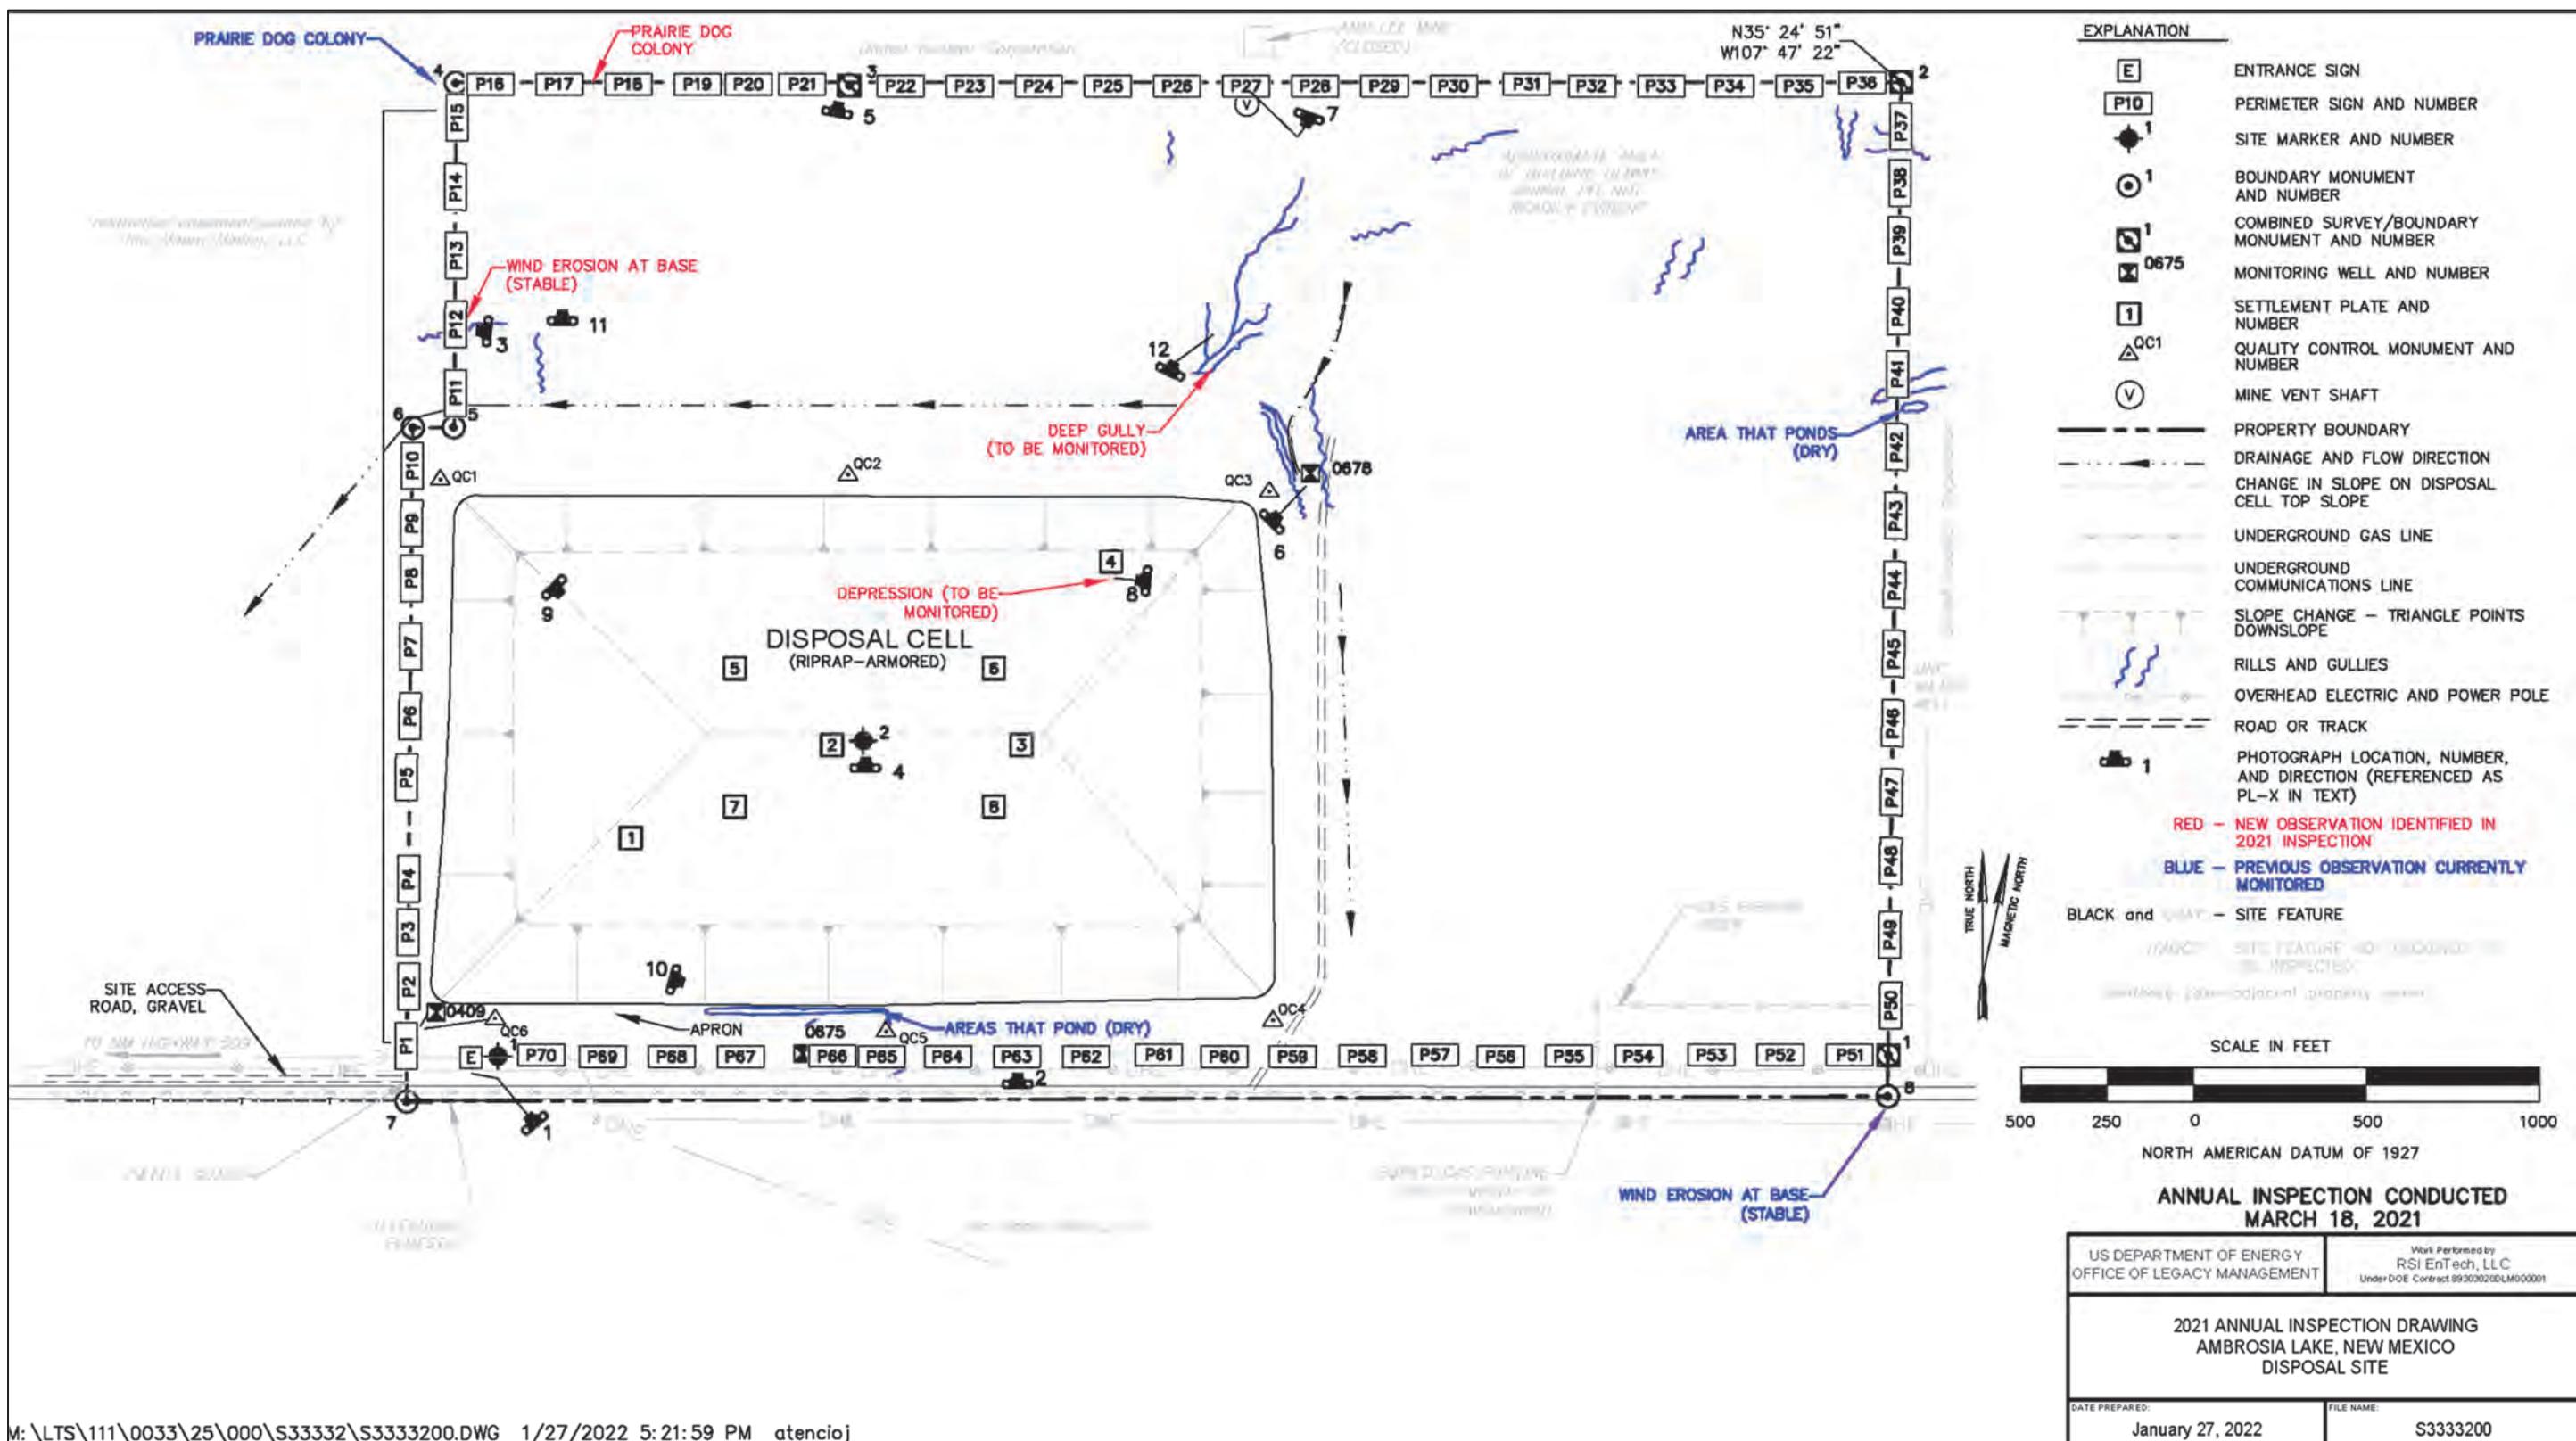
Figure 1-1. 2021 Annual Inspection Drawing for the Ambrosia Lake, New Mexico, Disposal Site

Figure 1-1 shows the locations of site features, including site surveillance features and inspection areas, in black and gray font. Site features that are present but not required to be inspected are shown in italic font. Observations from previous inspections that are currently monitored are shown in blue text, and new observations identified during the 2021 annual inspection are shown in red. Inspection results and recommended maintenance activities associated with site surveillance features are included in the following subsections. Photographs to support specific observations are identified in the text and in Figure 1-1 by photograph location (PL) numbers. The photographs and photograph log are presented in Section 1.10.

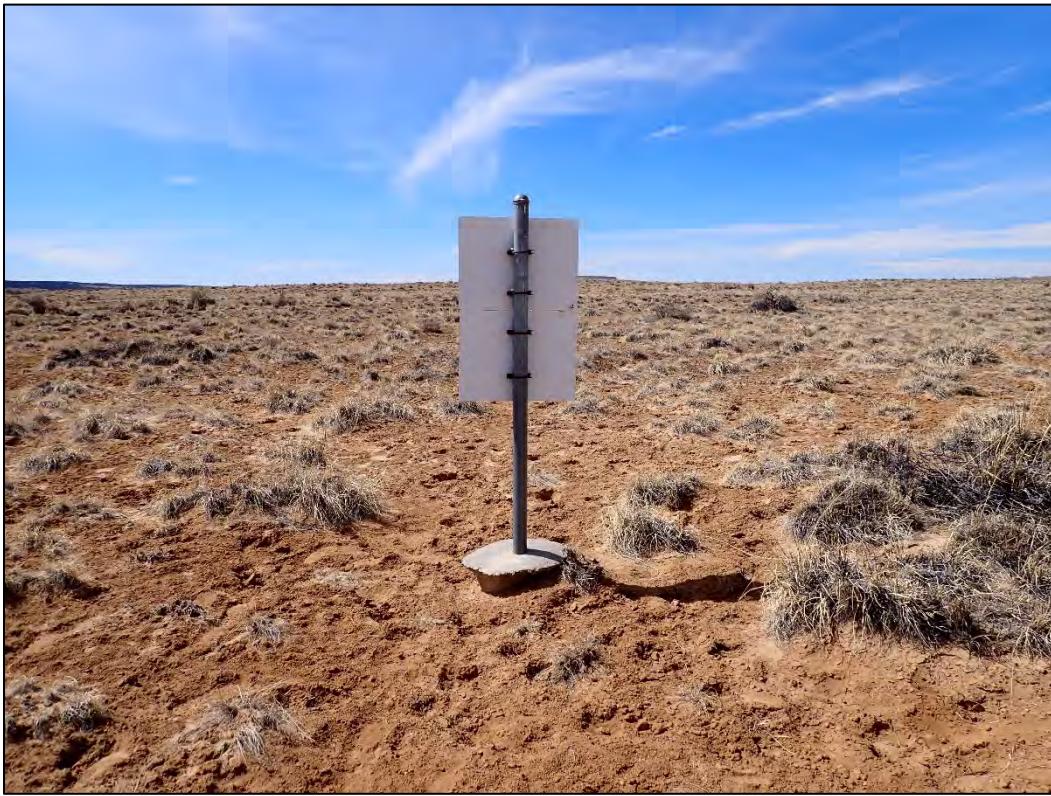
PL-3. Erosion Around Base of Perimeter Sign P12 (Stable)

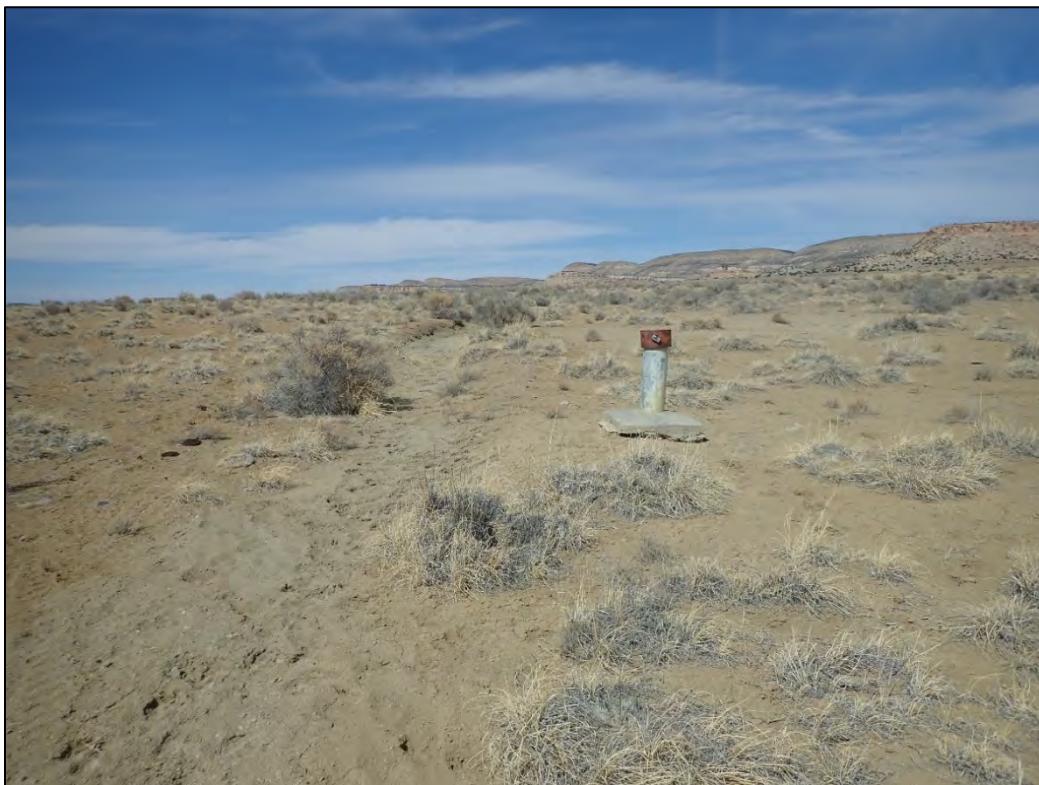
The site has three monitoring wells. A gully adjacent to well 0678 appears to be stable, and the well is not affected by the erosion (PL-6). All wellhead protectors observed during the inspection were undamaged, locked, and properly labeled. No maintenance needs were identified.

PL-6. Erosional Rills Around Monitoring Well 0678

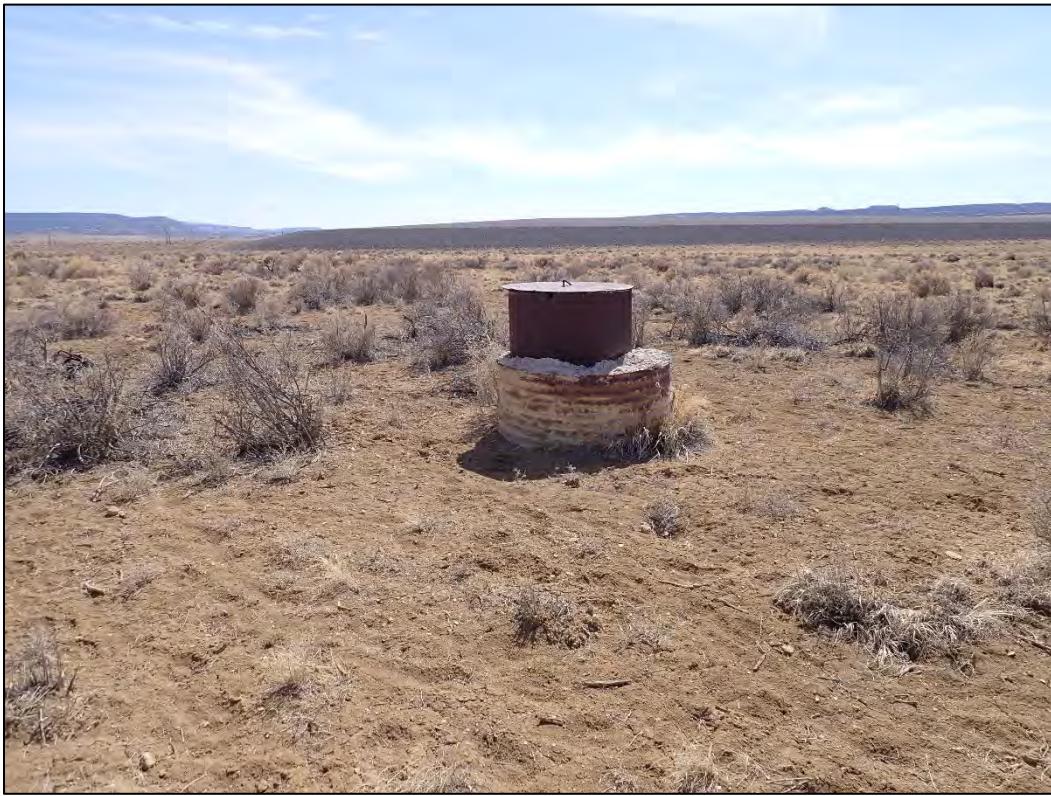
A mine vent shaft associated with an abandoned underground mine is within the site boundary in the northern portion of the site (PL-7). The vent has a spot-welded cover and a casing that rises approximately 3 feet above the ground. The vent was secure at the time of the inspection. Inspectors monitor the condition of the vent to ensure that the closure remains secure. No maintenance needs were identified.

PL-7. Mine Vent Shaft

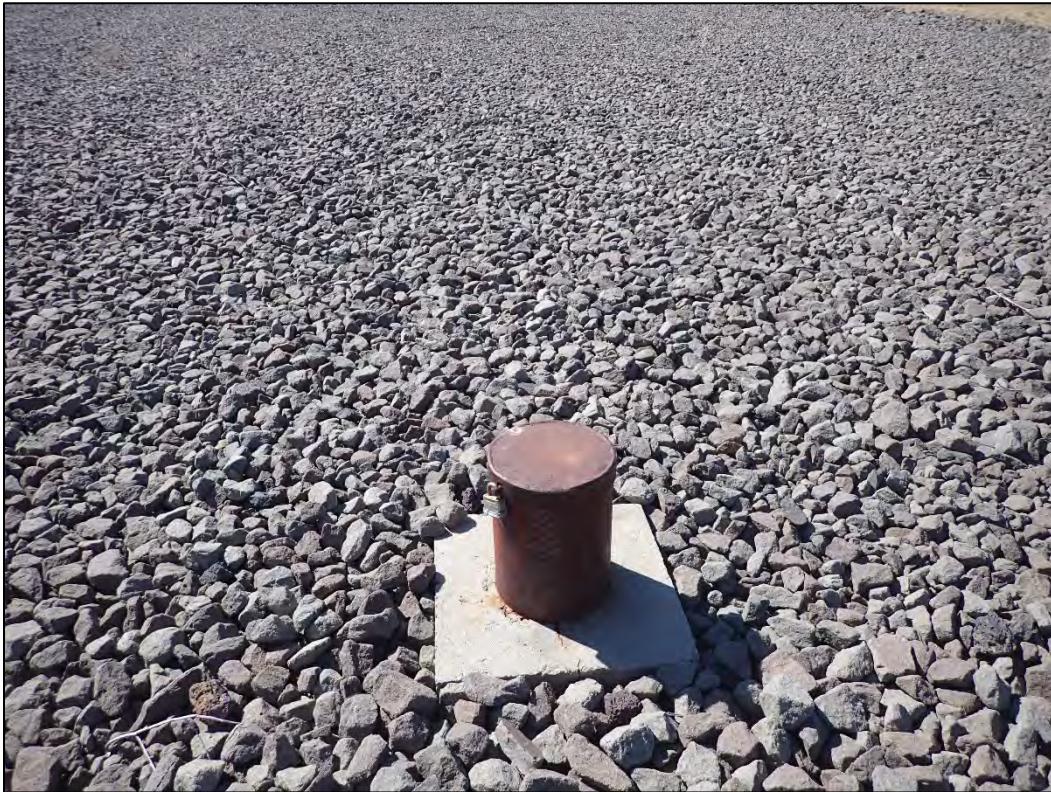
The disposal cell, completed in 1994, occupies 91 acres and is armored with basalt riprap to control erosion and deter animal and human intrusion. The top slope showed no evidence of cracking, slumping, or erosion, and there was no indication of riprap degradation. A shallow depression around settlement plate SP-4, near the northeast corner of the disposal cell cover, was first noted during the 1997 inspection and continued to grow in depth and area in subsequent years. The depression was repaired in August 2005. Visual observations during the 2017 annual inspection indicated that very minor additional settlement may have occurred since the depression was repaired. The area was inspected during the 2021 annual inspection, and settlement was shallow enough that it was determined not to have changed significantly (PL-8). Inspectors will continue to monitor this area.

PL-8. Settlement Plate SP-4 on Disposal Cell Top

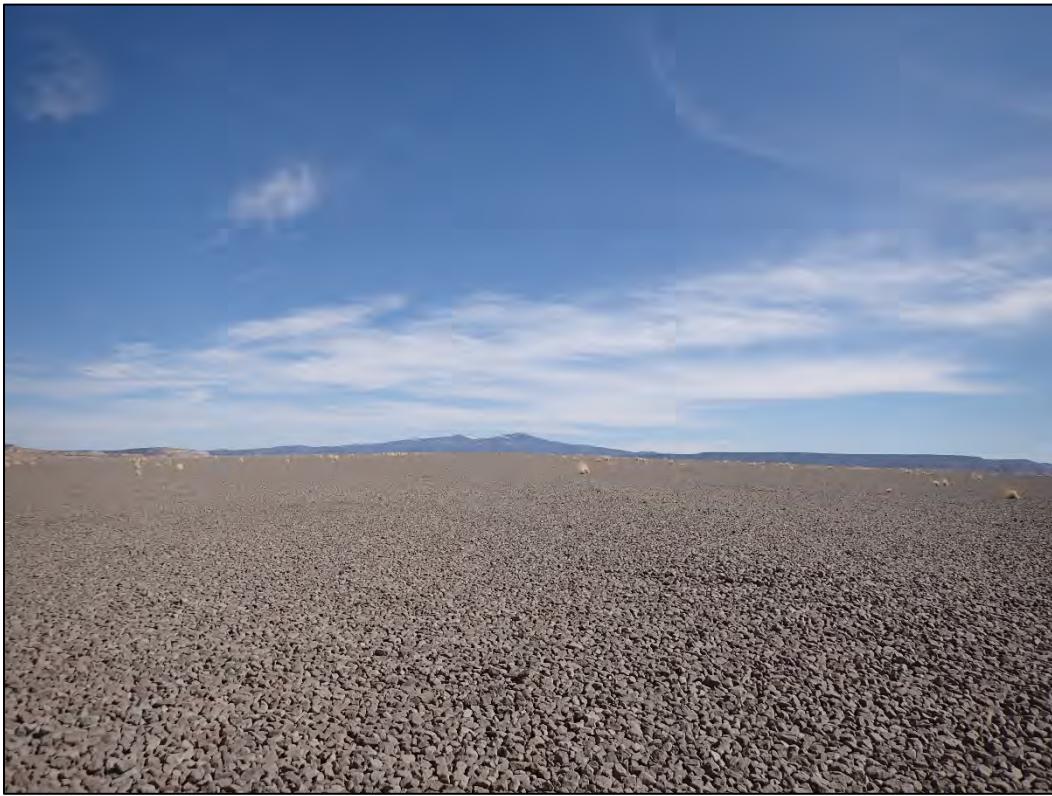
Scattered annual weeds and perennial grasses and forbs are growing on the disposal cell top (PL-9). In accordance with the LTSP, deep-rooted shrubs are to be removed from the disposal cell cover. No deep-rooted shrubs were noted during the inspection. No maintenance needs were identified.

PL-9. Top Slope of Disposal Cell

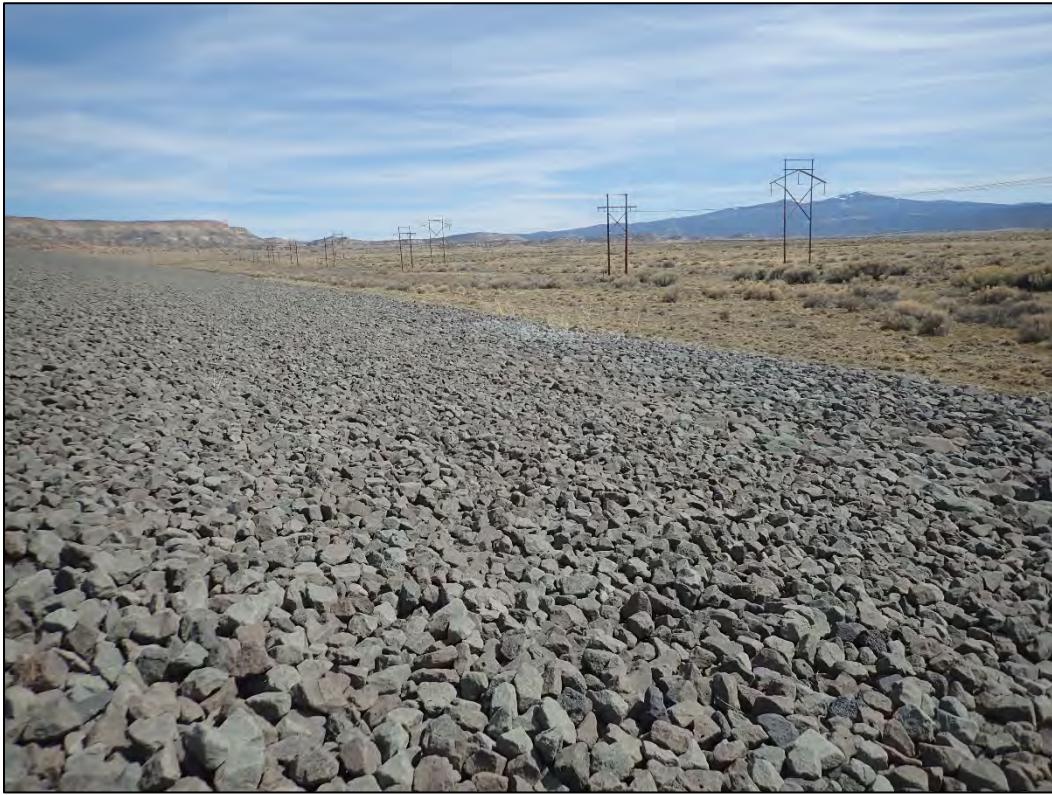
PL-10. Ponding Areas Along South Side Slope of Disposal Cell (Dry)

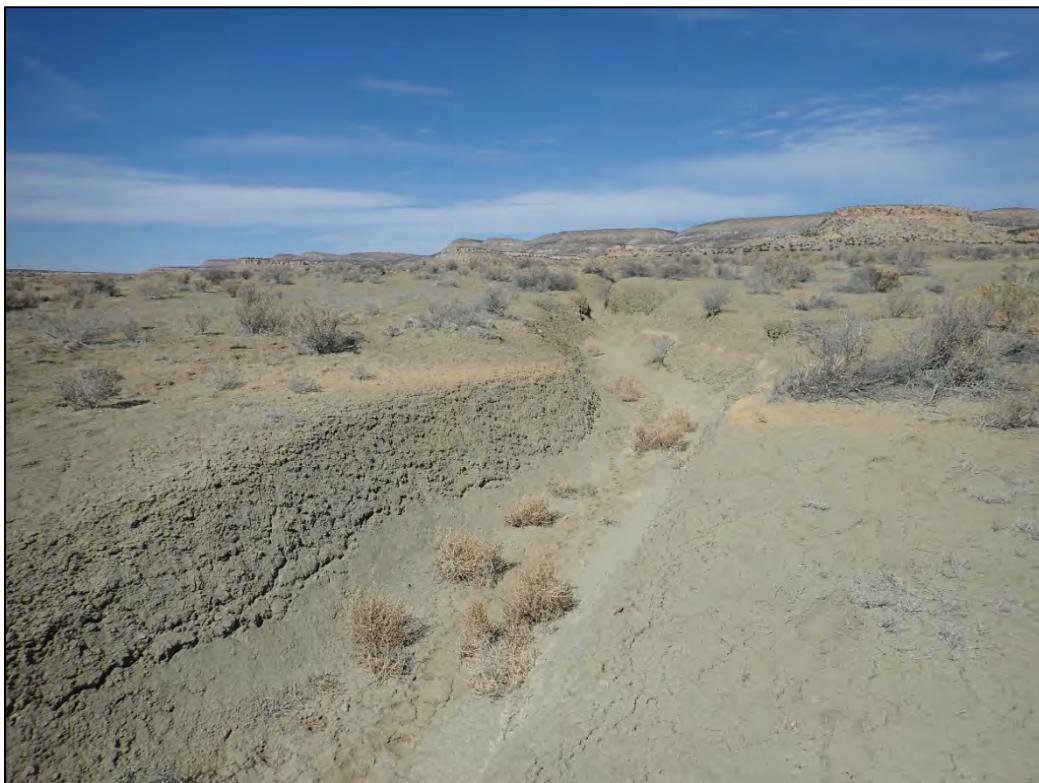
PL-12. Erosional Gully Northeast of Disposal Cell

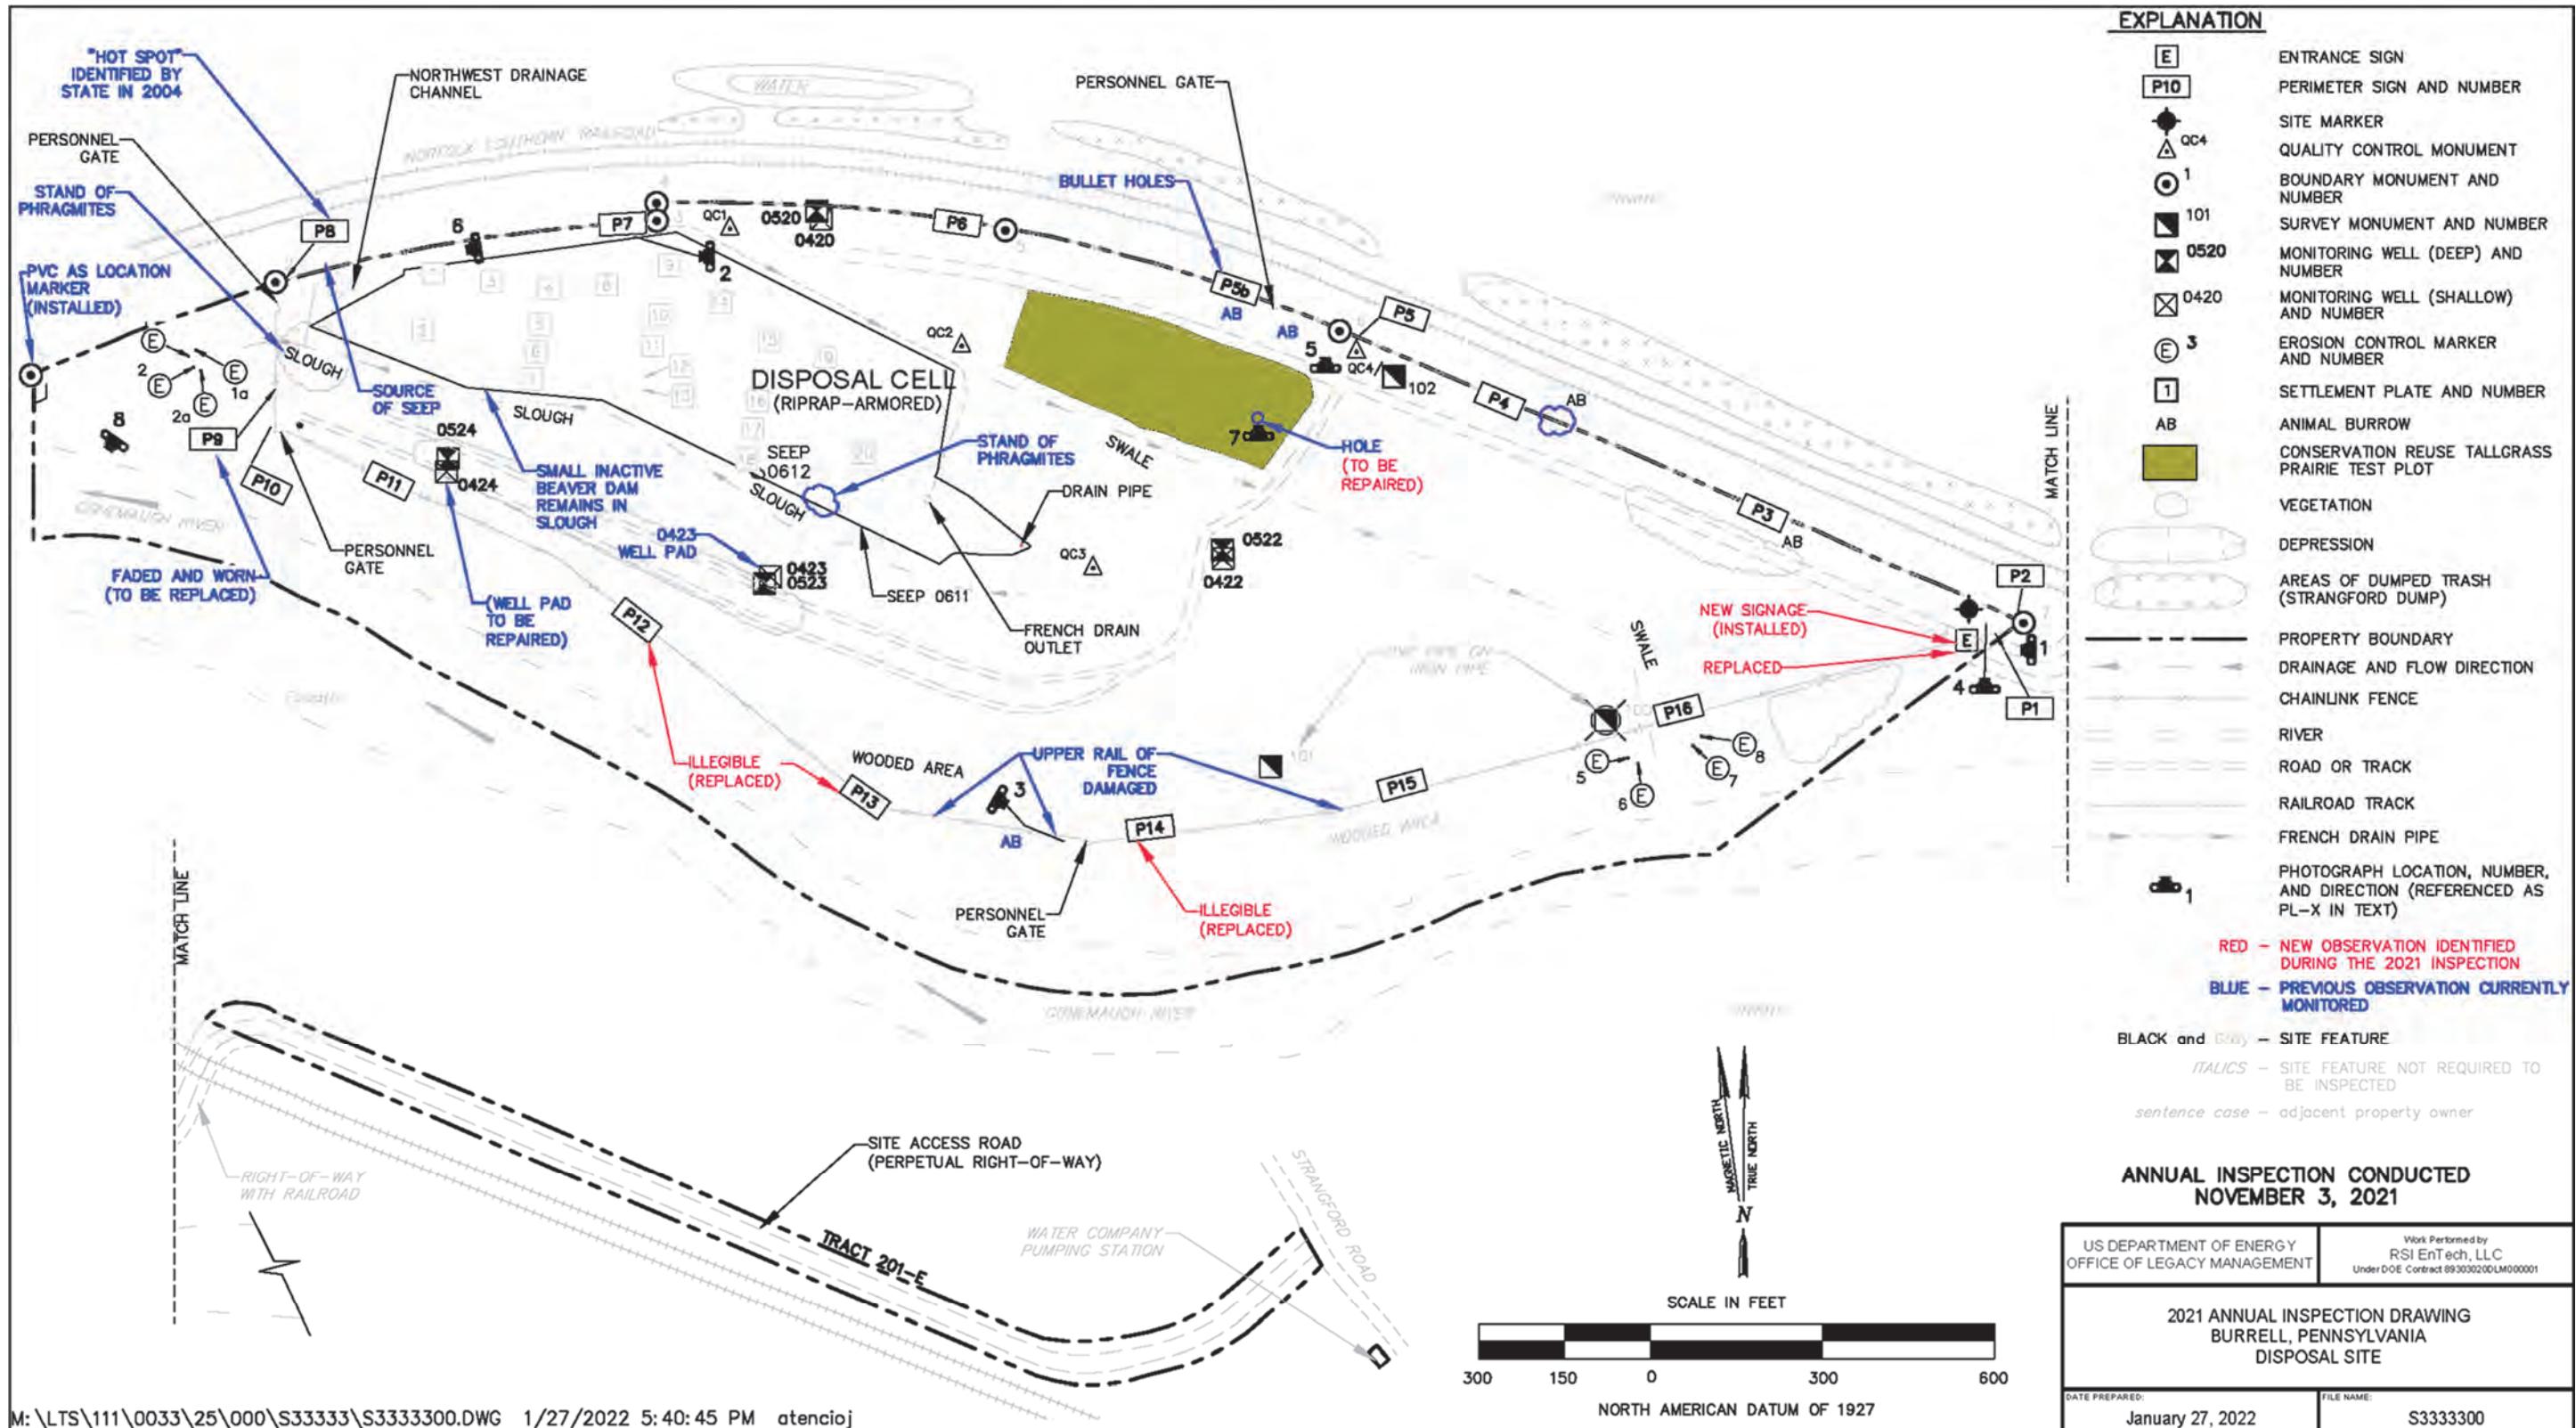
Figure 2-1. 2021 Annual Inspection Drawing for the Burrell, Pennsylvania, Disposal Site

Figure 2-1 shows the locations of site features, including site surveillance features and inspection areas, in black and gray font. Site features that are present but not required to be inspected are shown in italic font. Observations from previous inspections that are currently monitored are shown in blue text, and new observations identified during the 2021 annual inspection are shown in red. Inspection results and recommended maintenance activities associated with site surveillance features are included in the following subsections. Photographs to support specific observations are identified in the text and in Figure 2-1 by photograph location (PL) numbers. The photographs and photograph log are presented in Section 2.10.

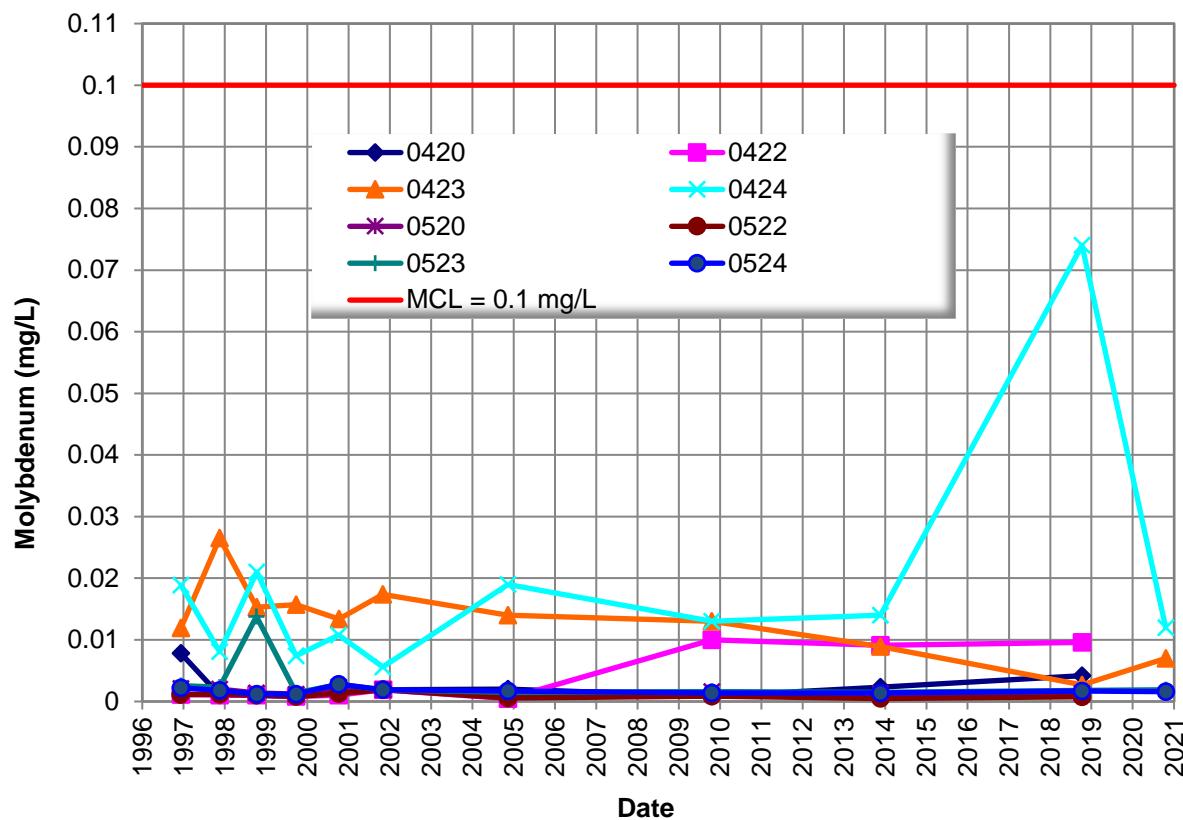
Figure 2-3. Molybdenum in Groundwater at the Burrell, Pennsylvania, Disposal Site

The molybdenum concentration measured in monitoring well 0424 in 2020 was 0.012 milligrams per liter (mg/L), which shows that the potentially significant increasing trend between 2013 and 2018 was not persistent (Figure 2-3). Concentrations for lead, selenium, and uranium measured in 2020 were all well below their respective MCLs (Figure 2-4, Figure 2-5, and Figure 2-6). Lead showed a downward trend in well 0423 (Figure 2-4) and uranium showed a downward trend in wells 0423 and 0424 (Figure 2-6). Selenium has an upward trend for all wells, but concentrations remain below the respective MCL (Figure 2-5). Selenium trends will be evaluated again in 2023 after the next schedule 5-year sampling event.

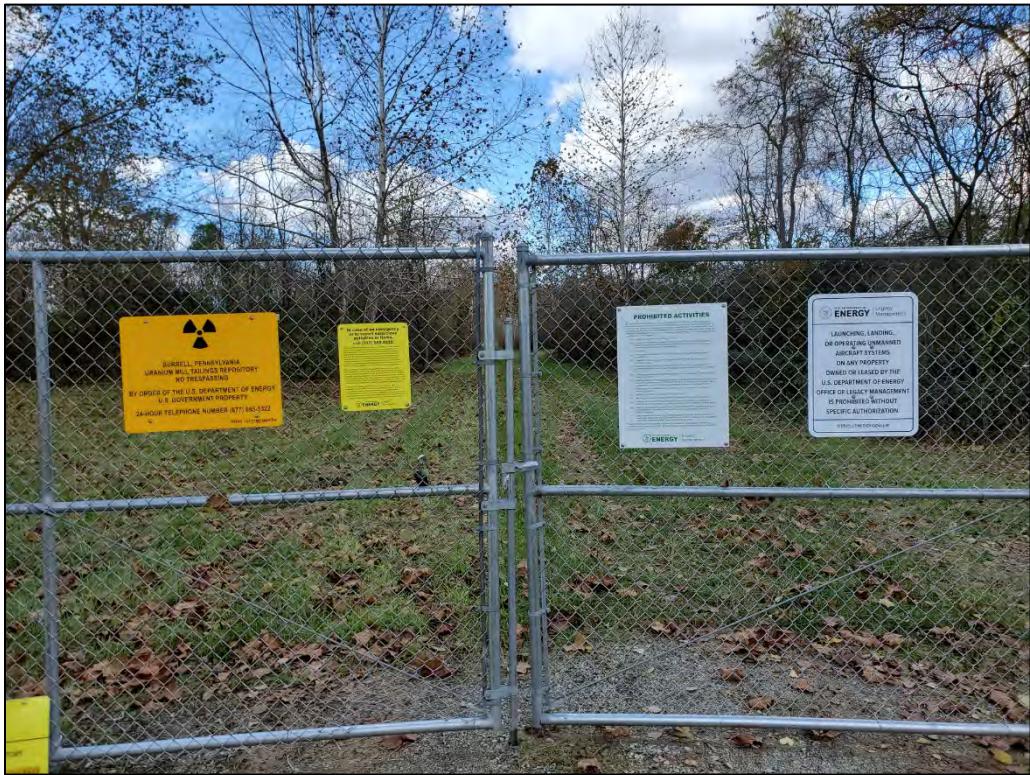
PL-1. Front Gate with New Signage

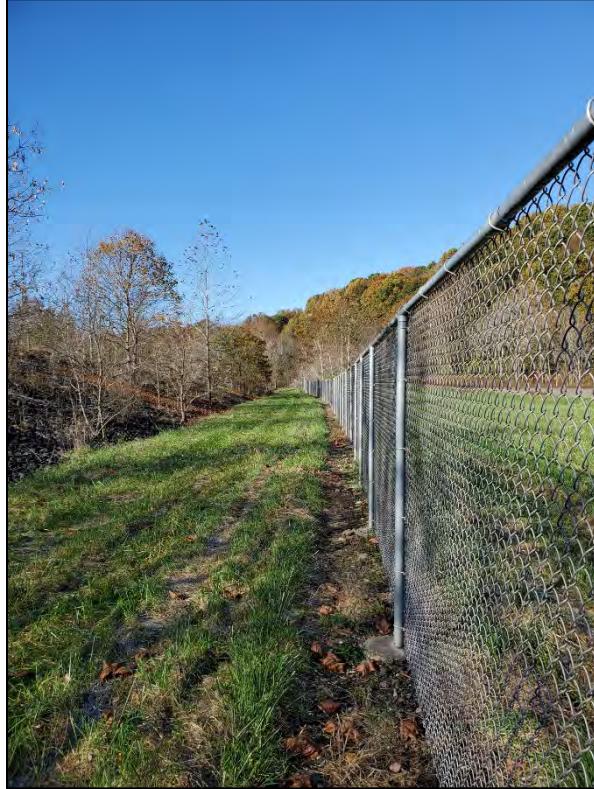
A chainlink security fence encloses the disposal cell and drainage features (PL-2). The site herbicide subcontractor keeps the fence line clear of vegetation, which should prolong the life of the security fence. Trees felled by strong storms have bent the upper rail of the south fence in a few spots, but the fence remains serviceable, and repairs are not required at this time (PL-3).

PL-2. North Fence Line

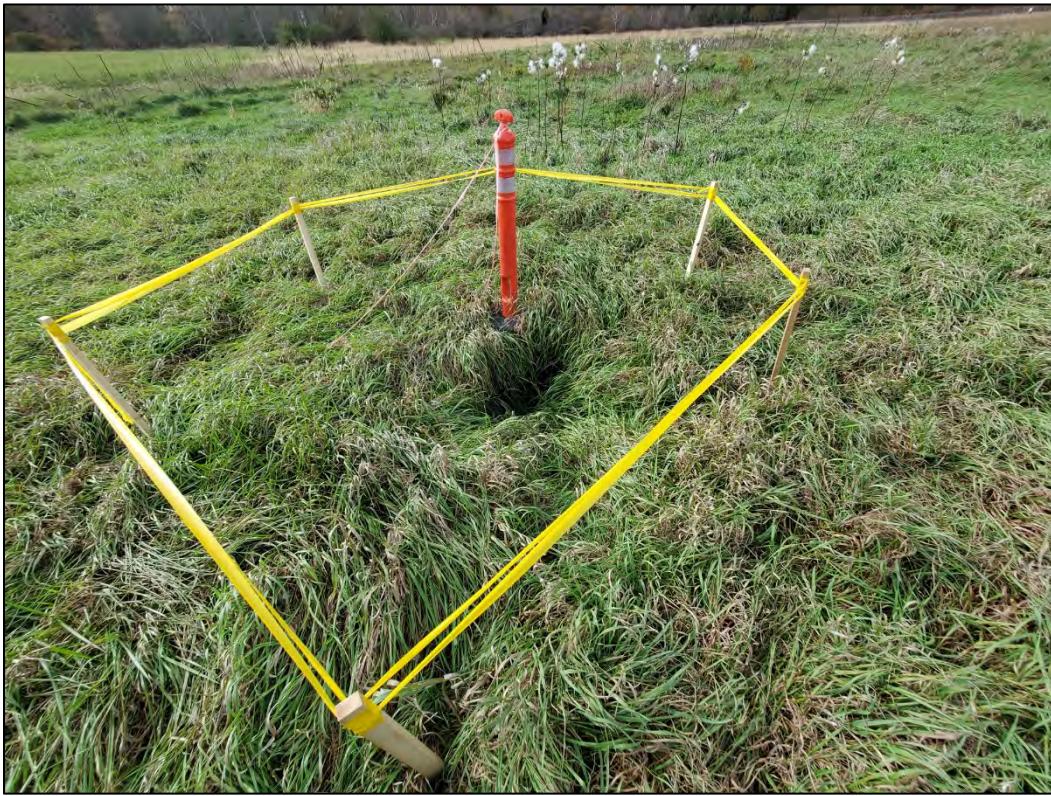
PL-7. Hole on East End of Test Prairie

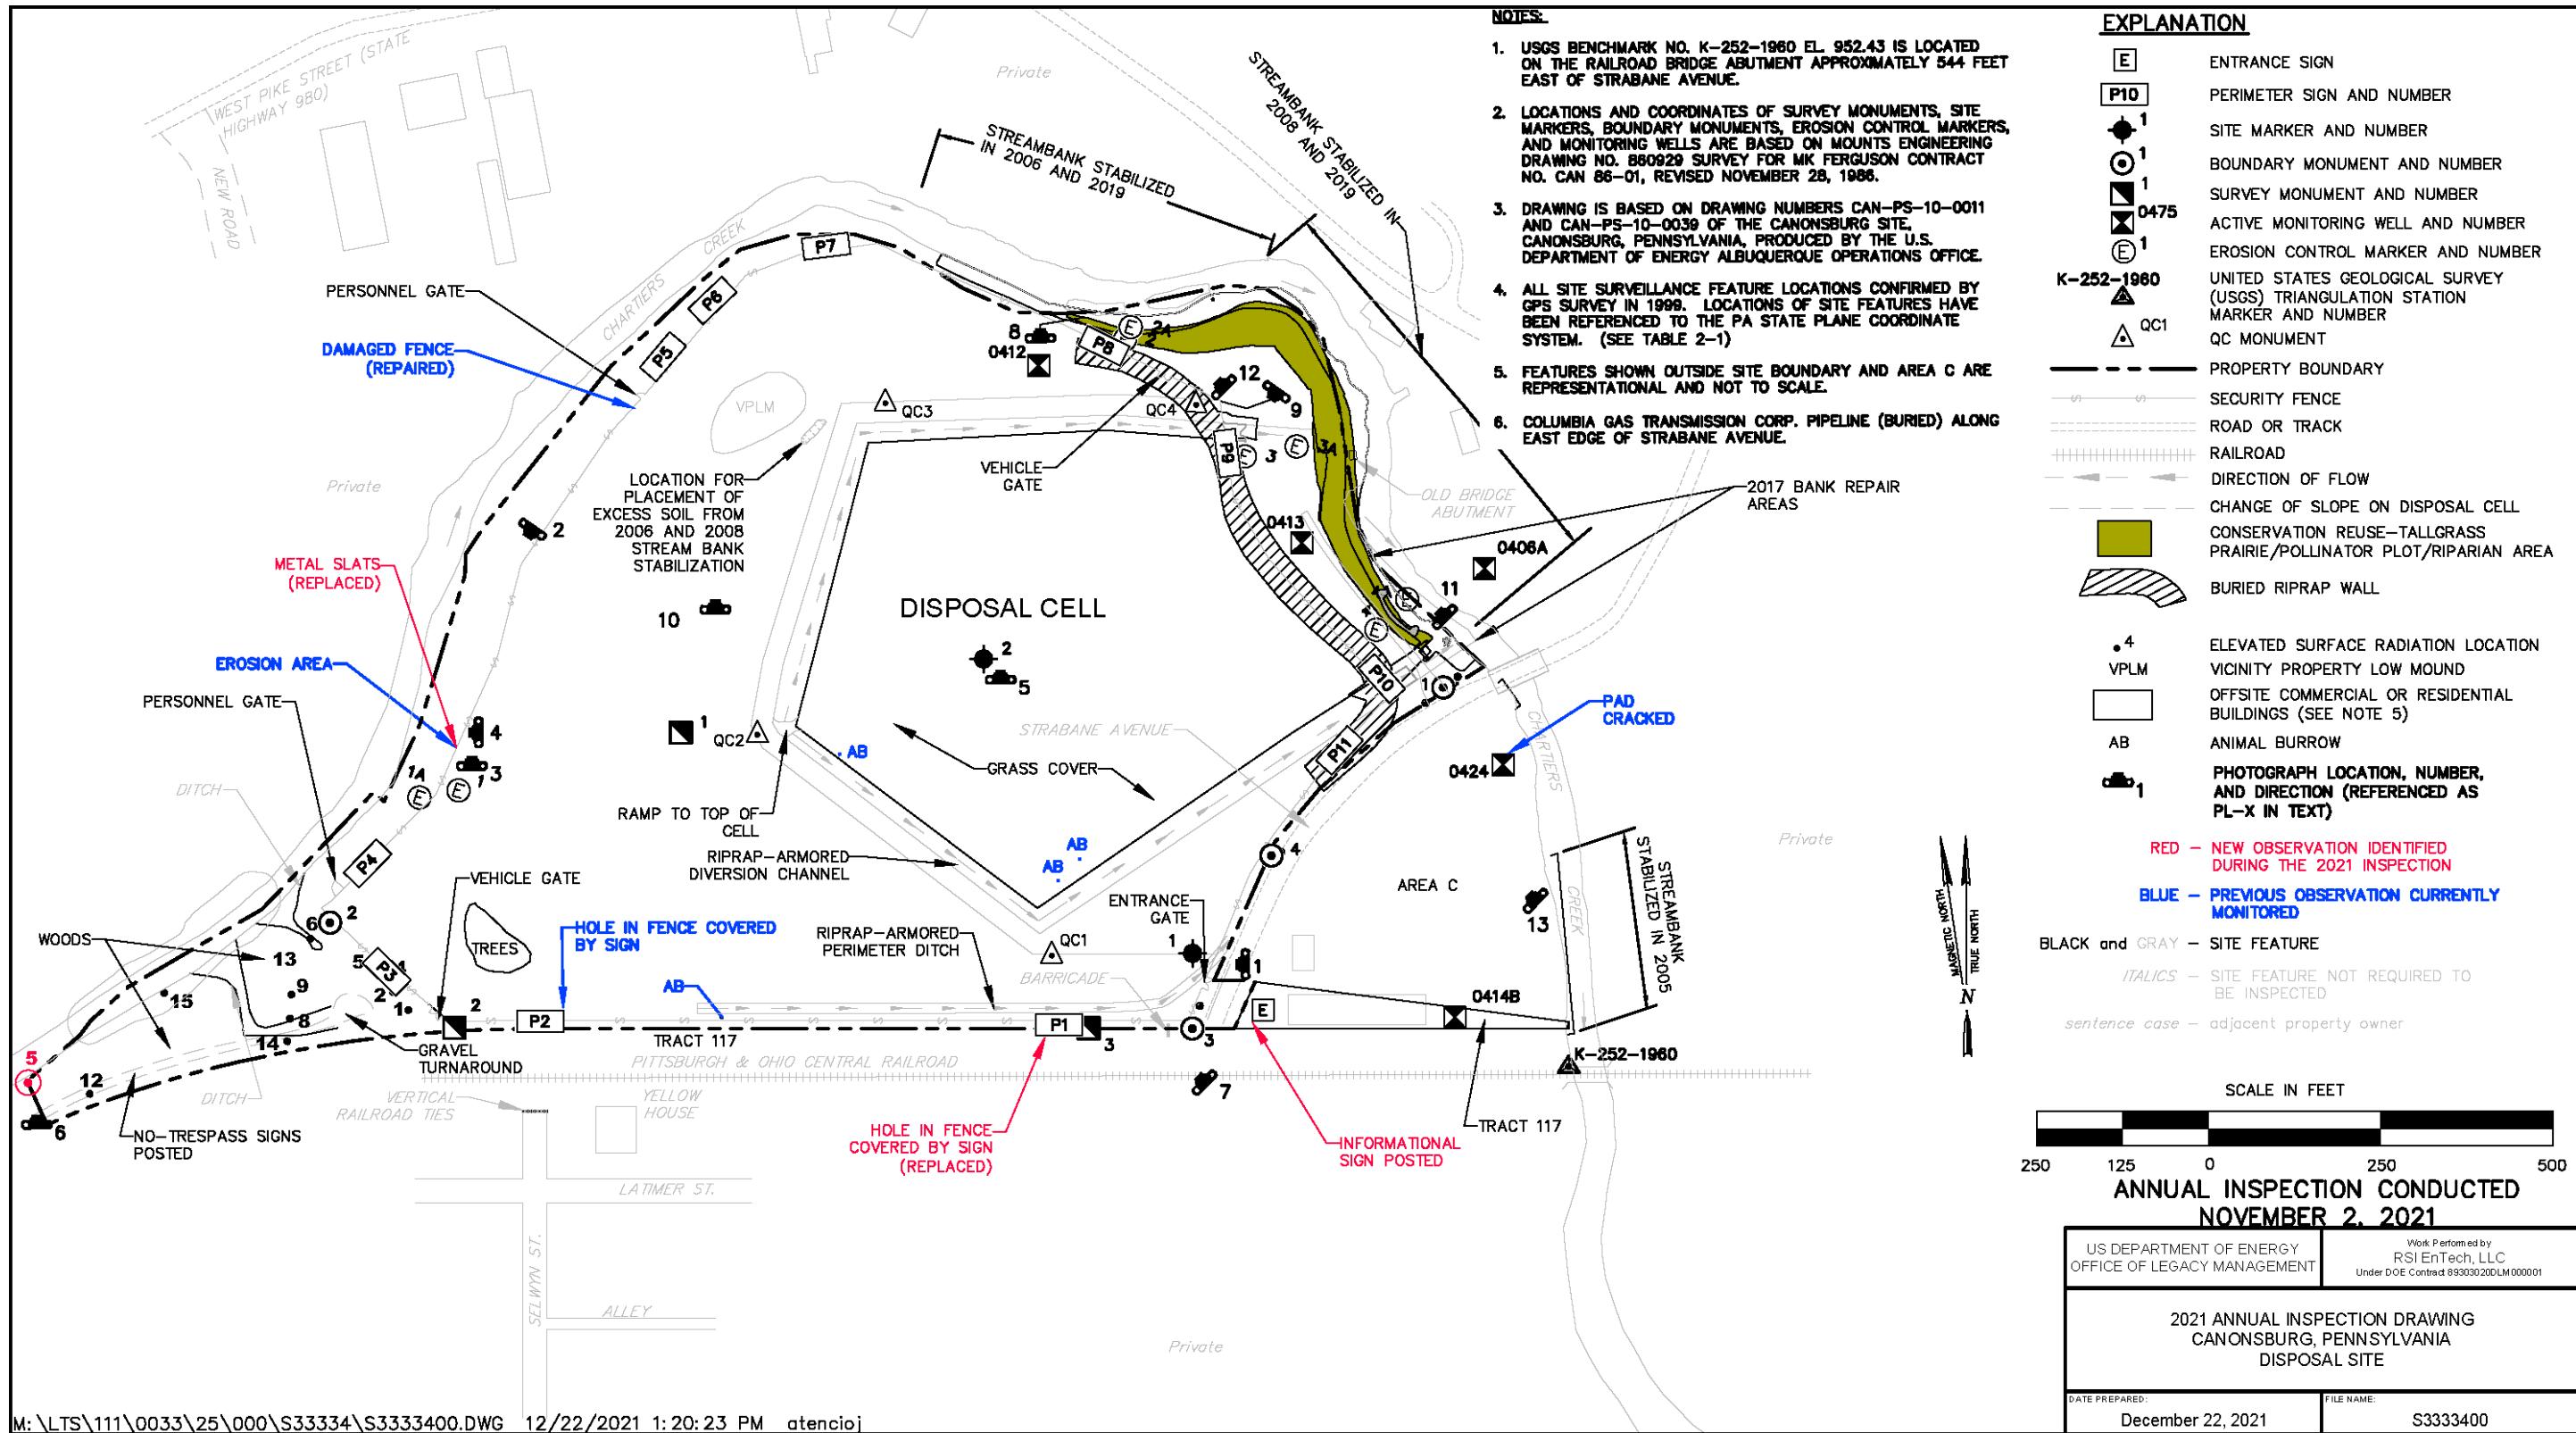
Figure 3-1. 2021 Annual Inspection Drawing for the Canonsburg, Pennsylvania, Disposal Site

Figure 3-1 shows the locations of site features, including site surveillance features and inspection areas, in black and gray font. Site features that are present but not required to be inspected are shown in italic font. Observations from previous inspections that are currently monitored are shown in blue text, and new observations identified during the 2021 annual inspection are shown in red. Inspection results and recommended maintenance activities associated with site surveillance features are included in the following subsections. Photographs to support specific observations are identified in the text and in Figure 3-1 by photograph location (PL) numbers. The photographs and photograph log are presented in Section 3.10.

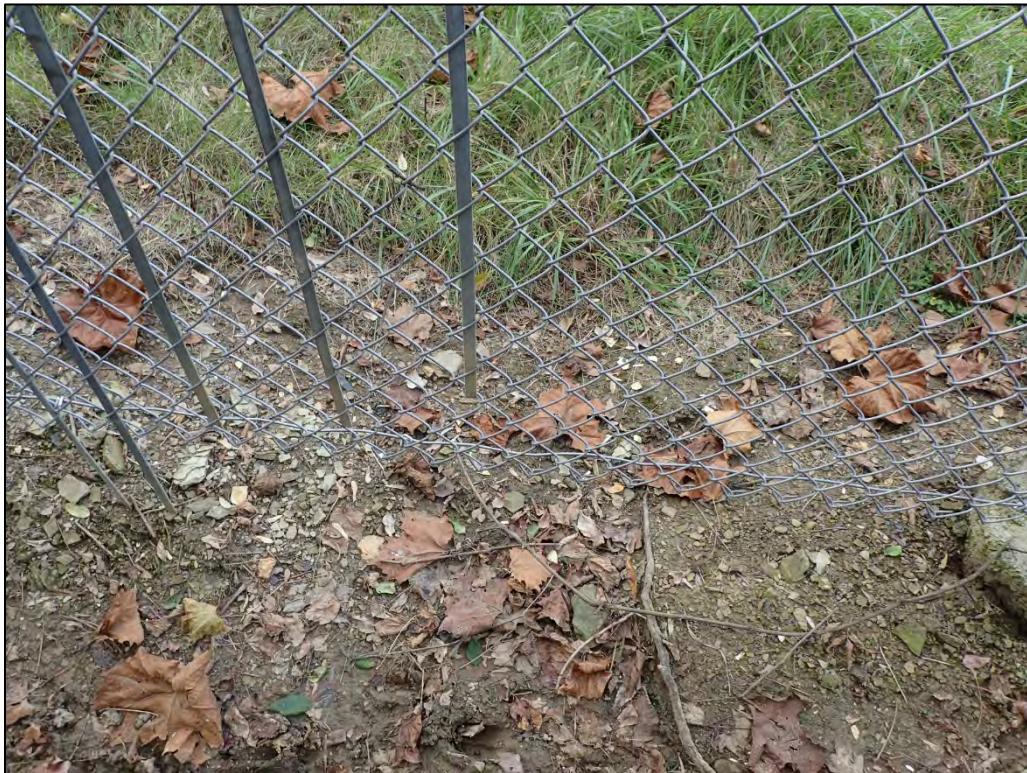
PL-3. Erosion Area Under West Fence

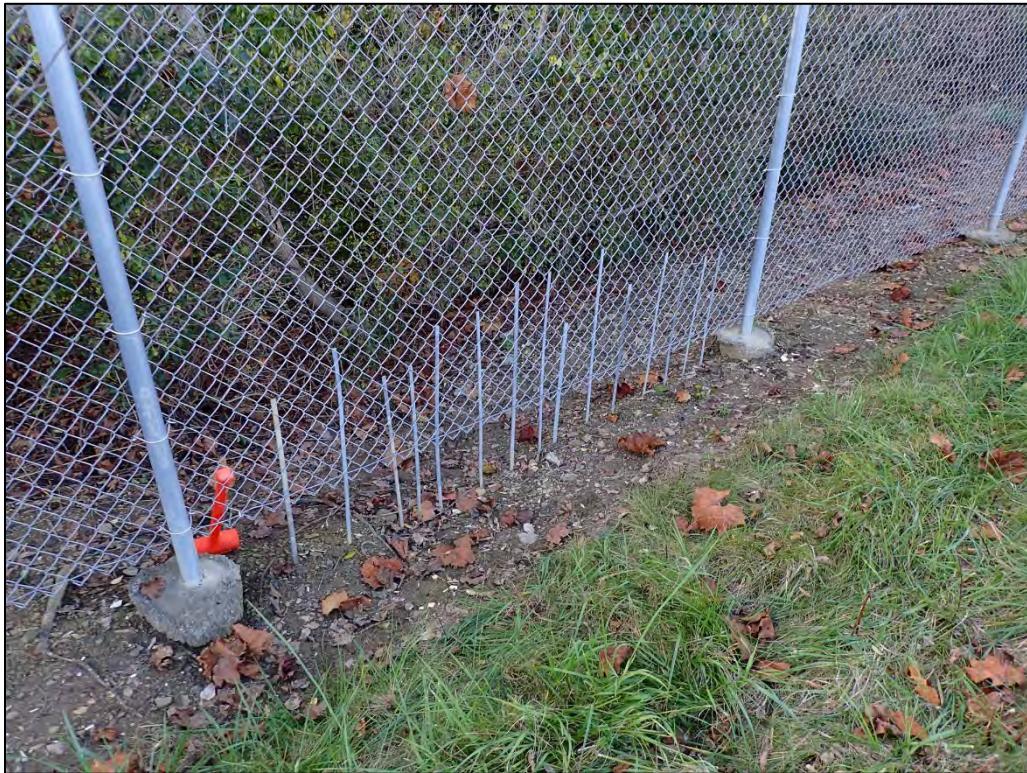
PL-4. New Slats in Fence at Erosion Area
