**U.S. DEPARTMENT OF
ENERGY**

2021 Annual Site Inspection and Monitoring Report for Uranium Mill Tailings Radiation Control Act Title I Disposal Sites

March 2022

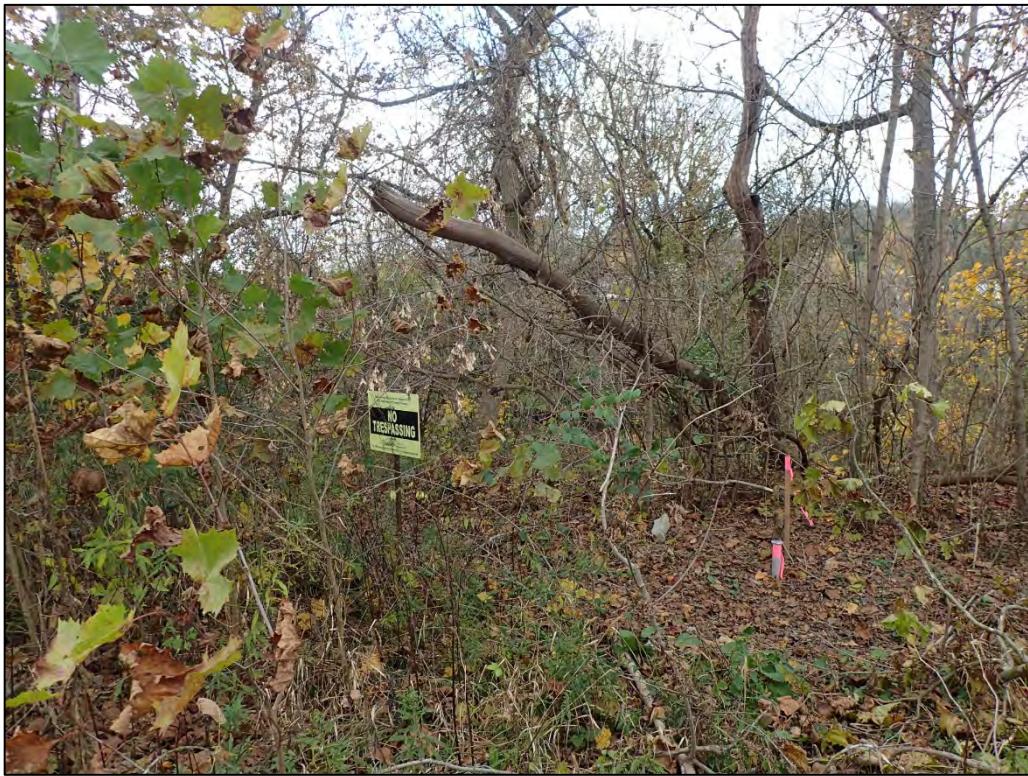
PL-6. New Southwest Boundary Monument BM-5

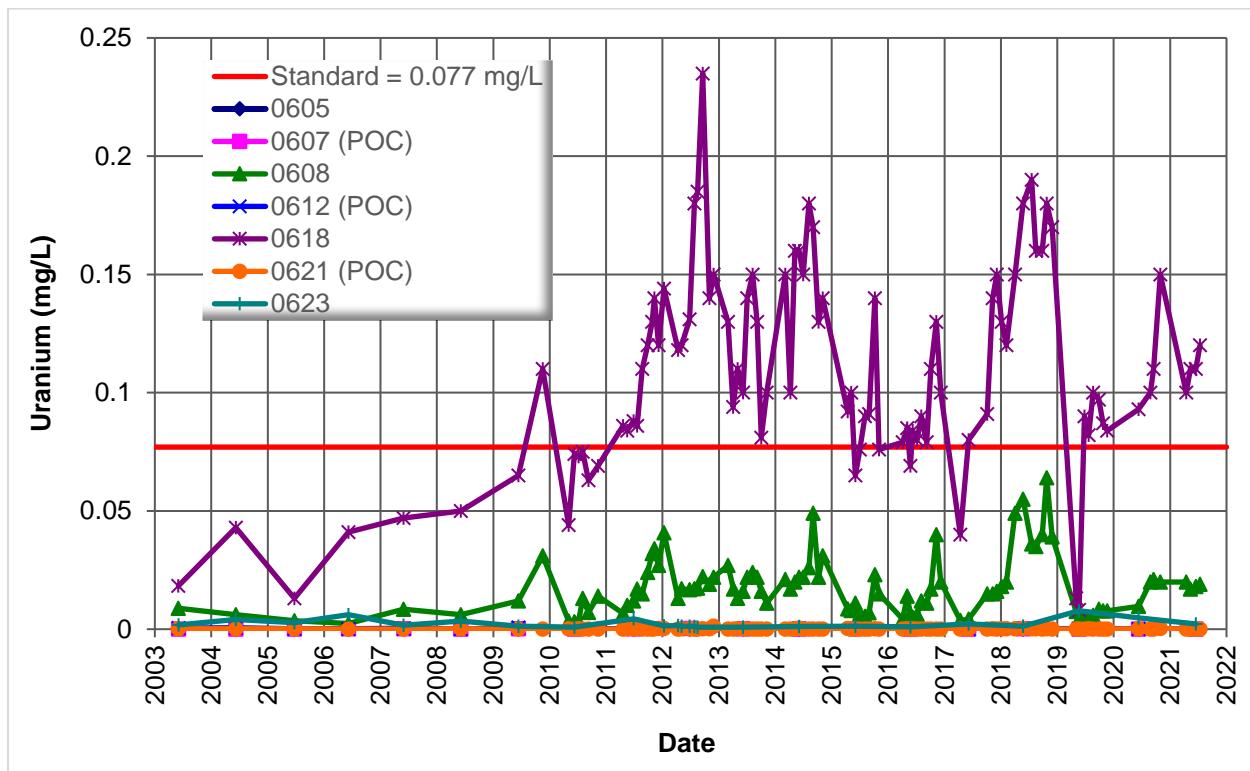
Figure 4-5. Uranium Concentrations in Groundwater at the Durango, Colorado, Disposal Site

Molybdenum, selenium, and uranium concentrations in POC wells (0607, 0612, and 0621) in the uppermost aquifer are below their respective standards.

Wells completed in the alluvium are sampled as a BMP. Uranium concentrations in well 0618 have consistently been higher than concentrations in the other onsite wells. To monitor and compare the elevated and variable uranium concentrations observed in this well, BMP wells 0608, 0618, and 0621 are sampled monthly as weather permits. Figure 4-5 shows variable uranium concentrations between 0.0082 milligrams per liter (mg/L) and 0.235 mg/L in well 0618 beginning in 2009 and continuing to the present. Uranium concentrations in well 0618 were measured at 0.12 mg/L in July 2021, which is within the range of measured historical concentrations. The cause of the variability in uranium concentration at well 0618 will be a focus of further investigation.

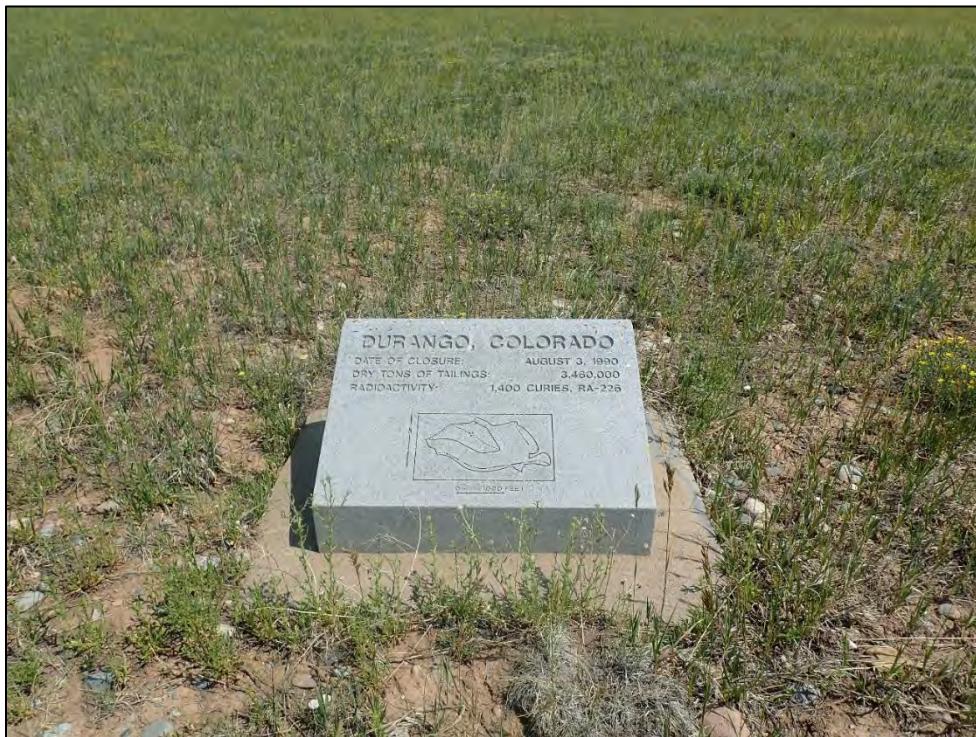
PL-1. Site Marker SMK-2

The site has two site markers. Site marker SMK-1 is just inside the original entrance gate and was in good condition. Site marker SMK-2 (PL-1) is on the top slope of the disposal cell. No new maintenance needs were identified.

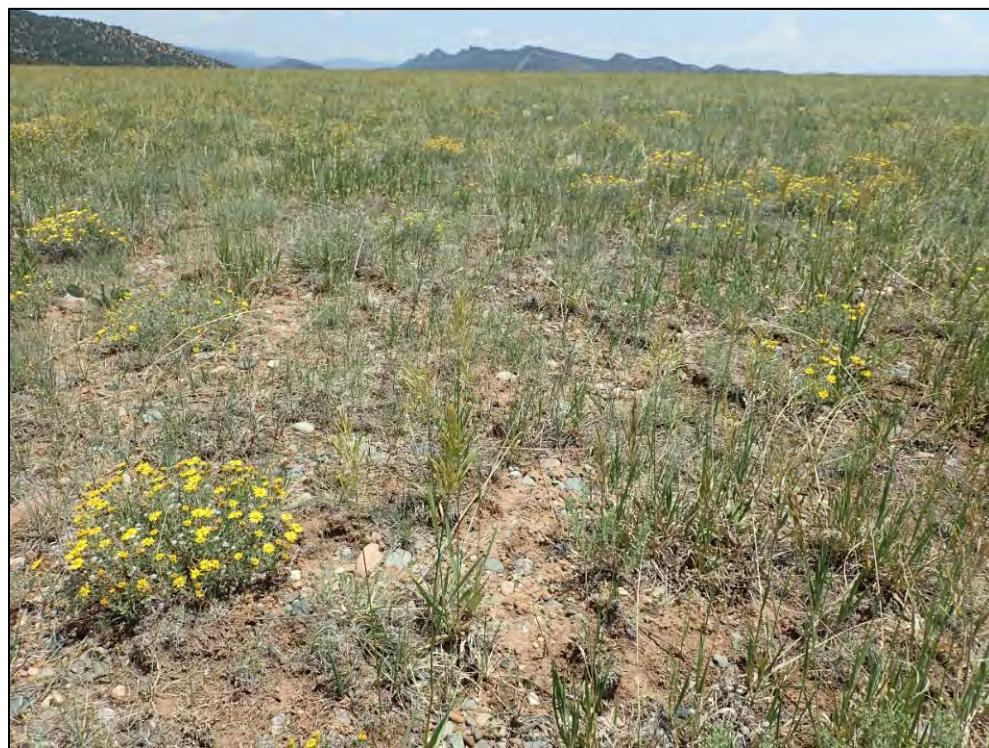
PL-2. Diverse Vegetation on Top Slope

The disposal cell, completed in 1990, occupies 60 acres (PL-2). It has a vegetated cover consisting primarily of perennial grasses and broadleaf plants. There was no evidence of erosion, settling, slumping, or other modifying processes on top of the disposal cell. Several small animal burrows were observed on the cell top-slope (PL-3) but are shallow and do not require repairs. Several noxious weeds were found on the top slope and will be treated following the inspection. No other maintenance needs were identified.

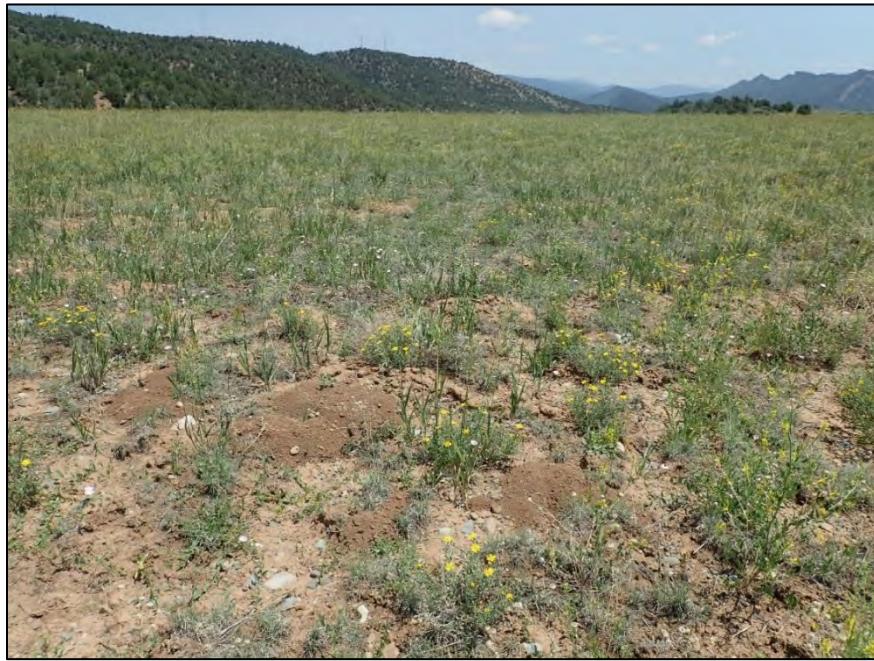
PL-3. Animal Burrows on Top Slope

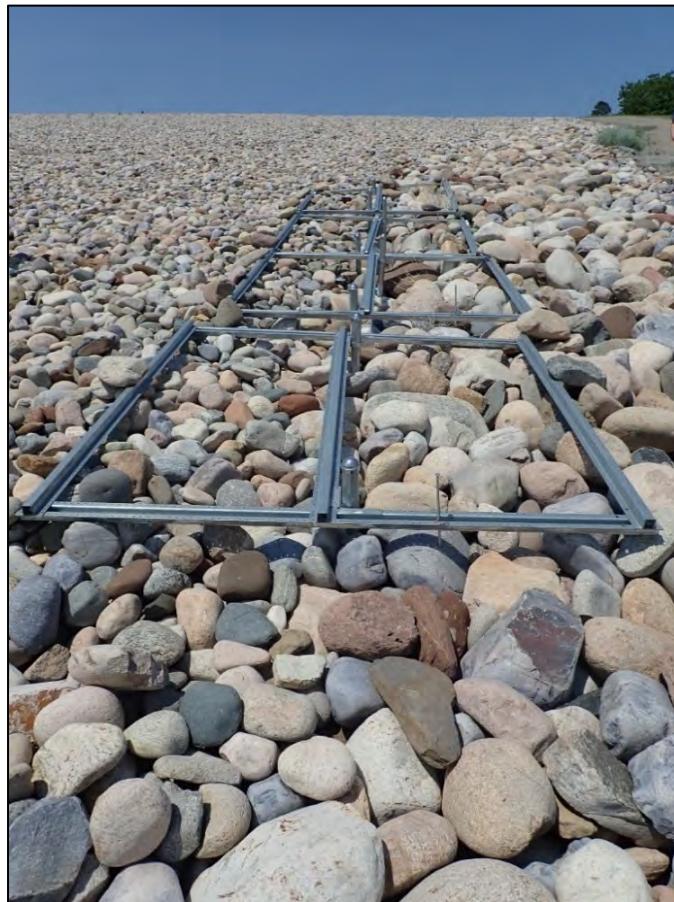
PL-4. Monitoring Grid over Linear Depression

The side slopes of the disposal cell are armored with rock riprap. Rock has moved along the north toe of the disposal cell, resulting in a linear depression approximately 18 feet (ft) long (PL-4) that first was observed in 2015 and continues to be monitored. Inspectors did not observe significant changes to the depression. Inspectors will continue to monitor this area.

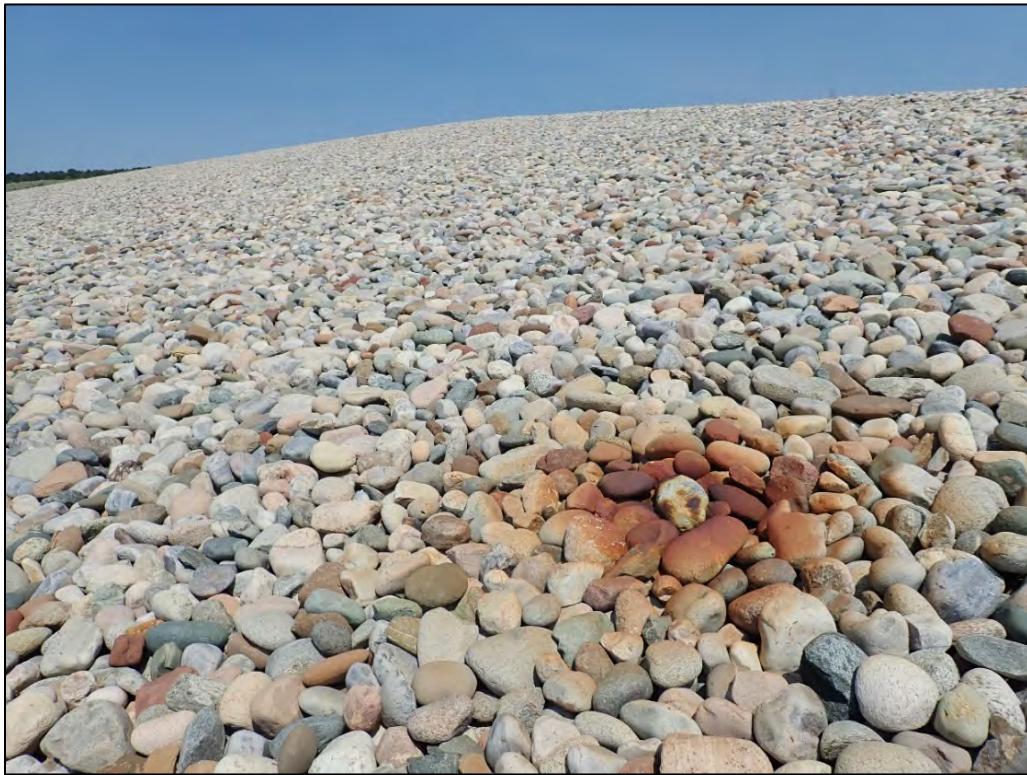
PL-5. Lightning Strike on Side Slope

Inspectors found several young volunteer trees and several noxious weeds growing on the side slopes. The noxious weeds were treated after the inspection. Inspectors noted several points on the side slopes that had sustained lightning strikes (PL-5). No other maintenance needs were identified.

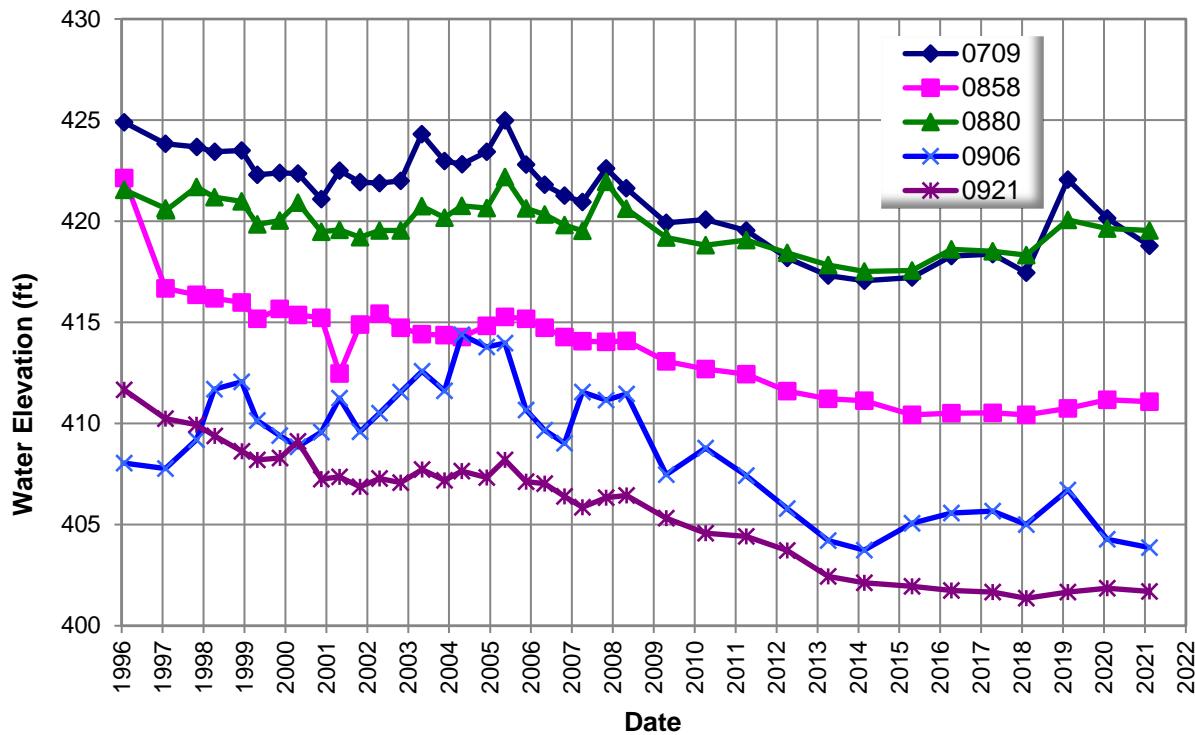
Figure 5-3. Water-Level Measurements at Disposal Cell Performance Monitoring Wells at the Falls City, Texas, Disposal Site

Water levels in all disposal cell performance wells had decreasing trends from 1996 to 2014 based on Mann-Kendall trend analyses (Figure 5-3). Water levels in these wells appear to have stabilized by 2014, but wells 0709, 0880, and 0906 have had increases in water level since 2014, which are more subtle in wells 0858 and 0921 (Figure 5-3). Groundwater compliance wells 0862, 0886, and 0963 had significant increasing water level trends since 1996, and wells 0891 and 0924 had no statistically significant trend (Figure 5-4). Wells with increasing water level trends each had a water elevation increase of about 5 ft since 1996.

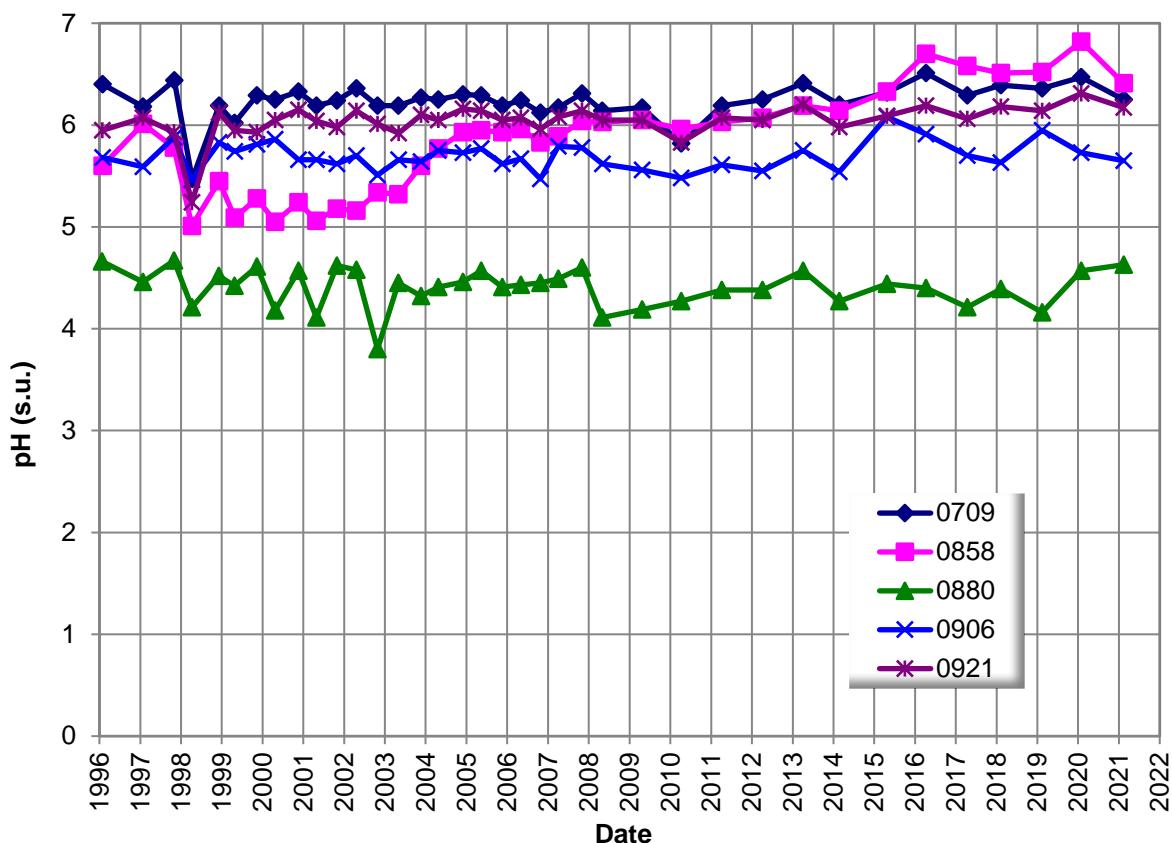
Figure 5-5. pH at Disposal Cell Performance Monitoring Wells at the Falls City, Texas, Disposal Site

pH: Wells 0858 and 0921 had significant increasing pH trends since 1996, based on Mann-Kendall trend analyses, and all other disposal cell performance wells had no significant trend. At the disposal cell performance monitoring wells, pH levels have historically been greater than the pH in tailings pore fluids (pH level of 2.93). The 2021 pH levels were within the range of historical values for all disposal cell performance monitoring wells (Figure 5-5).

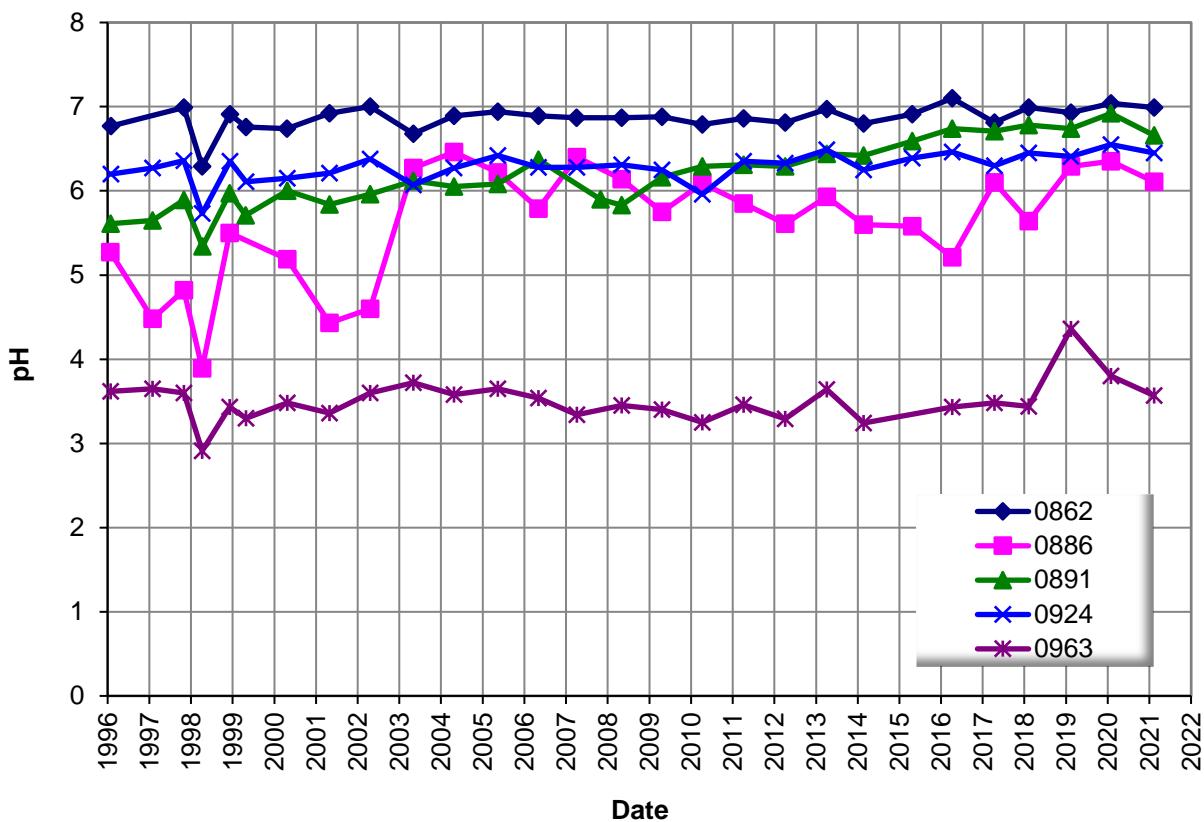
Figure 5-6. pH at Groundwater Compliance Monitoring Wells at the Falls City, Texas, Disposal Site

For compliance monitoring wells, statistically significant increasing trends in pH have been seen in wells 0886, 0891, and 0924 since 1996, with no significant trends in wells 0862 and 0963 (Figure 5-6). The 2021 pH levels were within the range of historical values for all groundwater compliance monitoring wells. The pH in monitoring well 0963 historically has been lower than at the other groundwater compliance wells, with a pH of 3.6 in 2021 compared to between 6.0–7.0 in the other wells. Overall, groundwater in well 0963 had a similar pH to that of the tailings pore fluids, even compared to the wells adjacent to the disposal cell.

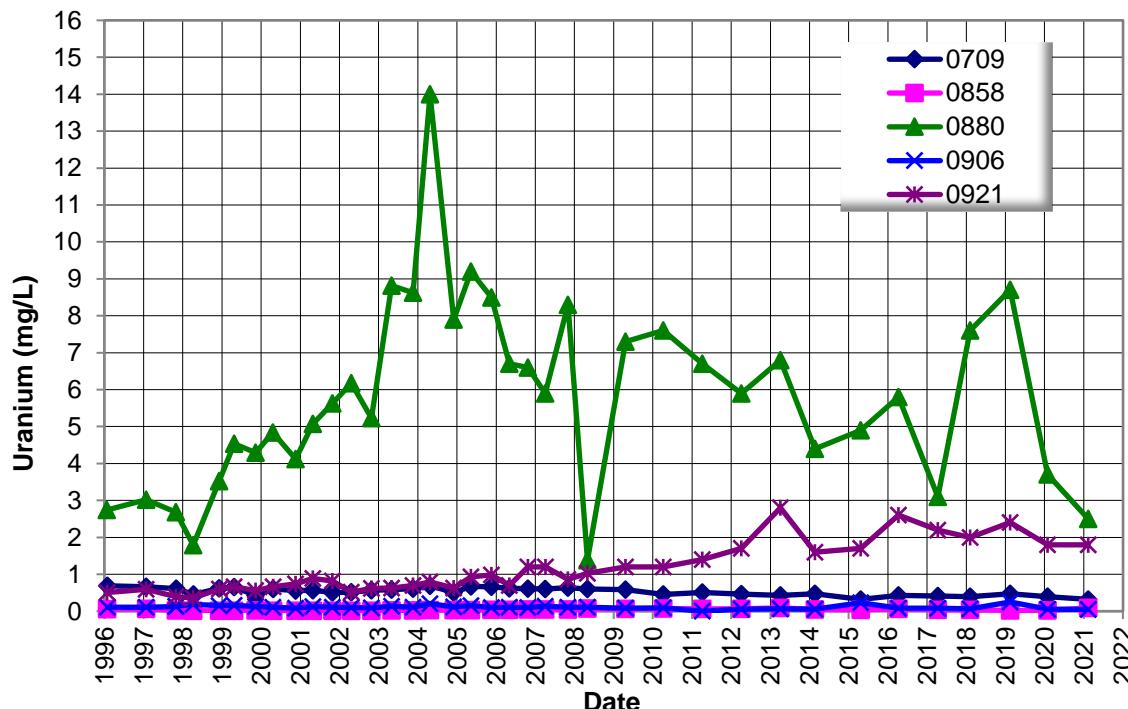
Figure 5-7. Uranium Concentrations at Disposal Cell Performance Monitoring Wells at the Falls City, Texas, Disposal Site

Uranium: The 2021 uranium concentrations for disposal cell performance monitoring wells were within the range of historical values for all groundwater compliance monitoring wells (Figure 5-7). In 2021, the uranium concentrations for monitoring wells 0709, 0906, and 0858 remained generally constant when compared with previous results. The uranium concentration in monitoring wells 0921 and 0880 decreased. Uranium concentrations in monitoring well 0880 show considerable variation, ranging from a high of 14 milligrams per liter (mg/L) in 2004 to a low of 1.38 mg/L in 2008. The 2021 uranium concentrations for groundwater compliance monitoring wells were within the range of historical values for all groundwater compliance monitoring wells (Figure 5-8).

Uranium concentrations in disposal cell performance monitoring well 0880 have varied considerably since 1996, ranging from 14 mg/L in 2004 to 1.38 mg/L in 2008 (Figure 5-7). The uranium concentration was 2.5 mg/L in 2021. The pH at this location is less than at other disposal cell performance monitoring wells. Water levels at all the cell performance monitoring wells trended lower from 2007 until 2016, then increased in recent years (Figure 5-3). Because the uranium concentrations at some of the cell performance monitoring wells have been steady and concentrations vary at other locations, local conditions are likely influencing uranium concentrations. This is reasonable because (1) the disposal cell is on tailings that were placed in existing open pit mines; (2) subeconomic ore remains in unmined areas; (3) the uppermost aquifer beneath the cell is oxidized and near the aquifer recharge area; and (4) uranium mineralization processes, which involve redistributing and concentrating uranium in the formation materials, are ongoing. Given local conditions, it is difficult to assess whether elevated uranium concentrations in the uppermost aquifer are a result of disposal cell performance or existing background conditions.

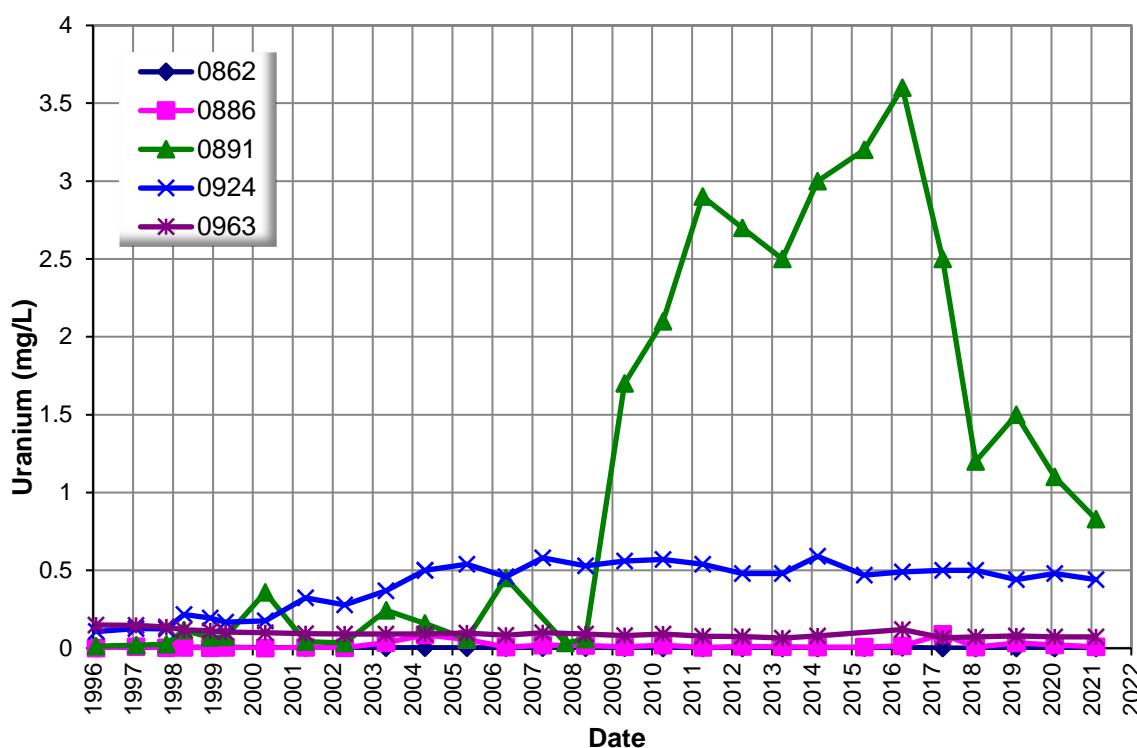
Figure 5-8. Uranium Concentrations in Groundwater Compliance Monitoring Wells at the Falls City, Texas, Disposal Site

The high uranium concentrations in groundwater compliance well 0891 since 2008, trending downward since 2016, likely reflects the passage of a groundwater with elevated uranium flowing from the direction of the former processing site. Historical data from upgradient monitoring wells that were abandoned in 2001 show a uranium anomaly moved past them (Figure 5-9) (DOE forthcoming). LM defined the groundwater flow directions in the Deweesville and the Dilworth aquifers and identified areas of low pH where tailings-derived fluids have consumed all the natural buffering capacity (DOE 2008; Figure 2-7; Figure 2-8). Monitoring well 0891 is completed in the Dilworth aquifer. Monitoring well 0963 (completed in the Deweesville Sandstone) is in a zone of low pH where groundwater in the Deweesville aquifer flows into the underlying Dilworth aquifer. Monitoring well 0966 is the next downgradient Dilworth aquifer well.

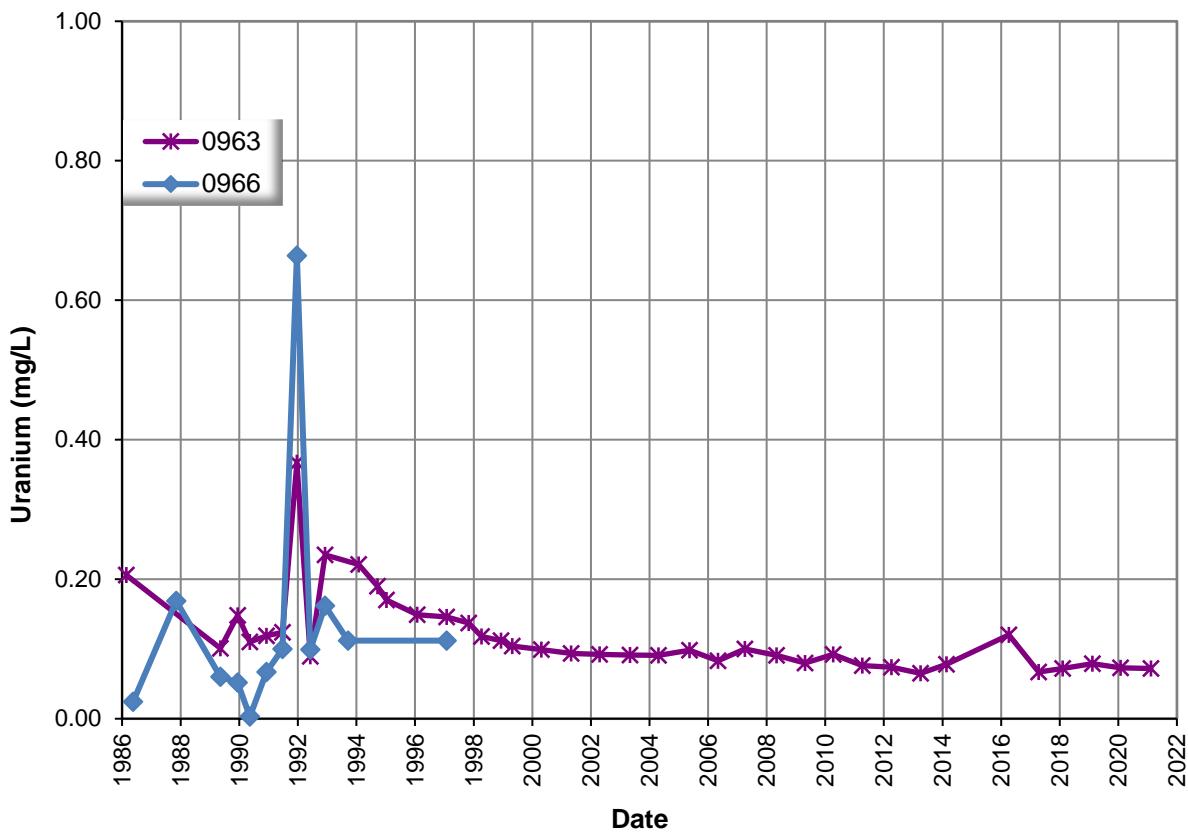
Figure 5-9. Uranium Concentrations in Monitoring Wells 0963 (in the Deweesville aquifer) and 0966 (in the Dilworth aquifer)

Figure 5-9 shows uranium concentration spikes in both wells (0963 and 0966) in 1992, with slowly declining uranium concentrations in 0963 over time (data for monitoring well 0966 are limited). This is likely due to an initial release of uranium and low pH tailings fluids during tailings deposition and subsequent acid leaching, with tailings removal by 1994 (DOE forthcoming). Monitoring well 0891 is the next Dilworth well directly downgradient of the low pH zone. Additionally, the elevated uranium at monitoring well 0891 is accompanied by elevated alkalinity and chloride, which also supports the conclusion that the elevated uranium is the result of passage of groundwater containing processing-related constituents.

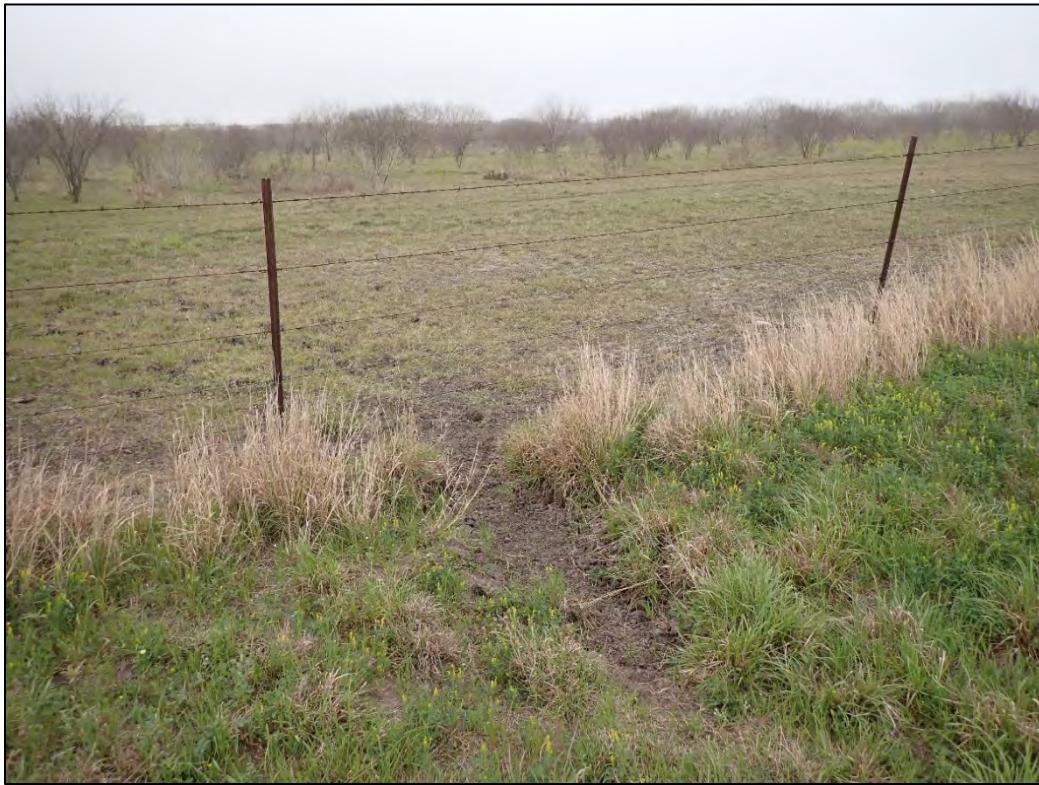
PL-9. Hog Crossing Under Southwest Fence Line

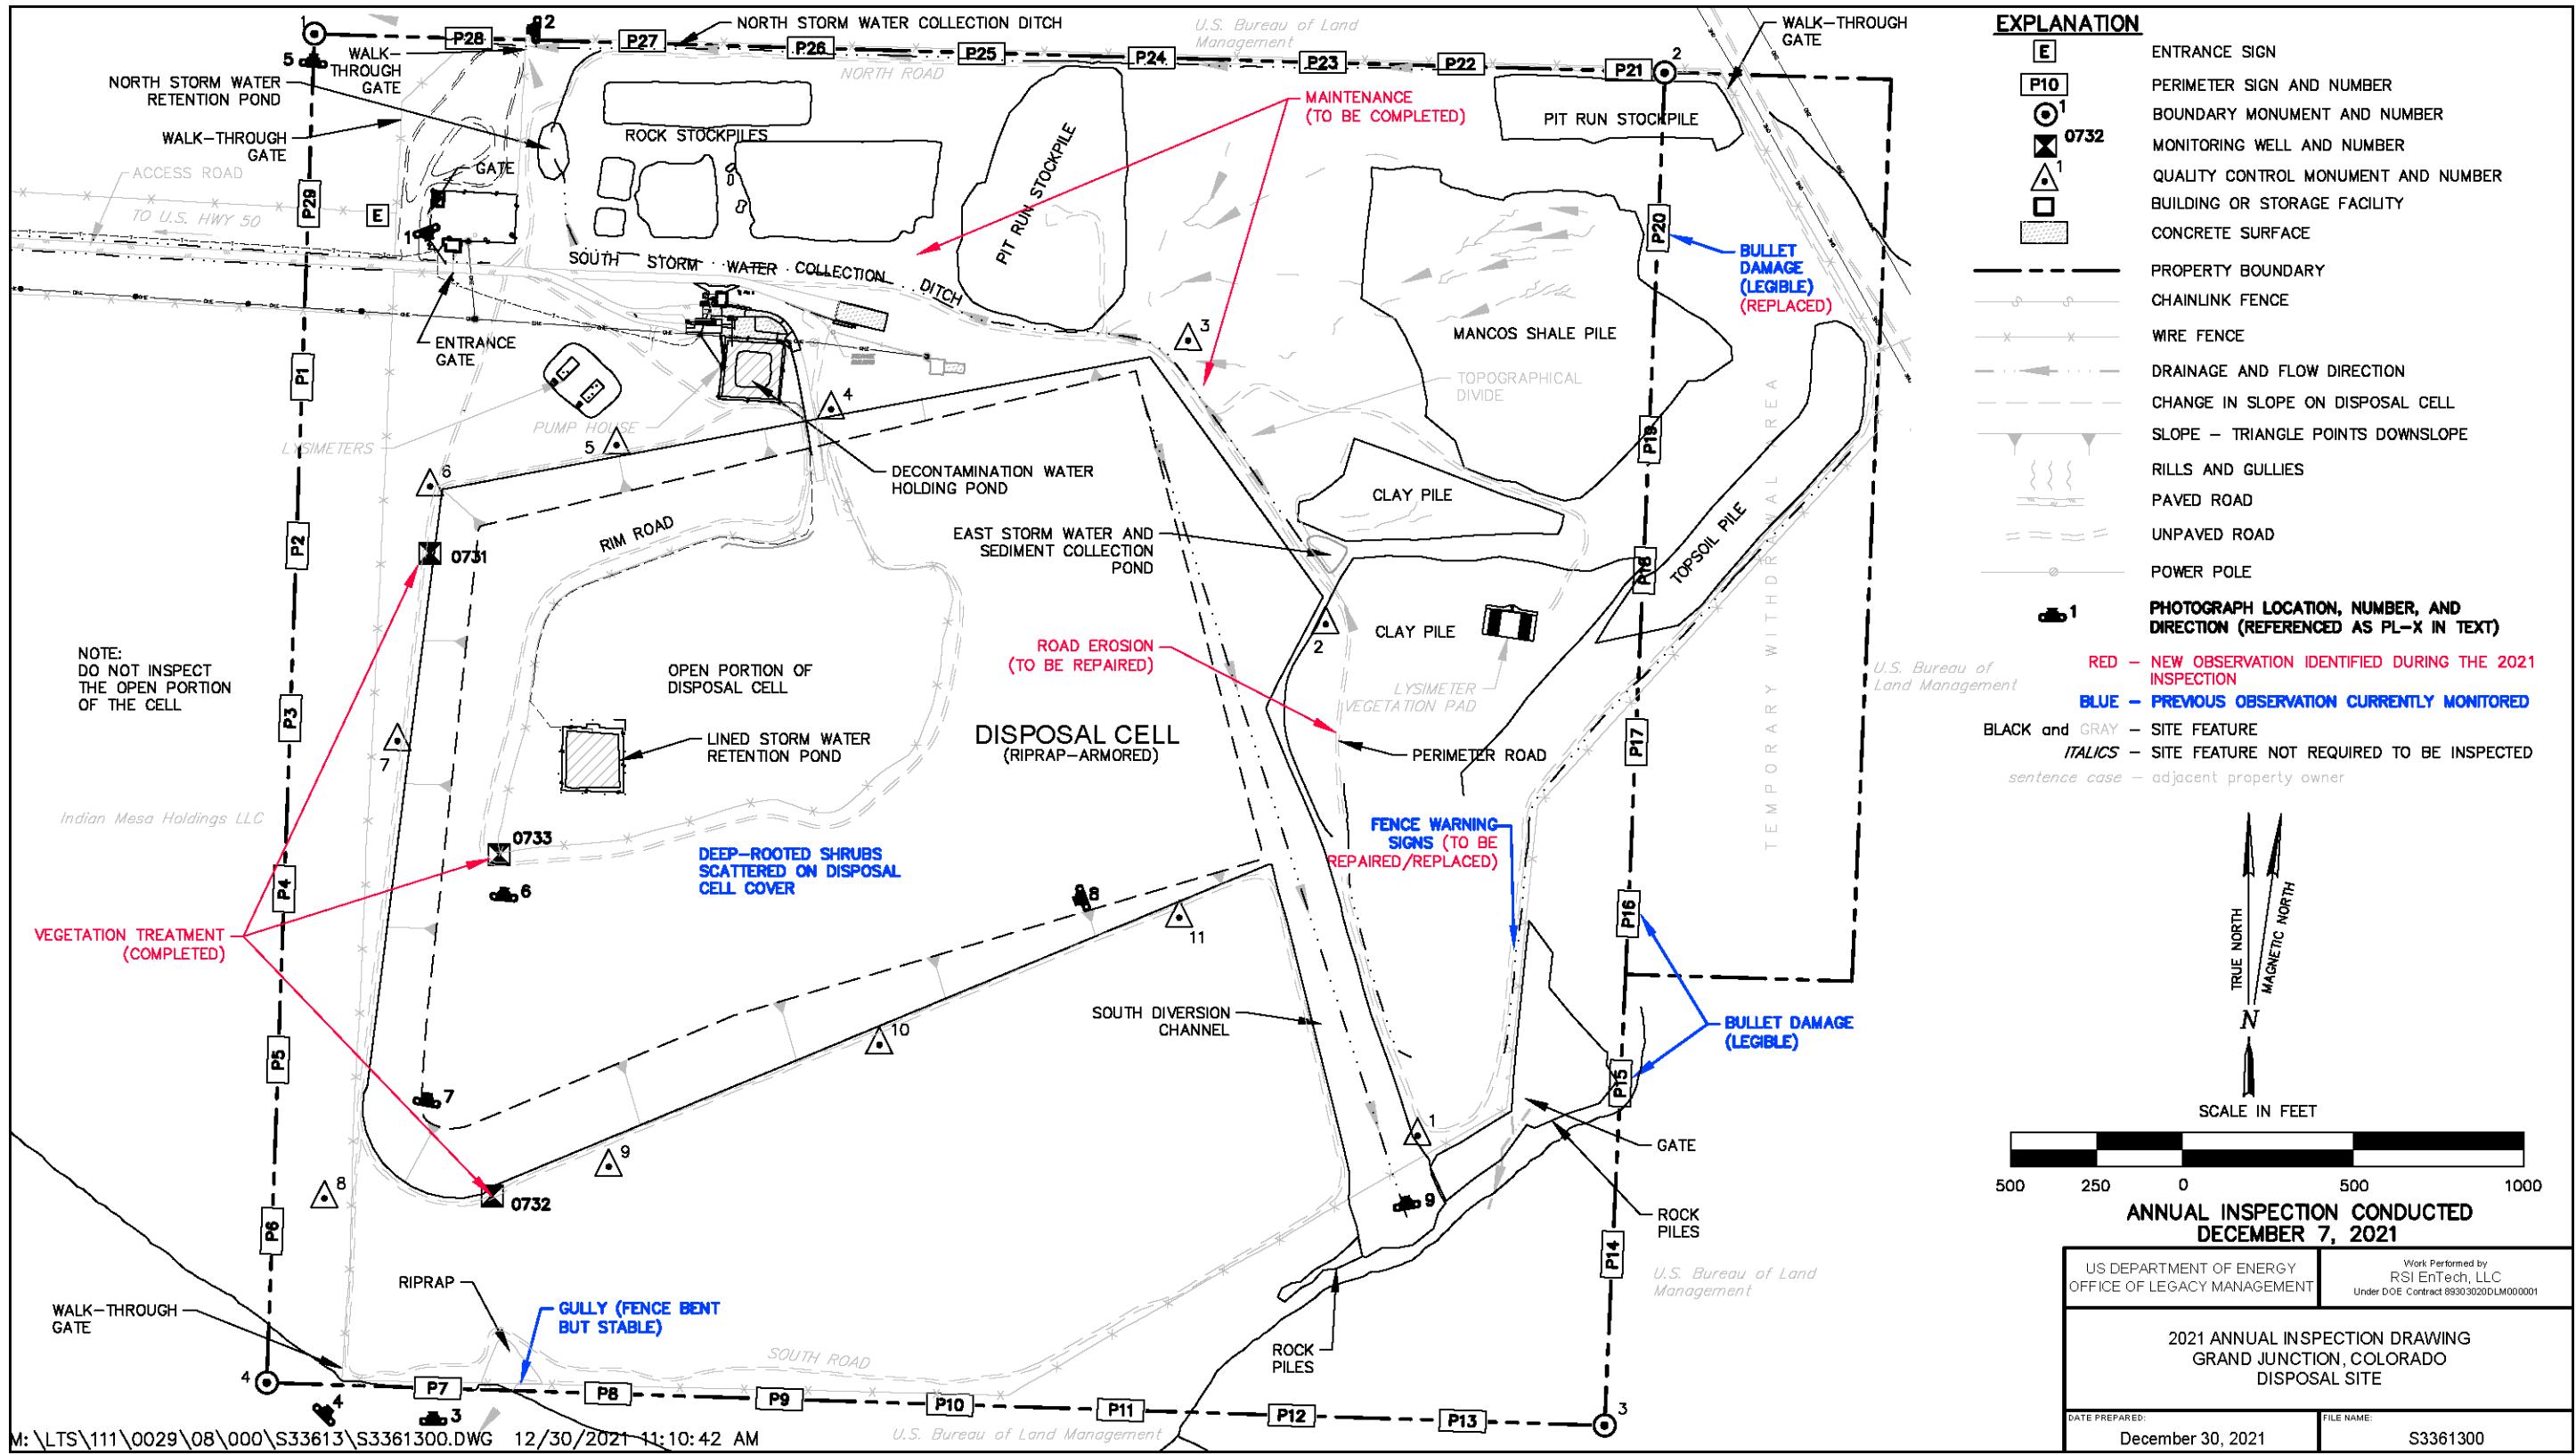
Figure 6-1. 2021 Annual Inspection Drawing for the Grand Junction, Colorado, Disposal Site

Most of the flat areas between the disposal cell and the site (property) boundary are vegetated with native shrubs, scant perennial grasses, and annual weeds. Localized erosion is present at two locations on the perimeter road adjacent to the east side of the disposal cell (Figure 6-1). Repairs to these areas will be completed with the ongoing maintenance of site stormwater collection ditches (Section 6.4.2.2). No other maintenance needs were identified.

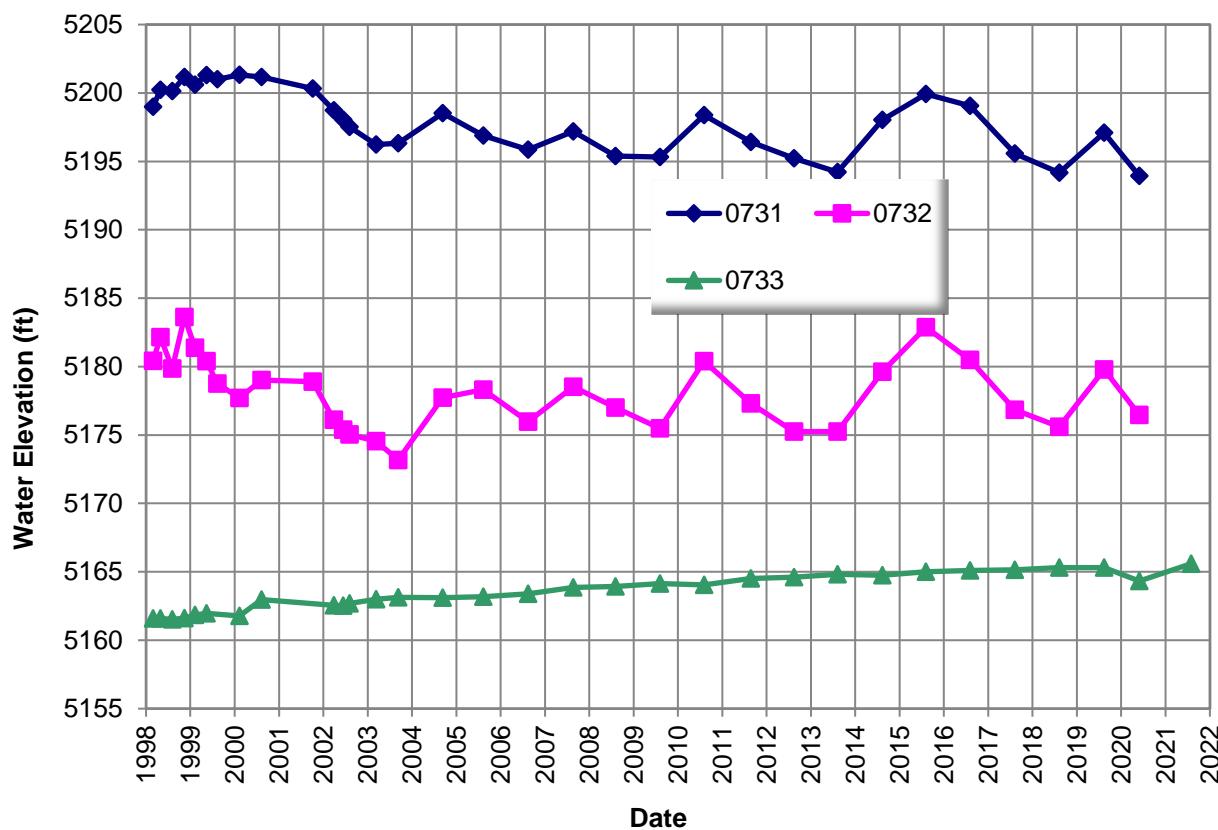
Figure 6-3. Water Level Measurements at the Grand Junction, Colorado, Disposal Site

Static water level measurements are obtained from each monitoring well before water quality samples are collected (Figure 6-3). Water levels in disposal cell monitoring well 0733 generally increased approximately 4 ft since 1998 and have remained lower than the adjacent water levels in the two paleochannel monitoring wells. Groundwater levels in wells 0731 and 0732 remained relatively constant with the same apparent trend in variability, suggesting the two paleochannel systems are influenced by the same upgradient recharge mechanisms. The 2020 sampling occurred in late May, whereas every previous sampling since 2003 occurred in August or early September. Consequently, water level measurements in 2020 may have a seasonal influence in relation to the historical data. 2021 groundwater levels in wells 0731 and 0732 are not reported, as both wells were filled with roots.

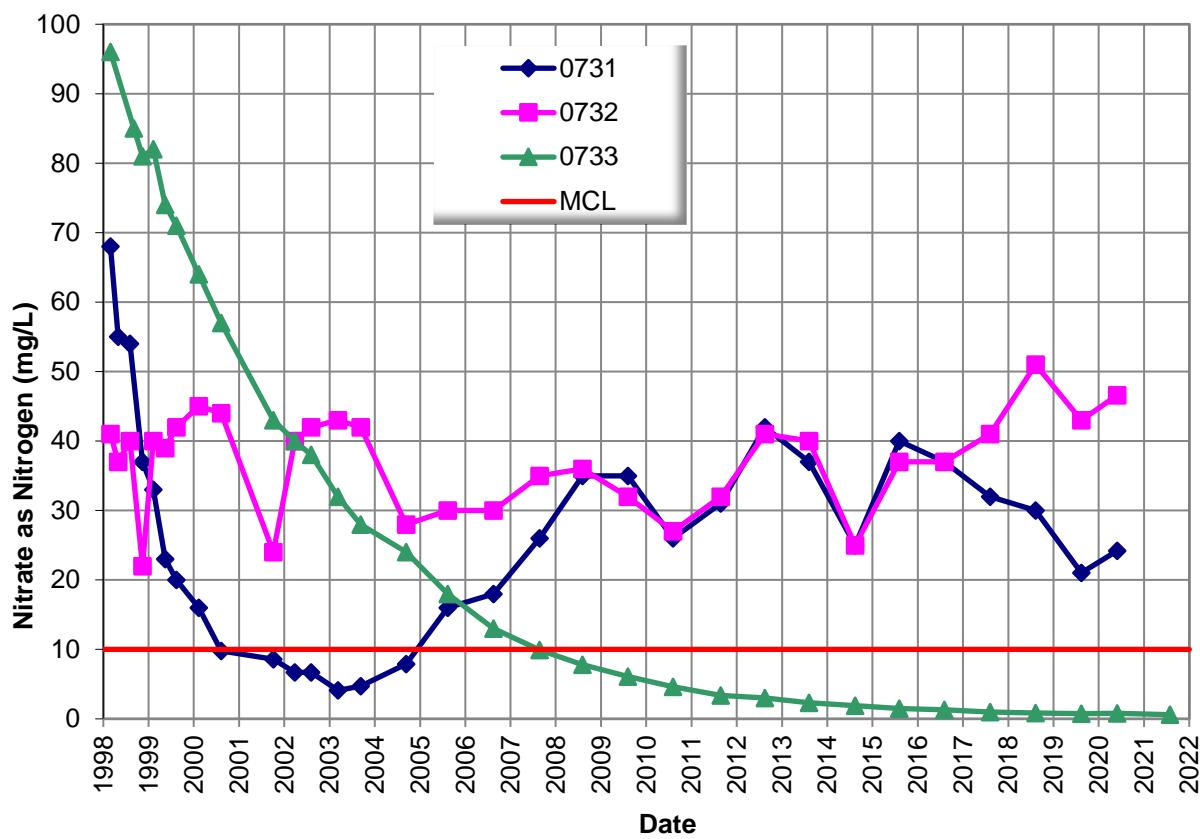
Figure 6-4. Nitrate (as Nitrogen) in Groundwater at the Grand Junction, Colorado, Disposal Site

Nitrate (as nitrogen) concentrations in disposal cell monitoring well 0733 continued to decline from 96 mg/L in 1998 to 0.6 mg/L in 2021; the 2021 numbers are significantly below the MCL of 10 mg/L (Figure 6-4). This is possibly due to increased reducing conditions (less oxygen) over time at the bottom of the disposal cell, creating denitrification (conversion of nitrate to nitrogen gas). Past concentrations of elevated nitrate (as nitrogen) in paleochannel monitoring wells 0731 and 0732 (compared to background nitrate concentrations up to 1.1 mg/L) may be the result of these wells adding oxygen to the Mancos Shale within the well screen and releasing nitrate.

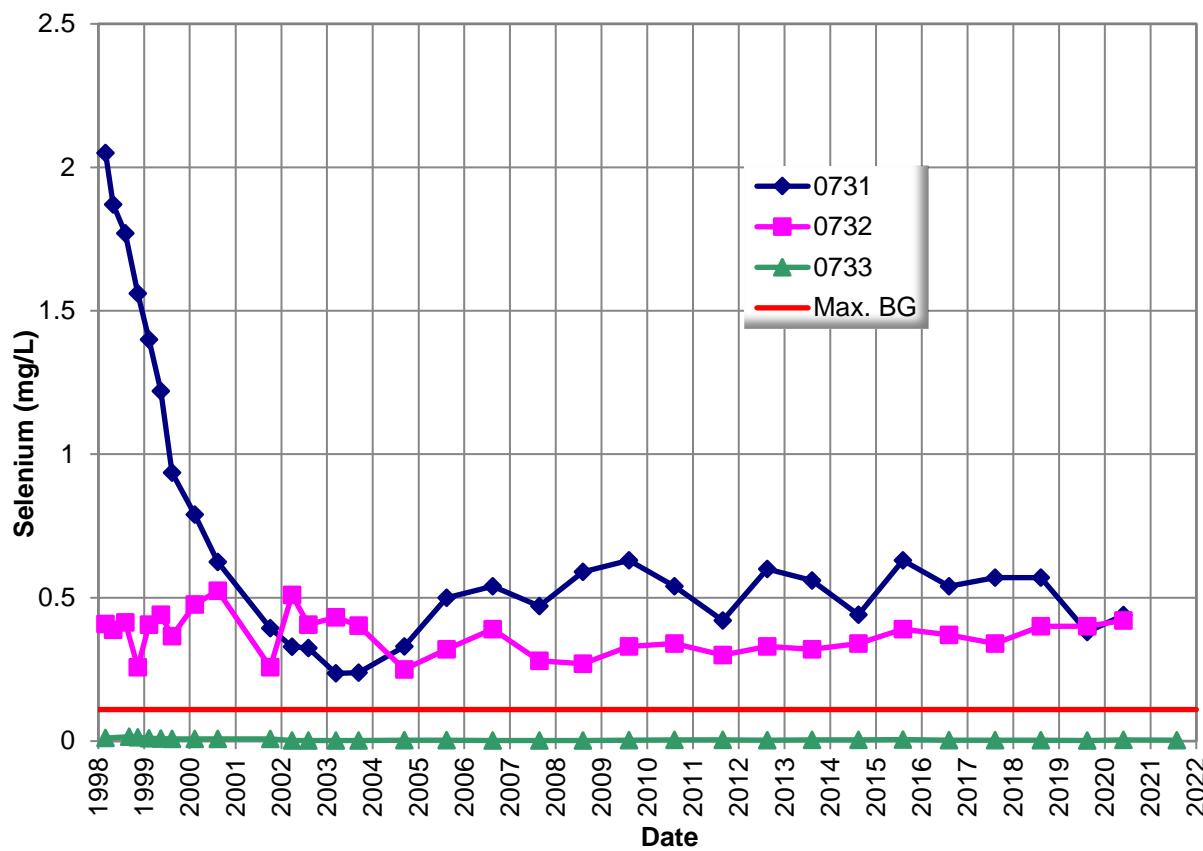
Figure 6-5. Selenium in Groundwater at the Grand Junction, Colorado, Disposal Site

Selenium occurs naturally in the Mancos Shale deposits that underlie the disposal cell (DOE 1991). Background groundwater concentrations in the Mancos Shale are at 0.11 mg/L, which exceeds the MCL of 0.01 mg/L (Table 6-3). As with nitrate, the addition of oxygen into the Mancos Shale because of the installation of these monitoring wells may contribute to the release of selenium from the Mancos Shale. Disposal cell monitoring well 0733 is not screened in the weathered Mancos Shale, and selenium concentrations remain below maximum background concentrations (Figure 6-5).

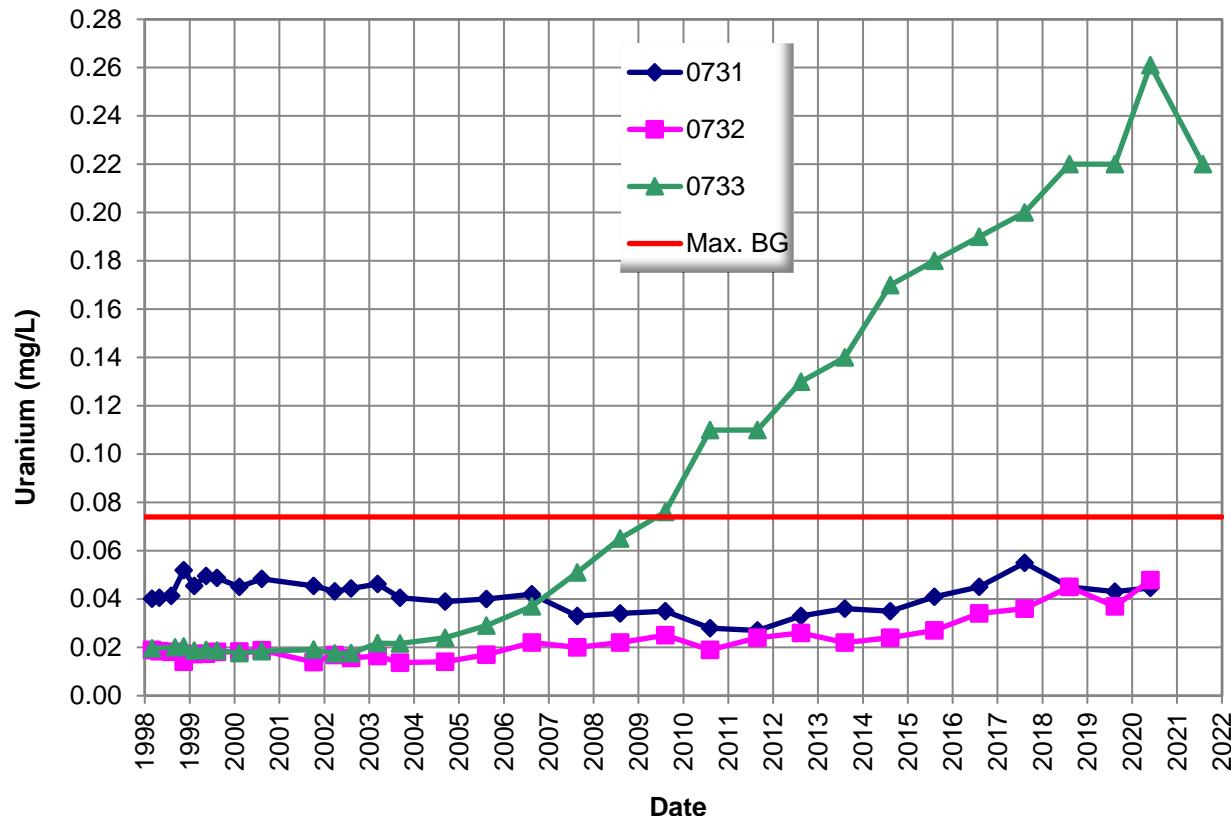
Figure 6-6. Uranium in Groundwater at the Grand Junction, Colorado, Disposal Site

Uranium concentrations in wells 0731 and 0732 have shown an apparent, gradually increasing trend since 2011 (Figure 6-6). Uranium concentrations in disposal cell monitoring well 0733 have increased from 0.02 mg/L in 2002 to 0.22 mg/L in 2021. Relatively high concentrations of uranium and other constituents are expected for a well screened in the disposal cell tailings. Constituents of concern and water levels in well 0733 are not subject to compliance goals and are monitored solely for information gathering purposes.
