**U.S. DEPARTMENT OF
ENERGY**

2021 Annual Site Inspection and Monitoring Report for Uranium Mill Tailings Radiation Control Act Title I Disposal Sites

March 2022

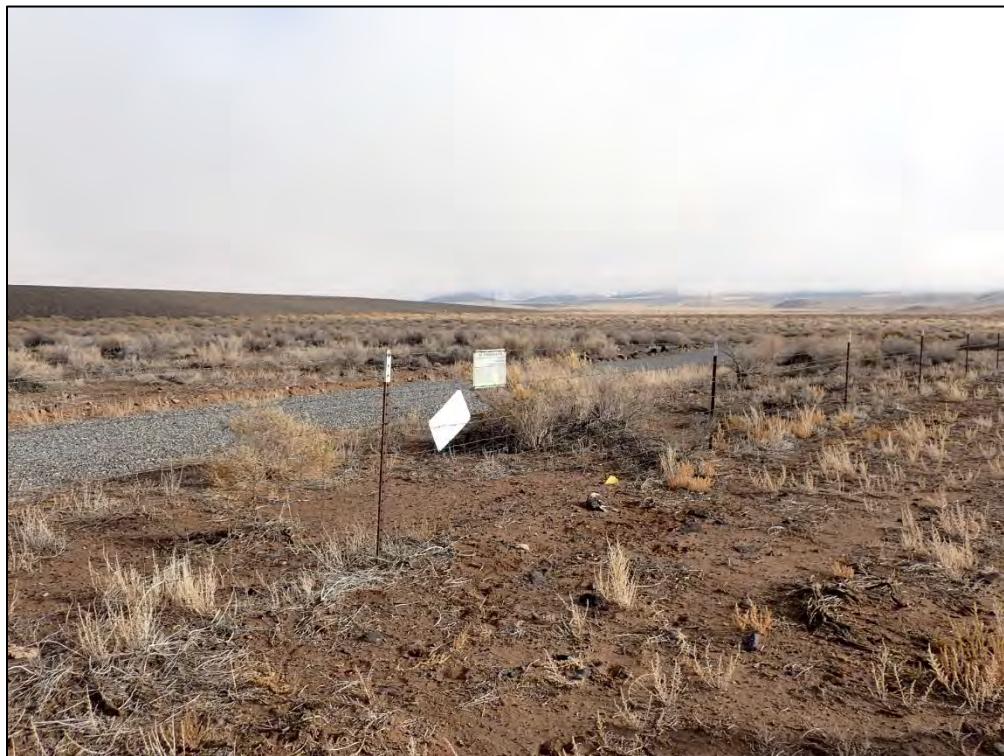
PL-4. Unsecured Perimeter Fence Sign

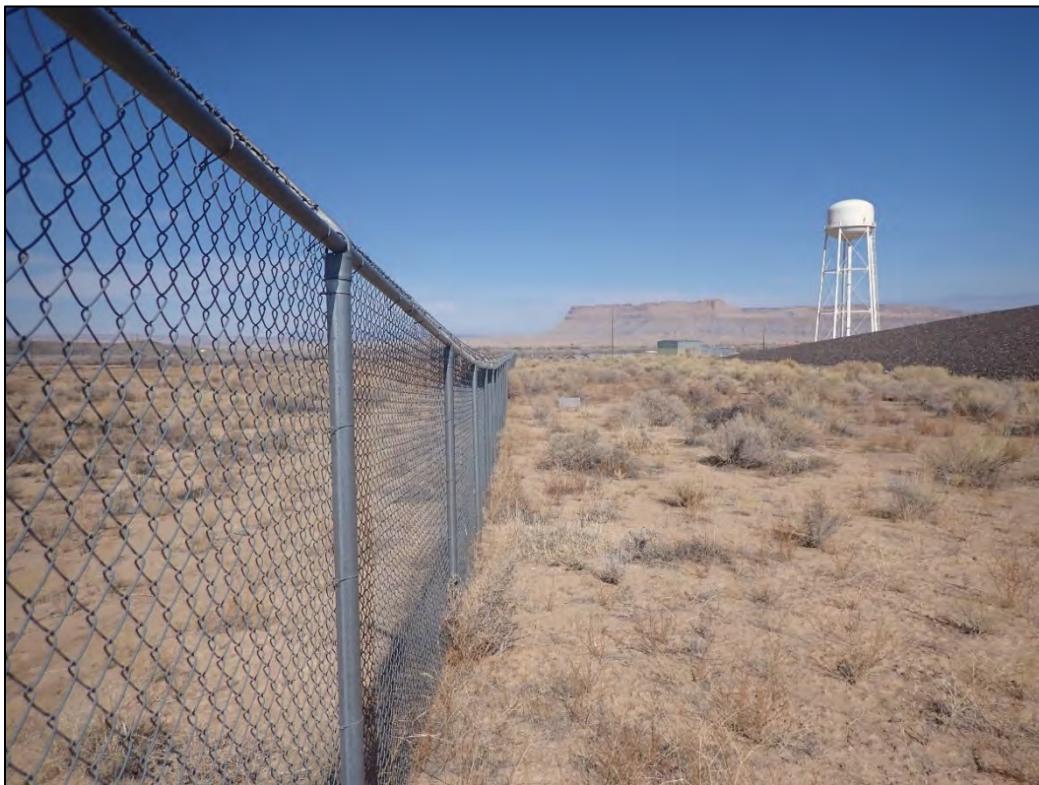
A chainlink security fence encloses the portion of the site that contains the disposal cell. Vehicle gates are at the south and east corners of the security fence, and a personnel gate is at the north corner of the security fence. The security fence (PL-1 and PL-2) was intact, and the gates were operable and locked at the time of the inspection.

PL-1. Chainlink Security Fence and Site Marker SMK-1 in Background

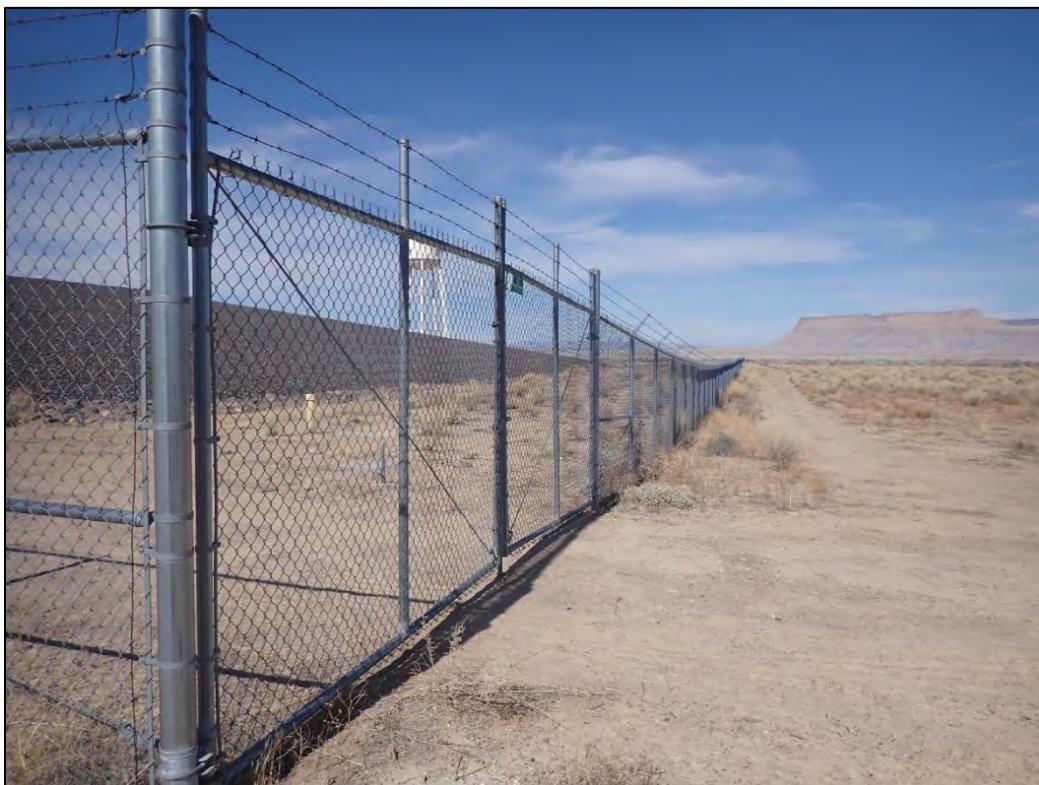
PL-2. East Vehicle Gate and Fence

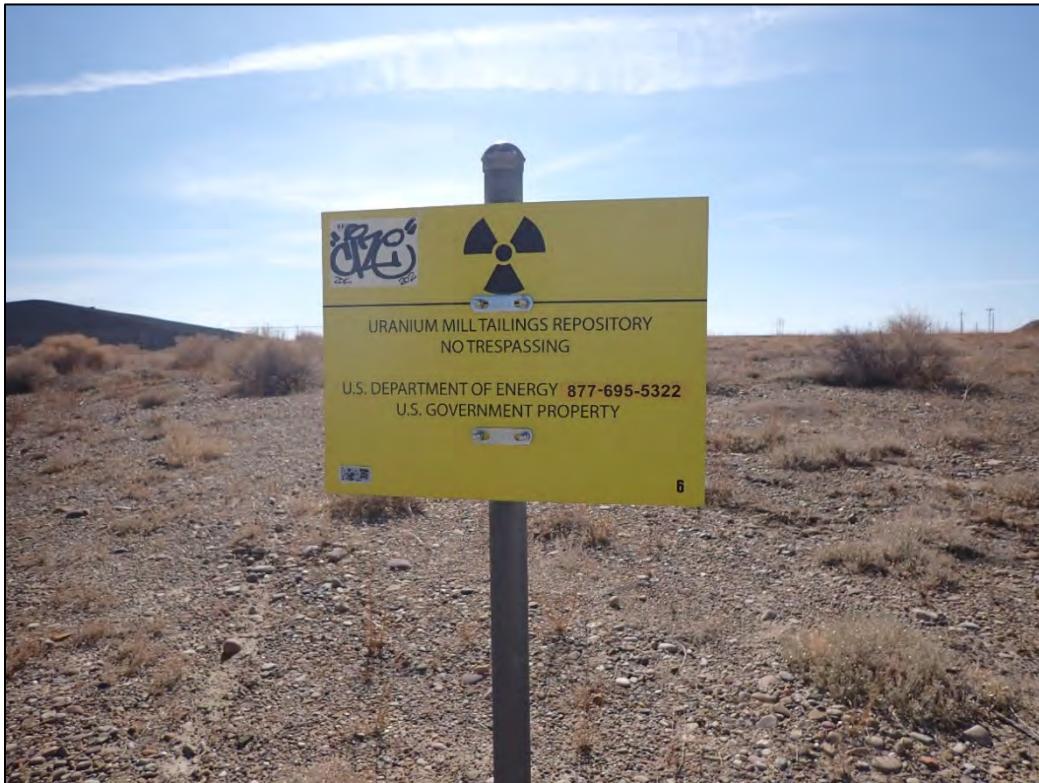
Seventeen perimeter signs, attached to steel posts set in concrete, are positioned along the unfenced property boundary. All perimeter signs were legible, although inspectors noted that perimeter sign P6 contained graffiti (PL-3). Because the sign is legible, it will not be replaced at this time.

PL-3. Graffiti on Perimeter Sign P6

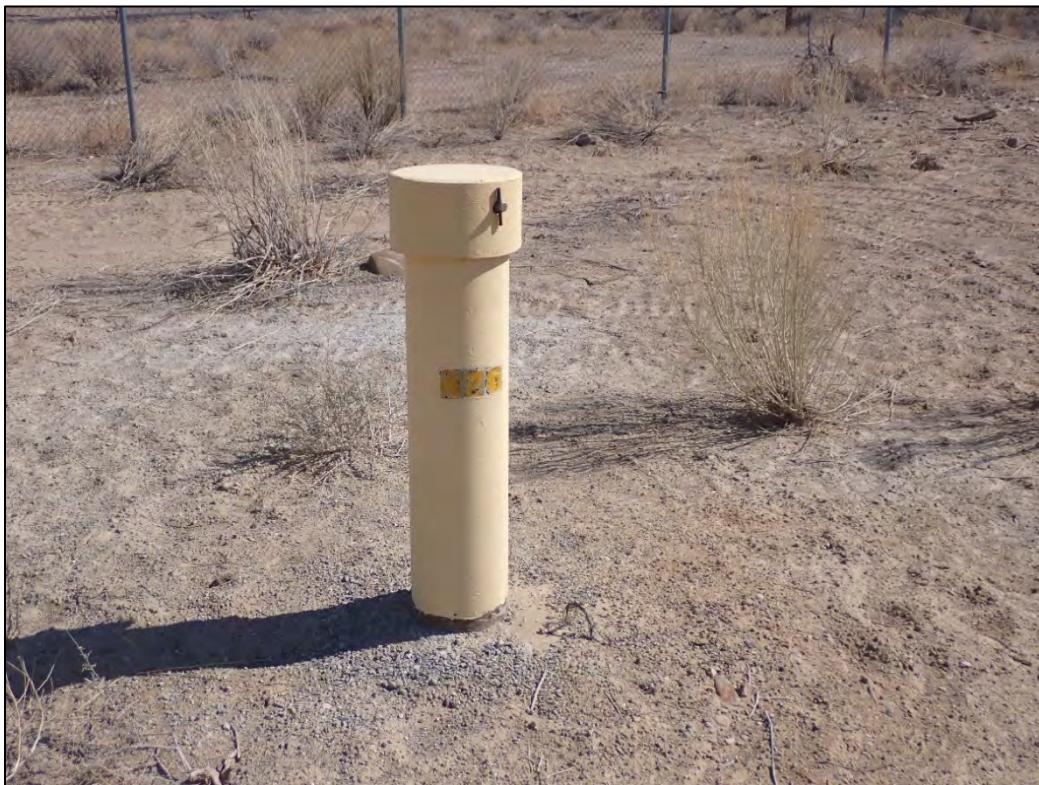
Twenty-two monitoring wells are on or near the site. The LTSP establishes four POC wells at the site for postclosure groundwater monitoring. All wellhead protectors observed during the inspection were undamaged and locked. Some of the concrete monitoring well collars were cracked, but the wellhead protectors were stable, and repairs are not necessary. Well identification numbers were faded or missing on several wells (PL-7). Well identification numbers will be reapplied before the next inspection.

PL-7. Faded Identification Numbers on Monitoring Well 0176

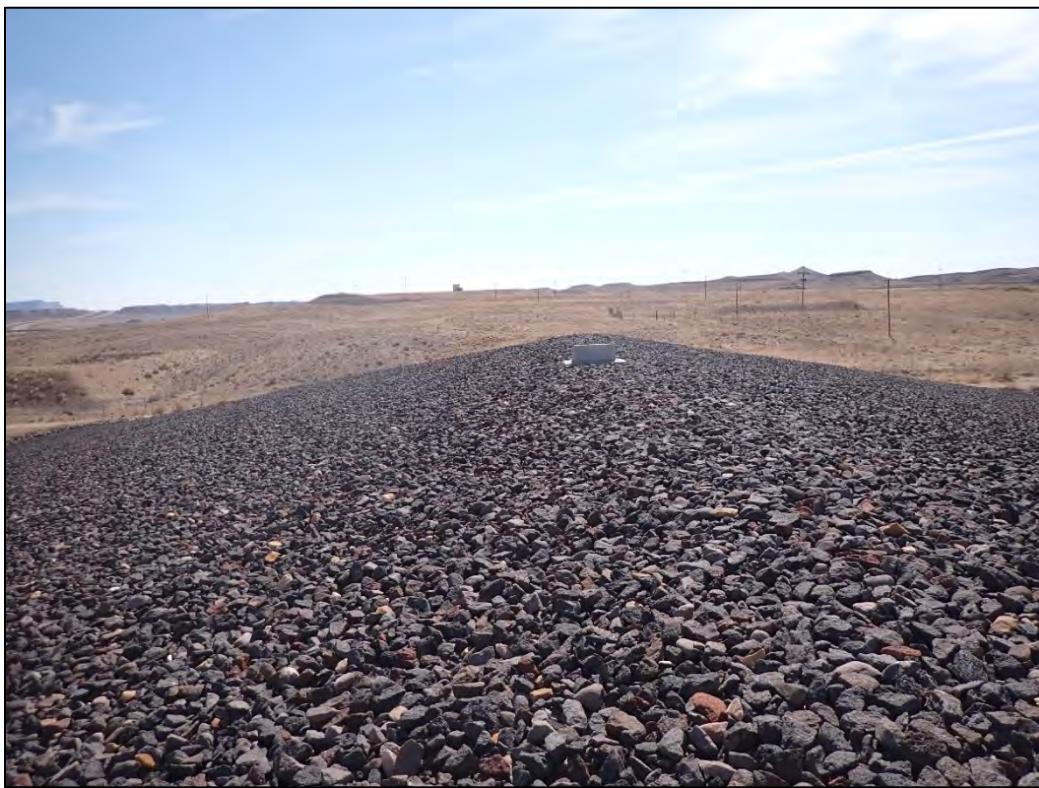
The disposal cell, completed in 1989, occupies 6 acres. The slopes of the disposal cell cover are armored with riprap, consisting primarily of competent basalt with a small fraction of sedimentary rocks, to control erosion. A small percentage of the rock, including basalt and sedimentary rock, has degraded, but the riprap cover is functioning as designed. Inspectors found no evidence of settling, slumping, erosion, or other modifying process that might affect the integrity of the disposal cell (PL-8, PL-9, and PL-10).

PL-8. Site Marker SMK-2 on Disposal Cell Top Slope

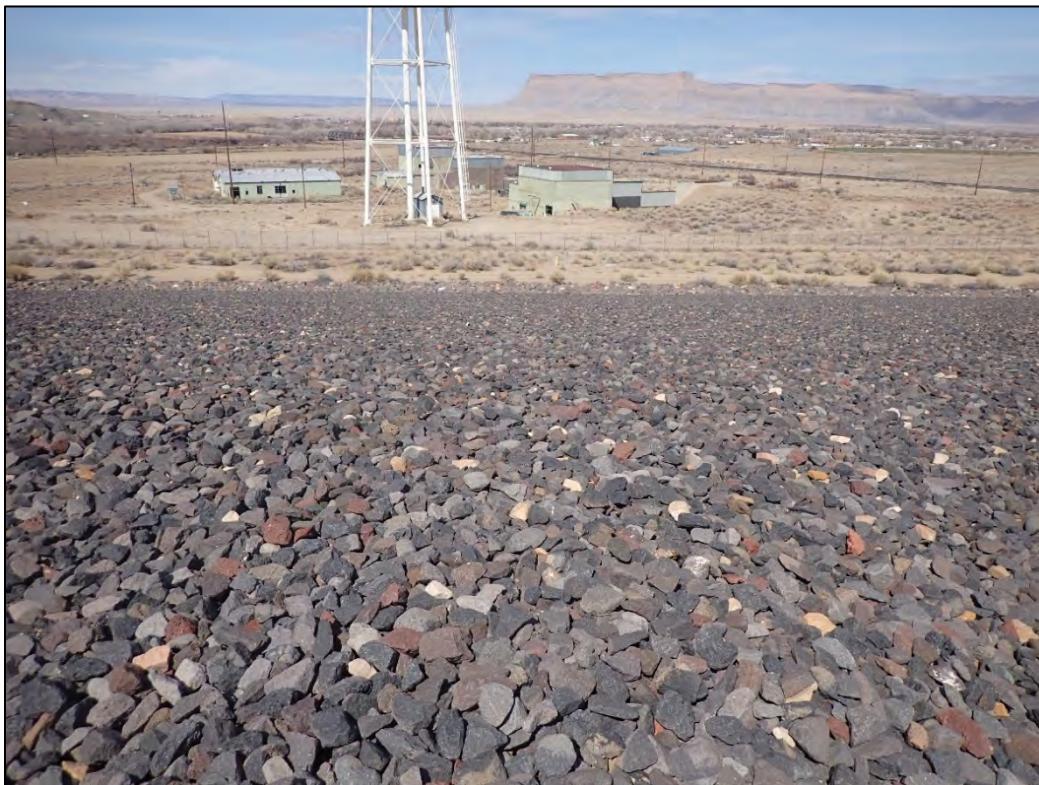
PL-9. Disposal Cell Northwest Side Slope

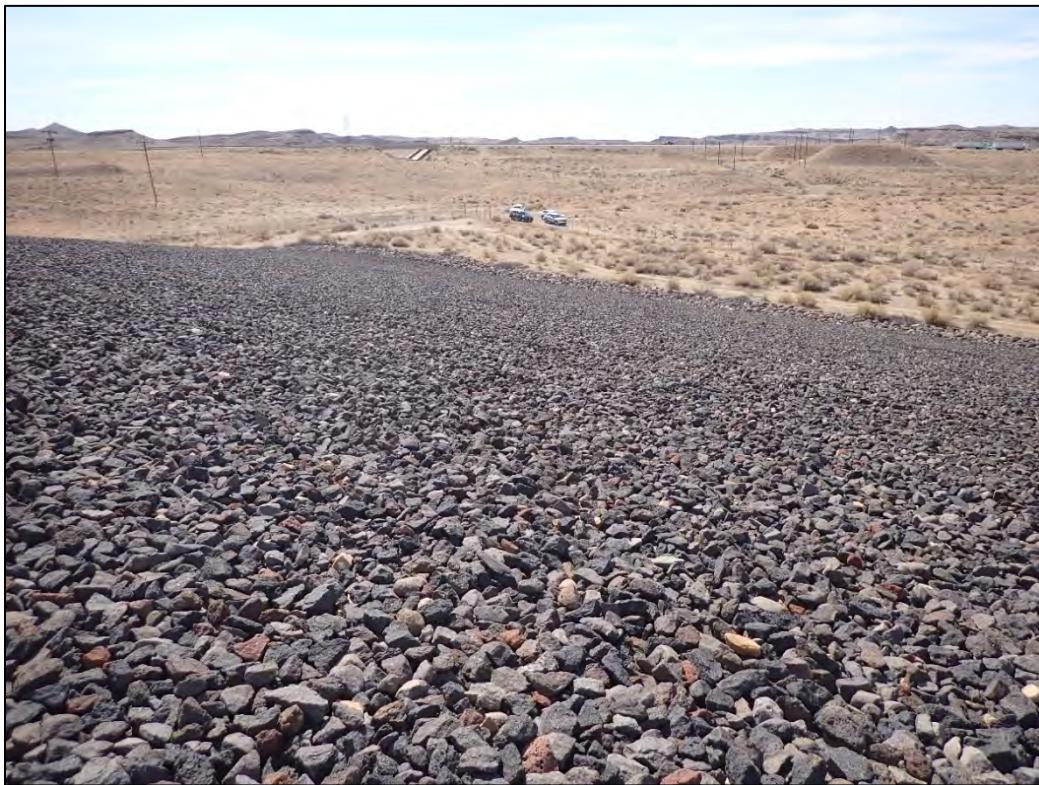
PL-10. Disposal Cell Southwest Side Slope

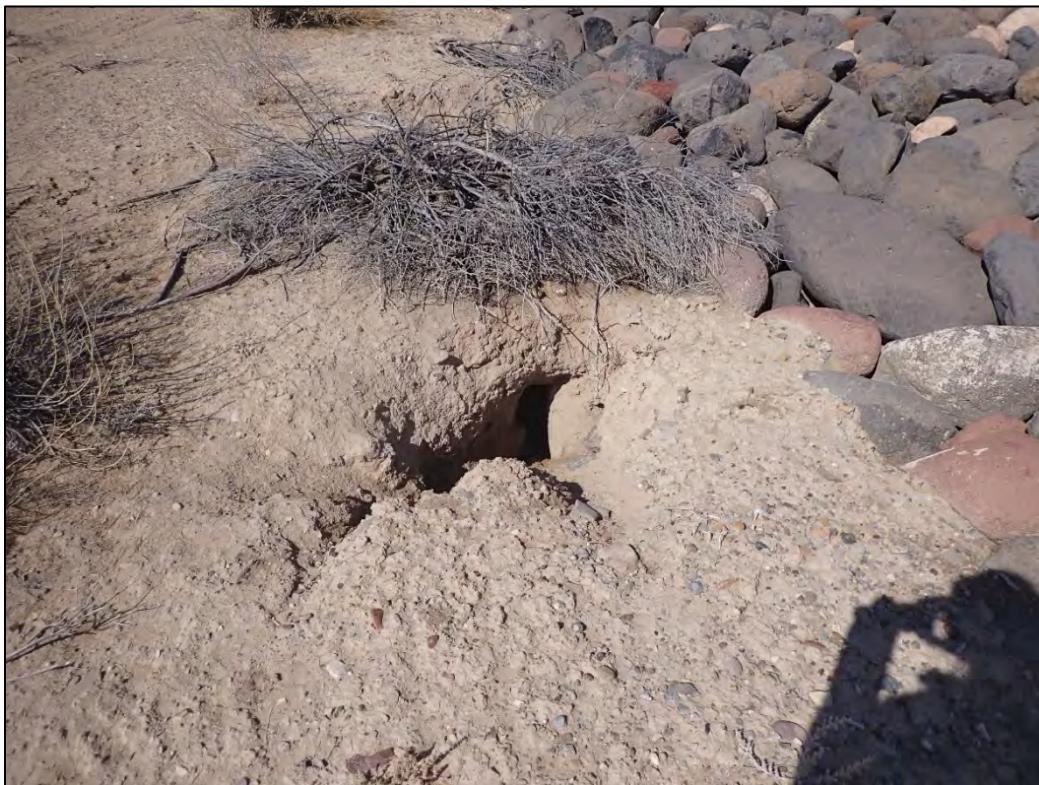
PL-11. Soil Piping on Edge of Rock Apron

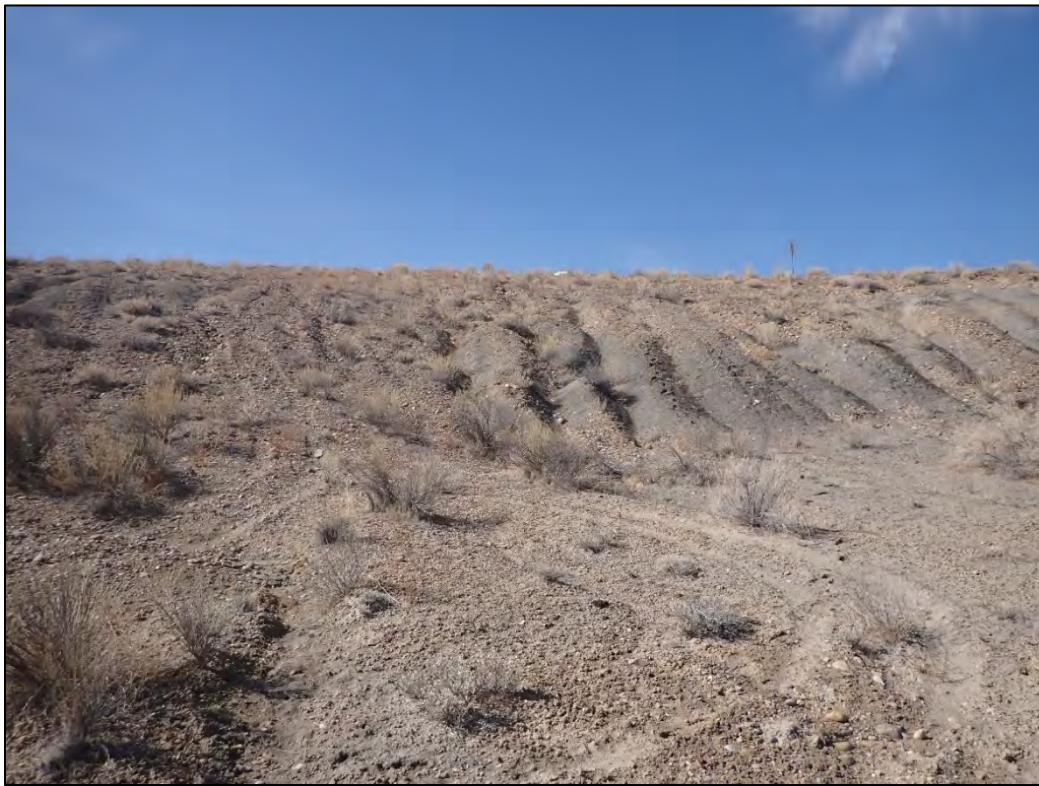
PL-12. Soil Erosion by Boundary Monument BM-7 (Offsite)

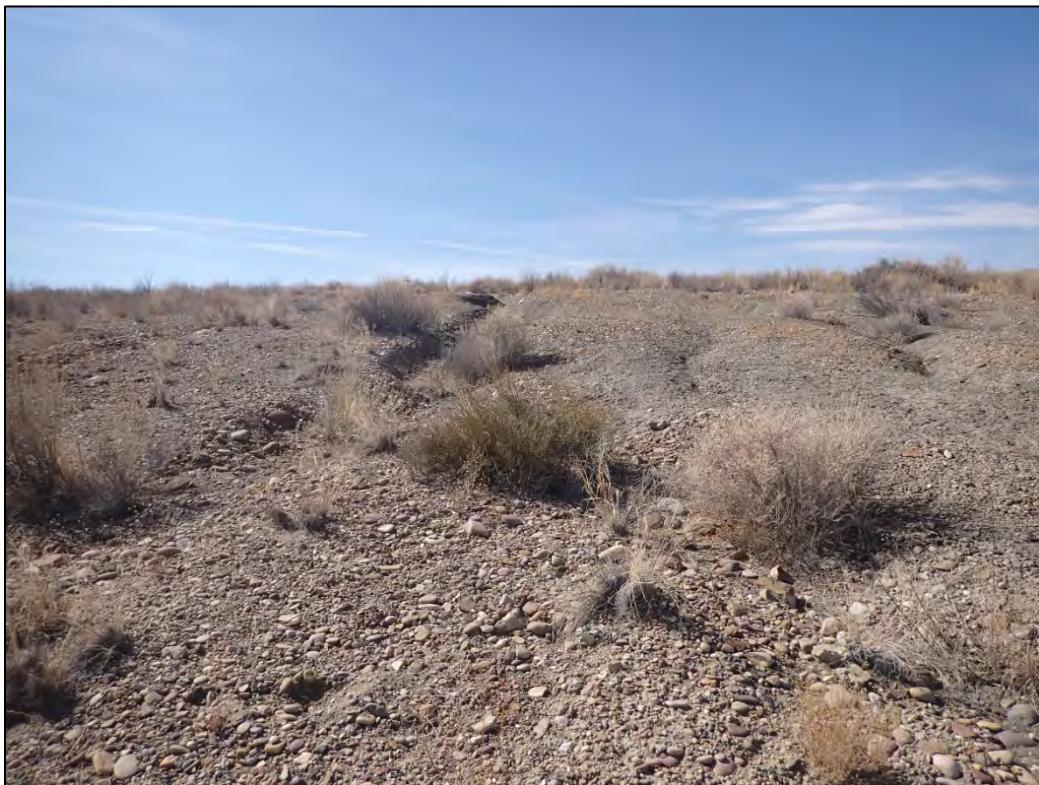
PL-13. Soil Erosion by Boundary Monument BM-8 (Onsite)

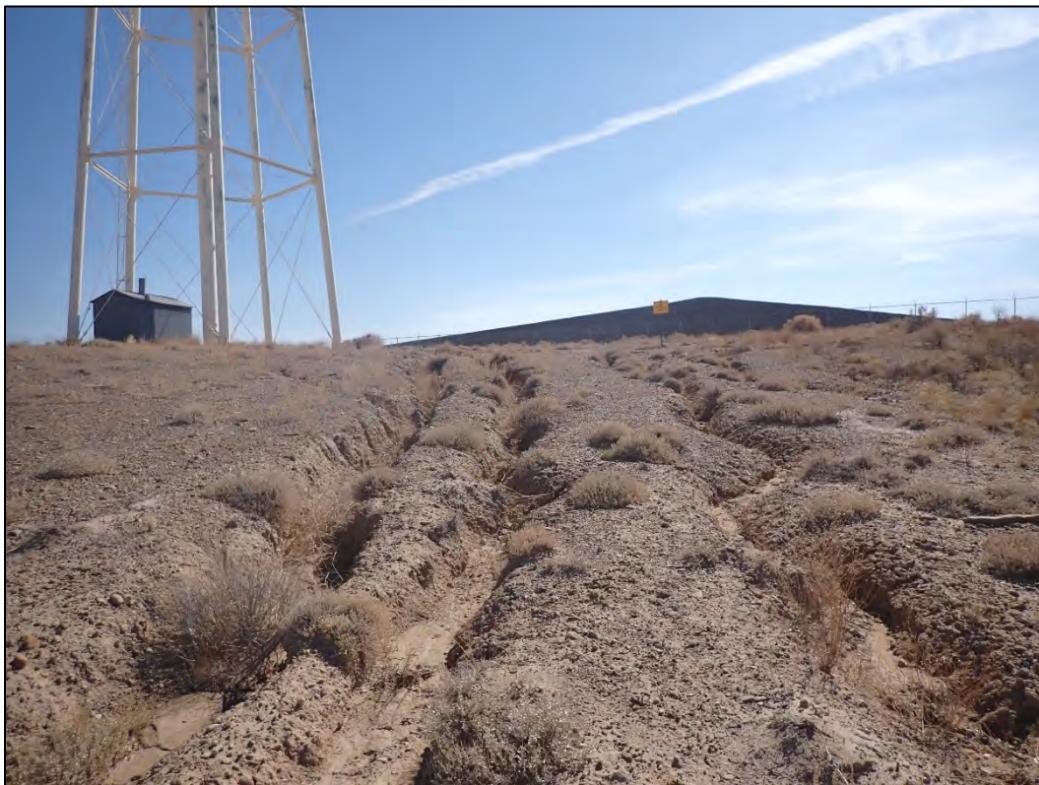
Areas of erosion noted during previous inspections include the natural drainage near the southwest side of the site and rills and gullies northwest of the water tower (PL-15). Evidence of continued erosion in these areas was apparent but does not threaten the integrity of the disposal

PL-15. Soil Erosion (Offsite)

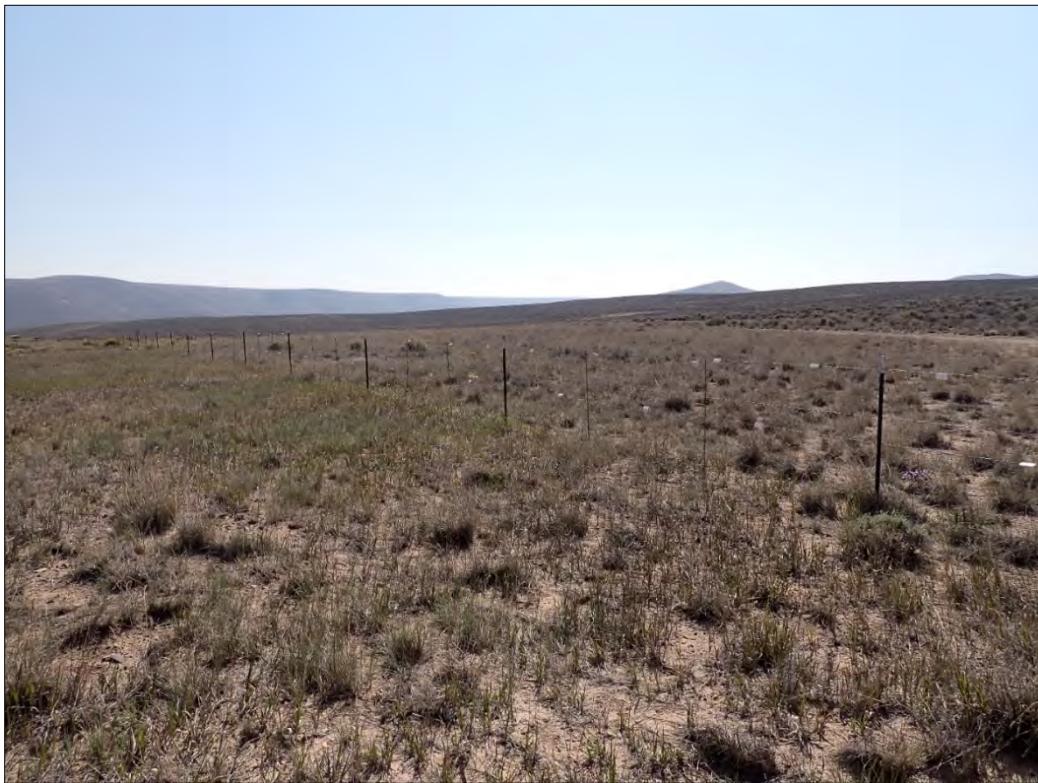
PL-1. Southeast Perimeter Fence with Flagging

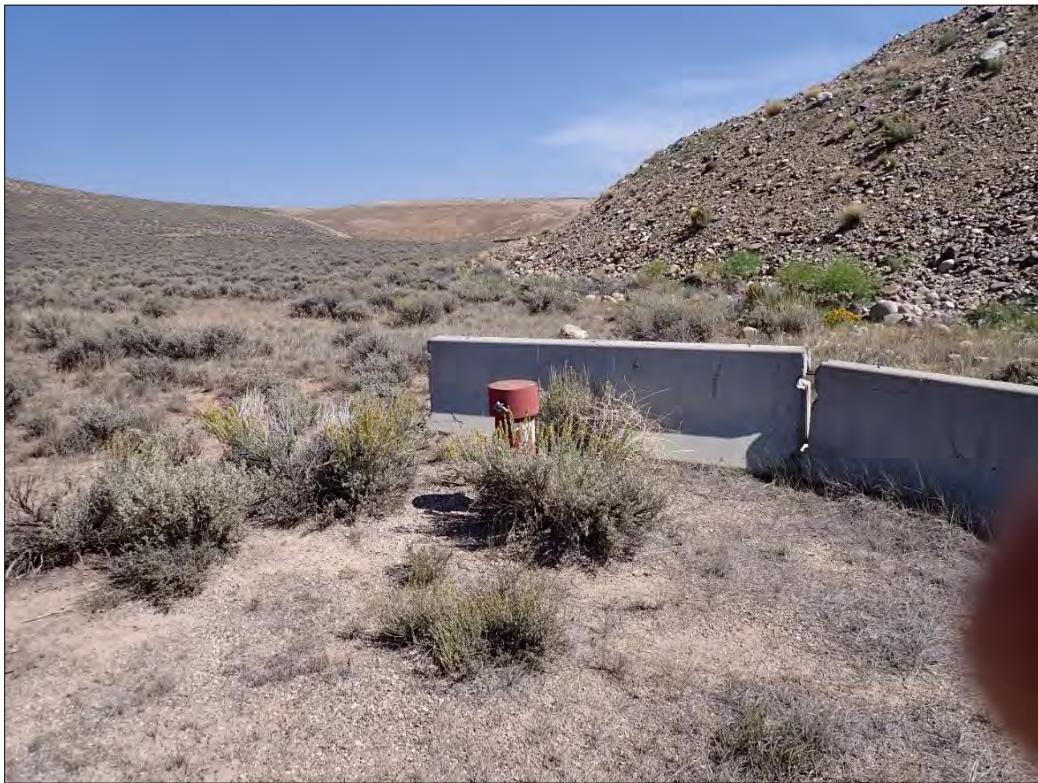
Gunnison County owns the land that adjoins the site boundary to the north and east and uses the land for a municipal landfill. The nearest landfill operations continue to be approximately 400 feet north of the site. Although landfill activities do not affect the site, inspectors will continue to monitor the level of activity occurring near the site boundary and surveillance features (e.g., fences and monitoring wells). With regard to groundwater flow, the landfill operations are cross gradient from the disposal cell. The only current concern for activities that could affect a site asset is a spoil pile near monitoring well 0716 (Figure 8-1 and PL-3). Inspectors will continue to monitor this area. No other maintenance needs were identified.

PL-3. Well 0716 Overgrown with Vegetation and Nearby Spoil Pile

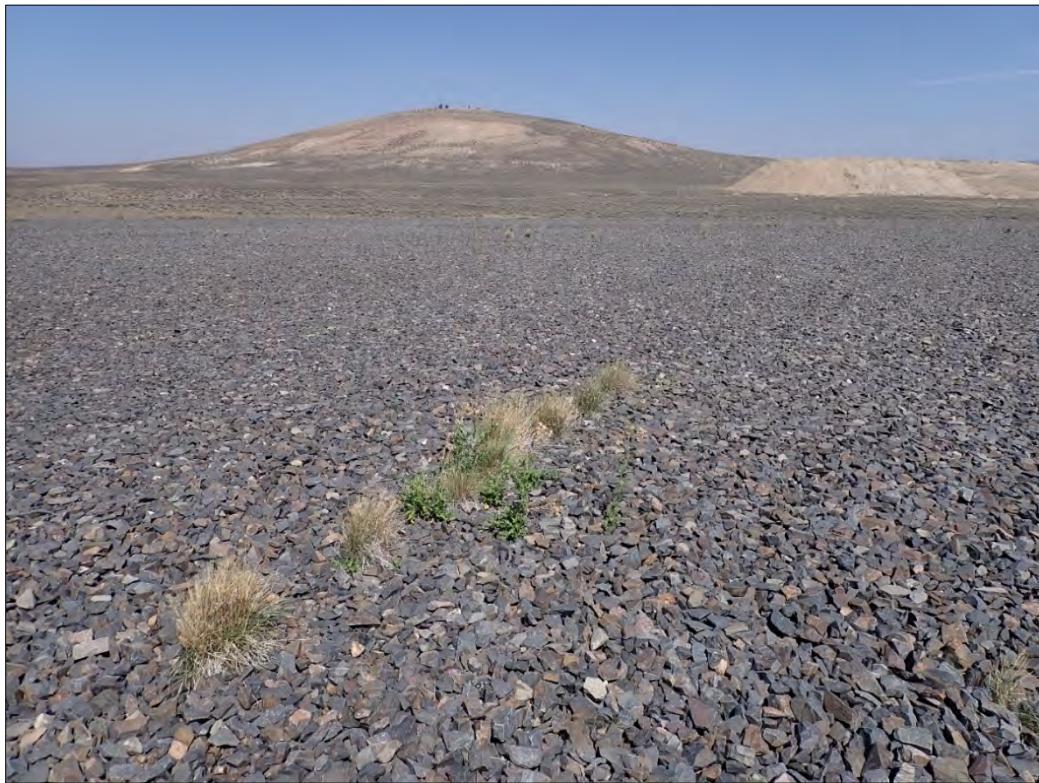
PL-5. Vegetation on Disposal Cell Top Slope

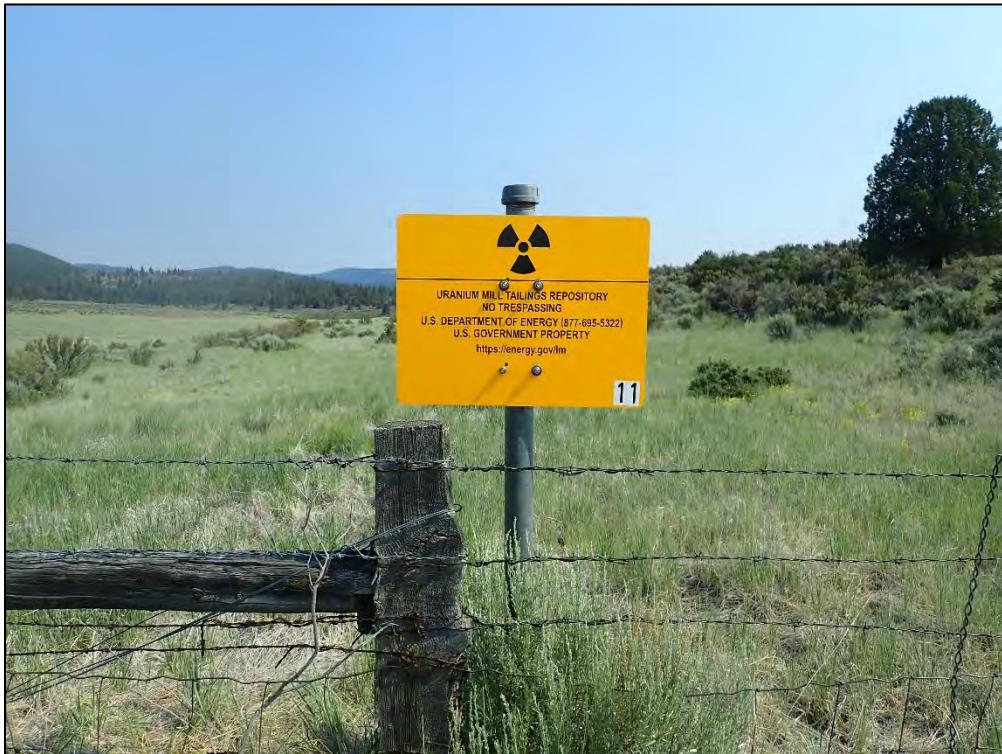
- Removed broken T-post at well 0516
- Replaced faded perimeter signs P10, P11, P12

PL-3. New Perimeter Sign P11

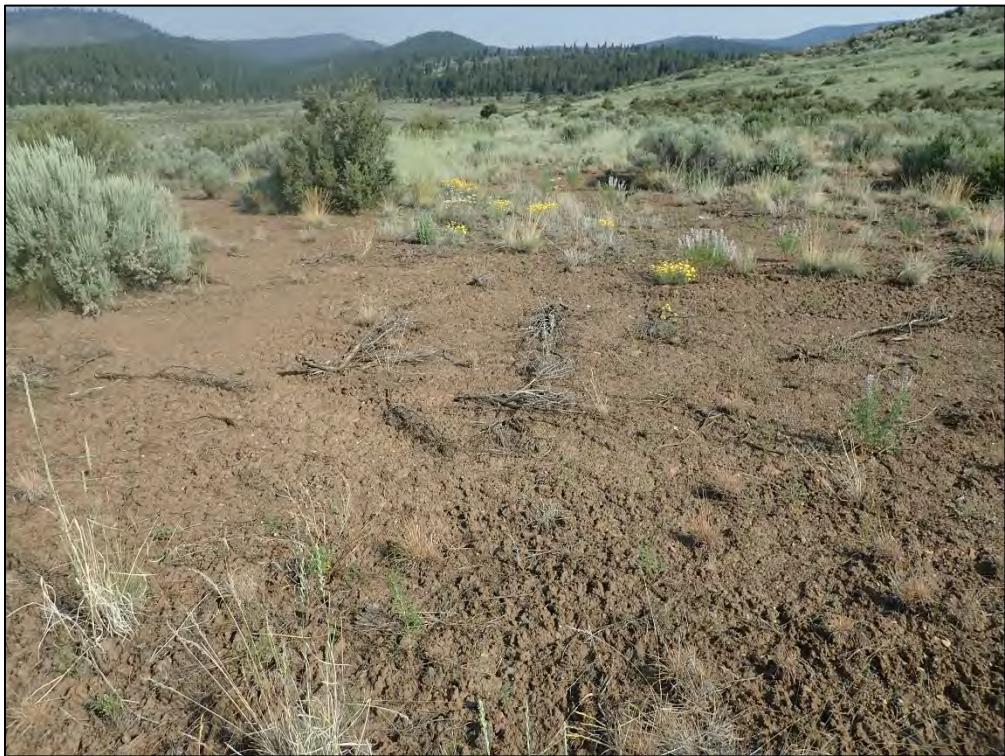
PL-10. Reclamation of 2018 Soil Cover Study Test Area

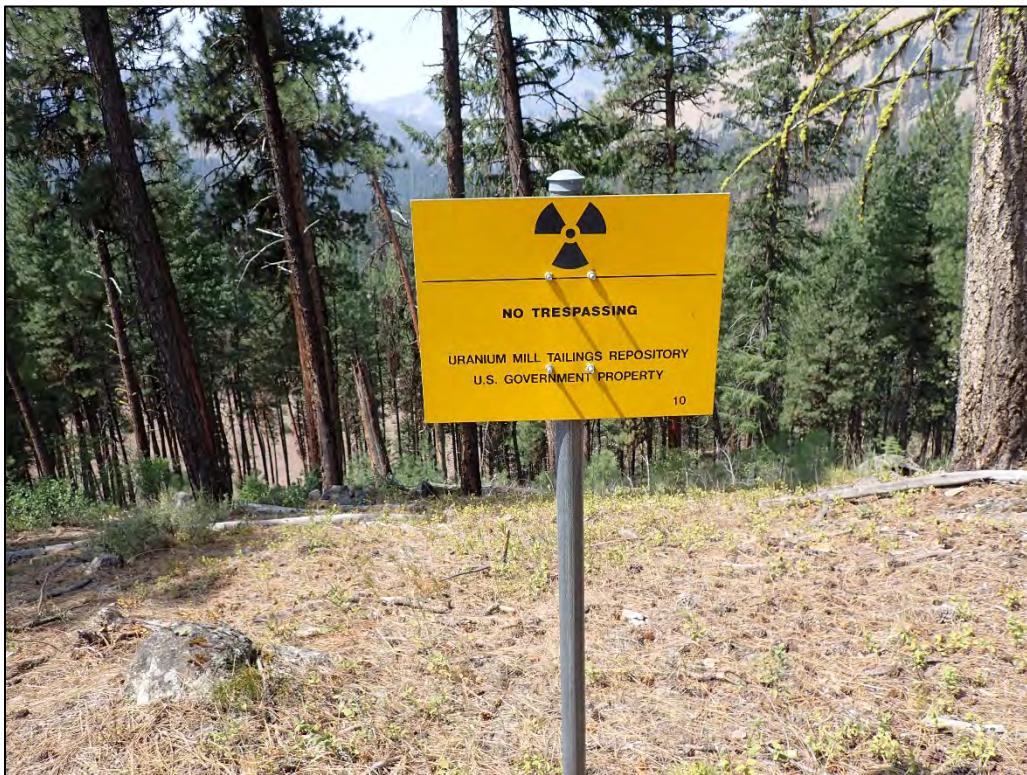
PL-2. Perimeter Sign P10

There are 18 perimeter signs attached to steel posts set in concrete positioned along the unfenced property boundary (PL-2). Several perimeter signs (P2, P3, P4, P13, and P15) have bullet damage but remain legible. Perimeter sign P3 was rotated about 90 degrees from its original position but was repaired during the inspection. Perimeter sign P7 is slightly bent from tree fall but remains legible. No maintenance needs were identified.

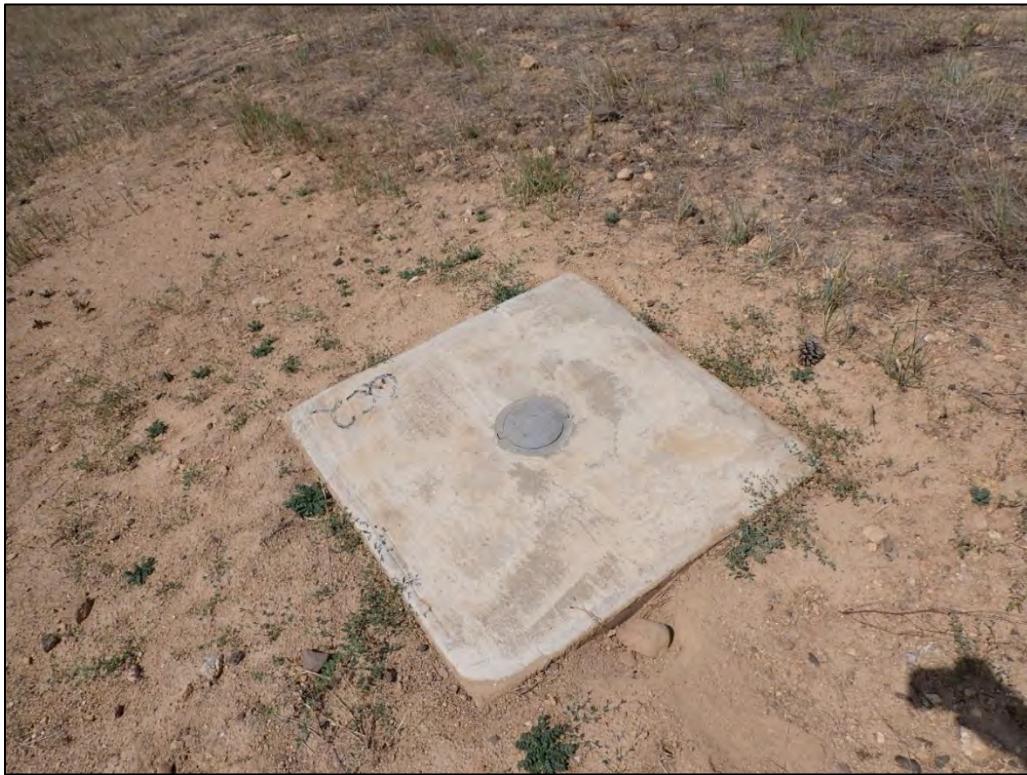
PL-4. Quality Control Monument QC-2

Three aerial survey quality control monuments, installed in October 2020, provide ground truth for aerial surveys at the site (PL-4). The quality control monuments were inspected during the 2021 annual inspection. No maintenance needs were identified.

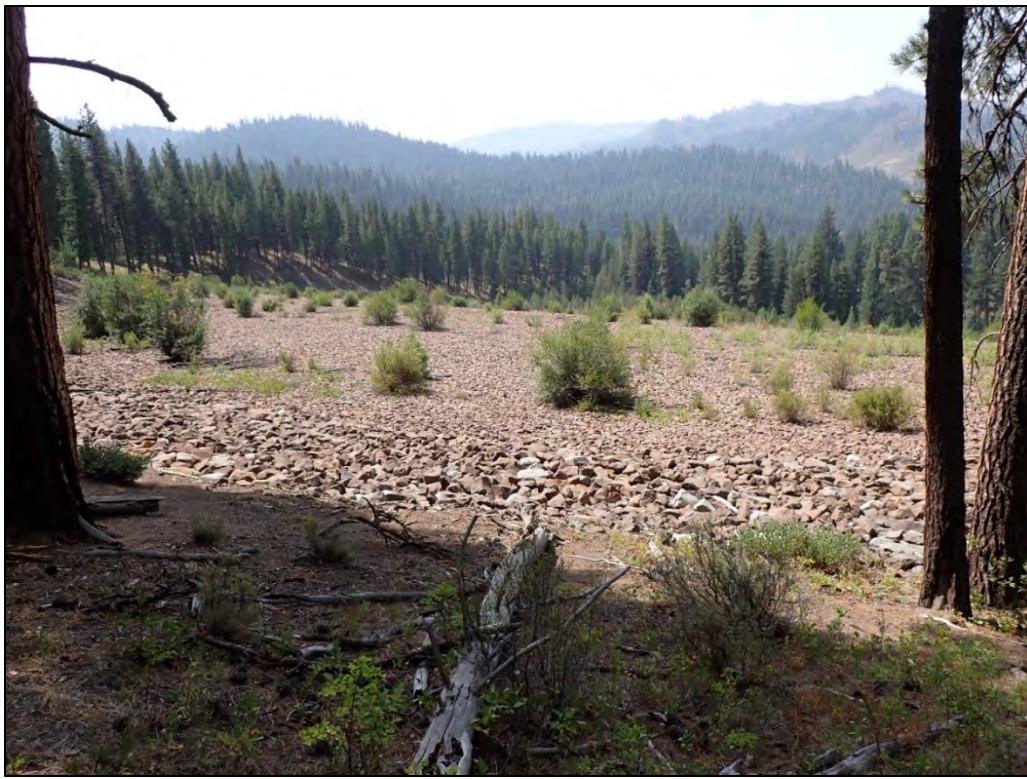
PL-5. Disposal Cell Cover

Natural vegetation continues to encroach on the top and side slopes of the disposal cell. Although the LTSP states that control of vegetation growth on the cell is not needed, LM concluded that controlling the growth of conifers—primarily ponderosa pine—would be a best management practice. Unlike the shrubs and other vegetation growing on the disposal cell, mature conifers could potentially become uprooted during windstorms and damage the surface of the disposal cell. Numerous ponderosa pine trees were observed on the disposal cell top and side slopes and were cut down and left in place in September 2018. Other plants growing on the disposal cell were not removed, as they do not present a physical threat to the integrity of the disposal cell (PL-5). No maintenance needs were identified.

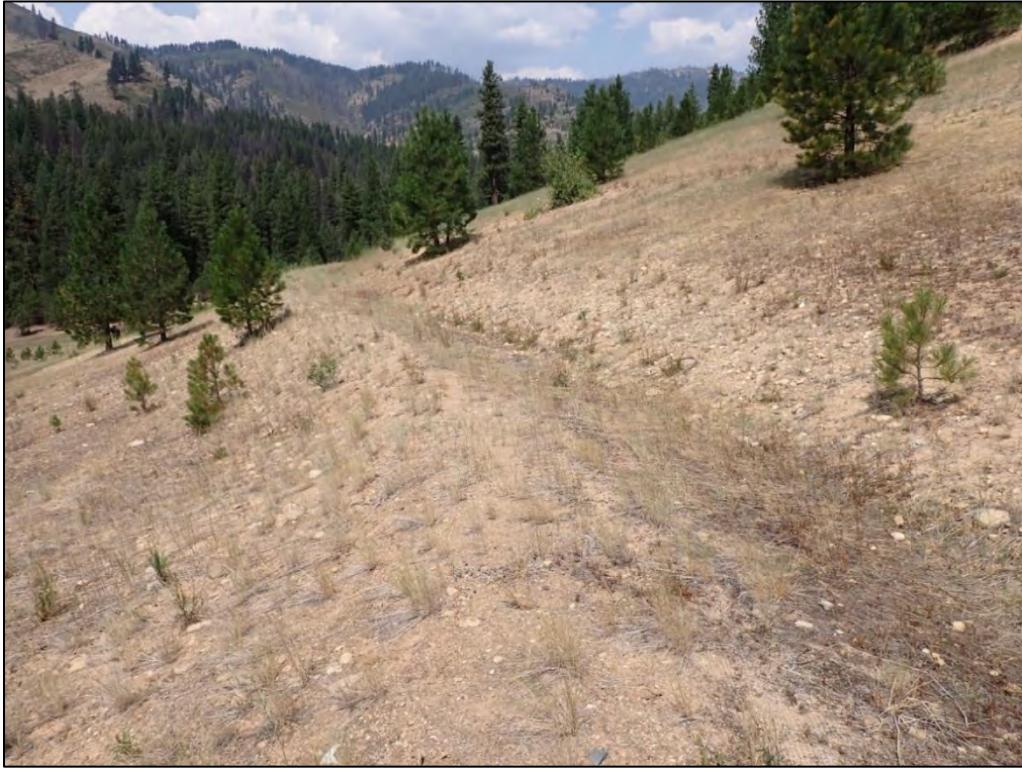
intercept stormwater runoff and route it offsite into Clear Creek. Over the years, minor erosion has breached the benches in several locations, and LM has repaired such erosion on numerous occasions, most recently in October 2016. The three interceptor benches (PL-7) and a collection ditch are inspected annually to ensure that erosion in this area does not affect overall site stability. During this year's inspection, the 2016 repairs appeared intact, and LM will continue to monitor the area as the vegetation continues to establish.

PL-7. Interceptor Bench 2

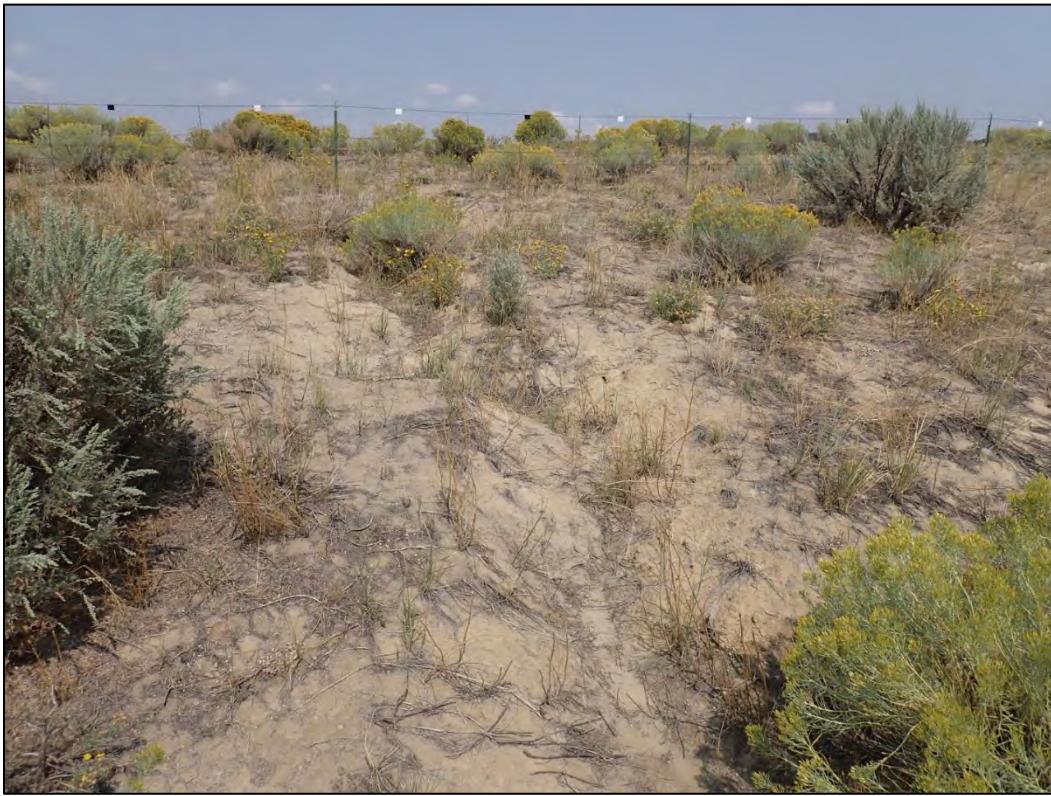
PL-3. Perimeter Fence Line

To facilitate LM's land management, a four-strand barbed-wire perimeter fence encloses the disposal cell, drainage structures, and much of the site. The site is in wintering grounds frequented by big-game animals (primarily pronghorn, deer, and elk) and is also surrounded by open range used to graze cattle. Minor damage to the perimeter fence from animal contact periodically occurs. On July 27, 2021, plastic fence flags were attached to the top strand of the perimeter fence to alert wildlife and reduce animal entanglements or strikes against fence lines (PL-3).

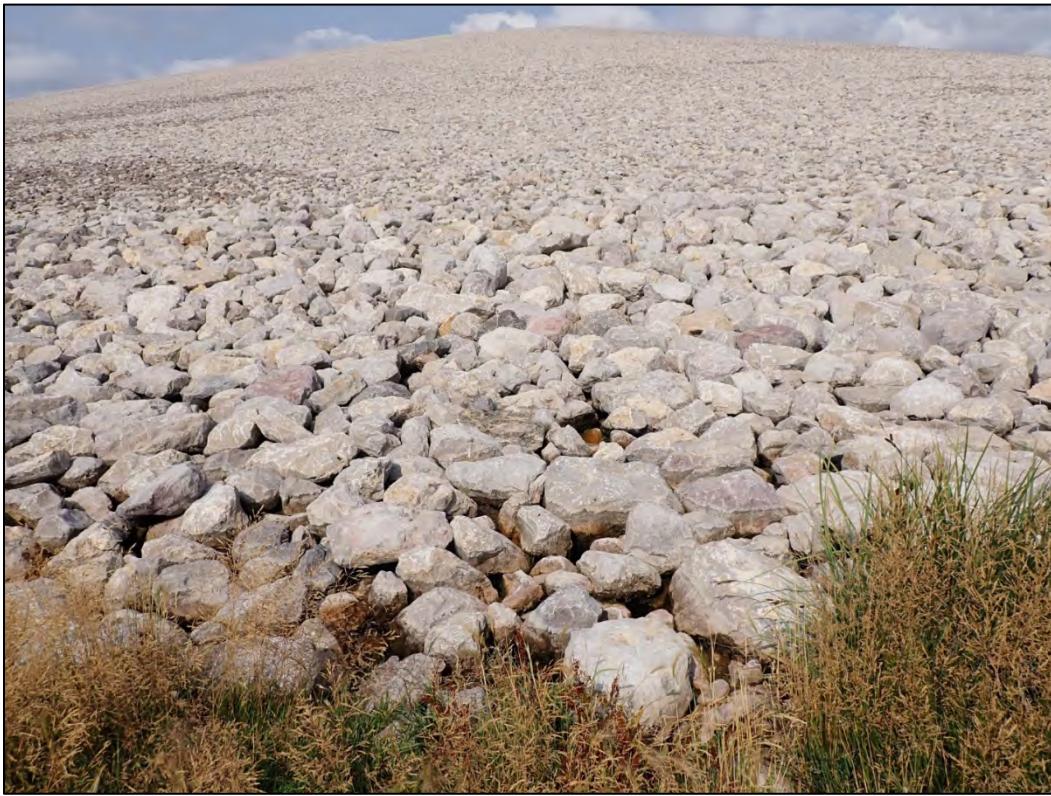
The Maybell, Colorado, Uranium Mill Tailings Radiation Control Act (UMTRCA) Title I Disposal Site was inspected on September 2, 2021. Standing water was observed in the disposal cell apron on the eastern toe slope. Inspectors identified several minor maintenance needs but found no cause for a follow-up inspection. Groundwater monitoring is not required.

PL-9. Standing Water in Side Slope Apron

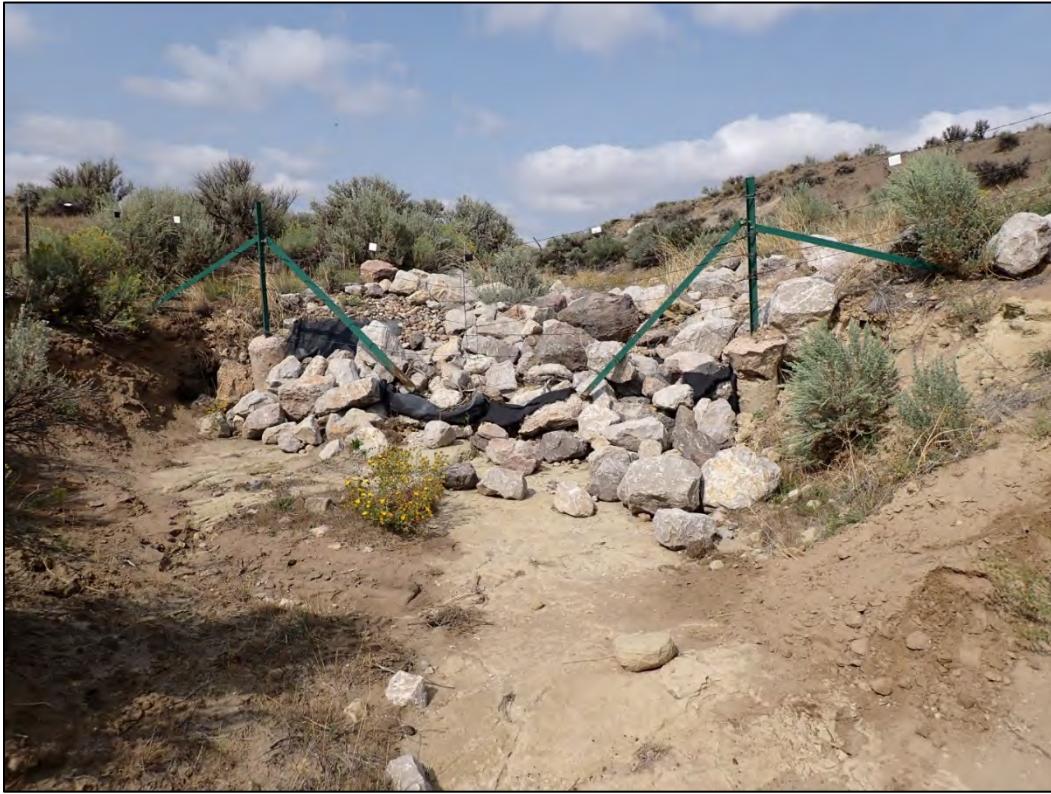
PL-12. Exposed Geofabric in Diversion Channel No. 1 Outlet

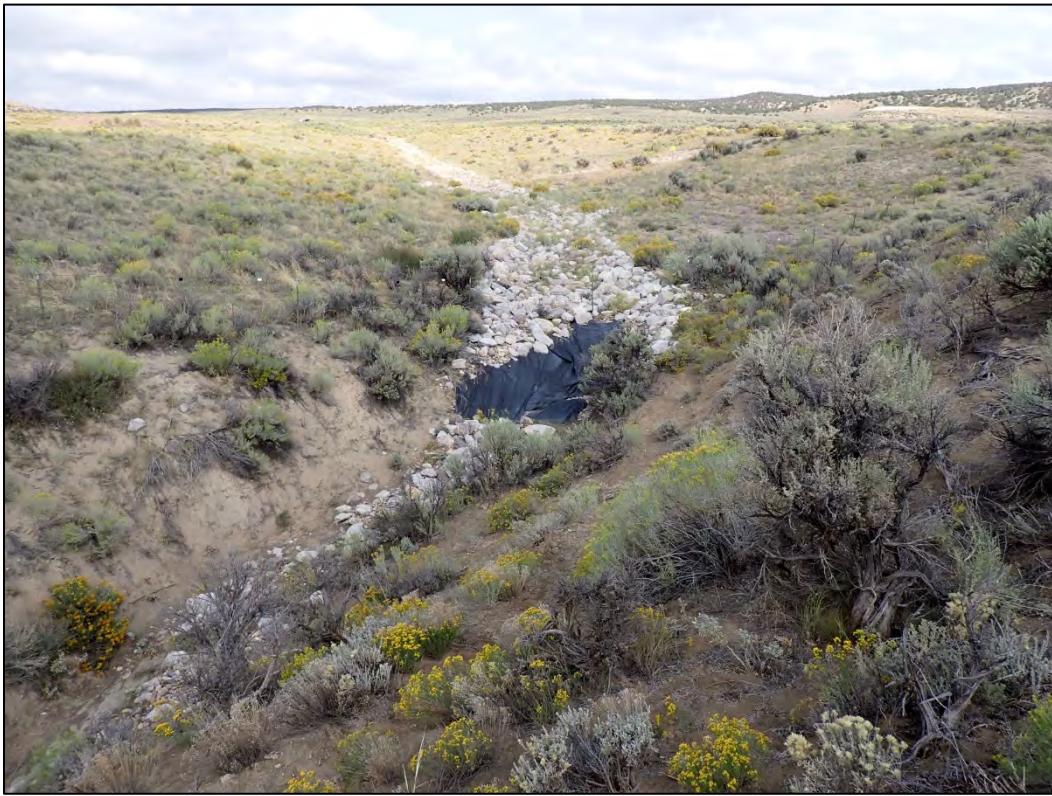
PL-13. Exposed Geofabric in Swale No. 1 Outlet

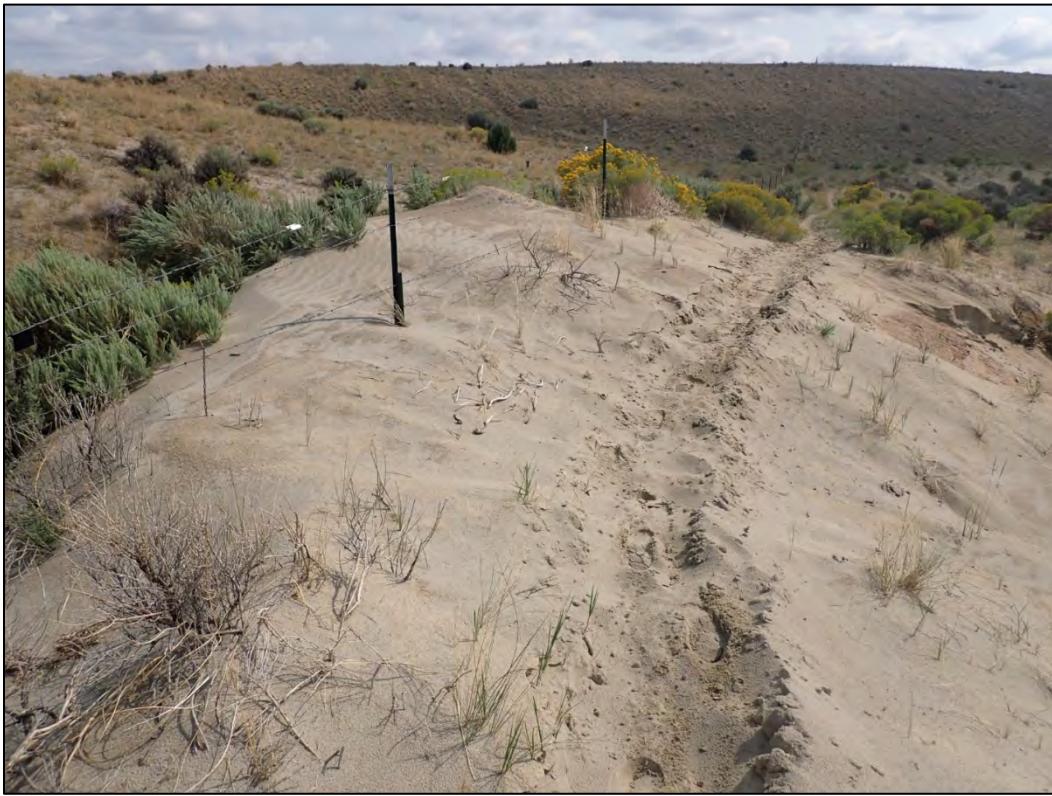
PL-15. Sand Accumulation Along Southern Fence Line Near Johnson Pit
