**U.S. DEPARTMENT OF
ENERGY**

2021 Annual Site Inspection and Monitoring Report for Uranium Mill Tailings Radiation Control Act Title I Disposal Sites

March 2022

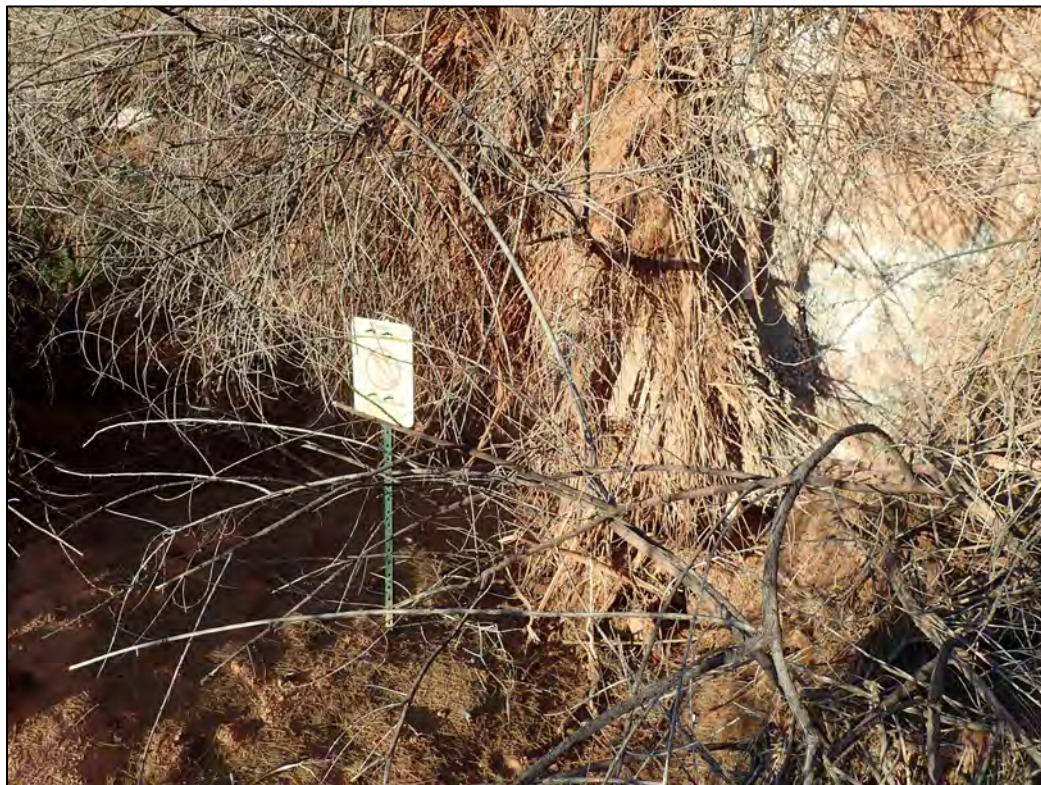
PL-1. Seep 0248

Since 2010, groundwater discharge from seeps had been observed at cross-gradient seep 0248, which typically exhibits dripping conditions; however, during the 2021 inspection seep 0248 was dry. Upgradient (background) seep 0261 (PL-5) was observed to be dripping during the inspection; it is approximately 0.5 mile upstream of seep 0248 in Gypsum Creek.

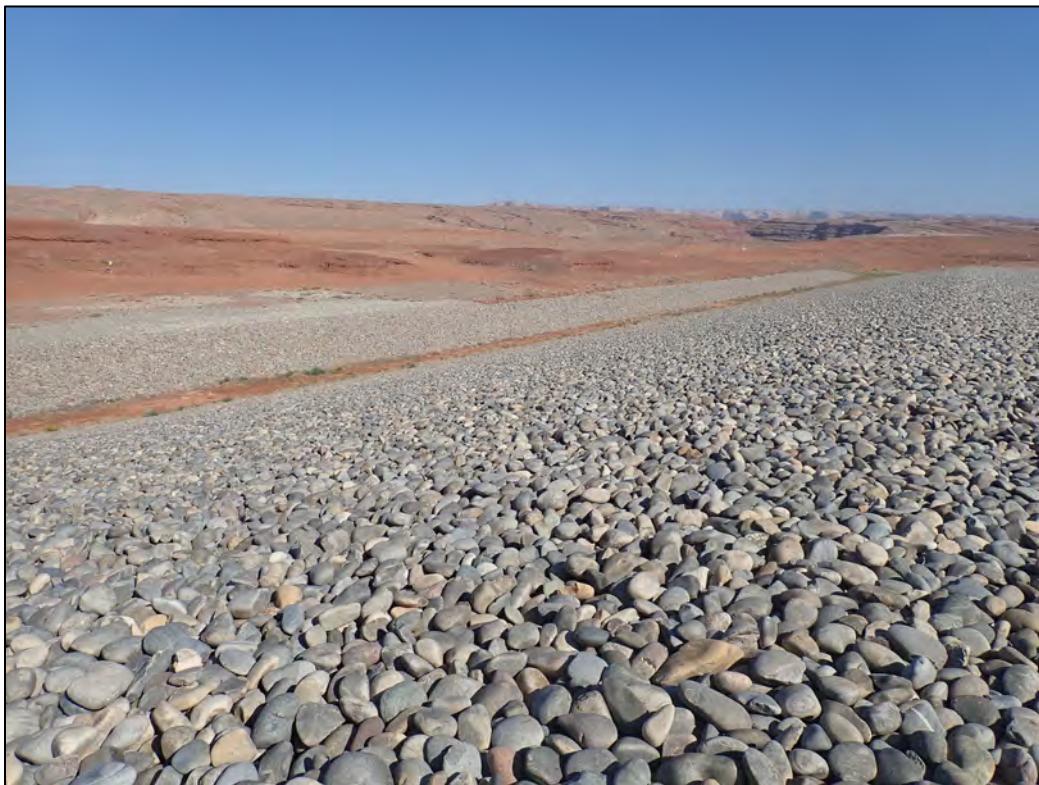
PL-14. Sloughed Rock

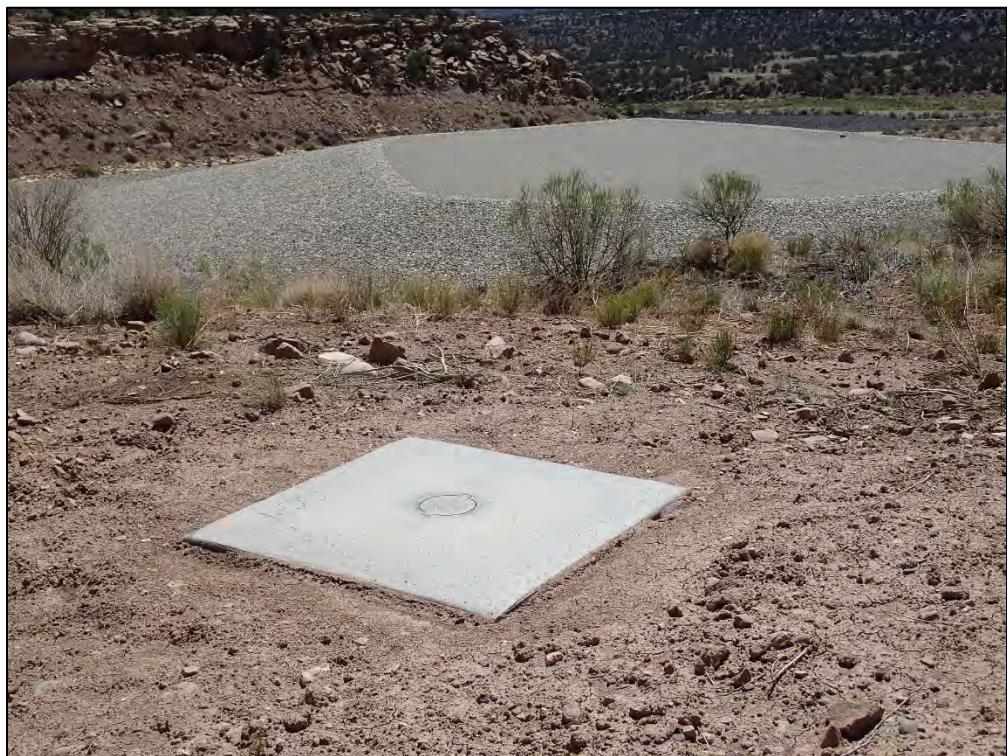
PL-4. Aerial Survey Quality Control Monument QC-4

Four aerial survey quality control monuments were installed before the 2021 inspection (PL-4). No maintenance needs were identified.

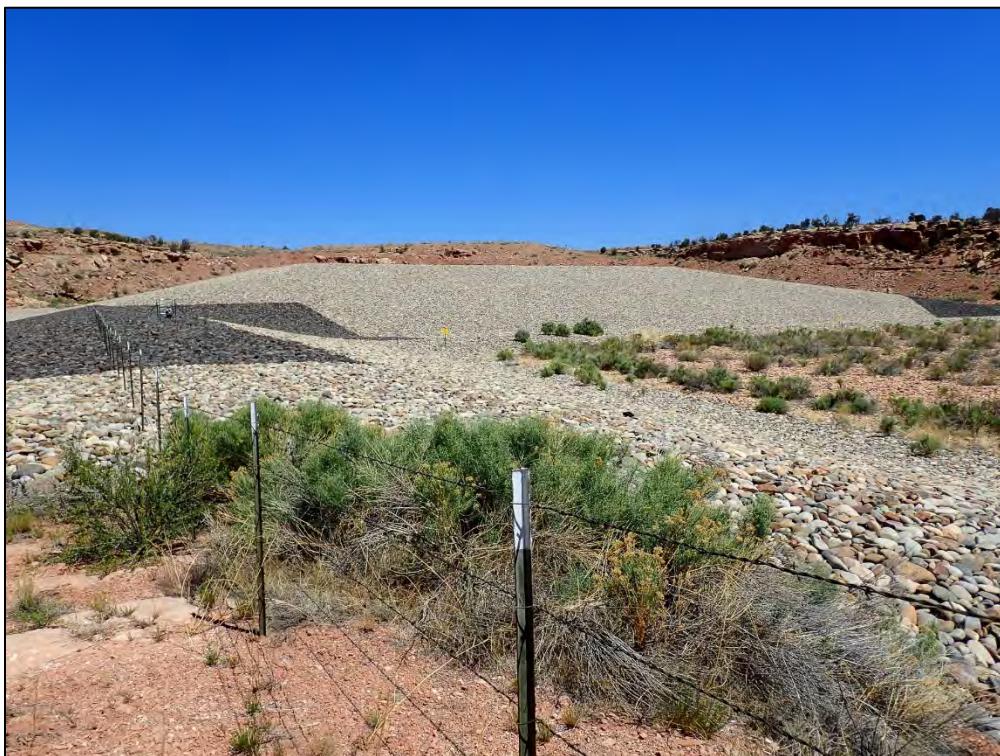
PL-6. Disposal Cell

The disposal cell, completed in 1998, occupies 10 acres (PL-6). The disposal cell is armored with riprap to control erosion. The riprap is rounded, with larger diameter rock on the side slopes versus on the top slope. There was no evidence of settling, slumping, erosion, rock degradation, or other modifying processes that might affect the integrity of the disposal cell.

Irregularities in the riprap on the top slope of the disposal cell continue to be observed. The irregularities consist of slightly darker rock that are not lower than surrounding areas and have not changed over time. Another irregularity in the apron area on the west side of the disposal cell appears to be old vehicle tracks. The irregularity does not present a threat to the disposal cell or surrounding area. Inspectors will continue to monitor these areas for potential impacts. No maintenance needs were identified.

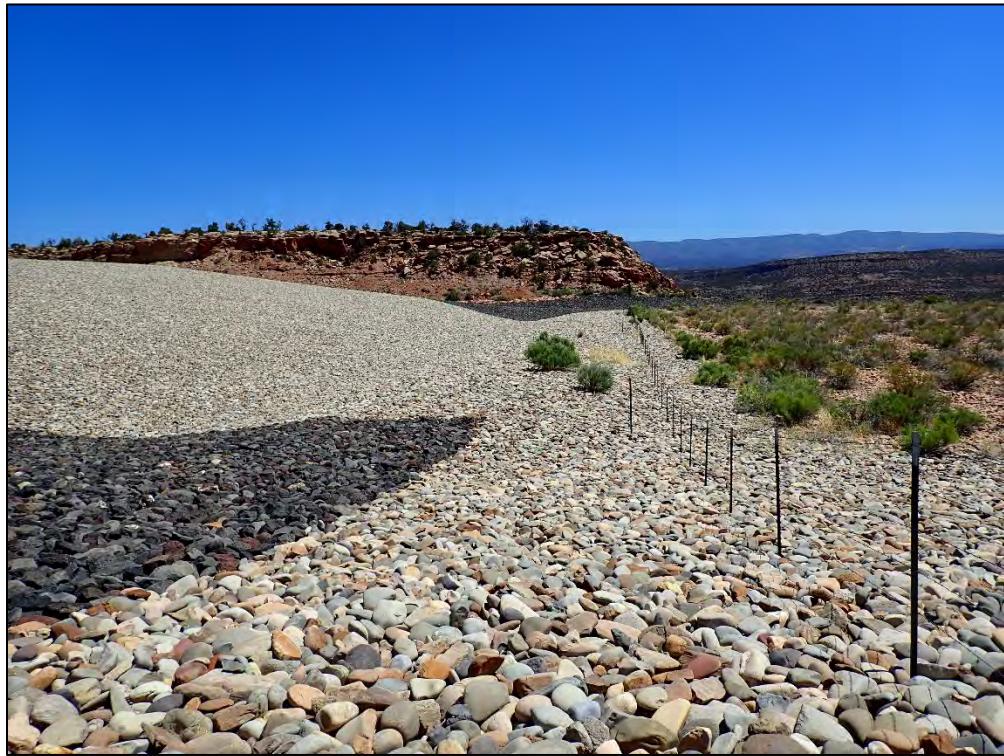
PL-7. Vegetation Growing near Southern Fence Line

- Treated vegetation growing in the fence line near perimeter sign P6
- Repaired detached fence bracket near perimeter sign P6

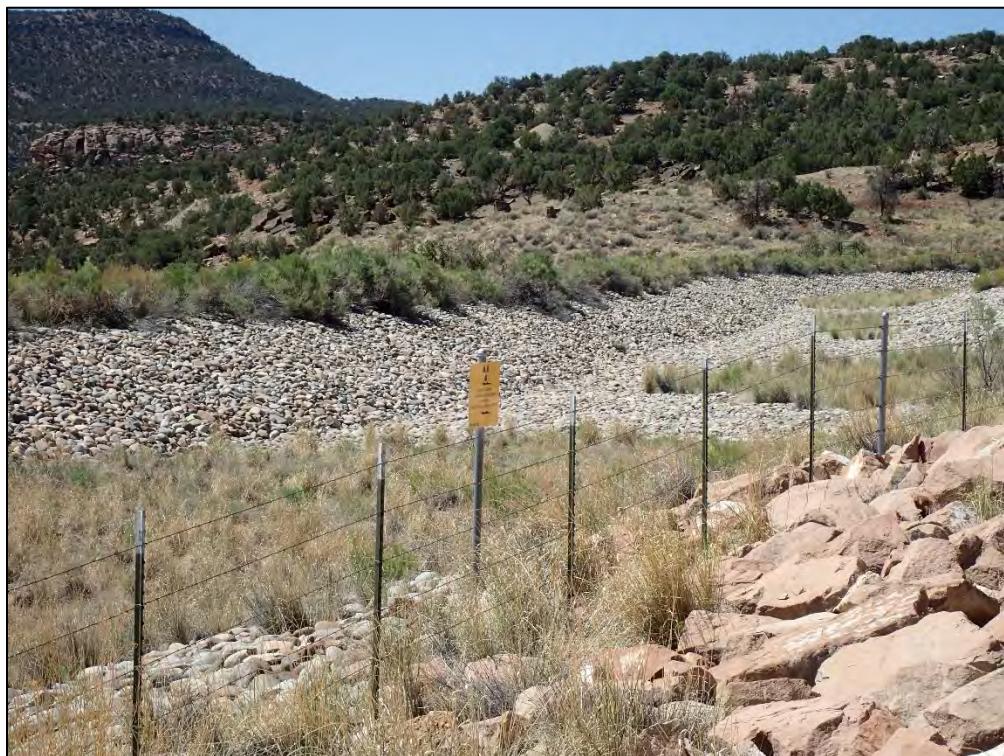
PL-8. Vegetation Growing in Interceptor Channel

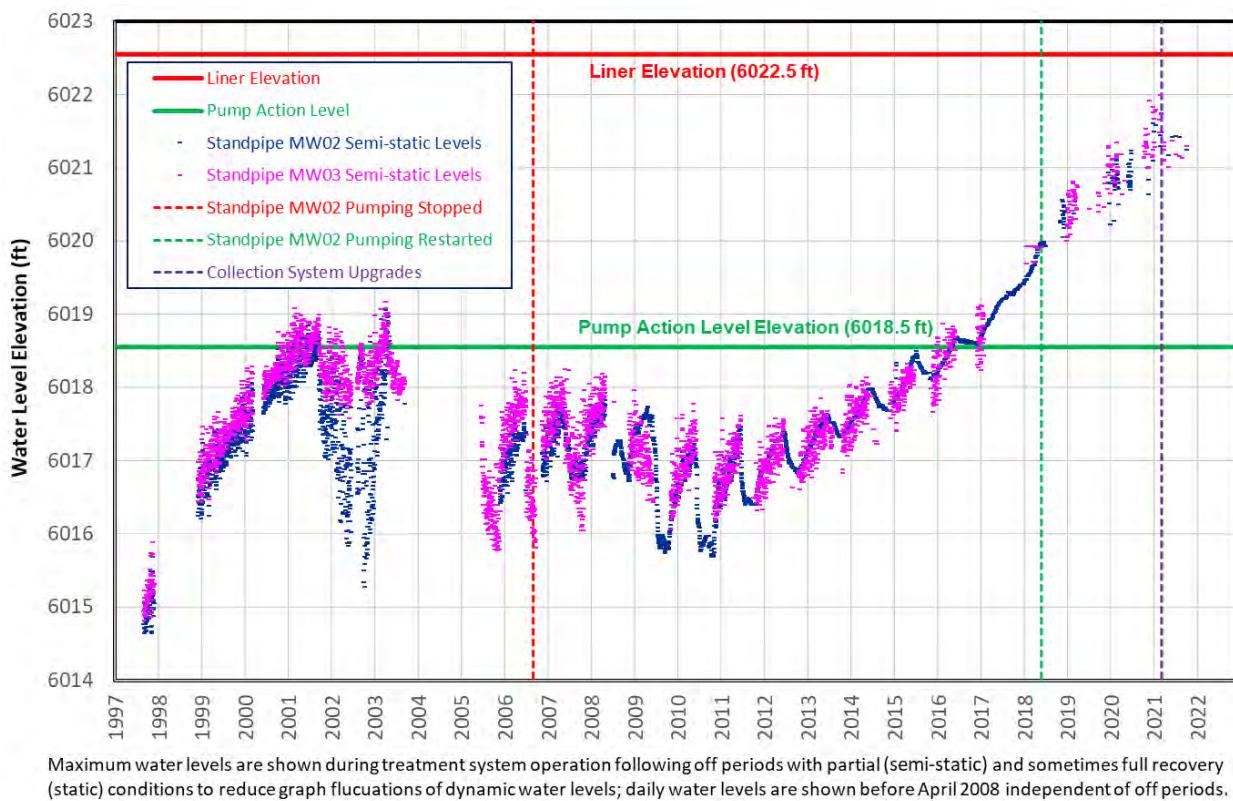
Figure 14-2. Disposal Cell Pore-Water Levels in Standpipes SP-02 and SP-03 at the Rifle, Colorado, Disposal Site

Real-time disposal cell water elevations collected in 2018 (using pressure transducers and dataloggers) continued to indicate that daily maximum or semistatic pore-water levels in standpipes SP-02 and SP-03 exceed the 6018.55 ft (6016 ft) pump action level (see Figure 14-2). In 2019, LM modified the seasonal pumping regimen for year-round pumping while a long-term solution is evaluated and implemented.

Data fluctuations for both standpipes observed from 2018 to 2021 are the result of partial overnight recharge due to well inefficiencies, and nonstatic levels have been filtered from the dataset shown in Figure 14-2. Downhole video taken in 2020 for both standpipes revealed fouling in the perforated interval. Redevelopment of standpipe SP-02 to remove mineral scale and biofouling was completed in December 2020. Initial testing results indicate an increase in production volume from standpipe SP-02 of approximately 22%. Downhole video in standpipe SP-03 also identified approximately 7.6 ft of 6- to 10-inch diameter rock riprap at the bottom of the standpipe. Potential methods to remove the rock and redevelop the standpipe are being considered to increase production.

In March 2021, the solar-powered pumping system was upgraded to provide additional operation of the pumps by increasing electrical storage ability. By adding batteries to store solar-generated electricity, the pumps are able to operate throughout the night and on overcast days. This should yield a more consistent and lower pore-water elevation and increase annual dewatering volume. The pumping system will continue to have limited availability in winter because aboveground effluent lines are susceptible to freezing.

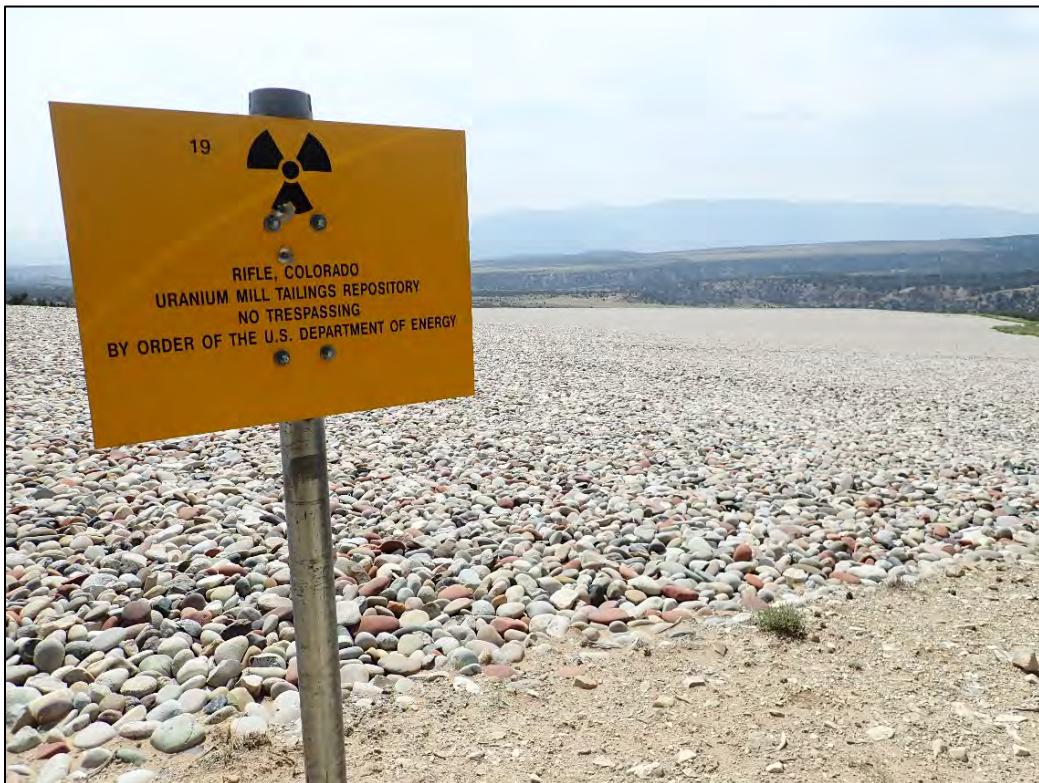
PL-2. Perimeter Sign P19

There are 27 perimeter signs positioned along the perimeter. Perimeter signs P0 through P11 are attached to the stock fence, and signs P12 through P26 are attached to steel posts set in concrete and set back 5 ft from the boundary (PL-2). Perimeter signs P15 and P19 have bullet damage, but remain legible and do not need to be replaced at this time. Perimeter sign P18 has shown minor cracks and peeling but remains legible. No other maintenance needs were identified.

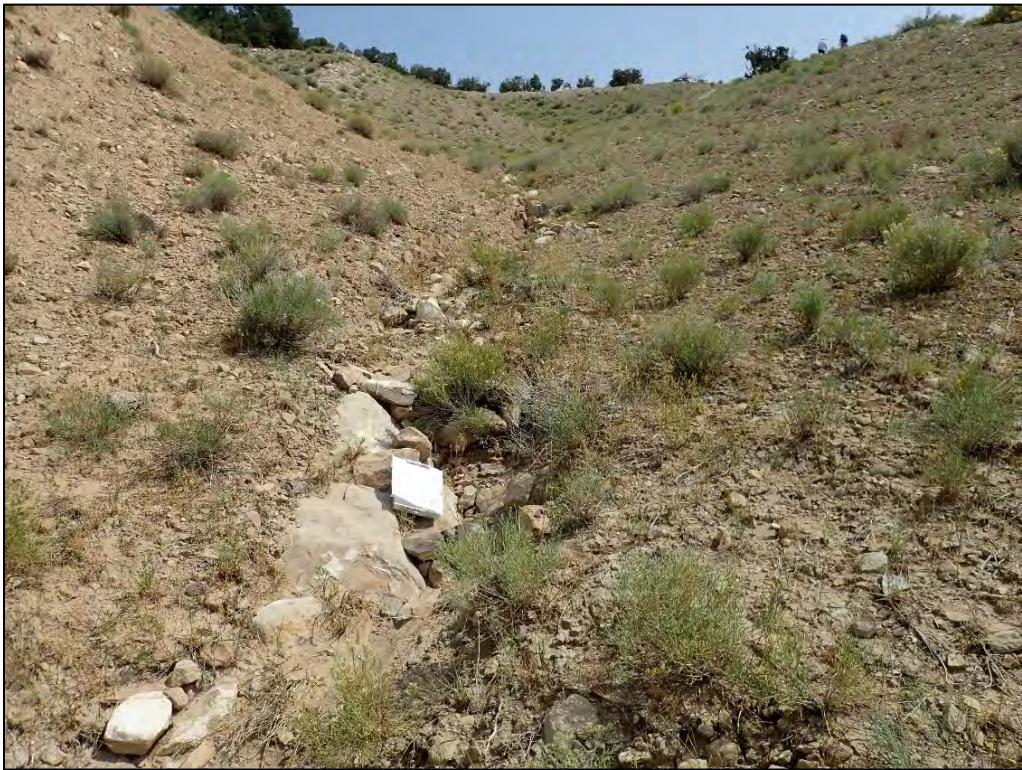
PL-7a. Gully Erosion in Interceptor Trench Outfall in 2021

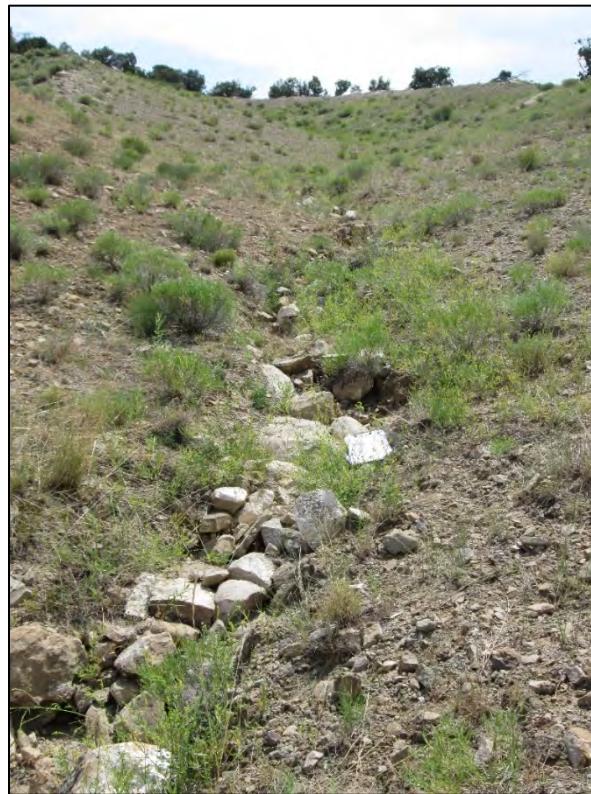
PL-7b. Gully Erosion in Interceptor Trench Outfall in 2016—Photo for Comparison

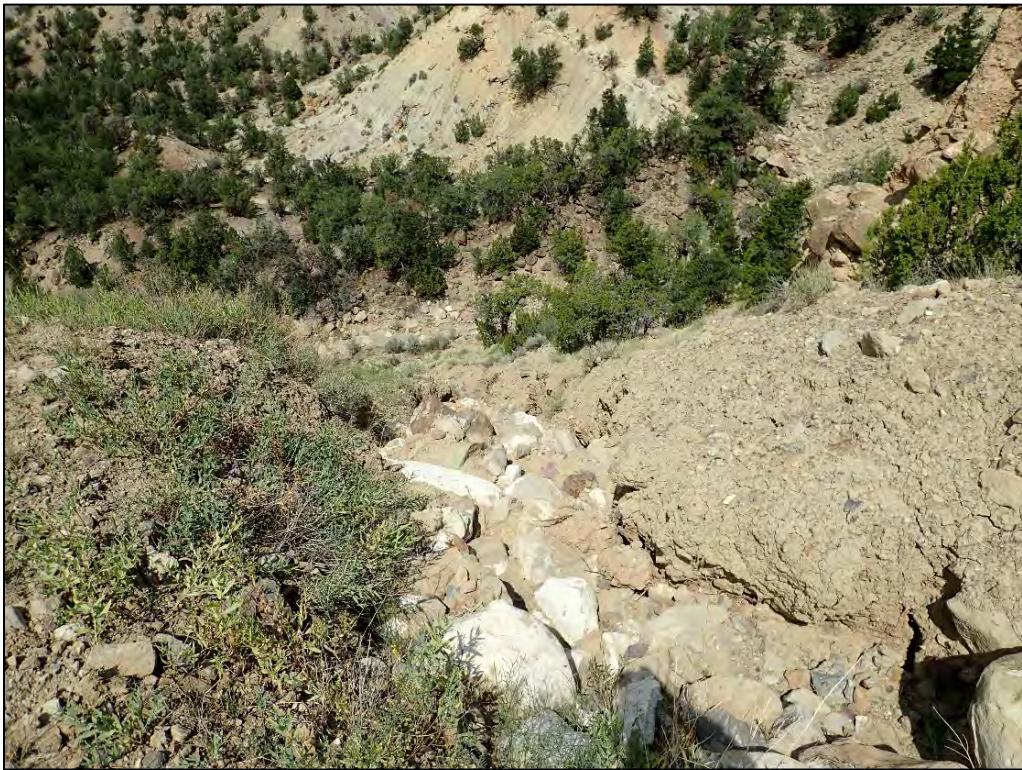
PL-8a. Gully Erosion in Interceptor Trench Outfall in 2021

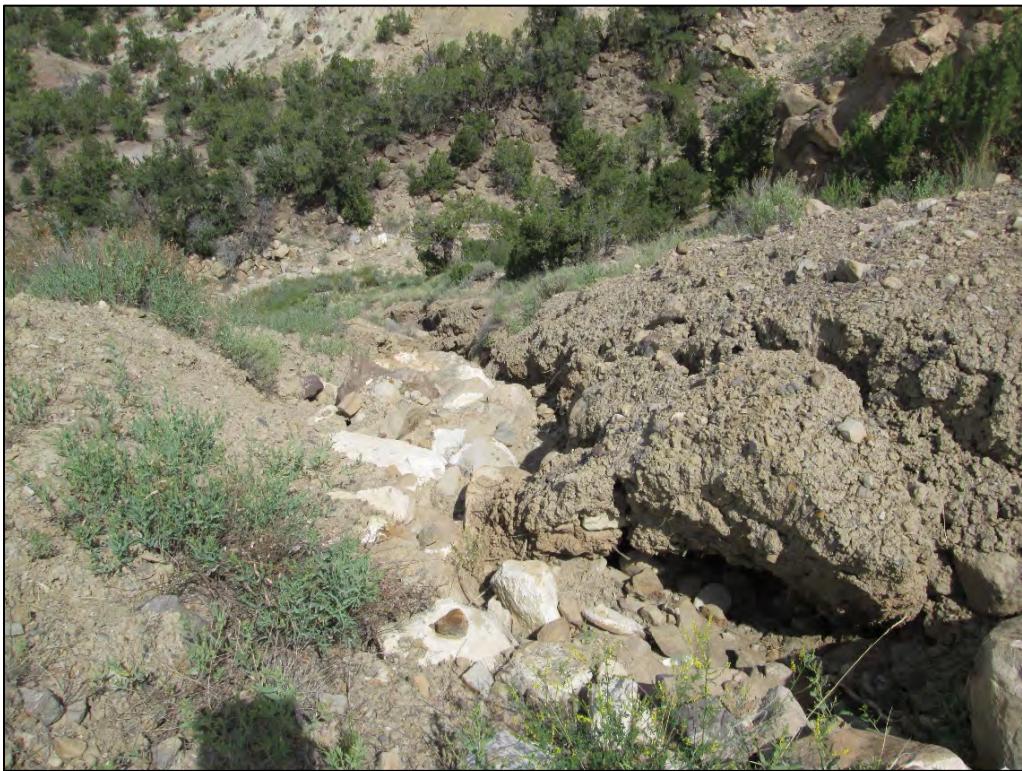
PL-8b. Gully Erosion in Interceptor Trench Outfall in 2016—Photo for Comparison

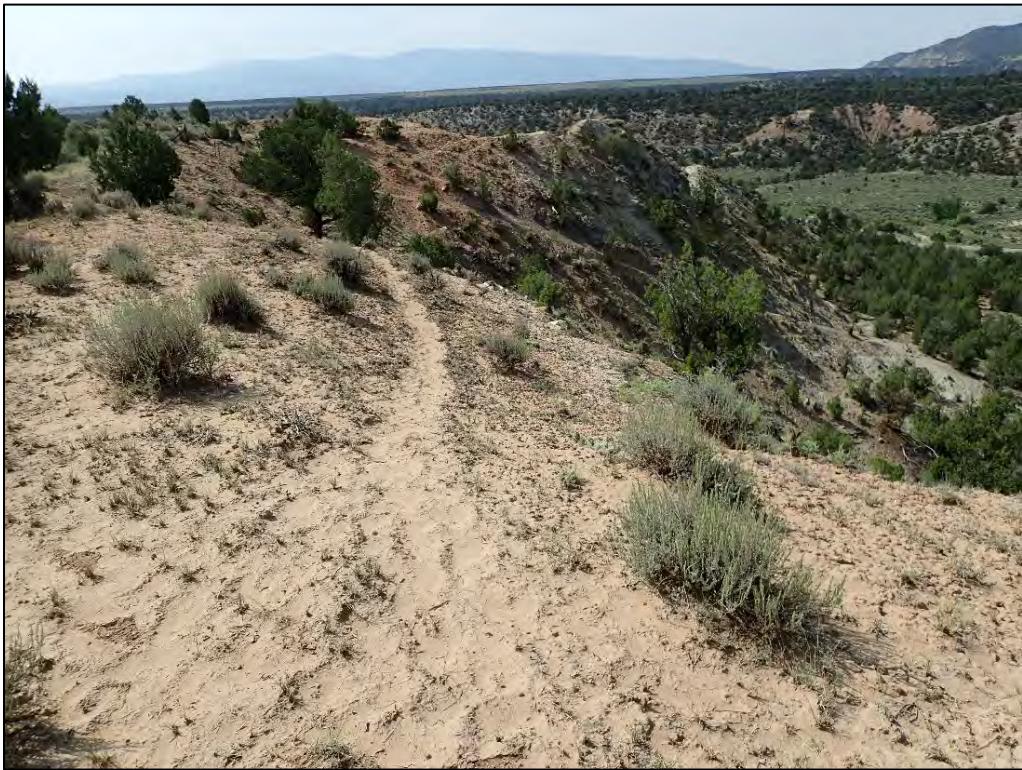
PL-9. Cattle Trail on Southwest Side of Site

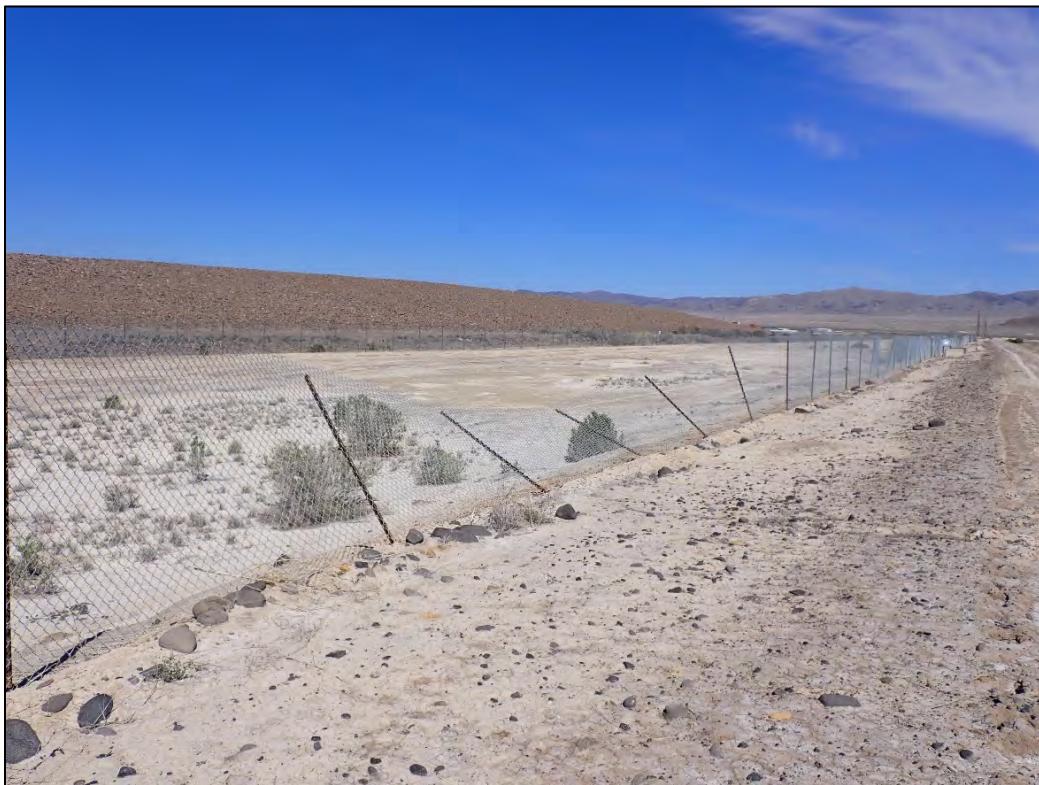
PL-1. Down Fence Along South Side of Cell

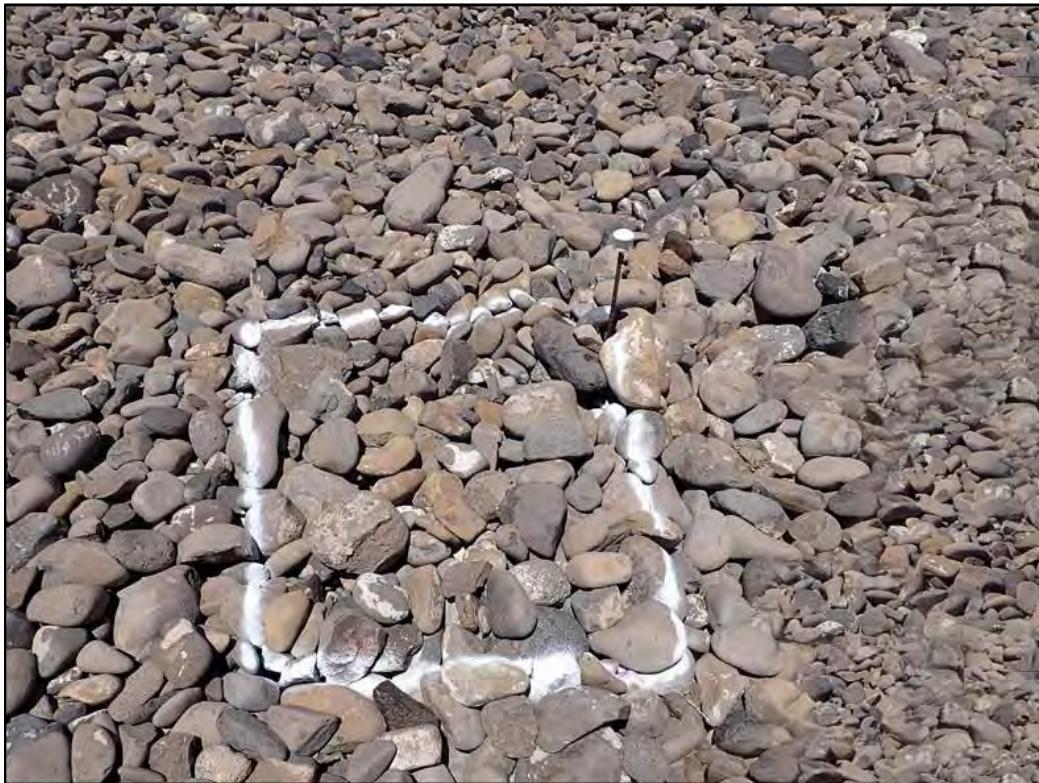
PL-5. (a) Rock Quality Plot No. I—2021

One of several types of rock used for the disposal cell erosion-protection riprap layer has exhibited minor degradation since the disposal cell was constructed. As a result, eight rock-quality monitoring plots, each measuring 1 square meter (indicated by Roman numerals I–VIII in Figure 15-1), were established in 2010 to monitor for continued rock degradation.

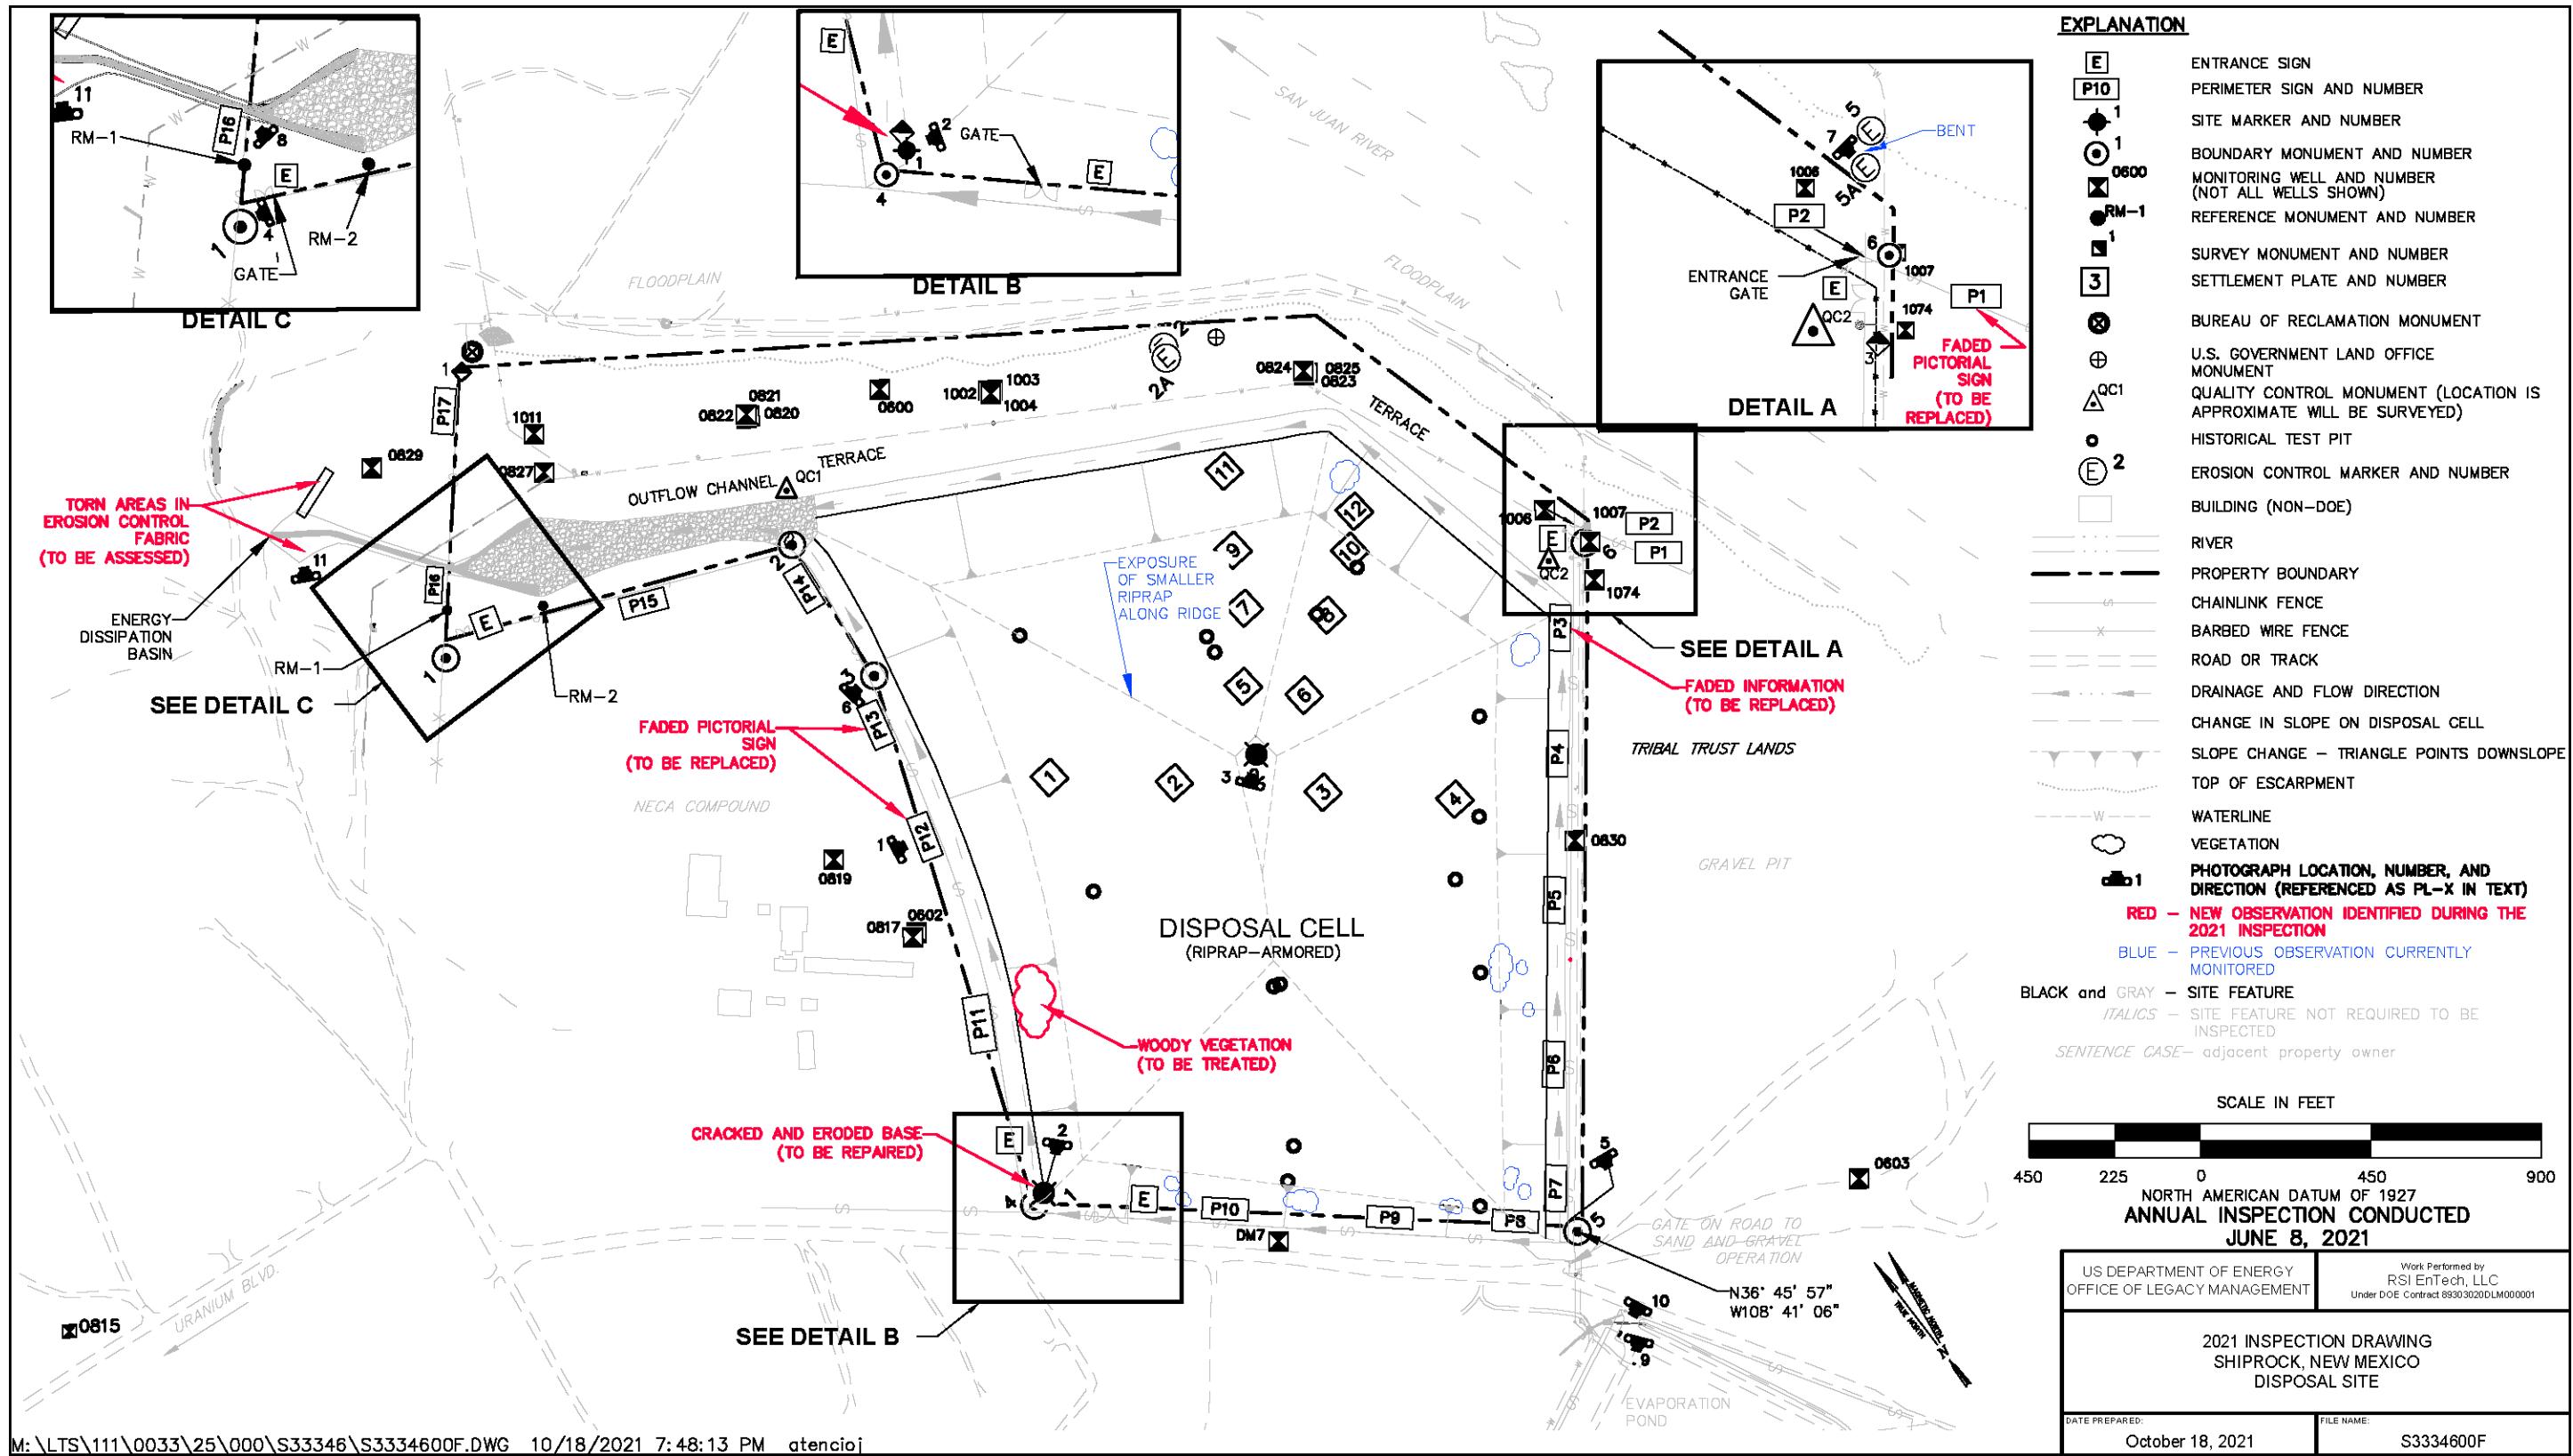
Figure 16-1. 2021 Annual Inspection Drawing for the Shiprock, New Mexico, Disposal Site

Figure 16-1 shows the locations of site features, including site surveillance features and inspection areas, in black and gray font. Site features that are present but not required to be inspected are shown in italic font. Observations from previous inspections that are currently monitored are shown in blue text, and new observations identified during the 2021 annual inspection are shown in red. Inspection results and recommended maintenance activities associated with site surveillance features are included in the following subsections. Photographs to support specific observations are identified in the text and in Figure 16-1 by photograph location (PL) numbers. The photographs and photograph log are presented in Section 16.10.

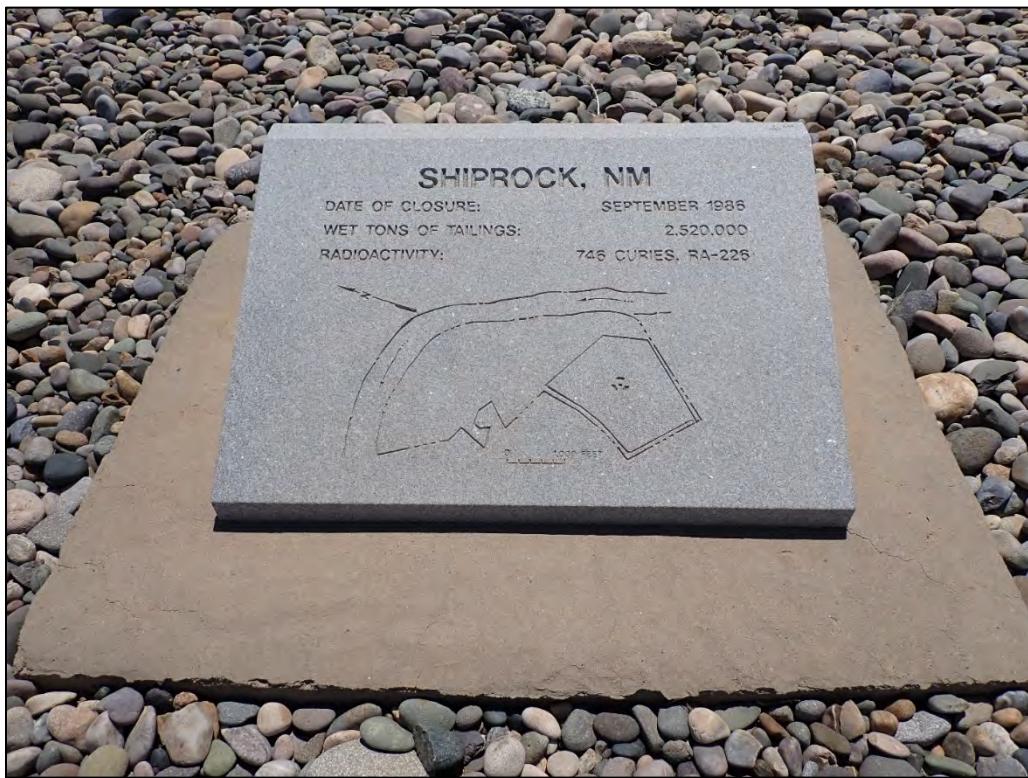
PL-3. Site Marker SMK-2 on Cell Top

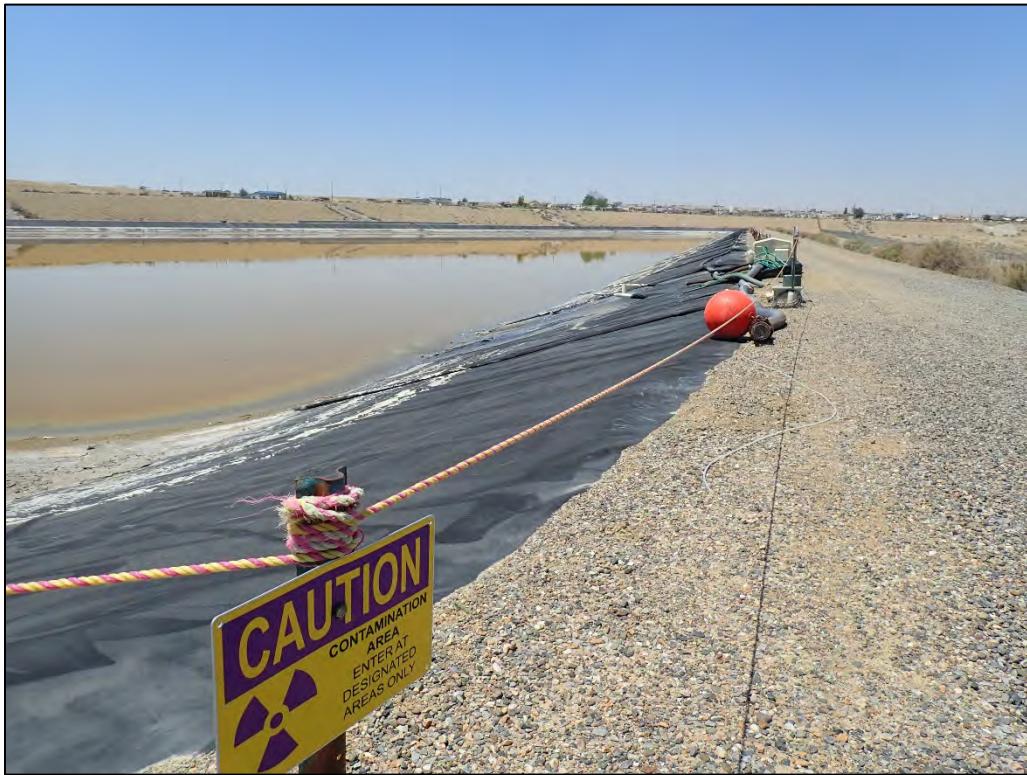
Inspectors noted three new torn areas in the erosion control fabric on the banks of the lower outflow channel, one of which was considered significant (PL-10). The tears will be assessed in 2022 once travel restrictions are lifted.

PL-10. Torn Areas in Erosion Control Fabric on Northwest End of Outflow Channel

- Replacing faded pictorial and information on perimeter signs
- Continuing to remove trash and debris (including tumbleweeds) along the perimeter fence
- Sealing the cracks and repairing erosion at the base of site marker SMK-1
- Treating deep-rooted woody shrubs on the top and side slopes of the disposal cell
- Assessing torn areas in erosion control fabric on the northwest end of the outflow channel

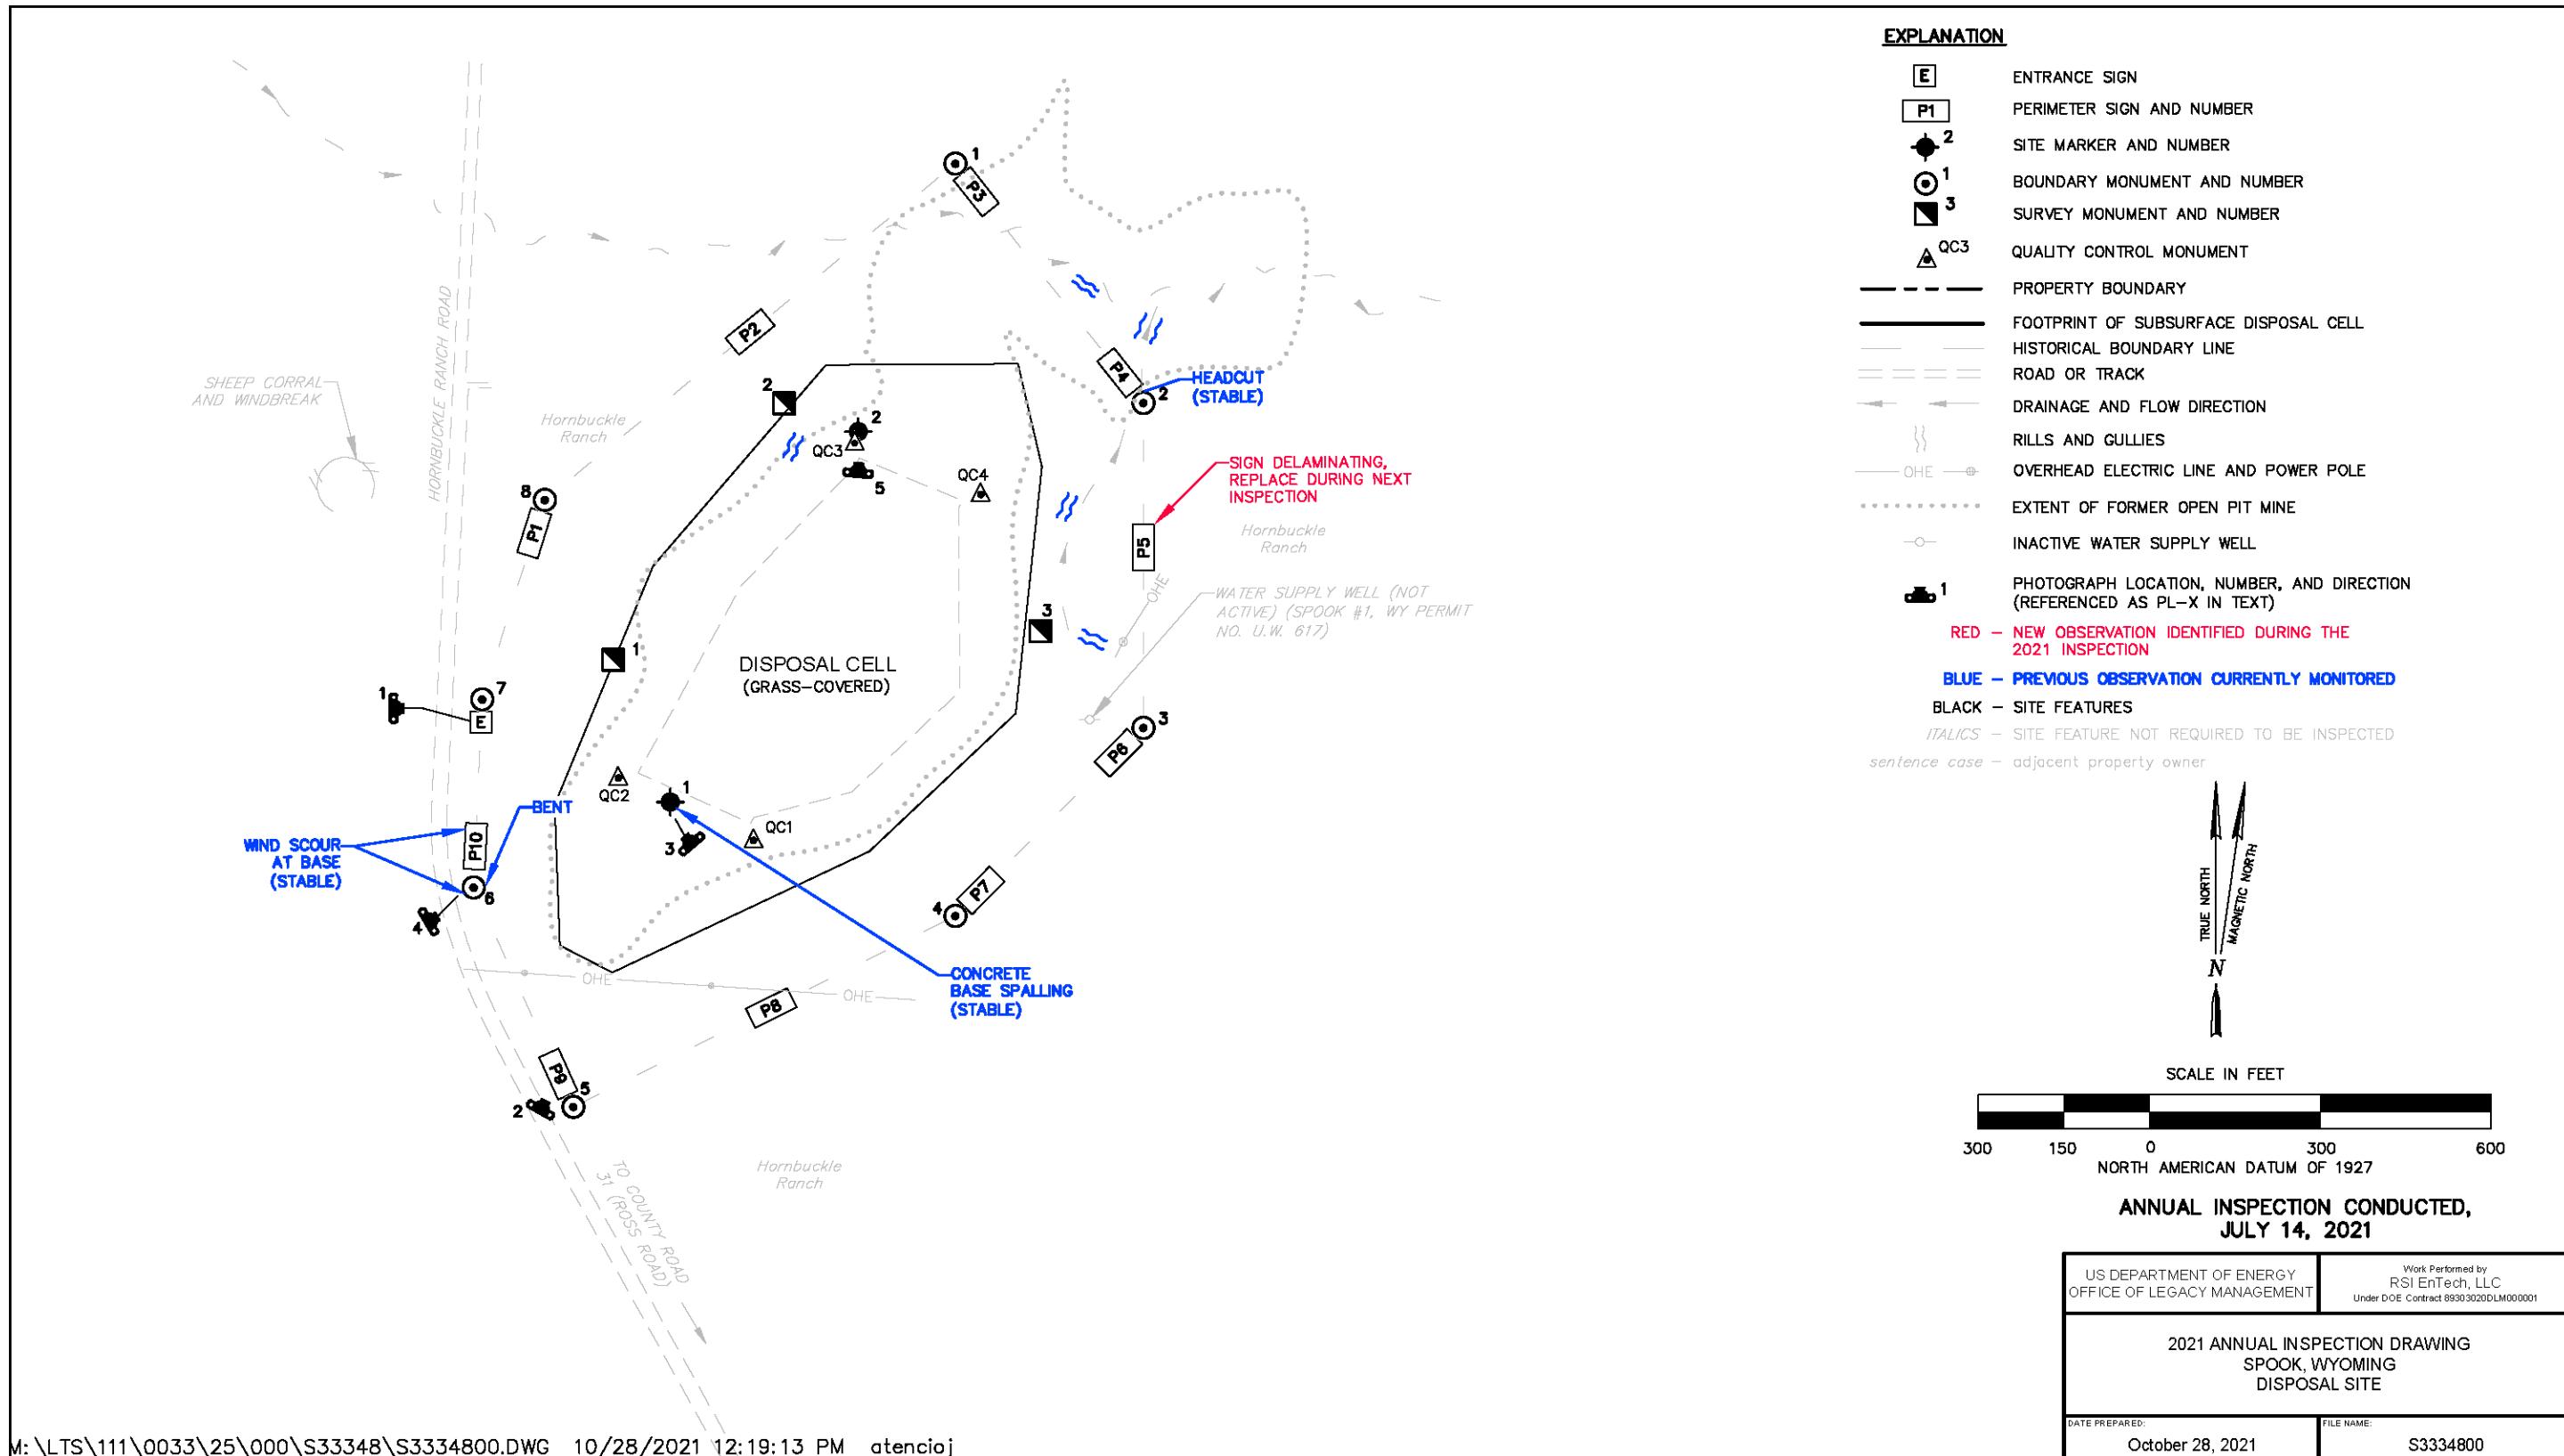
Figure 18-1. 2021 Annual Inspection Drawing for the Spook, Wyoming, Disposal Site

Figure 18-1 shows the locations of site features, including site surveillance features and inspection areas, in black and gray font. Site features that are present but not required to be inspected are shown in italic font. Observations from previous inspections that are currently monitored are shown in blue font. New observations are shown in red font. Inspection results and recommended maintenance activities associated with site surveillance features are included in the following subsections. Photographs to support specific observations are identified in the text and in Figure 18-1 by photograph location (PL) numbers. The photographs and photograph log are presented in Section 18.10.
