**U.S. DEPARTMENT OF
ENERGY**

2021 Annual Site Inspection and Monitoring Report for Uranium Mill Tailings Radiation Control Act Title I Disposal Sites

March 2022

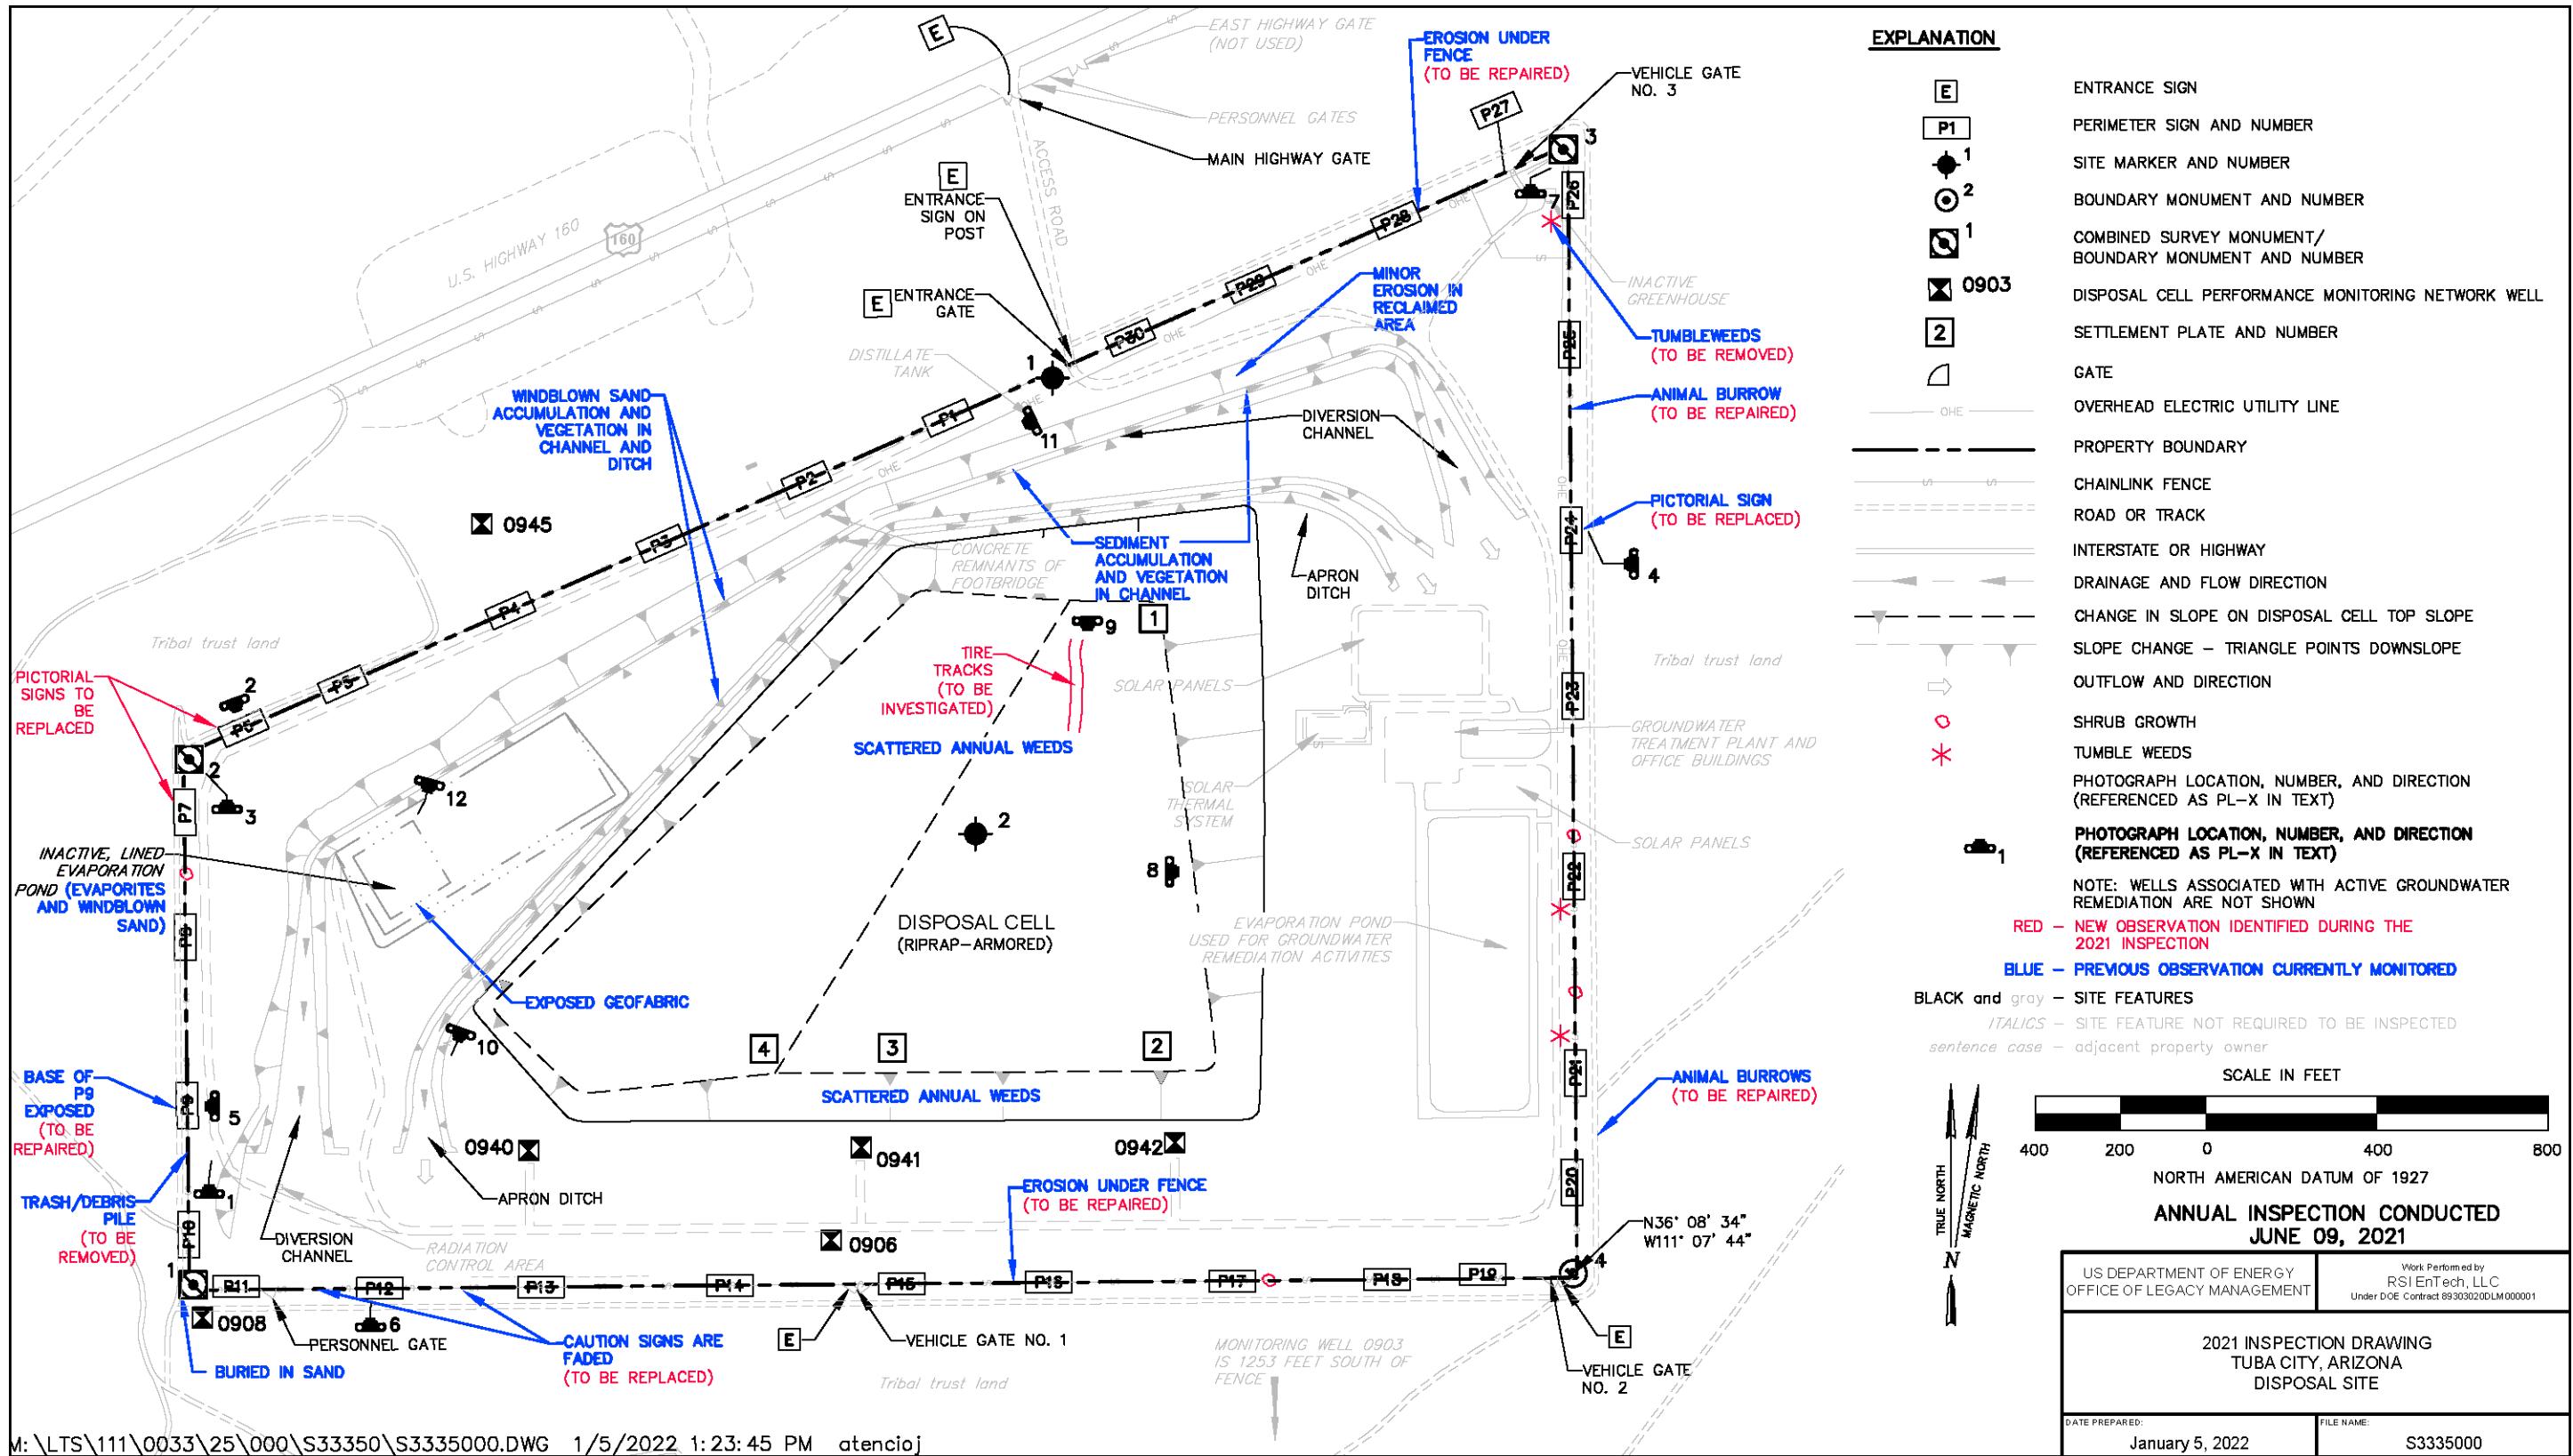
Figure 19-1. 2021 Annual Inspection Drawing for the Tuba City, Arizona, Disposal Site

Figure 19-1 shows the locations of site features, including site surveillance features and inspection areas, in black and gray font. Site features that are present but not required to be inspected are shown in italic font. Observations from previous inspections that are currently monitored are shown in blue, and new observations identified during the 2021 annual inspection are shown in red font. Inspection results and recommended maintenance activities associated with site surveillance features are included in the following subsections. Photographs to support specific observations are identified in the text and in Figure 19-1 by photograph location (PL) numbers. The photographs and photograph log are presented in Section 19.10.

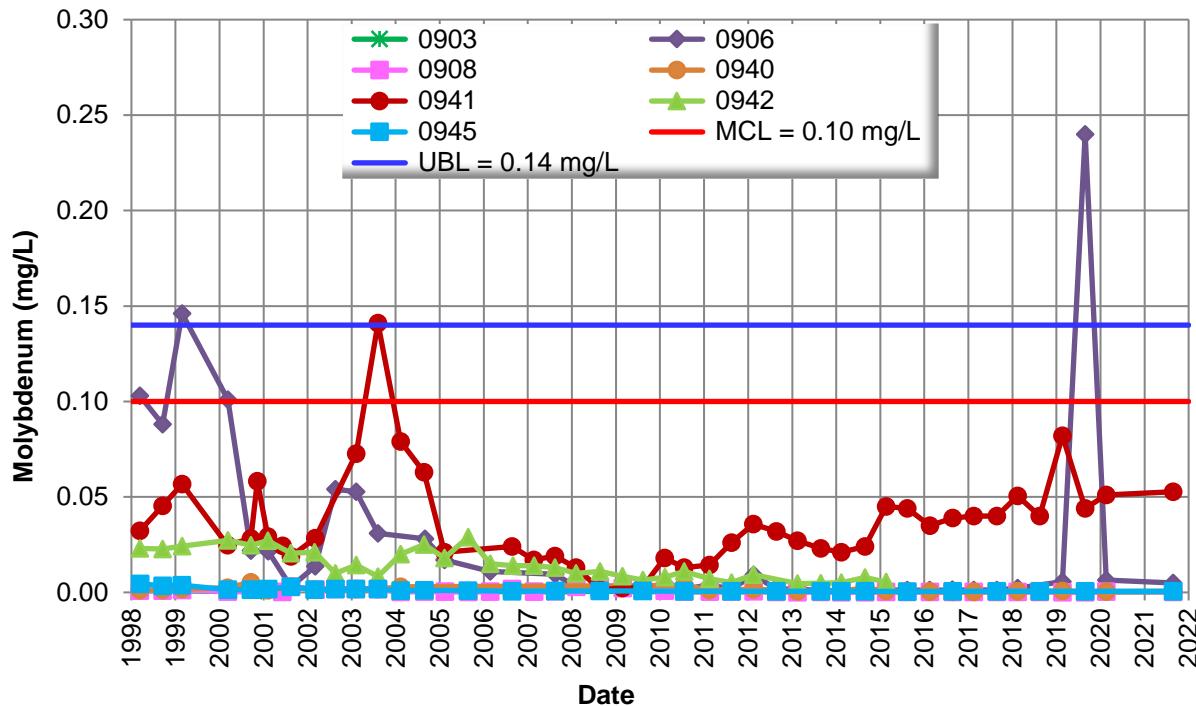
Figure 19-3. Molybdenum in Groundwater at the Tuba City, Arizona, Disposal Site

Since 2004, molybdenum concentrations have been below both the 0.10 milligram per liter (mg/L) MCL and the 0.14 mg/L UBL in all LTSP evaluative wells except well 0906 in August 2019 (Figure 19-3). Molybdenum concentrations in the westernmost downgradient well 0908 and in distal downgradient well 0903 (approximately 1250 feet south of the site perimeter) continue to be comparable to concentrations in background well 0945. Well 0906 exceeded the UBL for molybdenum in August 2019 for the first time since 1999. The UBL exceedance in well 0906 was measured during the 2019 pumping campaign. Molybdenum in well 0906 decreased below the MCL in February 2020 and remained below the MCL in August 2021.

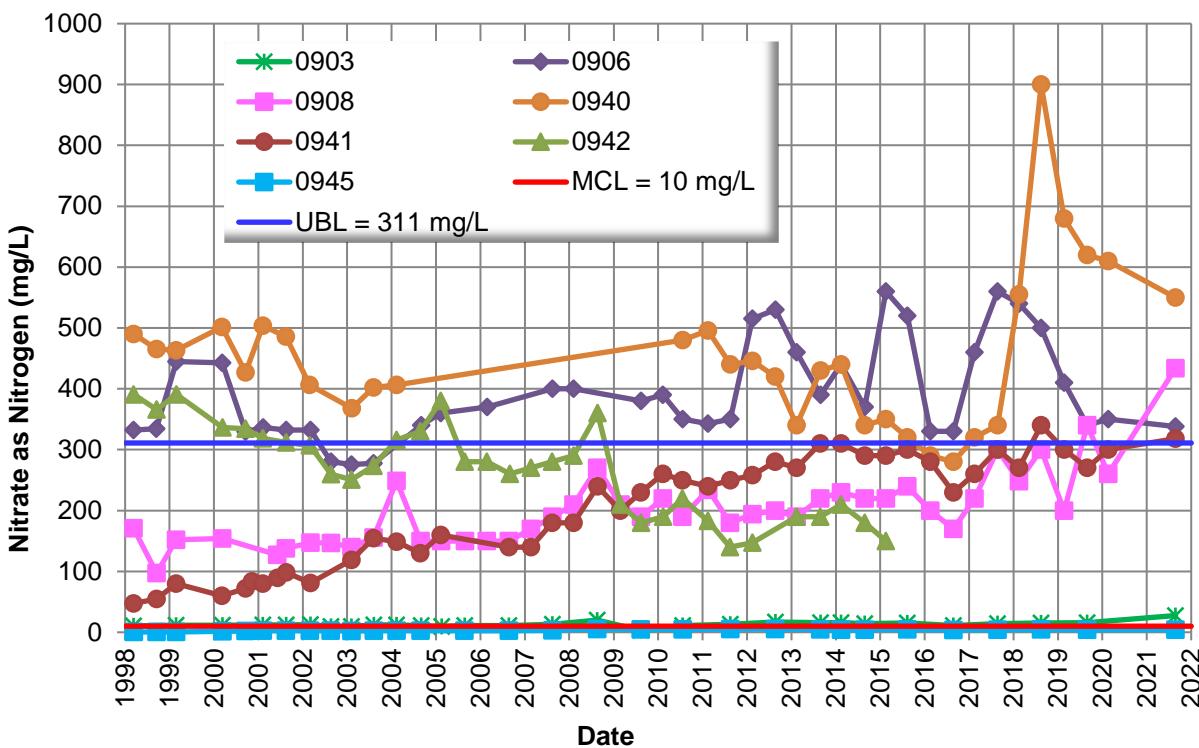
Figure 19-4. Nitrate in Groundwater at the Tuba City, Arizona, Disposal Site

Nitrate concentrations have historically exceeded the 10 mg/L MCL in all LTSP evaluative wells except background well 0945 (Figure 19-4). Exceedances of the 311 mg/L UBL were observed at compliance wells 0906 (338 mg/L), 0908 (434 mg/L), 0940 (550 mg/L), and 0941 (318 mg/L) in August 2021. Nitrate concentrations in distal downgradient well 0903 have regularly exceeded the MCL since 2004 but remained below the UBL in 2020.

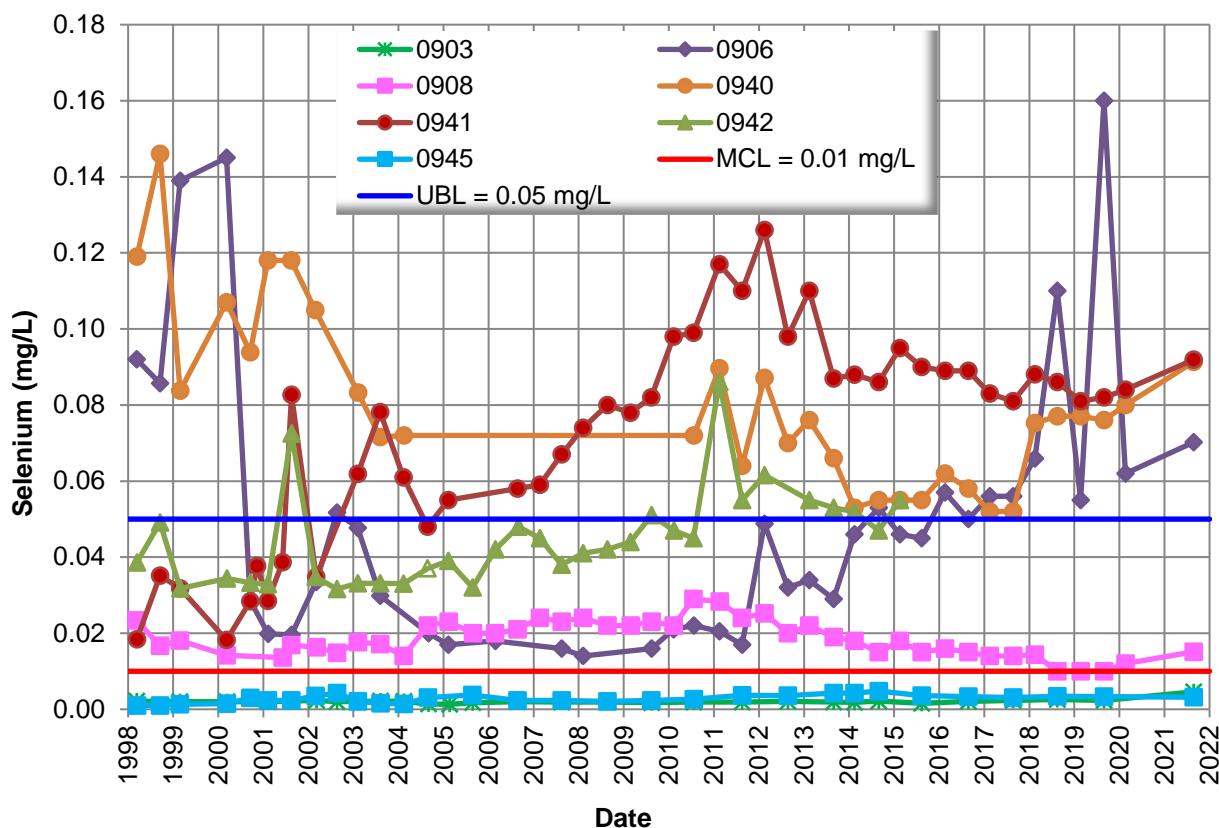
Figure 19-5. Selenium in Groundwater at the Tuba City, Arizona, Disposal Site

Selenium concentrations have historically exceeded the 0.01 mg/L MCL in all LTSP evaluative wells except background well 0945 and distal well 0903 (Figure 19-5). Concentrations in well 0908 exceeded the UBL for selenium in 1997 and have since remained at or slightly above the 0.01 mg/L MCL since August 2018. Selenium concentrations in well 0942 exceeded the UBL in February 2015, and that well has not been sampled since. Concentrations continued to exceed the 0.05 mg/L UBL in wells 0906, 0940, and 0941, all of which are immediately downgradient of the disposal cell. Selenium concentrations increased in well 0941 from 0.018 mg/L in 1998 to 0.09 mg/L in 2021. Selenium concentrations in distal downgradient well 0903 have consistently been below both the UBL and the MCL and, since late 2004, below levels measured in background well 0945.

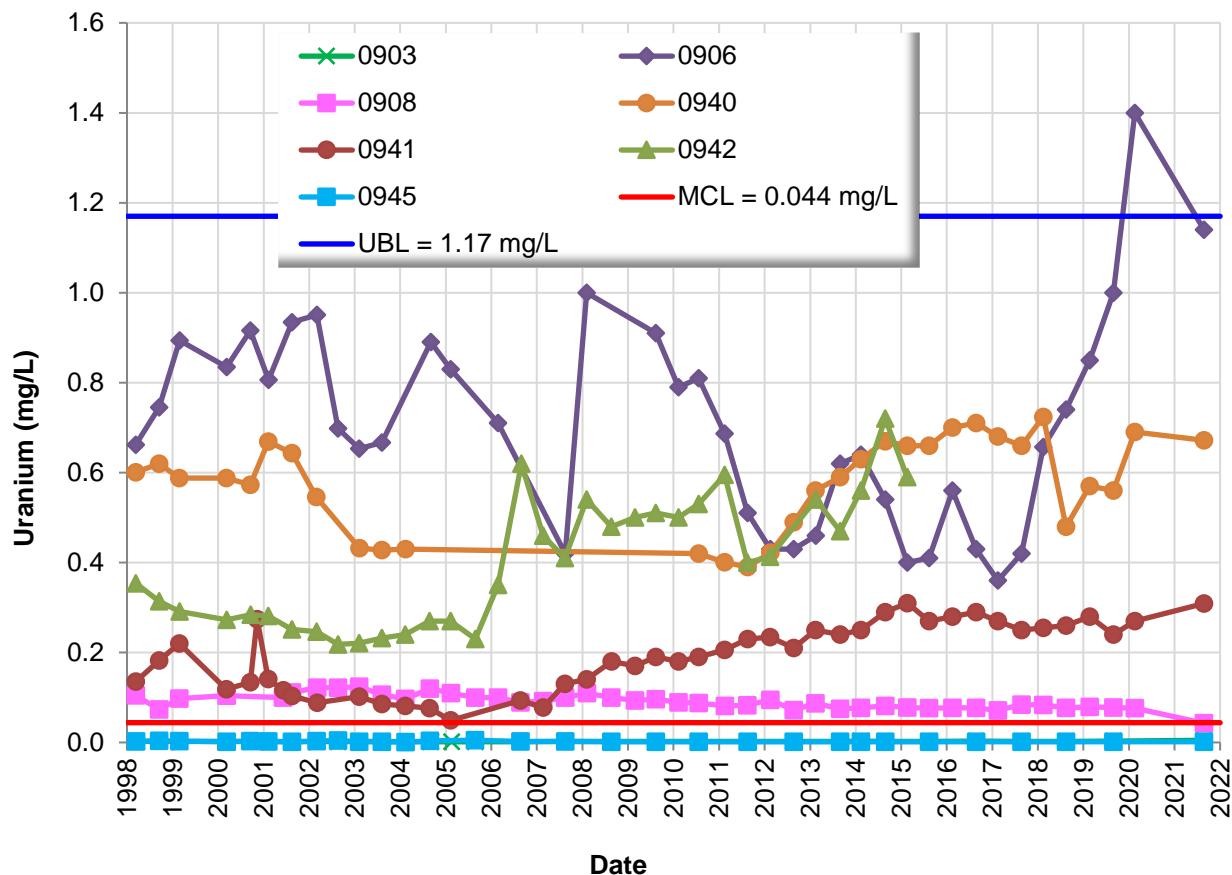
Figure 19-6. Uranium in Groundwater at the Tuba City, Arizona, Disposal Site

Uranium concentrations have historically exceeded the 0.044 mg/L MCL in all compliance wells except for distal downgradient well 0903 and background well 0945, both of which have always been below the MCL (Figure 19-6).

Uranium concentrations in central downgradient well 0941 have gradually increased since 2005 from 0.05 mg/L to 0.31 mg/L. Concentrations in well 0906 have more recently increased from 0.36 mg/L in February 2017 to 1.4 mg/L in February 2020, above the 1.17 mg/L UBL, then to 1.14 mg/L in August 2021, just below the UBL. Uranium concentration in well 0908 decreased to 0.043 mg/L, just below the MCL, in August 2021; this was the first time uranium concentrations were below the MCL in this well since evaluative monitoring began.

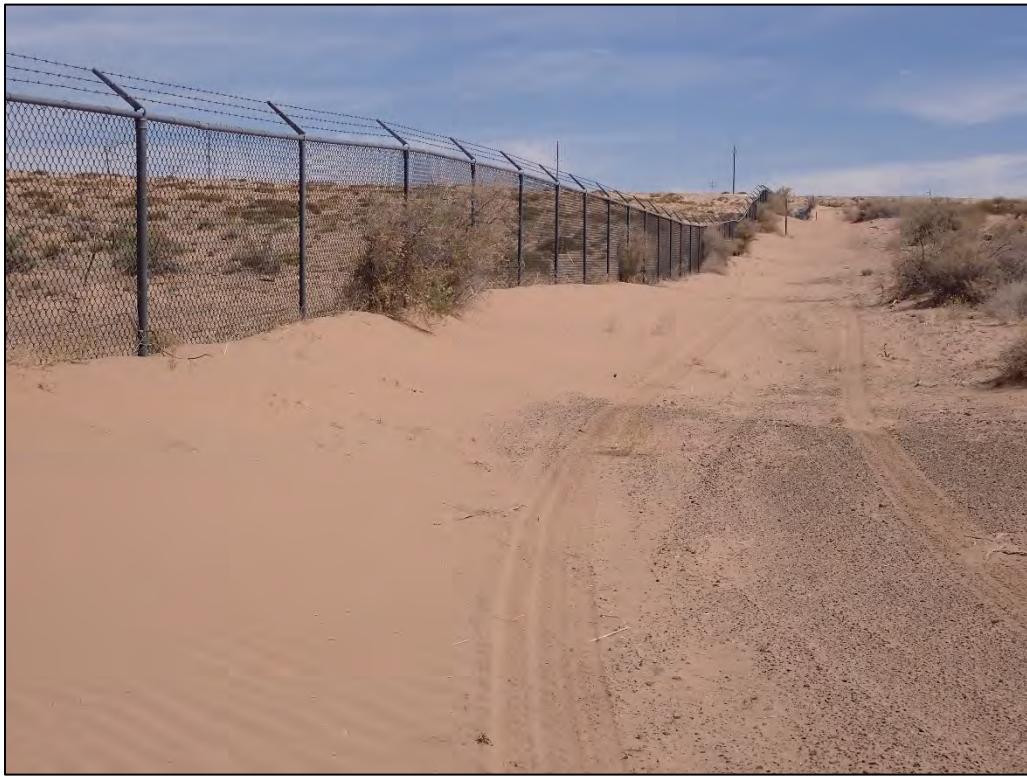
PL-1. Windblown Sand Accumulation Along Western Perimeter Fence

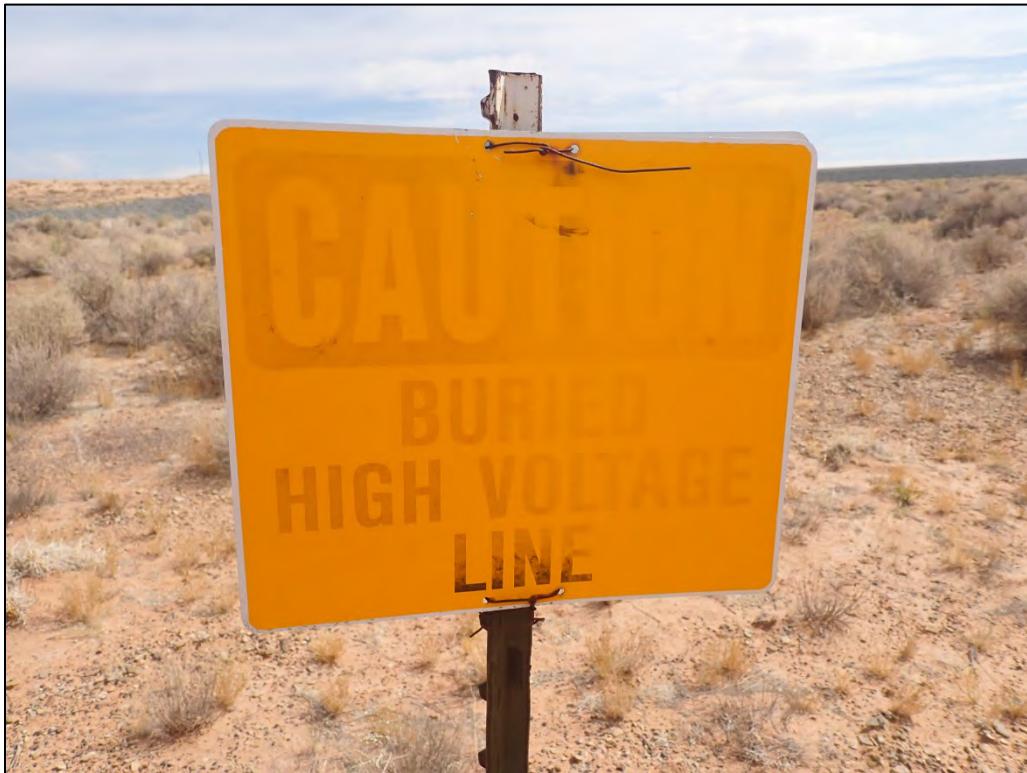
PL-6. Faded Caution Sign for Buried High Voltage Line

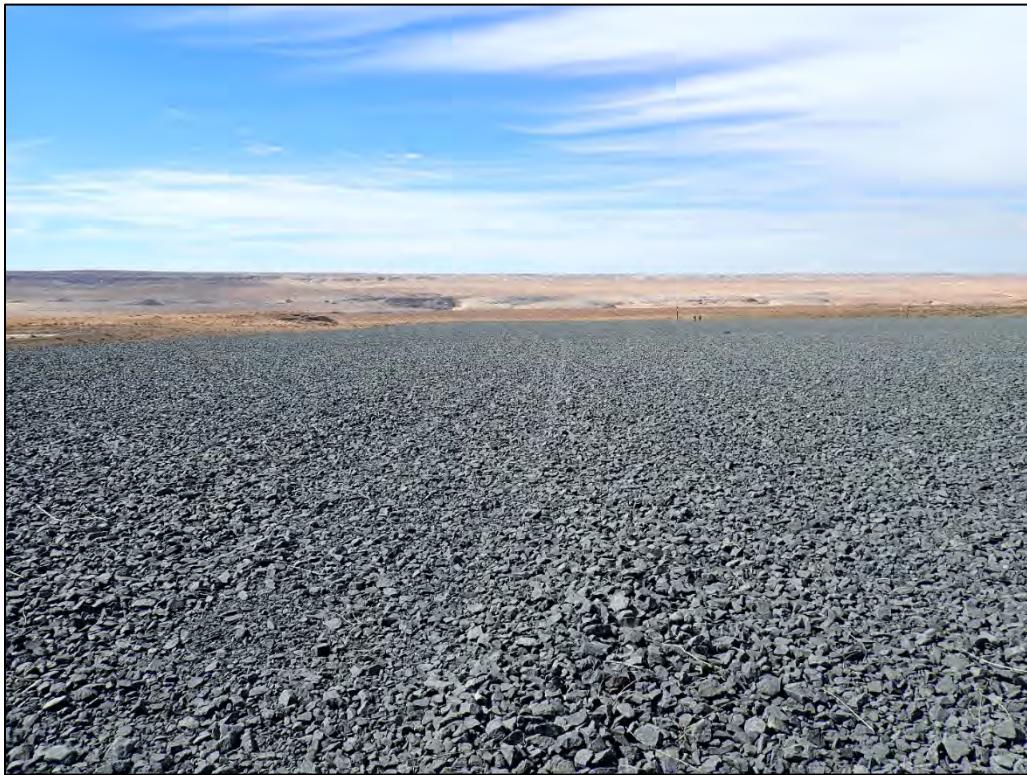
PL-9. Tire Tracks on Disposal Cell Top

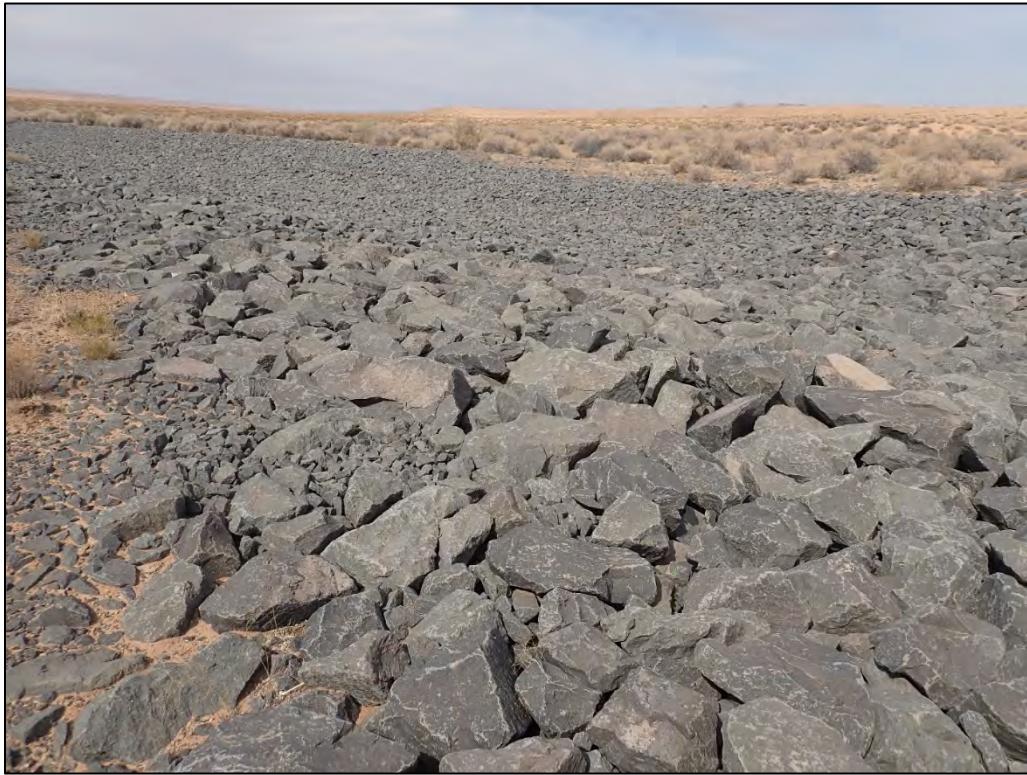
PL-10. Minor Sedimentation and Plant Growth in Mouth of South Apron Ditch

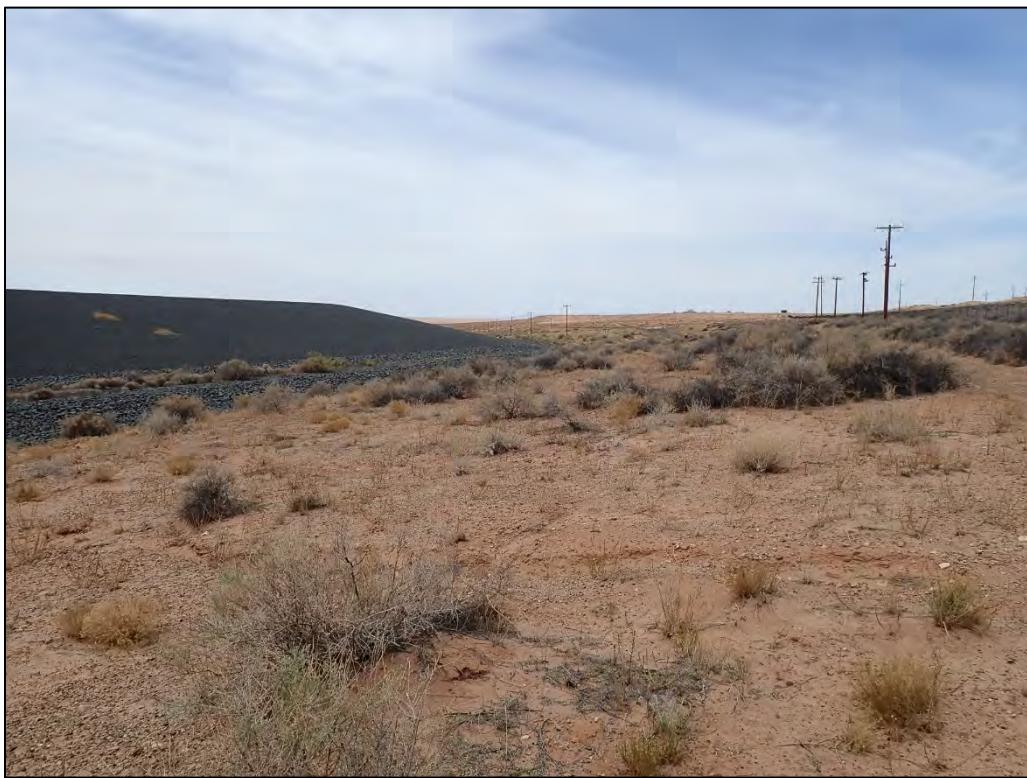
PL-11. Drought-Stricken Vegetation in Reclaimed Area

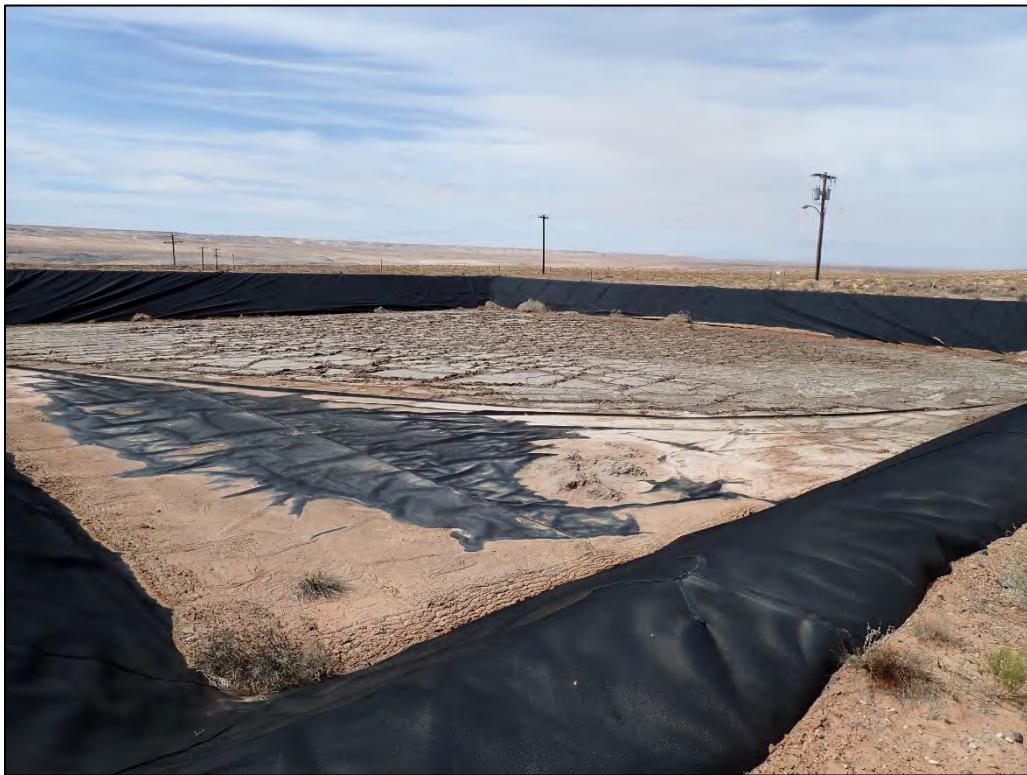
PL-12. Evaporites and Windblown Sand in Inactive Evaporation Pond
