## 2021 Annual Site Inspection and Monitoring Report for Uranium Mill Tailings Radiation Control Act Title I Disposal Sites

March 2022

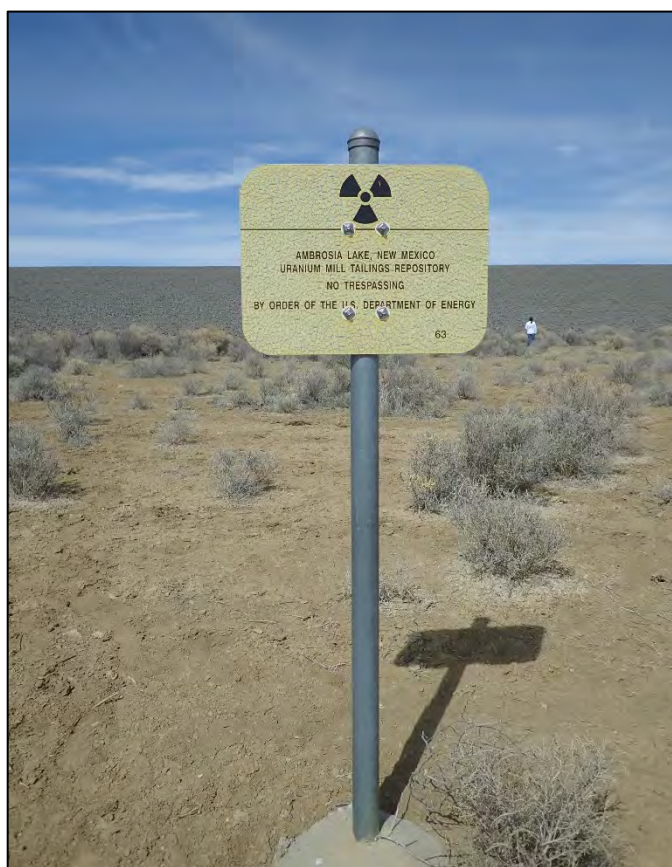
There are 70 perimeter signs, attached to steel posts set in concrete, positioned along the unfenced property boundary (PL-2). Posts for perimeter signs P1 through P15 include additional warning signs about mining restrictions. Many of the perimeter signs were cracked and weathered but remain legible. Erosion has occurred around the base of perimeter sign P12, but the perimeter sign is stable (PL-3). A new prairie dog colony was identified between perimeter signs P17 and P18. It does not threaten the integrity of either perimeter sign, no additional action is needed. No maintenance needs were identified.

*PL-2. Perimeter Sign P63*

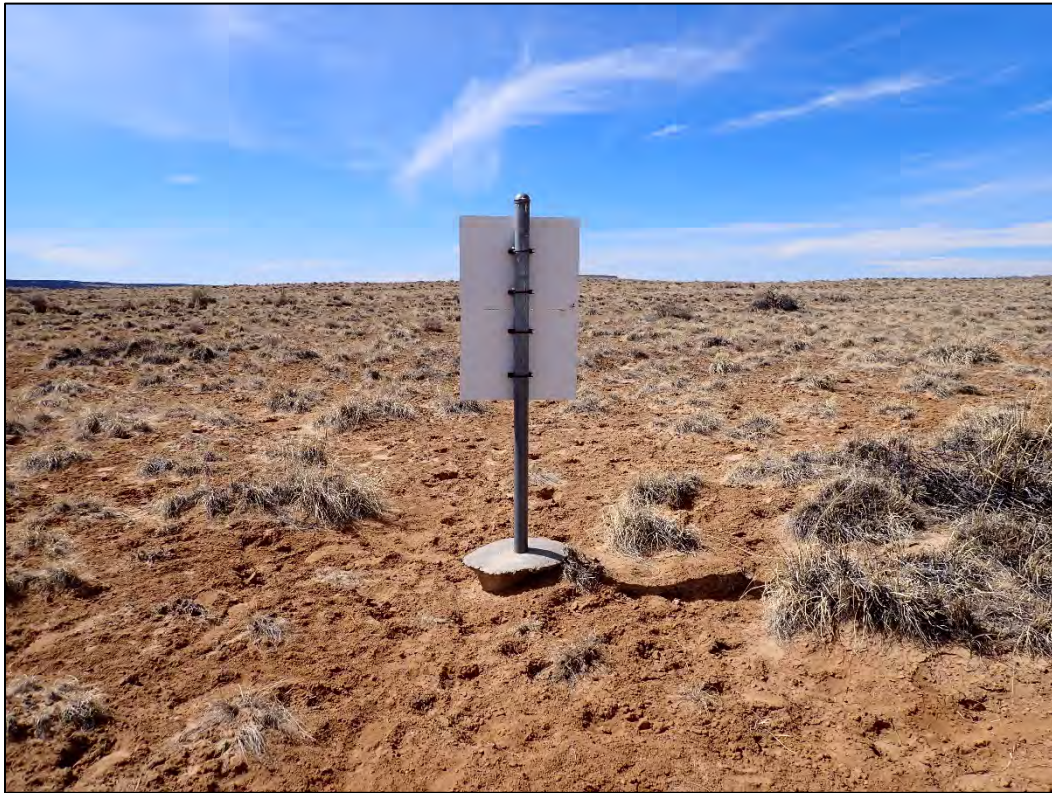
*PL-3. Erosion Around Base of Perimeter Sign P12 (Stable)*

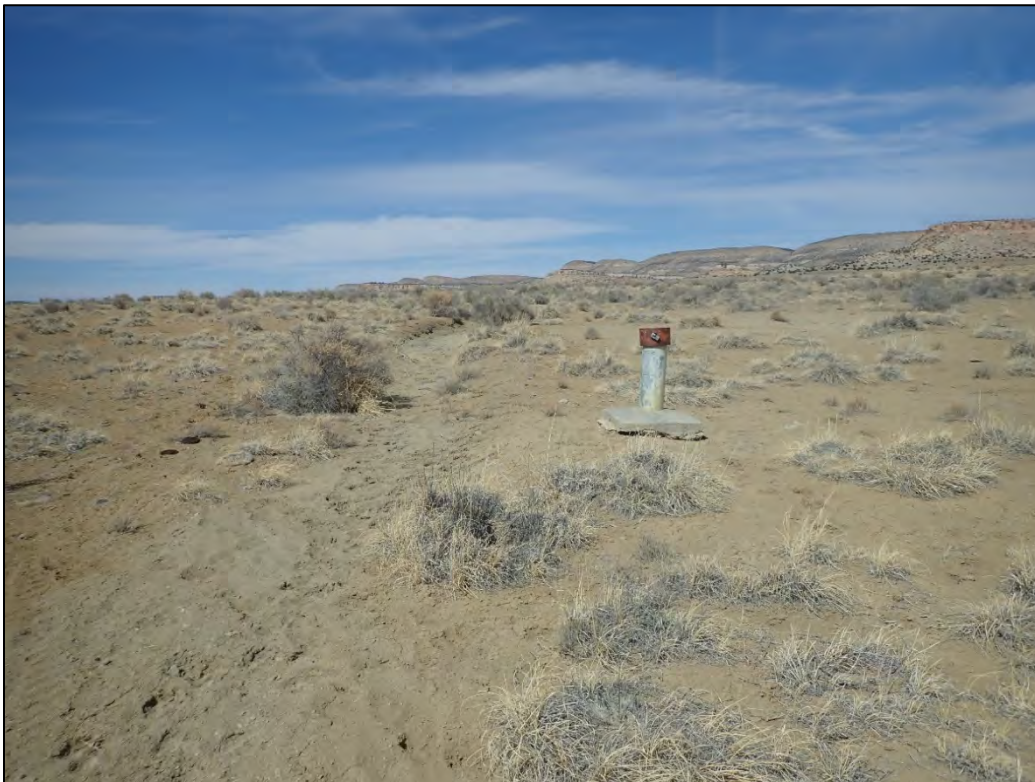
The site has three monitoring wells. A gully adjacent to well 0678 appears to be stable, and the well is not affected by the erosion (PL-6). All wellhead protectors observed during the inspection were undamaged, locked, and properly labeled. No maintenance needs were identified.

*PL-6. Erosional Rills Around Monitoring Well 0678*

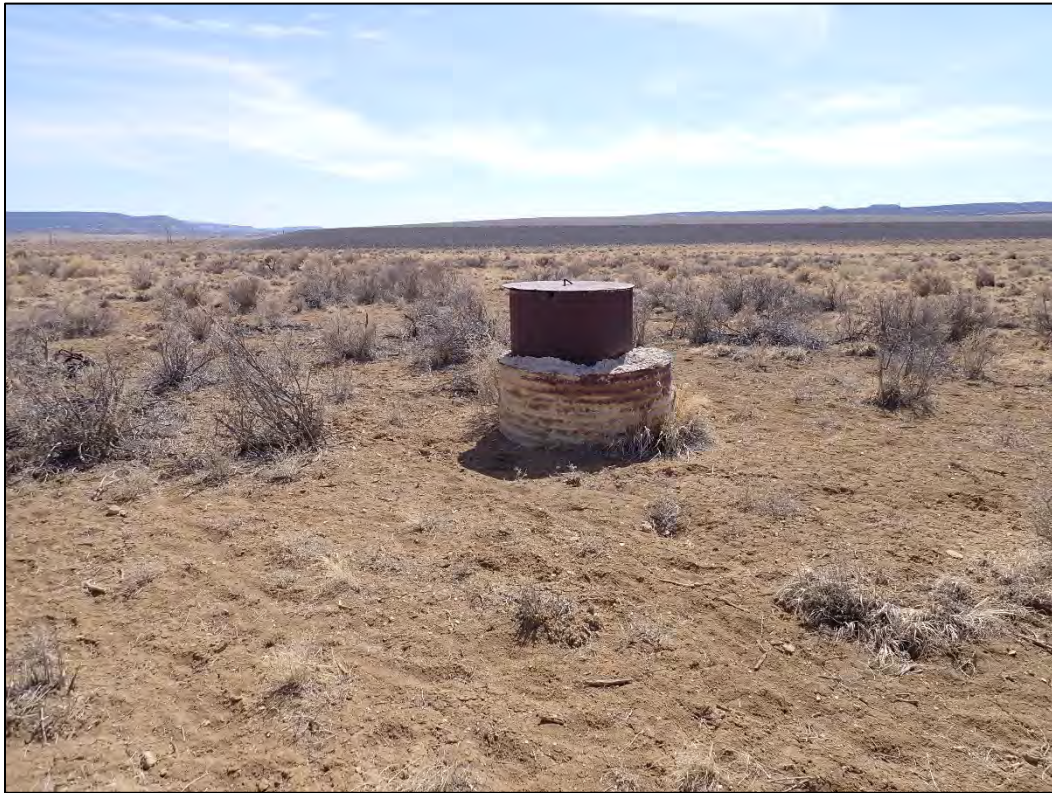
A mine vent shaft associated with an abandoned underground mine is within the site boundary in the northern portion of the site (PL-7). The vent has a spot-welded cover and a casing that rises approximately 3 feet above the ground. The vent was secure at the time of the inspection. Inspectors monitor the condition of the vent to ensure that the closure remains secure. No maintenance needs were identified.

*PL-7. Mine Vent Shaft*

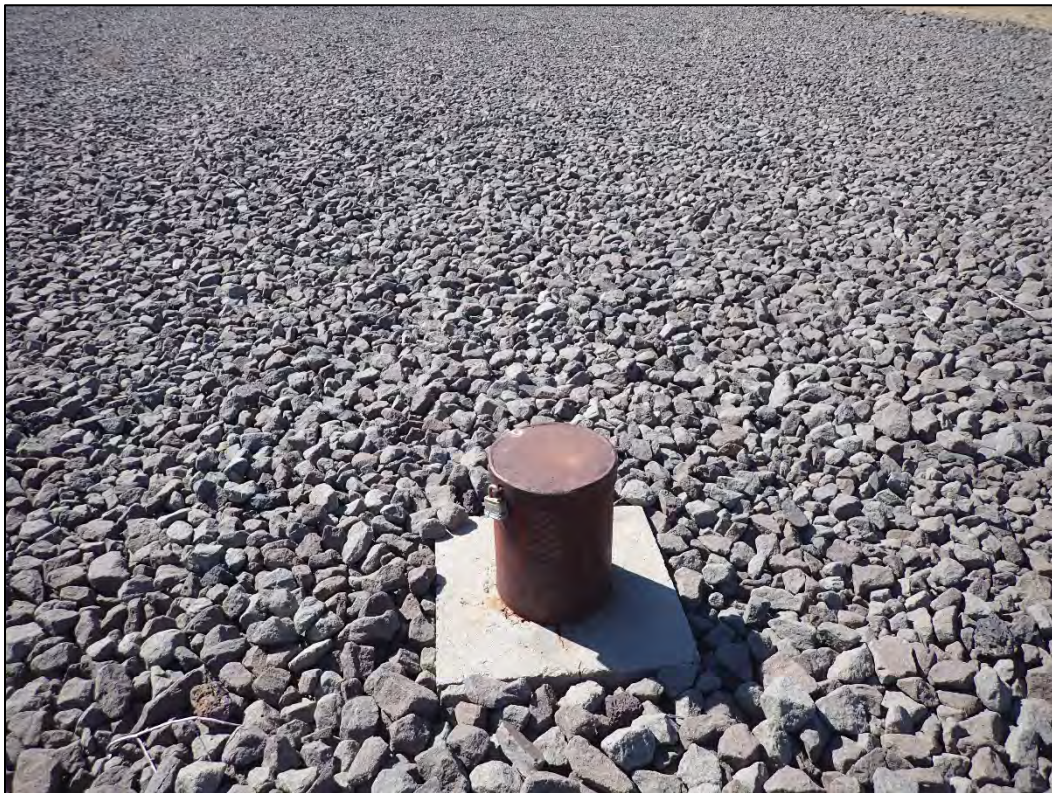
The disposal cell, completed in 1994, occupies 91 acres and is armored with basalt riprap to control erosion and deter animal and human intrusion. The top slope showed no evidence of cracking, slumping, or erosion, and there was no indication of riprap degradation. A shallow depression around settlement plate SP-4, near the northeast corner of the disposal cell cover, was first noted during the 1997 inspection and continued to grow in depth and area in subsequent years. The depression was repaired in August 2005. Visual observations during the 2017 annual inspection indicated that very minor additional settlement may have occurred since the depression was repaired. The area was inspected during the 2021 annual inspection, and settlement was shallow enough that it was determined not to have changed significantly (PL-8). Inspectors will continue to monitor this area.

*PL-8. Settlement Plate SP-4 on Disposal Cell Top*

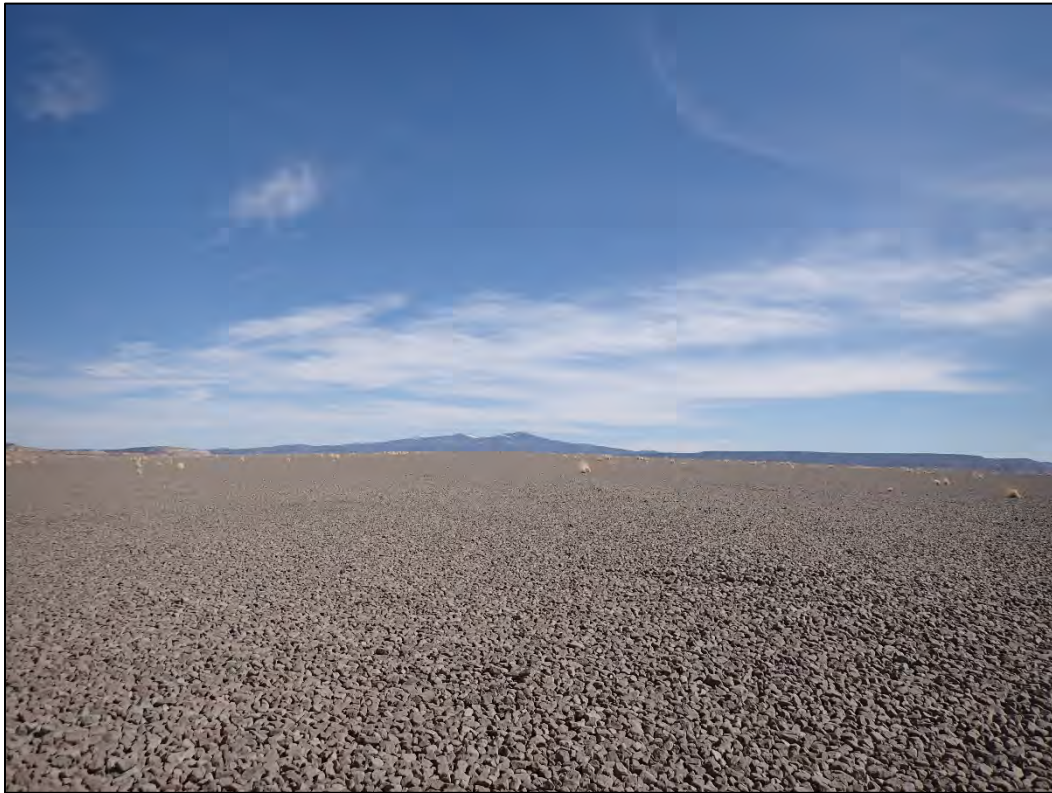
Scattered annual weeds and perennial grasses and forbs are growing on the disposal cell top (PL-9). In accordance with the LTSP, deep-rooted shrubs are to be removed from the disposal cell cover. No deep-rooted shrubs were noted during the inspection. No maintenance needs were identified.

*PL-9. Top Slope of Disposal Cell*

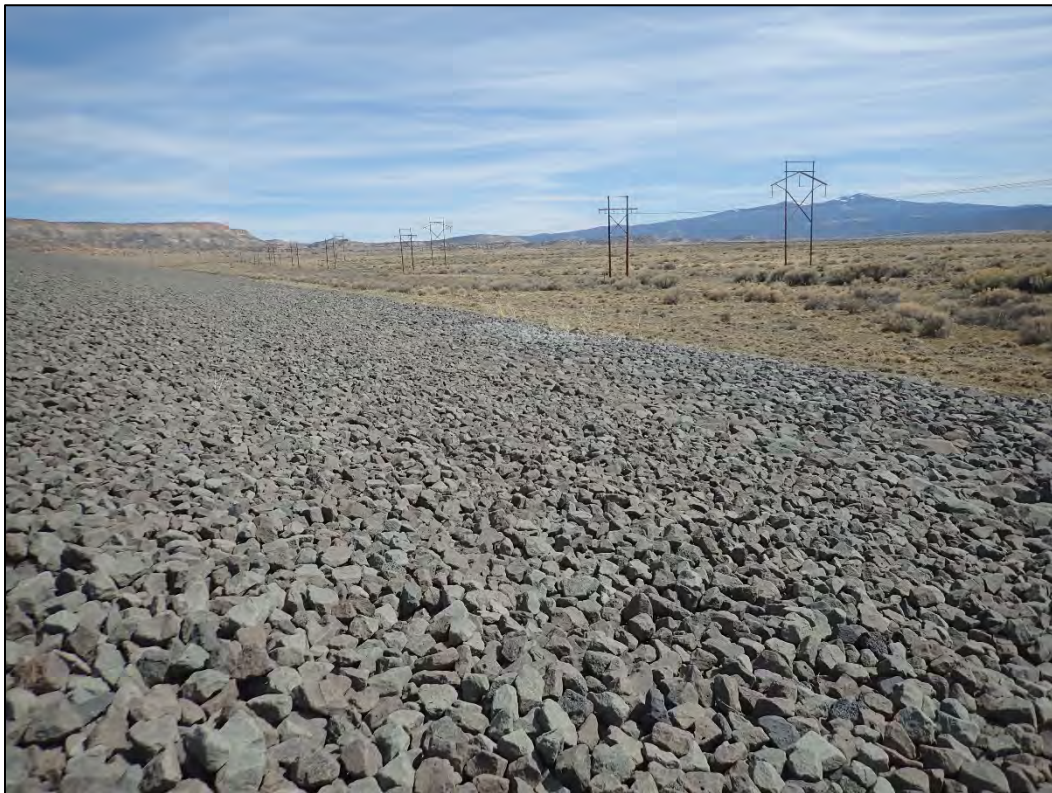
The basalt riprap-covered side slopes and apron showed no evidence of erosion, settling, slumping, or cracking. Standing water is occasionally observed in a portion of the south apron, but the area was dry during the inspection (PL-10). This location is the topographic low spot along the base of the disposal cell, and stormwater runoff collects in this area. No significant changes in the potential desiccation crack and small rills at the base of the disposal cell were observed. Inspectors will continue to monitor this area. No maintenance needs were identified.

*PL-10. Ponding Areas Along South Side Slope of Disposal Cell (Dry)*

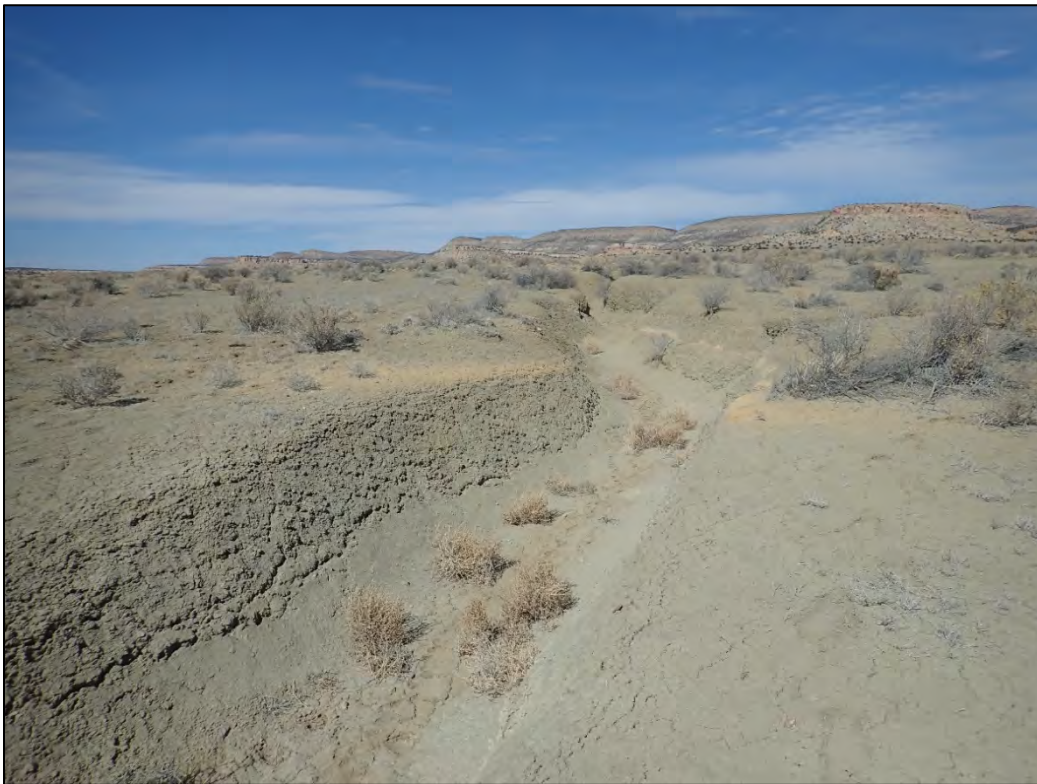
*PL-12. Erosional Gully Northeast of Disposal Cell*

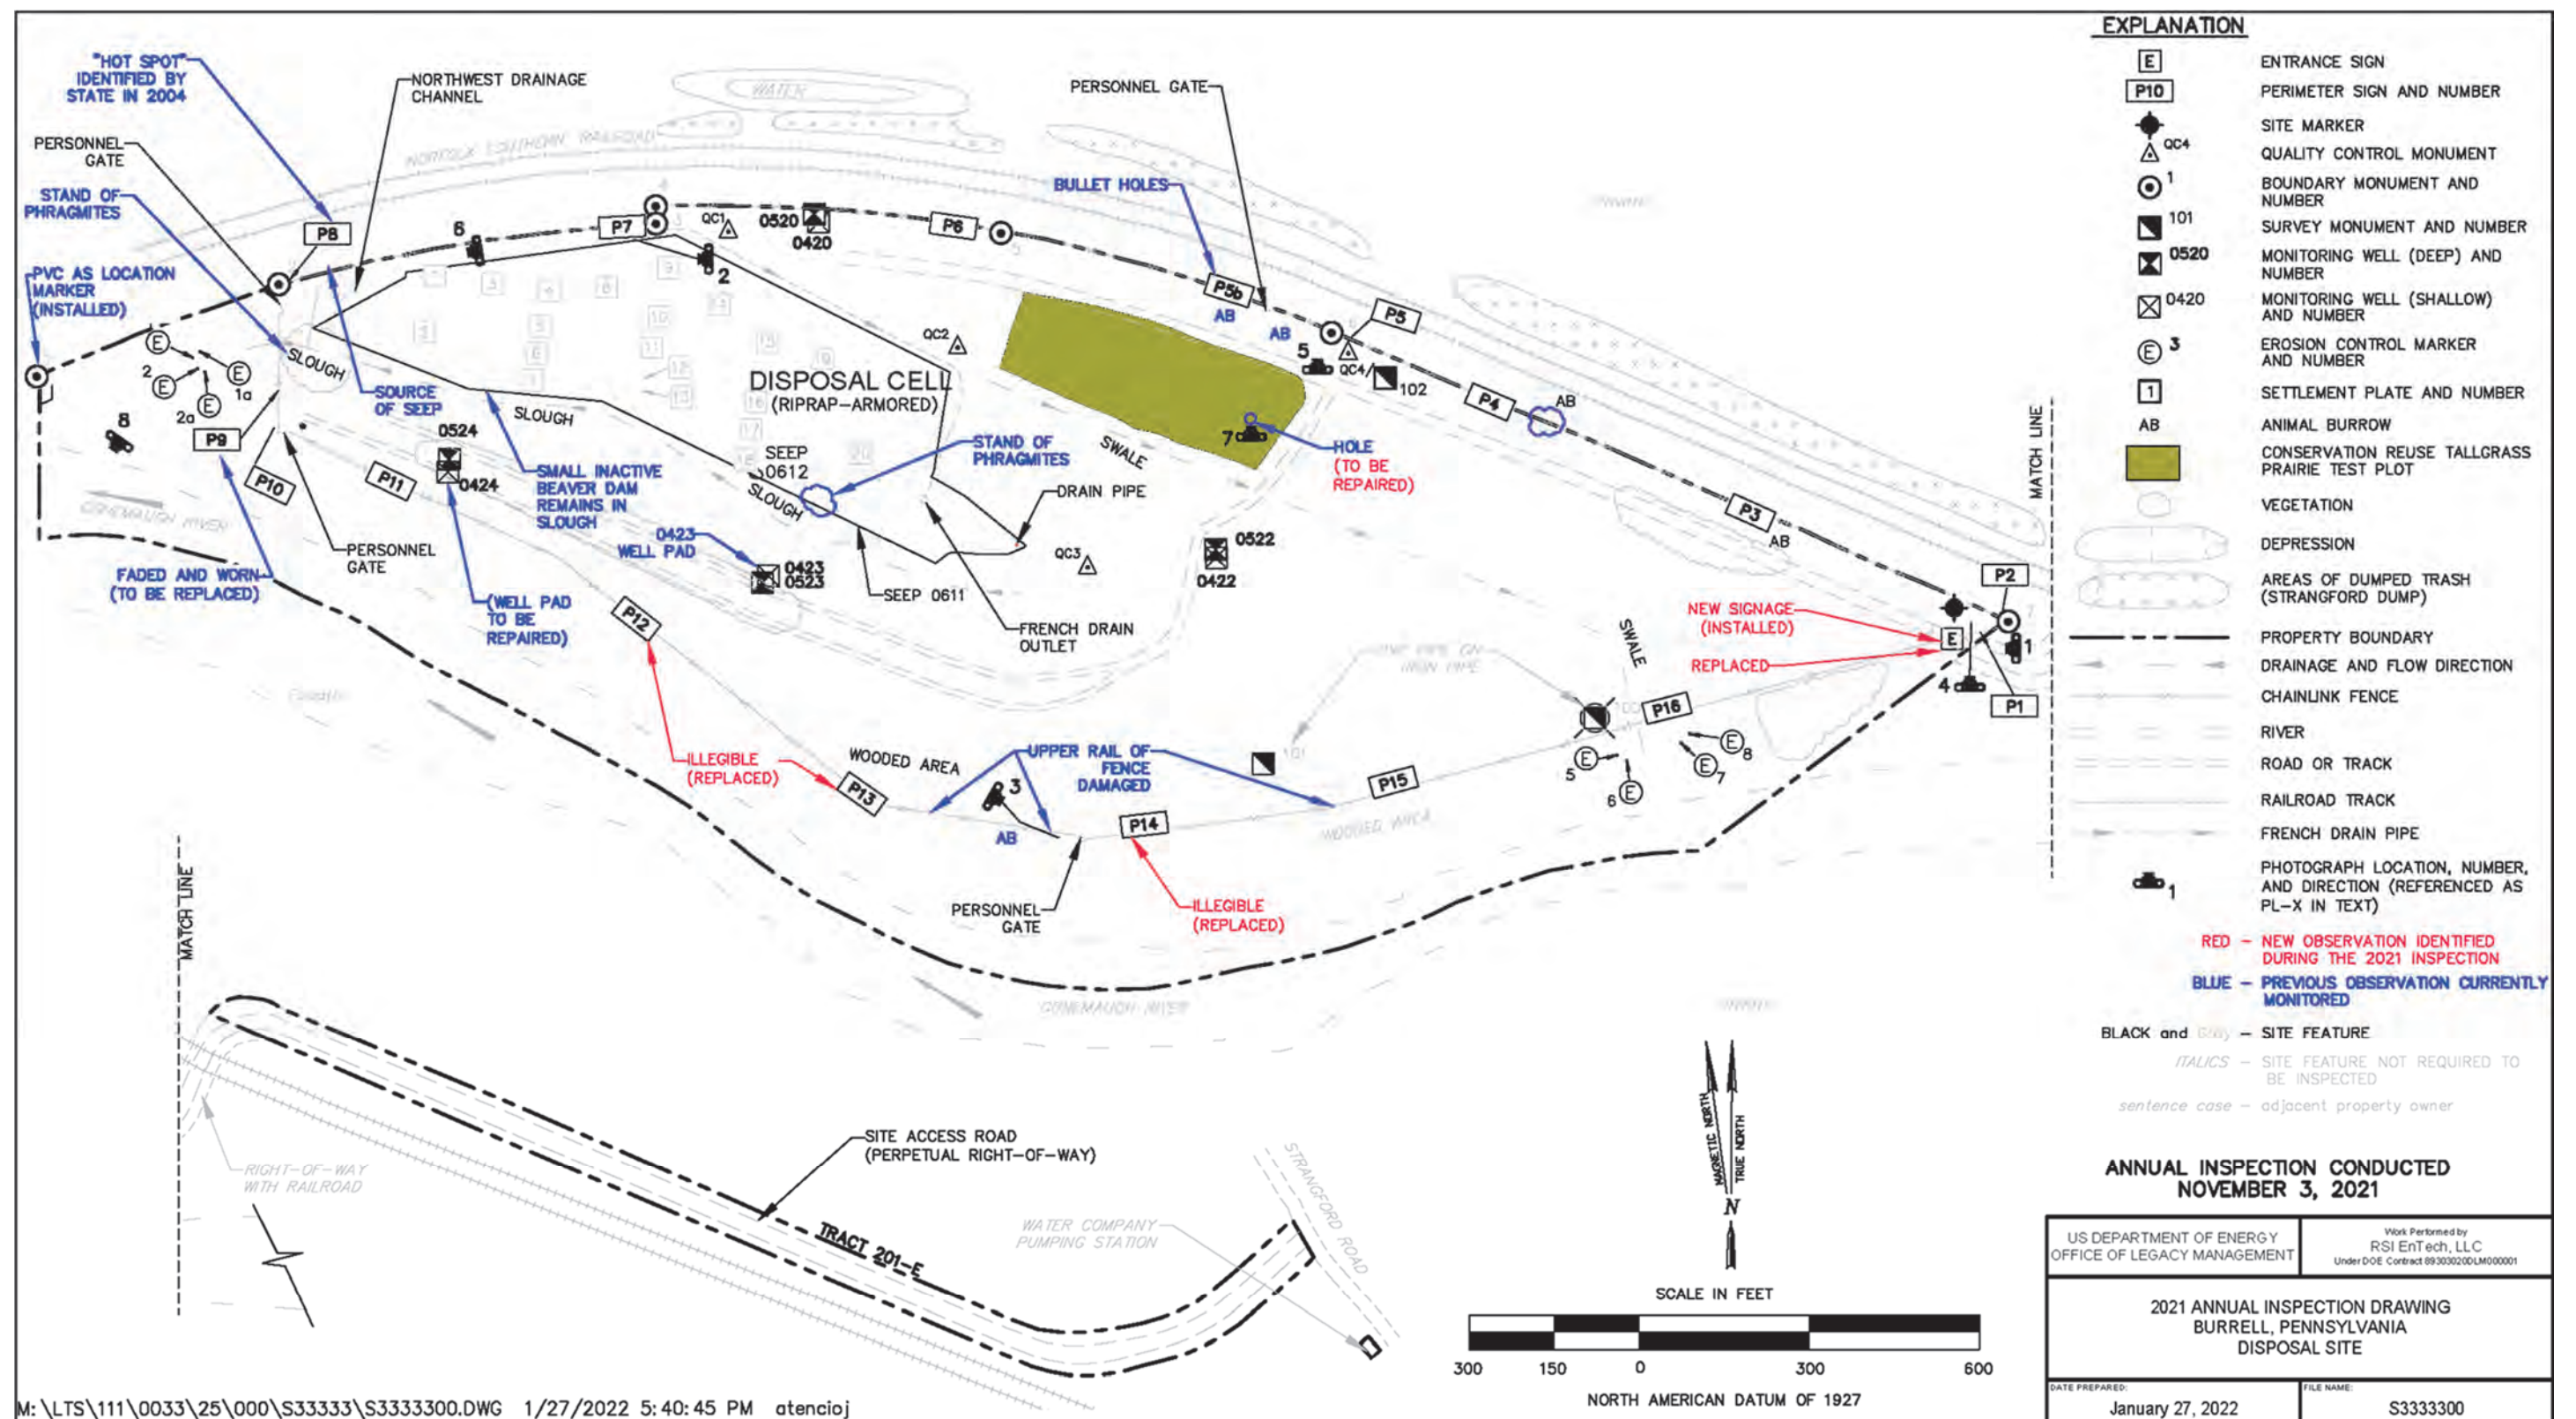
Figure 2-1. 2021 Annual Inspection Drawing for the Burrell, Pennsylvania, Disposal Site

There are 17 perimeter signs attached to the outside of the security fence. All perimeter signs were present. Perimeter sign P5b on the north fence has some bullet holes but is legible. Three perimeter signs (P12, P13, and P14) along the south fence that were faded and becoming illegible were replaced during the inspection. Perimeter sign P9 that has been faded and worn for some time will be replaced when conditions allow. No other maintenance needs were identified.

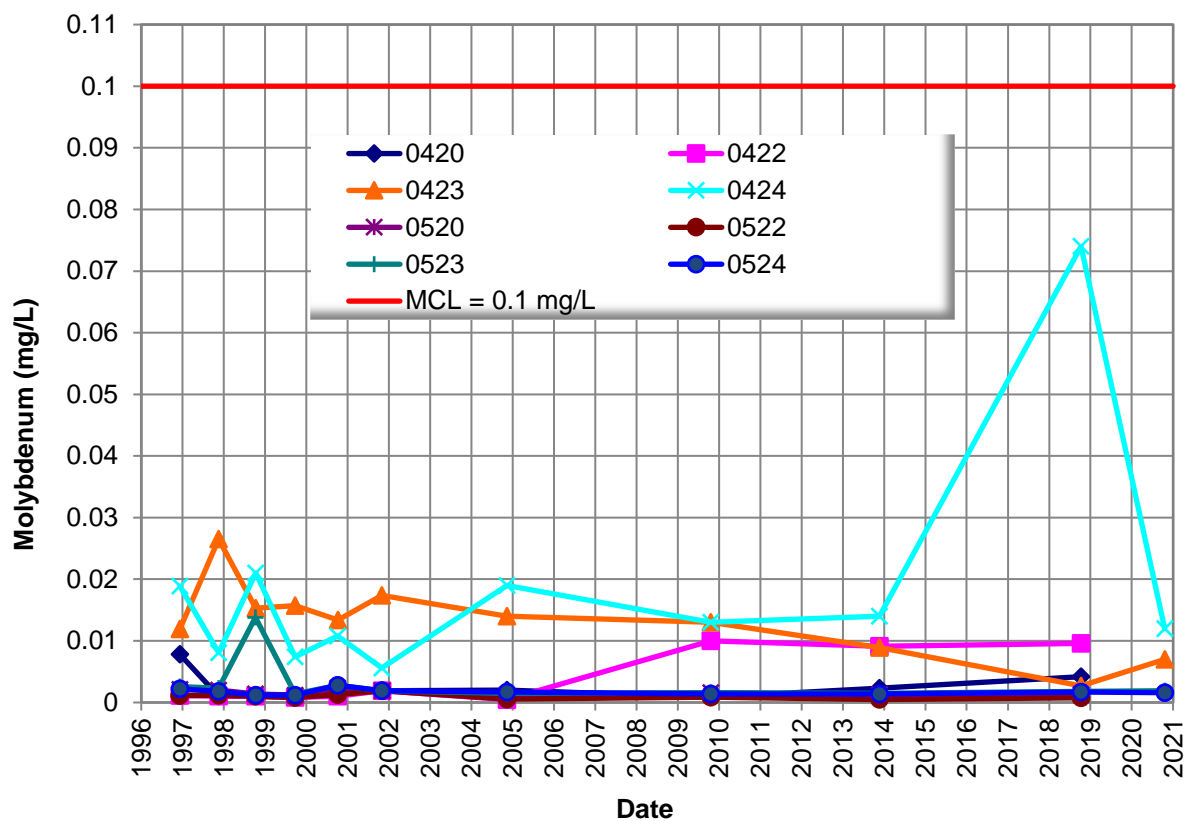
Figure 2-3. Molybdenum in Groundwater at the Burrell, Pennsylvania, Disposal Site

The molybdenum concentration measured in monitoring well 0424 in 2020 was 0.012 milligrams per liter (mg/L), which shows that the potentially significant increasing trend between 2013 and 2018 was not persistent (Figure 2-3). Concentrations for lead, selenium, and uranium measured in 2020 were all well below their respective MCLs (Figure 2-4, Figure 2-5, and Figure 2-6). Lead showed a downward trend in well 0423 (Figure 2-4) and uranium showed a downward trend in wells 0423 and 0424 (Figure 2-6). Selenium has an upward trend for all wells, but concentrations remain below the respective MCL (Figure 2-5). Selenium trends will be evaluated again in 2023 after the next schedule 5-year sampling event.

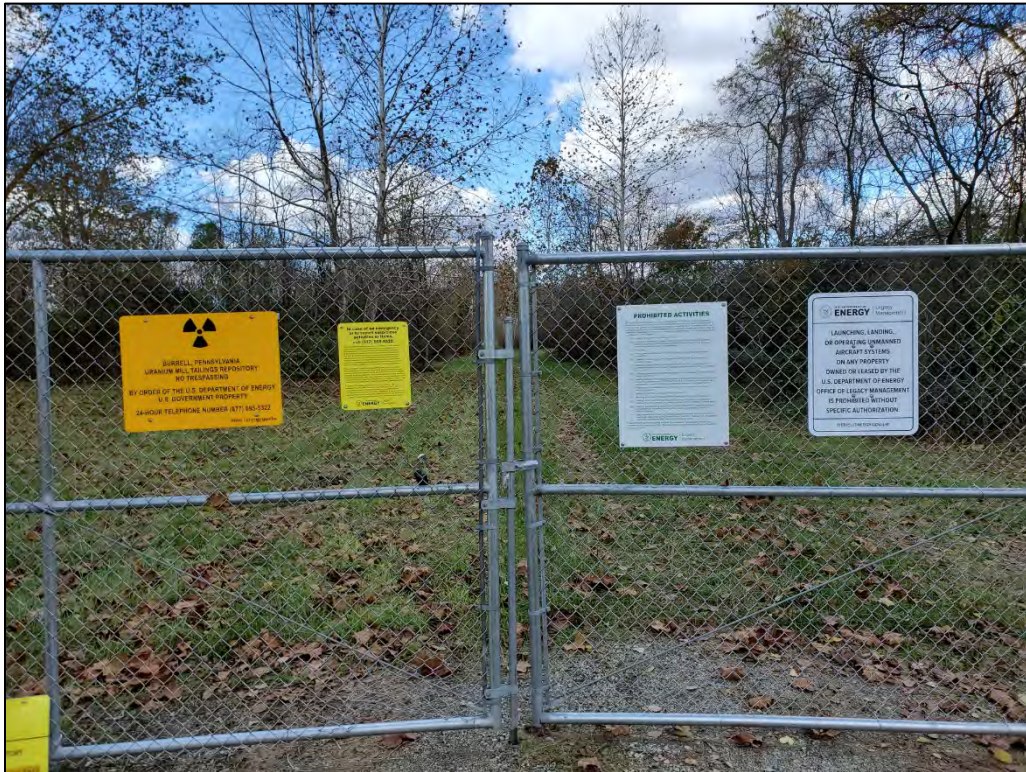
*PL-1. Front Gate with New Signage*

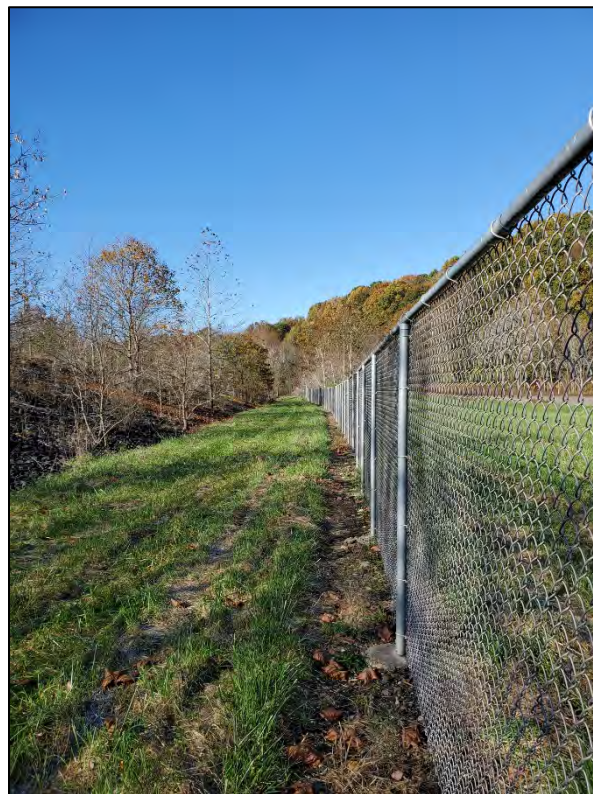
A chainlink security fence encloses the disposal cell and drainage features (PL-2). The site herbicide subcontractor keeps the fence line clear of vegetation, which should prolong the life of the security fence. Trees felled by strong storms have bent the upper rail of the south fence in a few spots, but the fence remains serviceable, and repairs are not required at this time (PL-3).

*PL-2. North Fence Line*

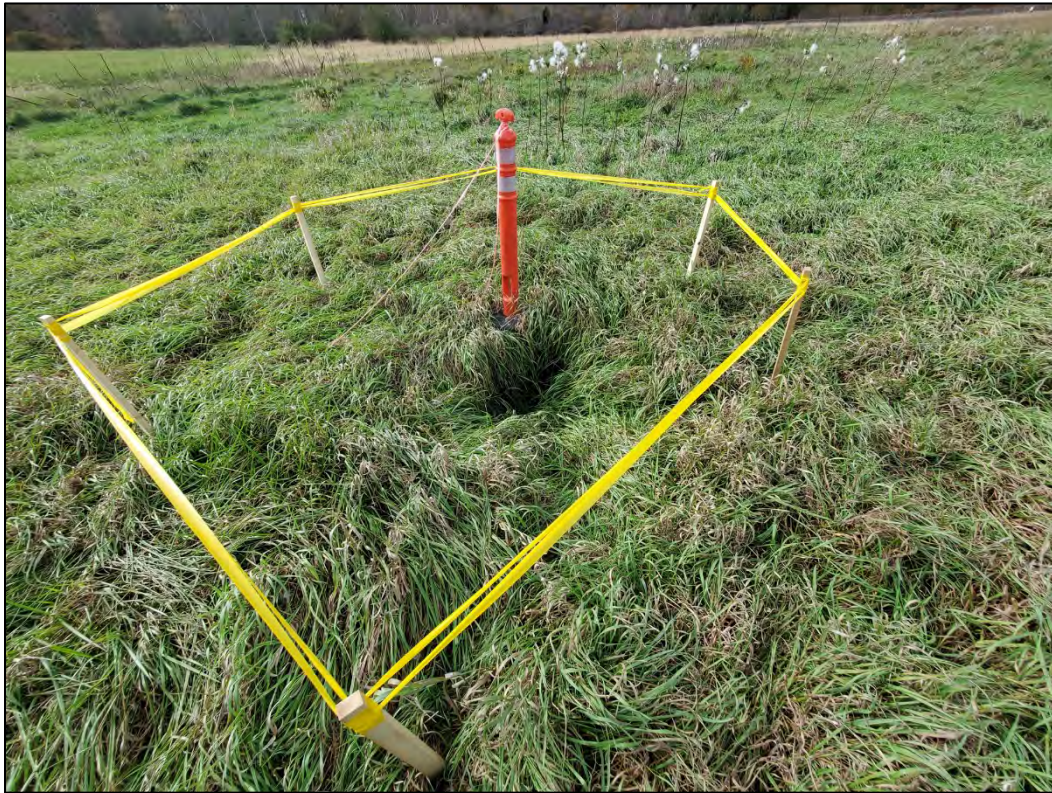
*PL-7. Hole on East End of Test Prairie*

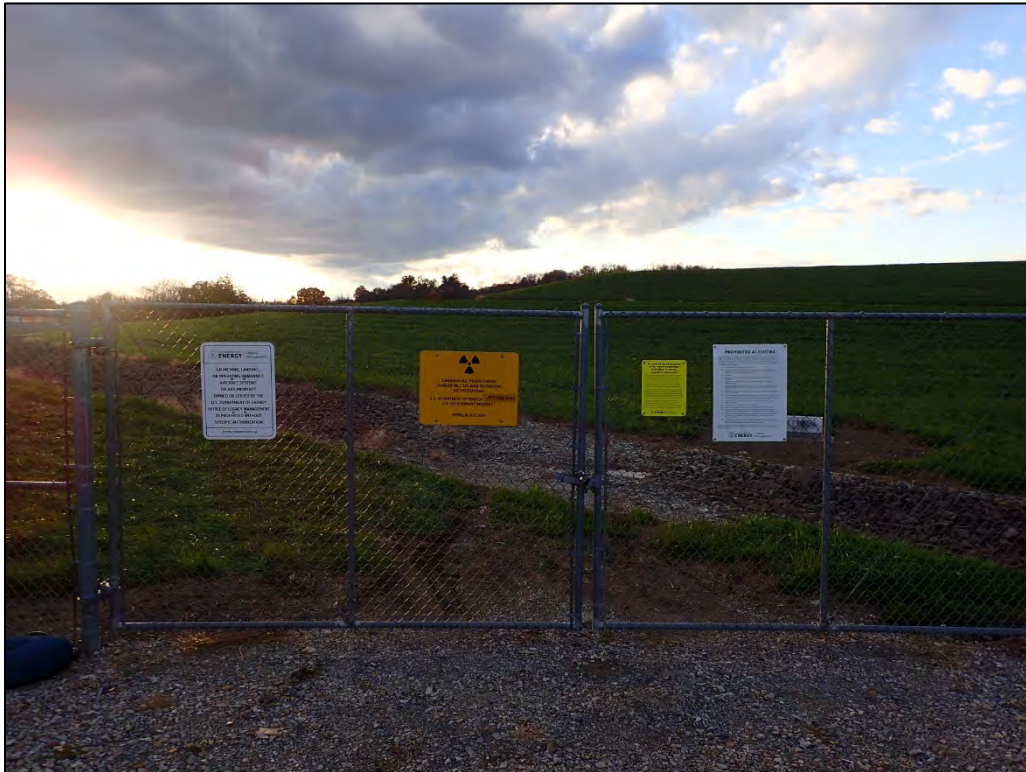
Main access to the site is from Strabane Avenue. There are three vehicle gates: the main entrance gate at the southeast corner of the site along Strabane Avenue, a vehicle access gate at the southwest corner of the site, and a vehicle access gate north of the disposal cell between perimeter signs P8 and P9. There are also two personnel access gates. All gates were locked and functional. The entrance sign is posted on the main entrance gate. Three additional information signs were also posted on the main entrance gate during the inspection (PL-1). No maintenance needs were identified.

*PL-1. Signage on Entrance Gate*

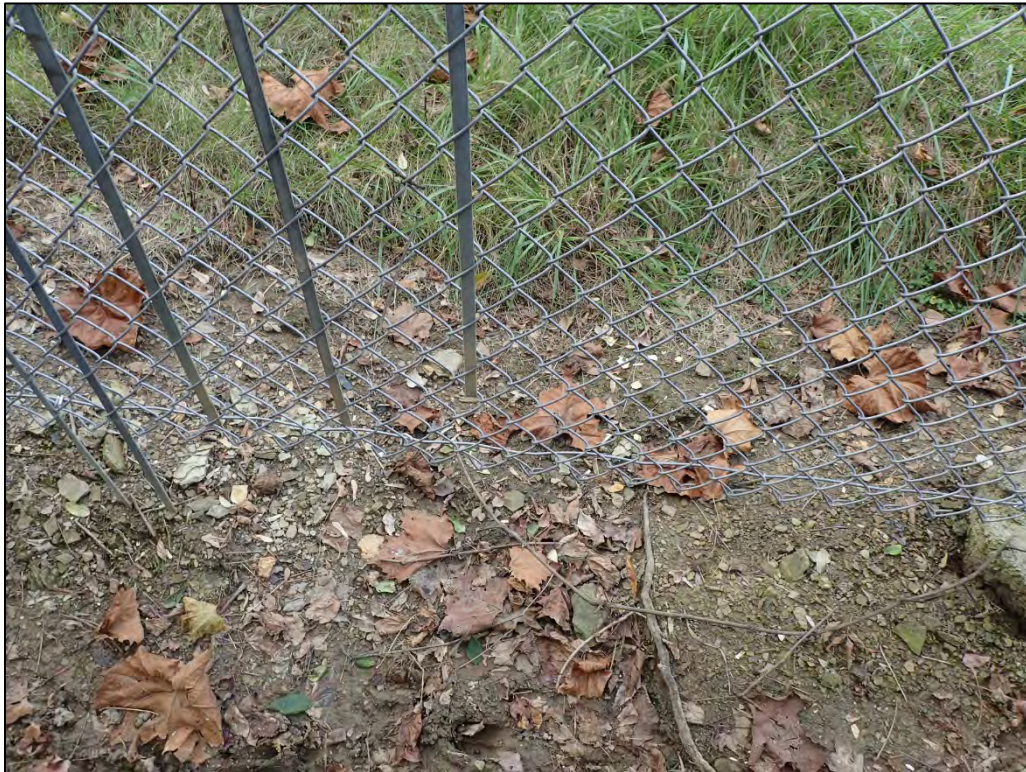
*PL-3. Erosion Area Under West Fence*

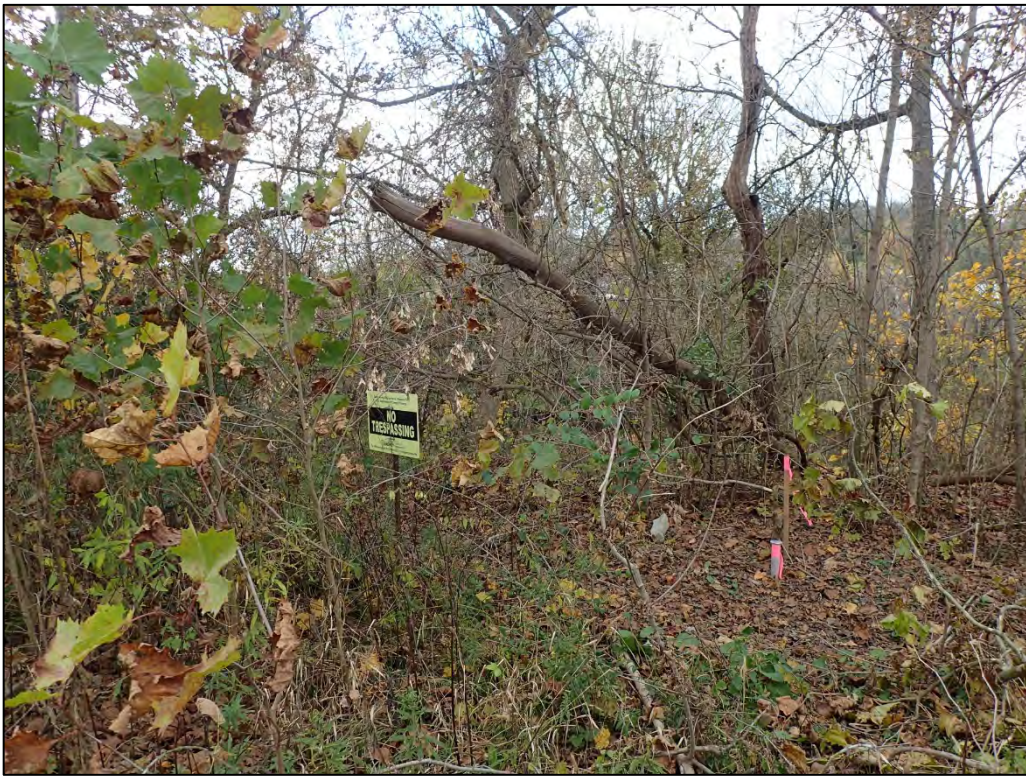
*PL-6. New Southwest Boundary Monument BM-5*

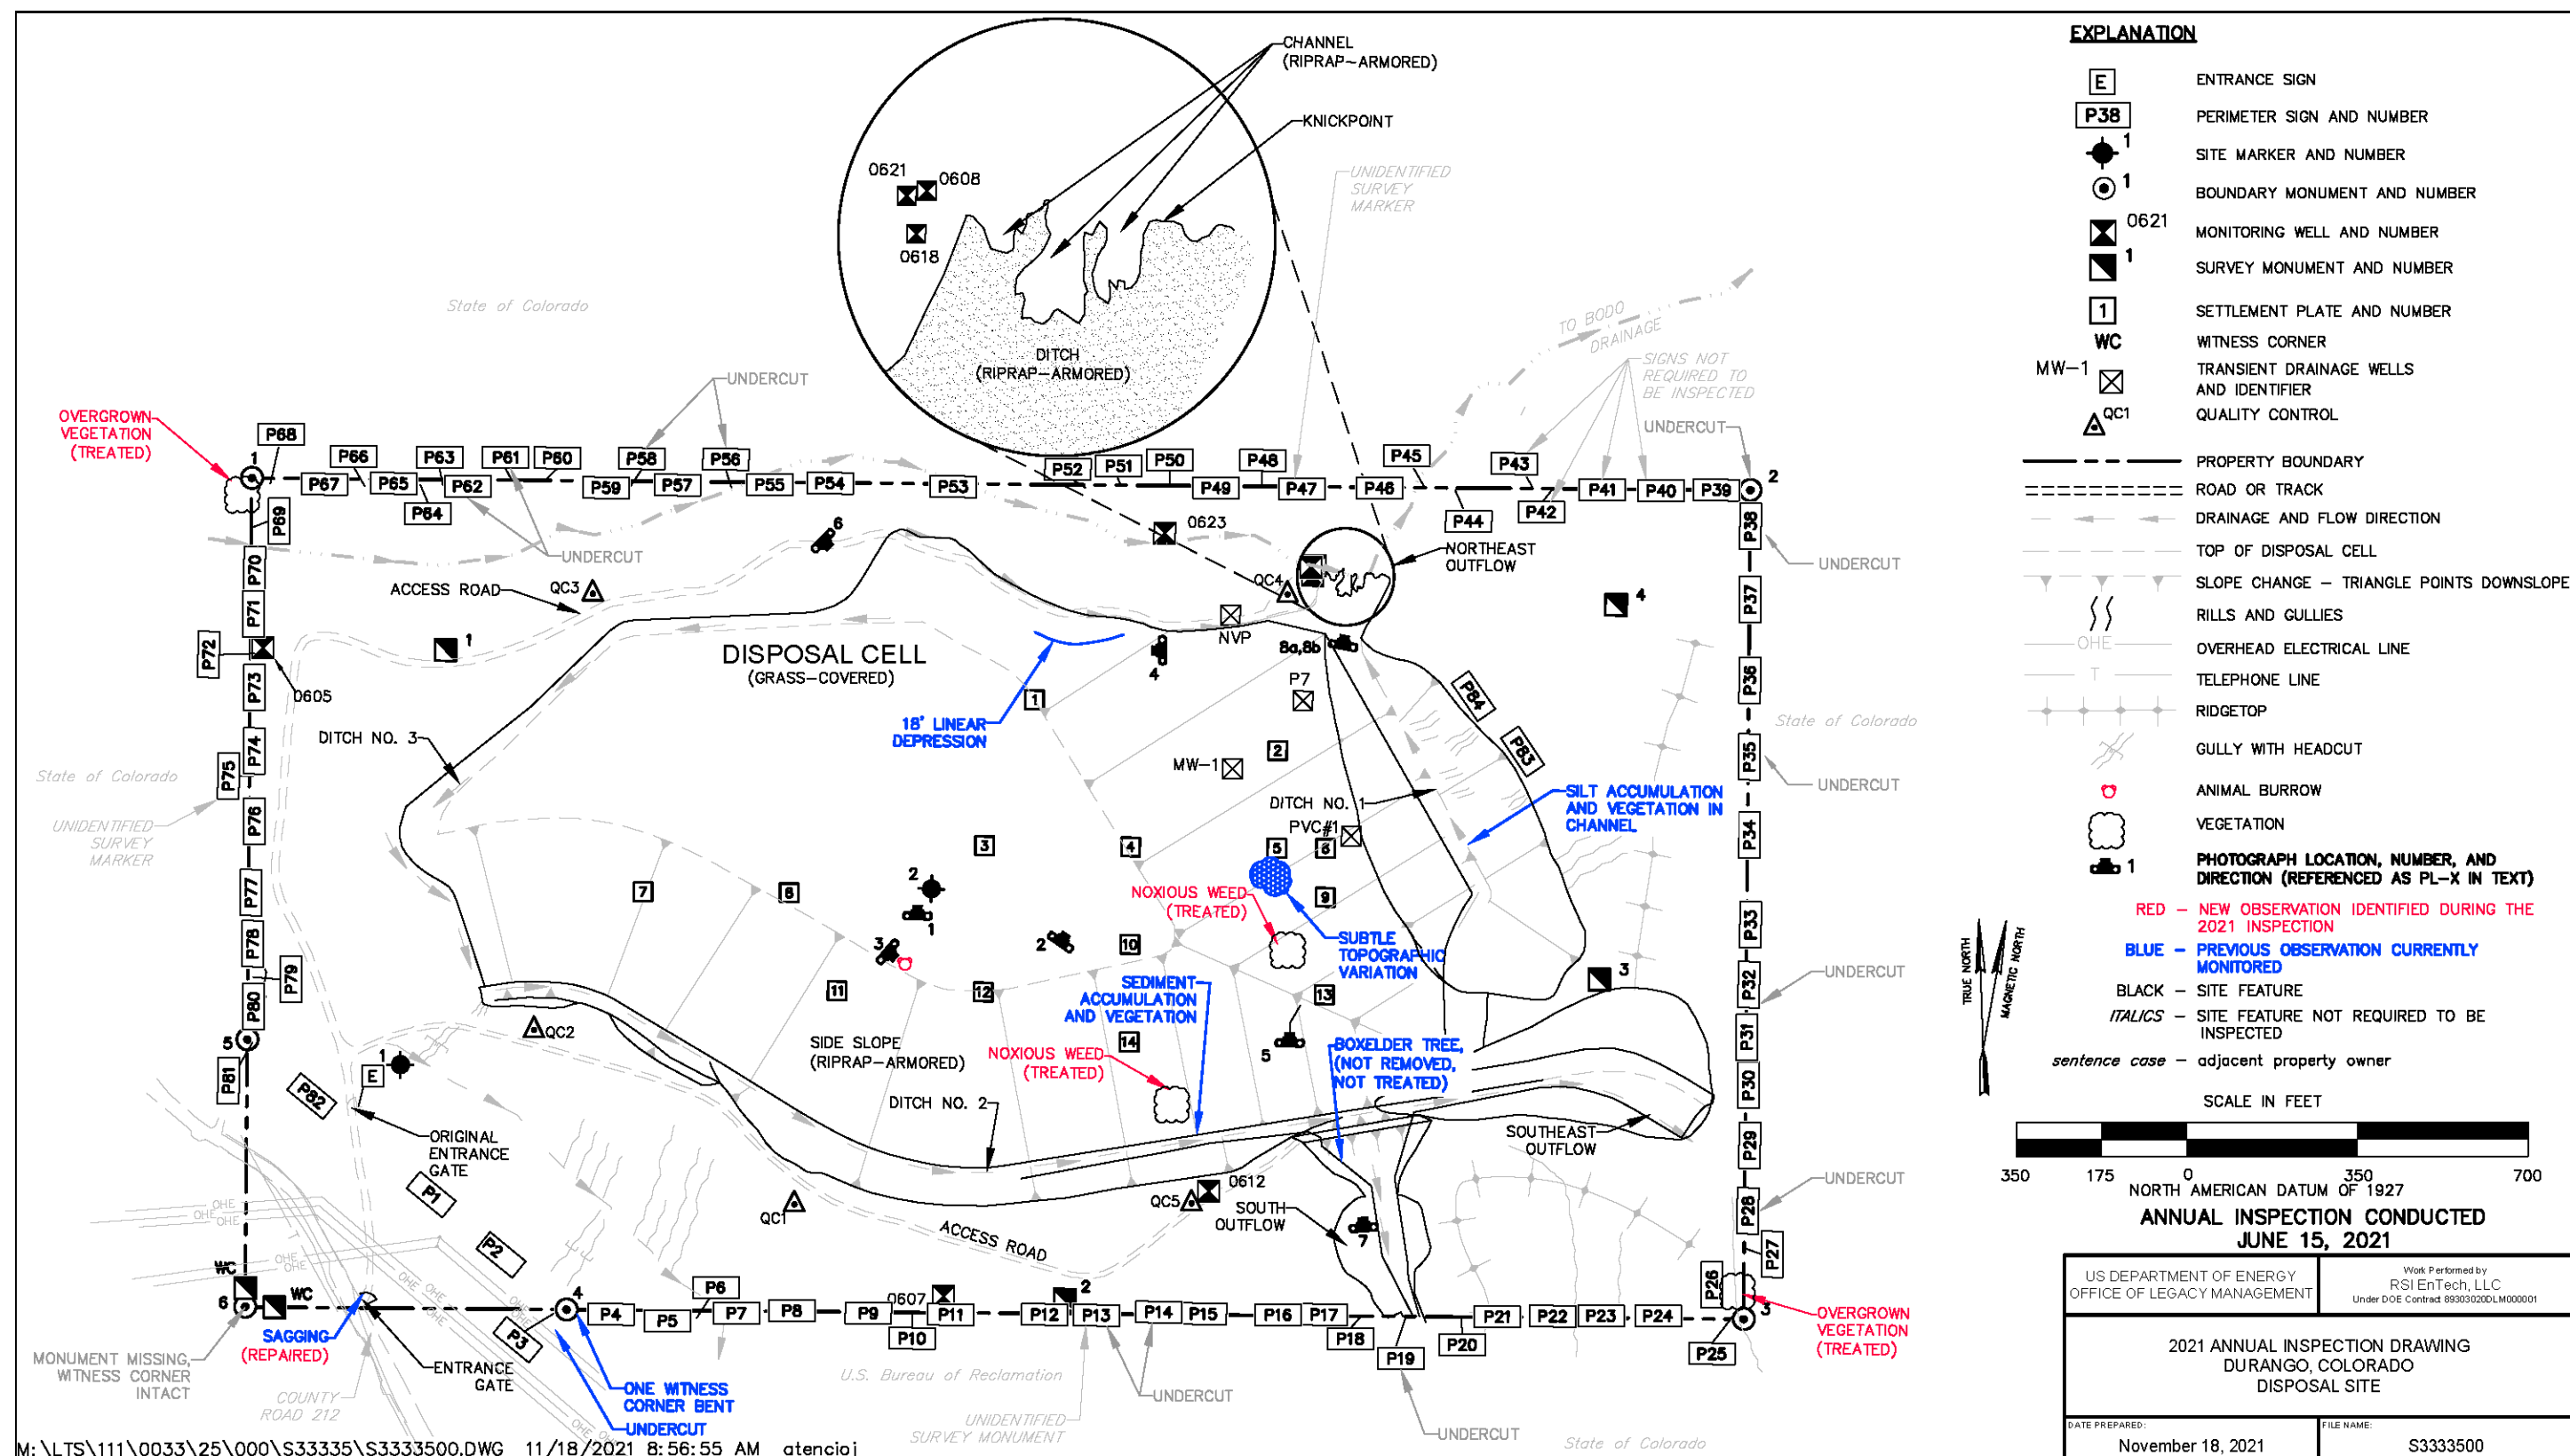
Figure 4-1. 2021 Annual Inspection Drawing for the Durango, Colorado, Disposal Site

Inspectors noted no change in depth or length of the linear depression on the toe of the northeast side slope. LM will continue monitoring the linear depression to understand its cause and potential impacts. No changes were observed on the top of the disposal cell or associated drainage features. Inspectors identified several maintenance needs that will be addressed.

Inspectors noted that perimeter sign P26 is surrounded by vegetation that was treated after the inspection. The concrete bases of several perimeter signs continue to be undercut, but the positions of the signs remain uncompromised. No other maintenance needs were identified.

The side slopes of the disposal cell are armored with rock riprap. Rock has moved along the north toe of the disposal cell, resulting in a linear depression approximately 18 feet (ft) long (PL-4) that first was observed in 2015 and continues to be monitored. Inspectors did not observe significant changes to the depression. Inspectors will continue to monitor this area.

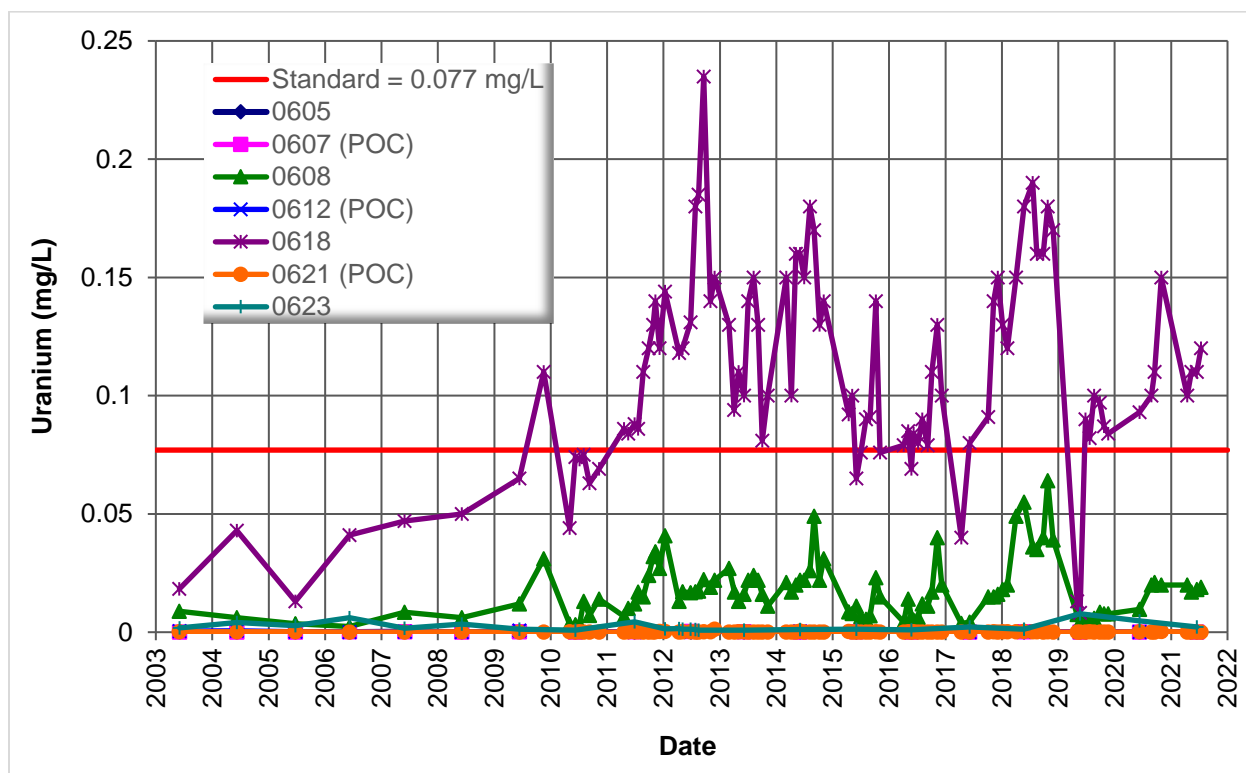
Figure 4-5. Uranium Concentrations in Groundwater at the Durango, Colorado, Disposal Site

Wells completed in the alluvium are sampled as a BMP. Uranium concentrations in well 0618 have consistently been higher than concentrations in the other onsite wells. To monitor and compare the elevated and variable uranium concentrations observed in this well, BMP wells 0608, 0618, and 0621 are sampled monthly as weather permits. Figure 4-5 shows variable uranium concentrations between 0.0082 milligrams per liter (mg/L) and 0.235 mg/L in well 0618 beginning in 2009 and continuing to the present. Uranium concentrations in well 0618 were measured at 0.12 mg/L in July 2021, which is within the range of measured historical concentrations. The cause of the variability in uranium concentration at well 0618 will be a focus of further investigation.
