## 2021 Annual Site Inspection and Monitoring Report for Uranium Mill Tailings Radiation Control Act Title I Disposal Sites

March 2022

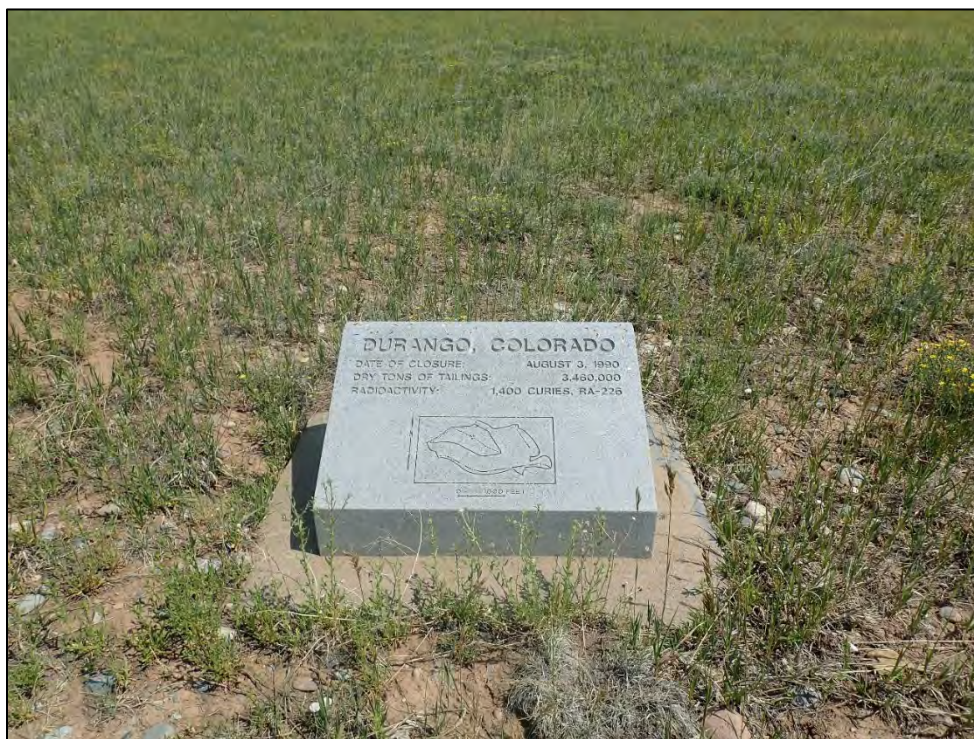
The site has two site markers. Site marker SMK-1 is just inside the original entrance gate and was in good condition. Site marker SMK-2 (PL-1) is on the top slope of the disposal cell. No new maintenance needs were identified.

*PL-1. Site Marker SMK-2*

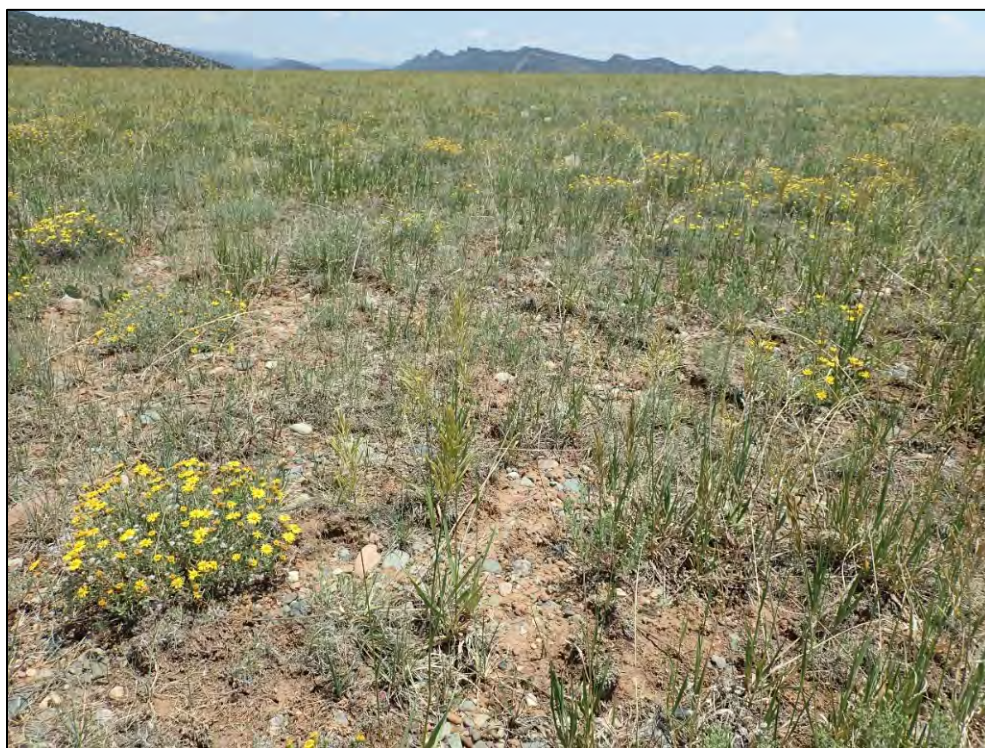
The disposal cell, completed in 1990, occupies 60 acres (PL-2). It has a vegetated cover consisting primarily of perennial grasses and broadleaf plants. There was no evidence of erosion, settling, slumping, or other modifying processes on top of the disposal cell. Several small animal burrows were observed on the cell top-slope (PL-3) but are shallow and do not require repairs. Several noxious weeds were found on the top slope and will be treated following the inspection. No other maintenance needs were identified.

*PL-2. Diverse Vegetation on Top Slope*

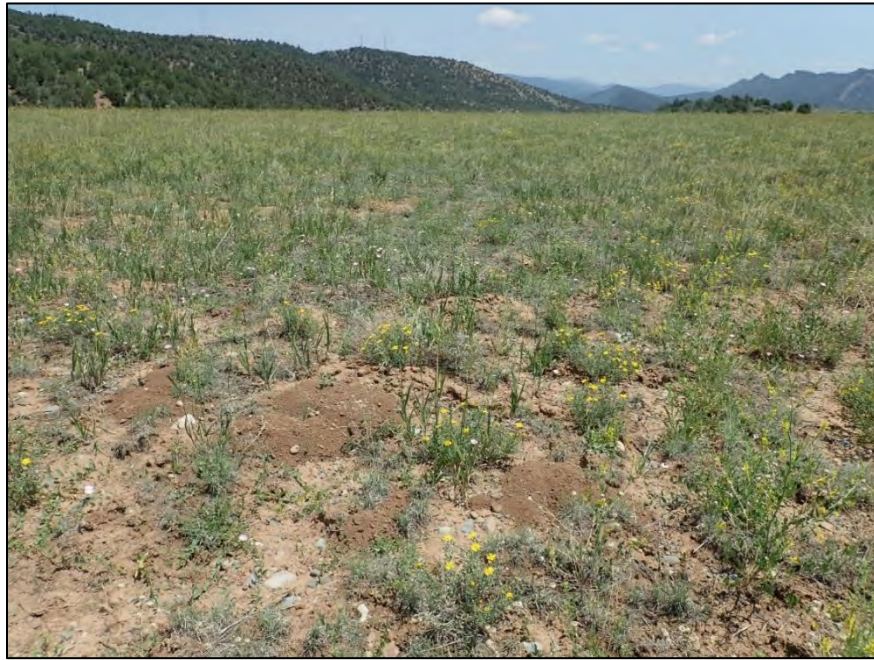
*PL-3. Animal Burrows on Top Slope*

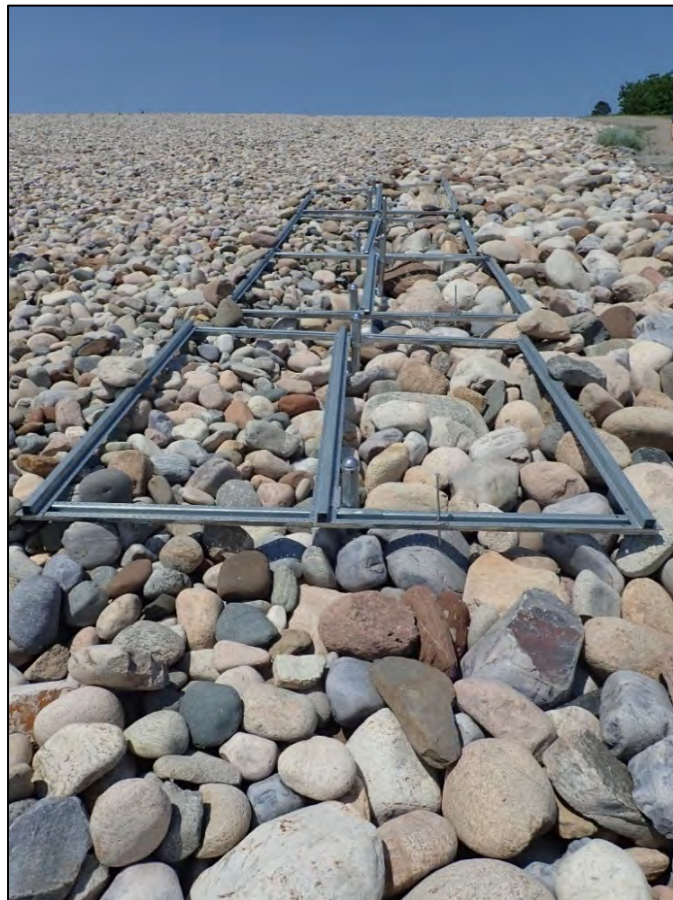
The side slopes of the disposal cell are armored with rock riprap. Rock has moved along the north toe of the disposal cell, resulting in a linear depression approximately 18 feet (ft) long (PL-4) that first was observed in 2015 and continues to be monitored. Inspectors did not observe significant changes to the depression. Inspectors will continue to monitor this area.

*PL-4. Monitoring Grid over Linear Depression*

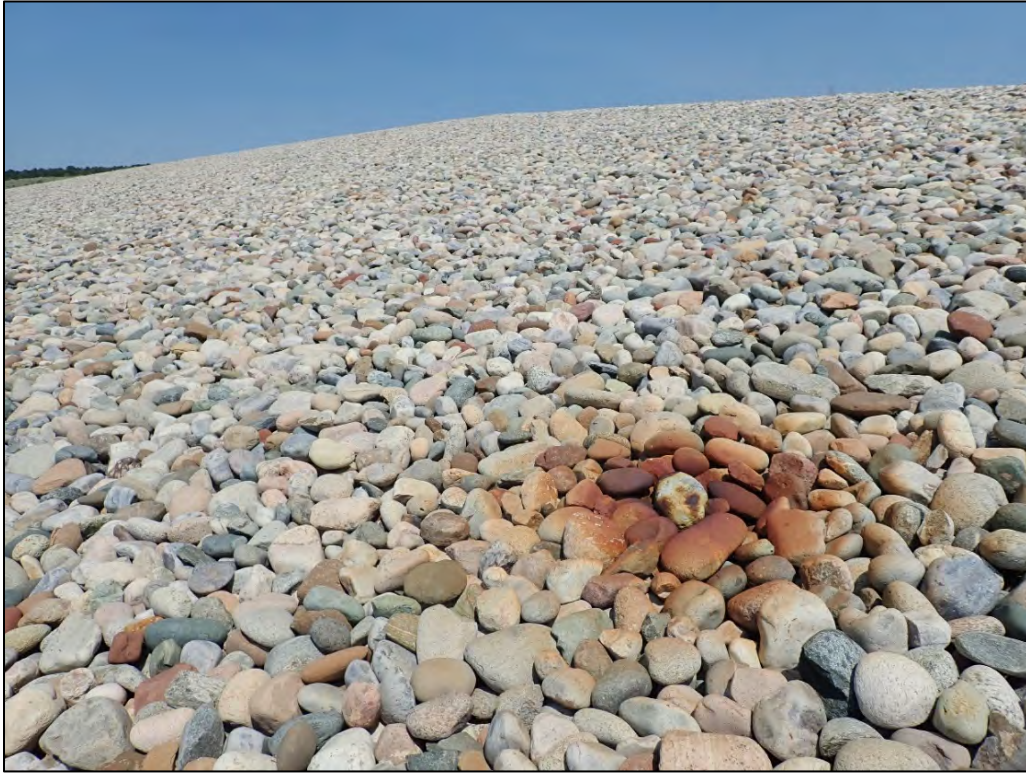
Inspectors found several young volunteer trees and several noxious weeds growing on the side slopes. The noxious weeds were treated after the inspection. Inspectors noted several points on the side slopes that had sustained lightning strikes (PL-5). No other maintenance needs were identified.

*PL-5. Lightning Strike on Side Slope*

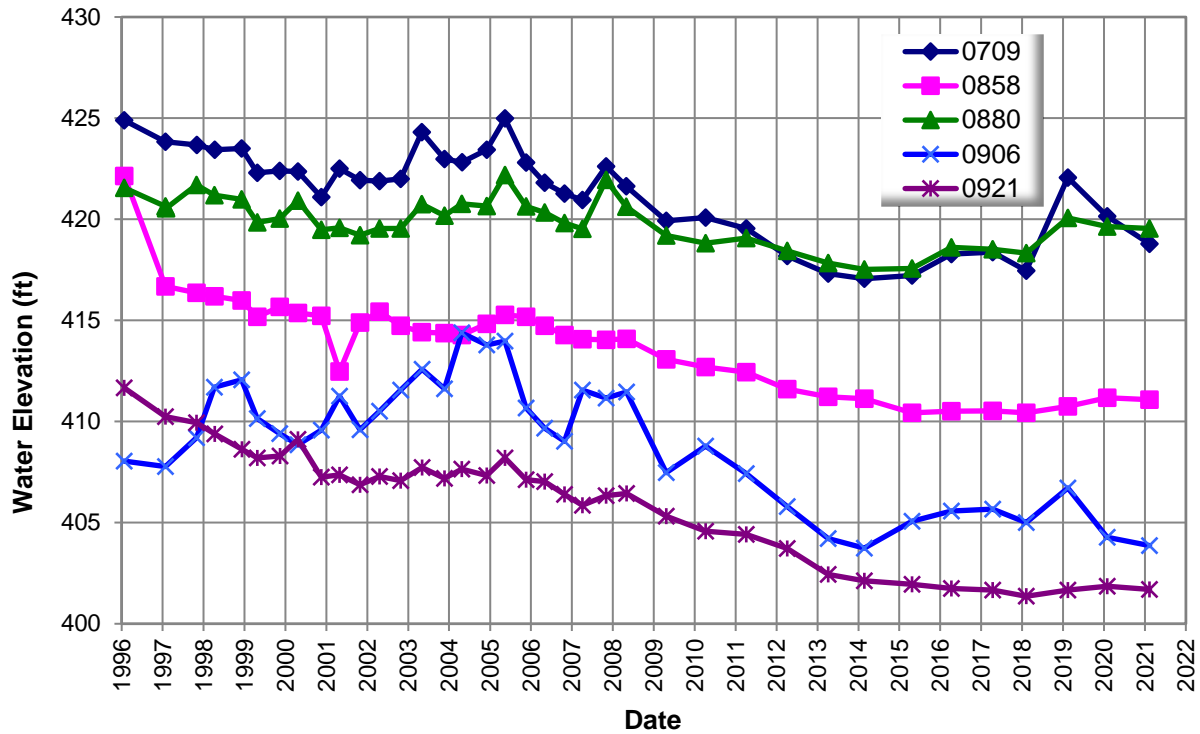
Figure 5-3. Water-Level Measurements at Disposal Cell Performance Monitoring Wells at the Falls City, Texas, Disposal Site

Water levels in all disposal cell performance wells had decreasing trends from 1996 to 2014 based on Mann-Kendall trend analyses (Figure 5-3). Water levels in these wells appear to have stabilized by 2014, but wells 0709, 0880, and 0906 have had increases in water level since 2014, which are more subtle in wells 0858 and 0921 (Figure 5-3). Groundwater compliance wells 0862, 0886, and 0963 had significant increasing water level trends since 1996, and wells 0891 and 0924 had no statistically significant trend (Figure 5-4). Wells with increasing water level trends each had a water elevation increase of about 5 ft since 1996.

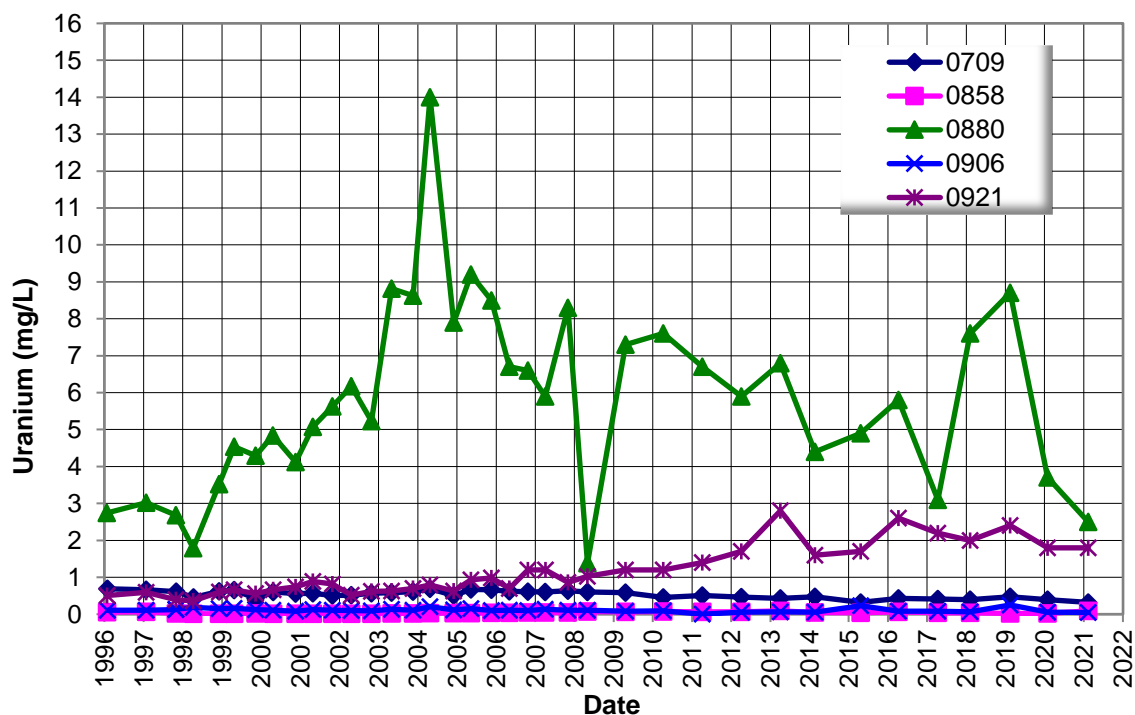
Figure 5-7. Uranium Concentrations at Disposal Cell Performance Monitoring Wells at the Falls City, Texas, Disposal Site

**Uranium:** The 2021 uranium concentrations for disposal cell performance monitoring wells were within the range of historical values for all groundwater compliance monitoring wells (Figure 5-7). In 2021, the uranium concentrations for monitoring wells 0709, 0906, and 0858 remained generally constant when compared with previous results. The uranium concentration in monitoring wells 0921 and 0880 decreased. Uranium concentrations in monitoring well 0880 show considerable variation, ranging from a high of 14 milligrams per liter (mg/L) in 2004 to a low of 1.38 mg/L in 2008. The 2021 uranium concentrations for groundwater compliance monitoring wells were within the range of historical values for all groundwater compliance monitoring wells (Figure 5-8).

Uranium concentrations in disposal cell performance monitoring well 0880 have varied considerably since 1996, ranging from 14 mg/L in 2004 to 1.38 mg/L in 2008 (Figure 5-7). The uranium concentration was 2.5 mg/L in 2021. The pH at this location is less than at other disposal cell performance monitoring wells. Water levels at all the cell performance monitoring wells trended lower from 2007 until 2016, then increased in recent years (Figure 5-3). Because the uranium concentrations at some of the cell performance monitoring wells have been steady and concentrations vary at other locations, local conditions are likely influencing uranium concentrations. This is reasonable because (1) the disposal cell is on tailings that were placed in existing open pit mines; (2) subeconomic ore remains in unmined areas; (3) the uppermost aquifer beneath the cell is oxidized and near the aquifer recharge area; and (4) uranium mineralization processes, which involve redistributing and concentrating uranium in the formation materials, are ongoing. Given local conditions, it is difficult to assess whether elevated uranium concentrations in the uppermost aquifer are a result of disposal cell performance or existing background conditions.

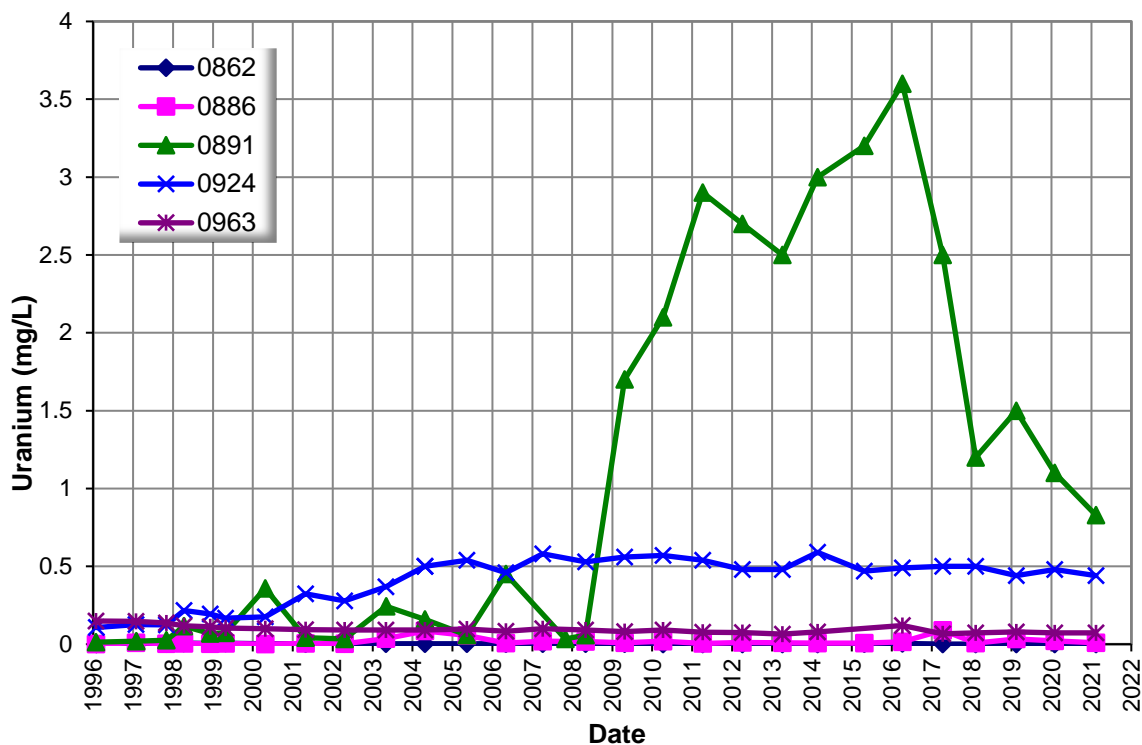
Figure 5-8. Uranium Concentrations in Groundwater Compliance Monitoring Wells at the Falls City, Texas, Disposal Site

The high uranium concentrations in groundwater compliance well 0891 since 2008, trending downward since 2016, likely reflects the passage of a groundwater with elevated uranium flowing from the direction of the former processing site. Historical data from upgradient monitoring wells that were abandoned in 2001 show a uranium anomaly moved past them (Figure 5-9) (DOE forthcoming). LM defined the groundwater flow directions in the Deweesville and the Dilworth aquifers and identified areas of low pH where tailings-derived fluids have consumed all the natural buffering capacity (DOE 2008; Figure 2-7; Figure 2-8). Monitoring well 0891 is completed in the Dilworth aquifer. Monitoring well 0963 (completed in the Deweesville Sandstone) is in a zone of low pH where groundwater in the Deweesville aquifer flows into the underlying Dilworth aquifer. Monitoring well 0966 is the next downgradient Dilworth aquifer well.

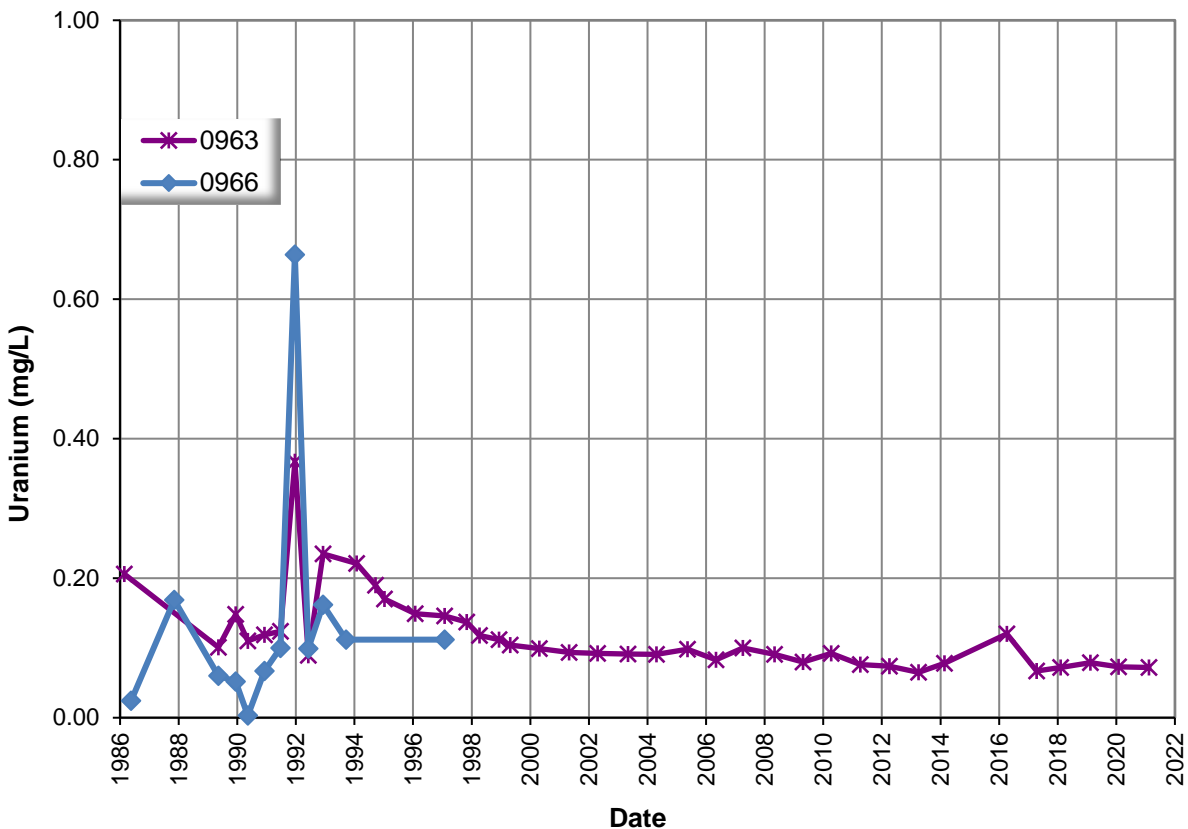
*Figure 5-9. Uranium Concentrations in Monitoring Wells 0963 (in the Deweesville aquifer) and 0966 (in the Dilworth aquifer)*

Figure 5-9 shows uranium concentration spikes in both wells (0963 and 0966) in 1992, with slowly declining uranium concentrations in 0963 over time (data for monitoring well 0966 are limited). This is likely due to an initial release of uranium and low pH tailings fluids during tailings deposition and subsequent acid leaching, with tailings removal by 1994 (DOE forthcoming). Monitoring well 0891 is the next Dilworth well directly downgradient of the low pH zone. Additionally, the elevated uranium at monitoring well 0891 is accompanied by elevated alkalinity and chloride, which also supports the conclusion that the elevated uranium is the result of passage of groundwater containing processing-related constituents.

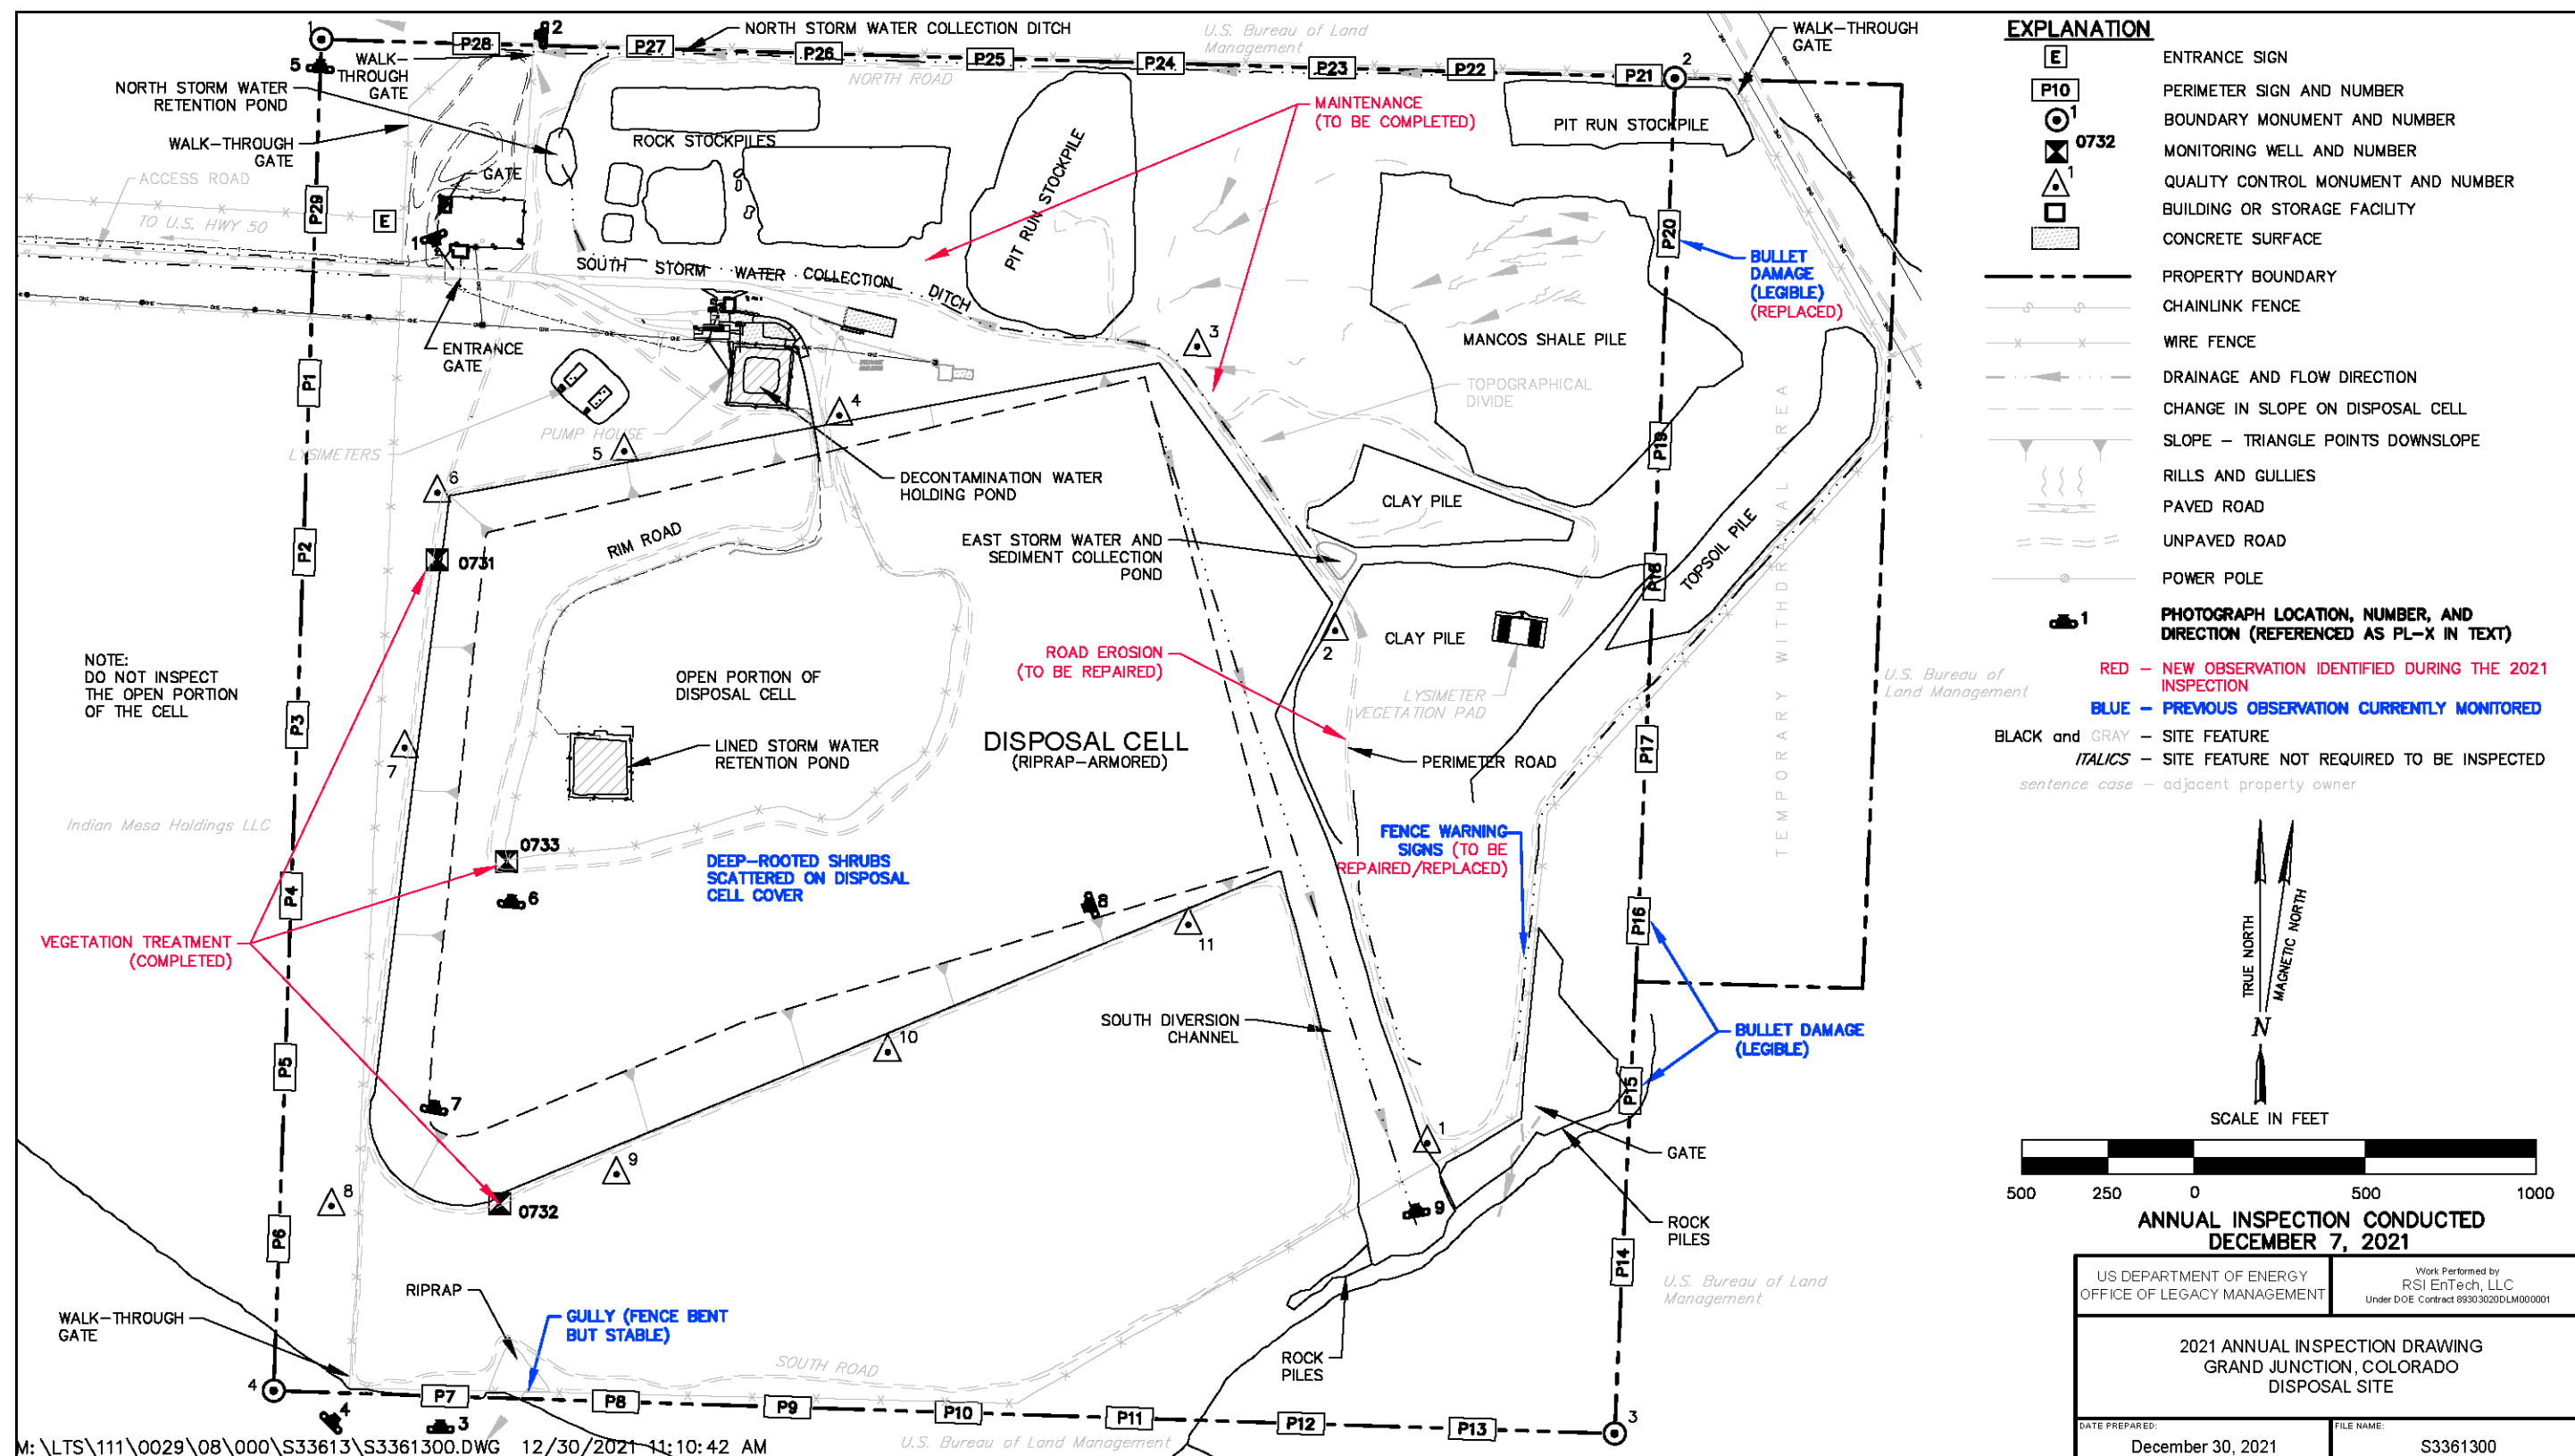
Figure 6-1. 2021 Annual Inspection Drawing for the Grand Junction, Colorado, Disposal Site

Most of the flat areas between the disposal cell and the site (property) boundary are vegetated with native shrubs, scant perennial grasses, and annual weeds. Localized erosion is present at two locations on the perimeter road adjacent to the east side of the disposal cell (Figure 6-1). Repairs to these areas will be completed with the ongoing maintenance of site stormwater collection ditches (Section 6.4.2.2). No other maintenance needs were identified.

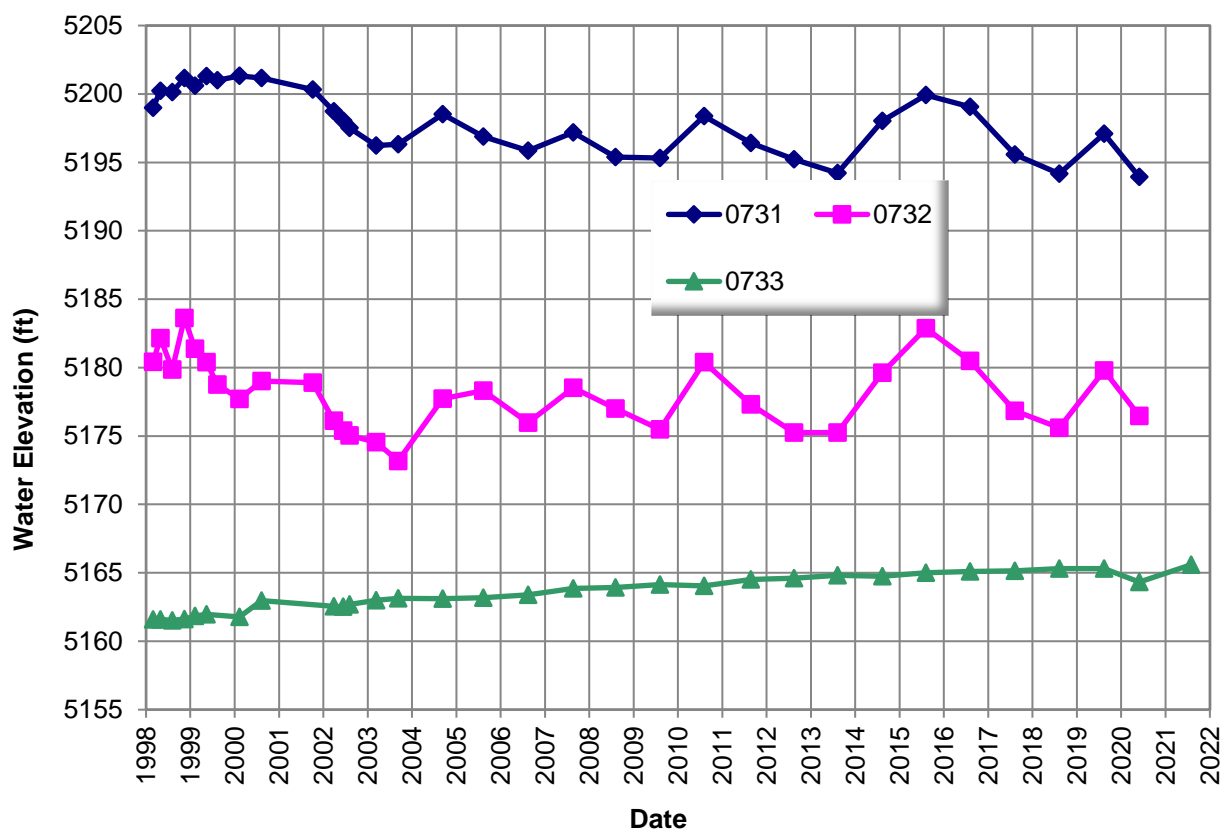
Figure 6-3. Water Level Measurements at the Grand Junction, Colorado, Disposal Site

Static water level measurements are obtained from each monitoring well before water quality samples are collected (Figure 6-3). Water levels in disposal cell monitoring well 0733 generally increased approximately 4 ft since 1998 and have remained lower than the adjacent water levels in the two paleochannel monitoring wells. Groundwater levels in wells 0731 and 0732 remained relatively constant with the same apparent trend in variability, suggesting the two paleochannel systems are influenced by the same upgradient recharge mechanisms. The 2020 sampling occurred in late May, whereas every previous sampling since 2003 occurred in August or early September. Consequently, water level measurements in 2020 may have a seasonal influence in relation to the historical data. 2021 groundwater levels in wells 0731 and 0732 are not reported, as both wells were filled with roots.

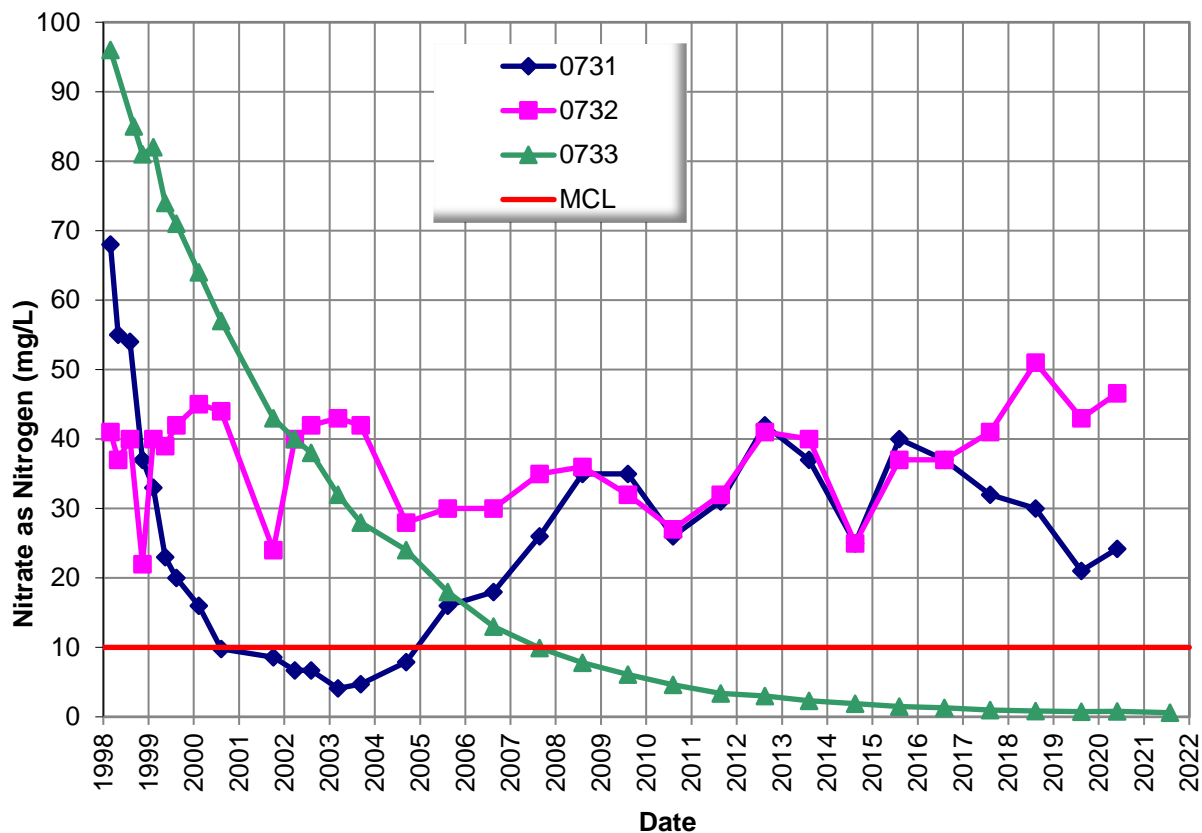
Figure 6-4. Nitrate (as Nitrogen) in Groundwater at the Grand Junction, Colorado, Disposal Site

Nitrate (as nitrogen) concentrations in disposal cell monitoring well 0733 continued to decline from 96 mg/L in 1998 to 0.6 mg/L in 2021; the 2021 numbers are significantly below the MCL of 10 mg/L (Figure 6-4). This is possibly due to increased reducing conditions (less oxygen) over time at the bottom of the disposal cell, creating denitrification (conversion of nitrate to nitrogen gas). Past concentrations of elevated nitrate (as nitrogen) in paleochannel monitoring wells 0731 and 0732 (compared to background nitrate concentrations up to 1.1 mg/L) may be the result of these wells adding oxygen to the Mancos Shale within the well screen and releasing nitrate.

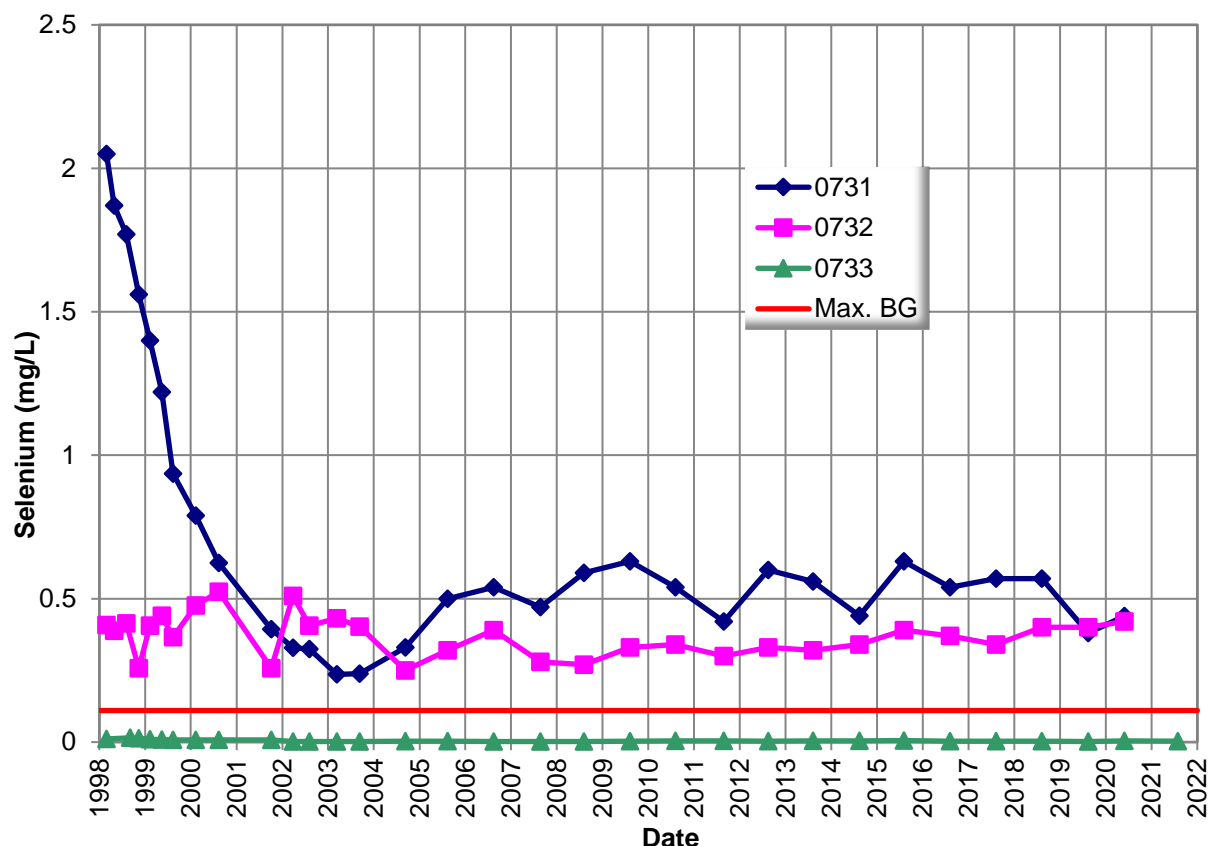
Figure 6-5. Selenium in Groundwater at the Grand Junction, Colorado, Disposal Site

Selenium occurs naturally in the Mancos Shale deposits that underlie the disposal cell (DOE 1991). Background groundwater concentrations in the Mancos Shale are at 0.11 mg/L, which exceeds the MCL of 0.01 mg/L (Table 6-3). As with nitrate, the addition of oxygen into the Mancos Shale because of the installation of these monitoring wells may contribute to the release of selenium from the Mancos Shale. Disposal cell monitoring well 0733 is not screened in the weathered Mancos Shale, and selenium concentrations remain below maximum background concentrations (Figure 6-5).

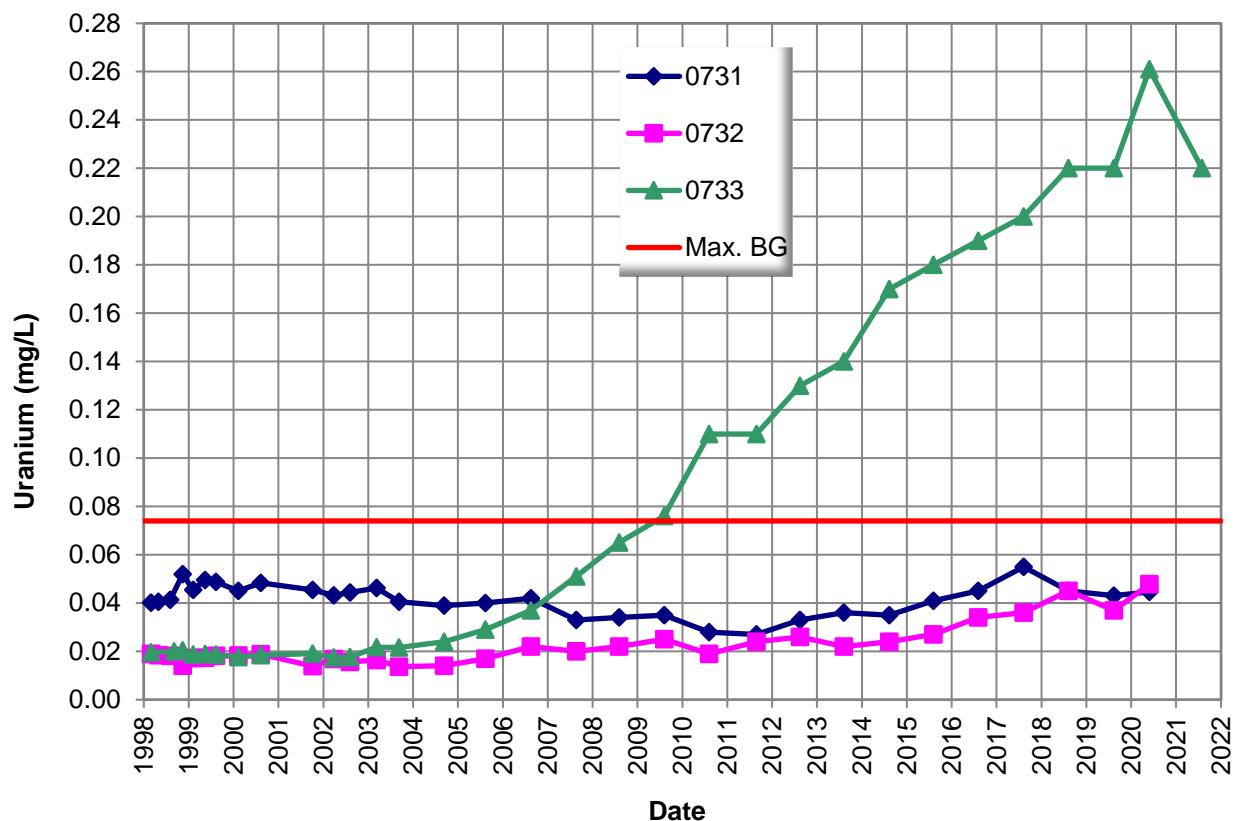
Figure 6-6. Uranium in Groundwater at the Grand Junction, Colorado, Disposal Site

Uranium concentrations in wells 0731 and 0732 have shown an apparent, gradually increasing trend since 2011 (Figure 6-6). Uranium concentrations in disposal cell monitoring well 0733 have increased from 0.02 mg/L in 2002 to 0.22 mg/L in 2021. Relatively high concentrations of uranium and other constituents are expected for a well screened in the disposal cell tailings. Constituents of concern and water levels in well 0733 are not subject to compliance goals and are monitored solely for information gathering purposes.

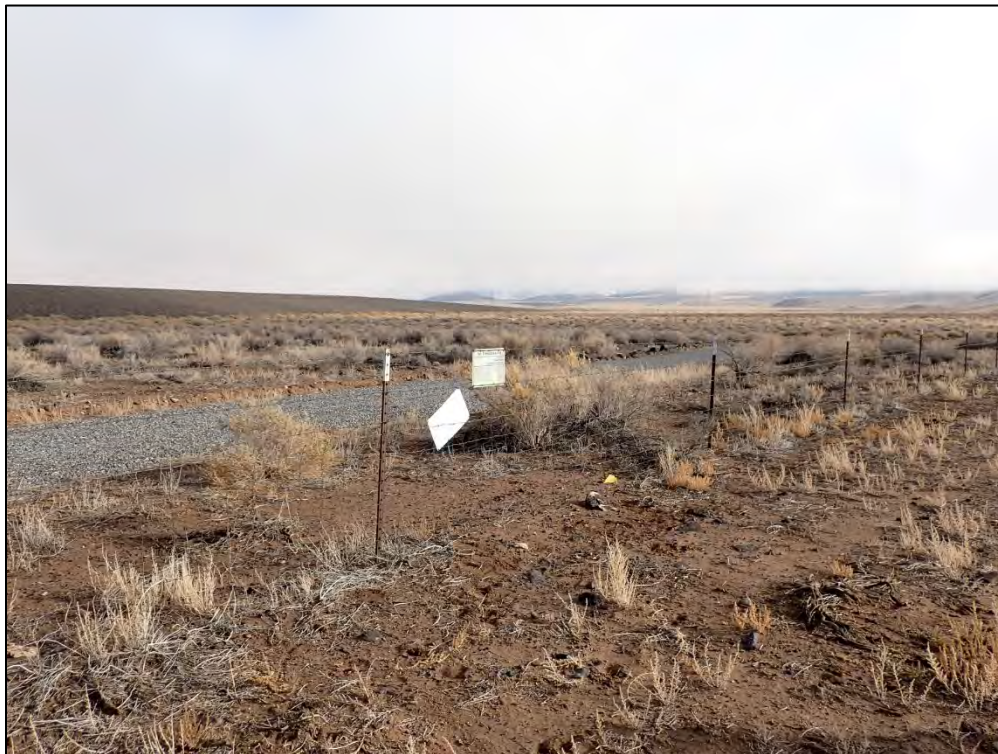
*PL-4. Unsecured Perimeter Fence Sign*

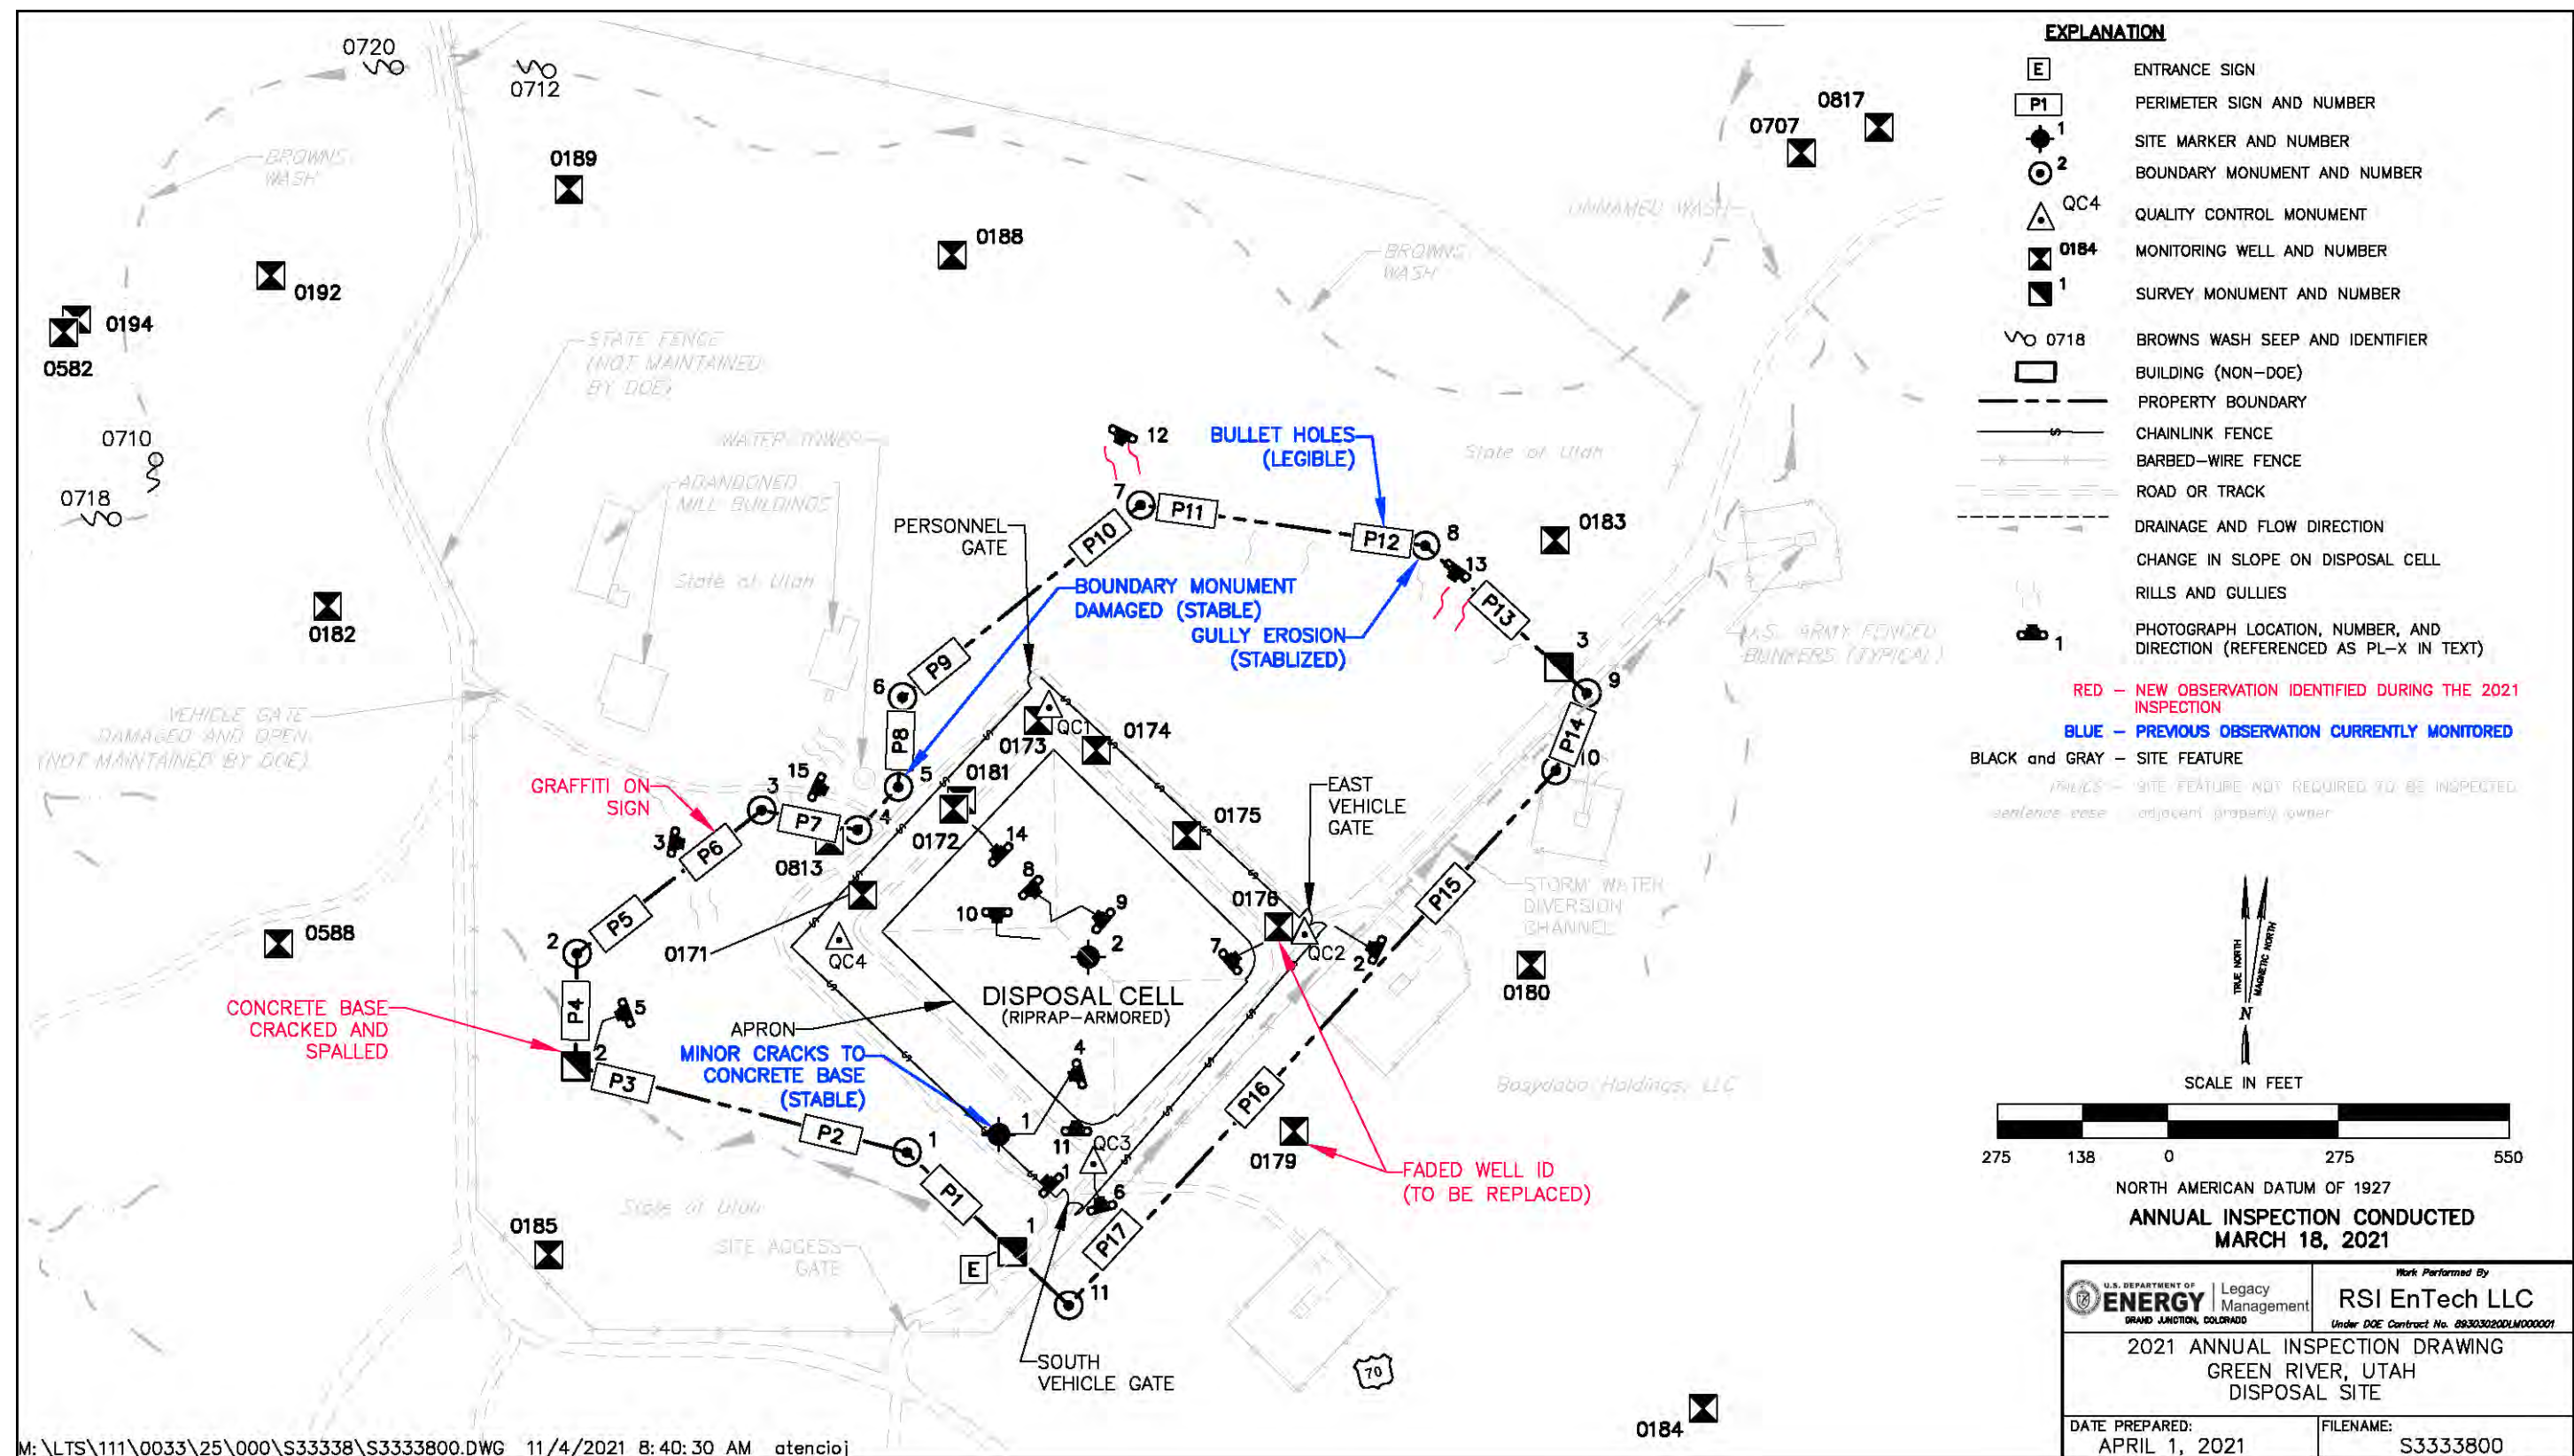
Figure 7-1. 2021 Annual Inspection Drawing for the Green River, Utah, Disposal Site

Figure 7-1 shows the locations of site features, including site surveillance features and inspection areas, in black and gray font. Site features that are present but not required to be inspected are shown in italic font. Observations from previous inspections that are currently monitored are shown in blue, and new observations identified during the 2021 annual inspection are shown in red. Inspection results and recommended maintenance activities associated with site surveillance features are described in the following subsections. Photographs to support specific observations are identified in the text and in Figure 7-1 by photograph location (PL) numbers. The photographs and photograph log are presented in Section 7.10.
