## 2021 Annual Site Inspection and Monitoring Report for Uranium Mill Tailings Radiation Control Act Title I Disposal Sites

March 2022

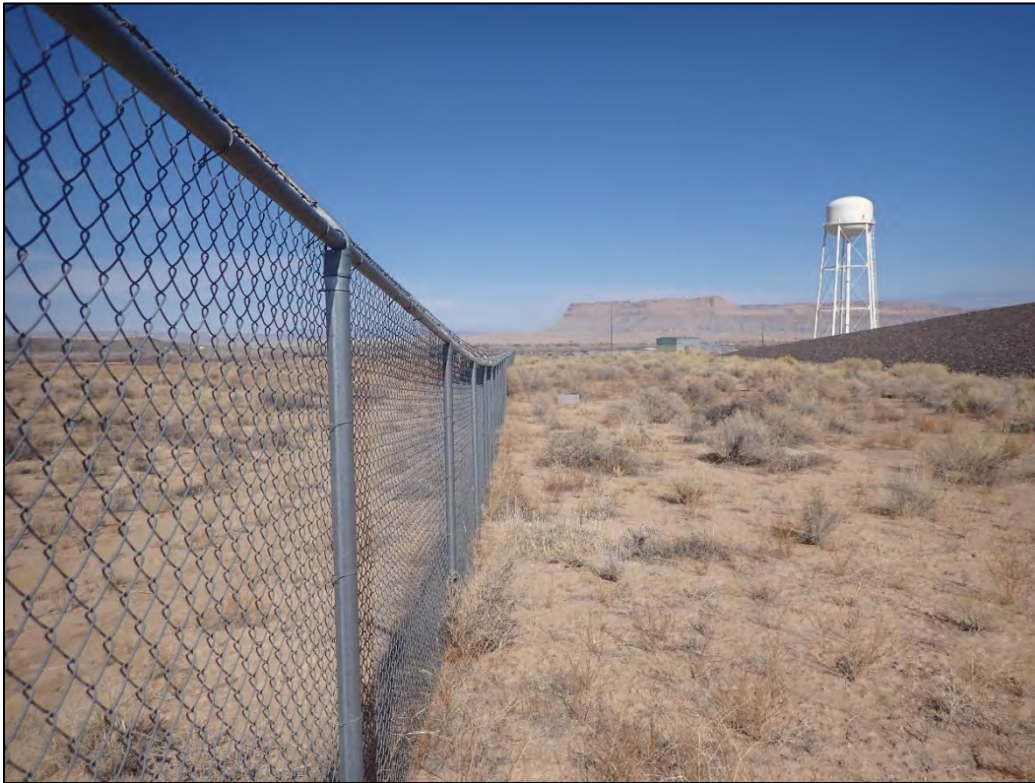
A chainlink security fence encloses the portion of the site that contains the disposal cell. Vehicle gates are at the south and east corners of the security fence, and a personnel gate is at the north corner of the security fence. The security fence (PL-1 and PL-2) was intact, and the gates were operable and locked at the time of the inspection.

*PL-1. Chainlink Security Fence and Site Marker SMK-1 in Background*

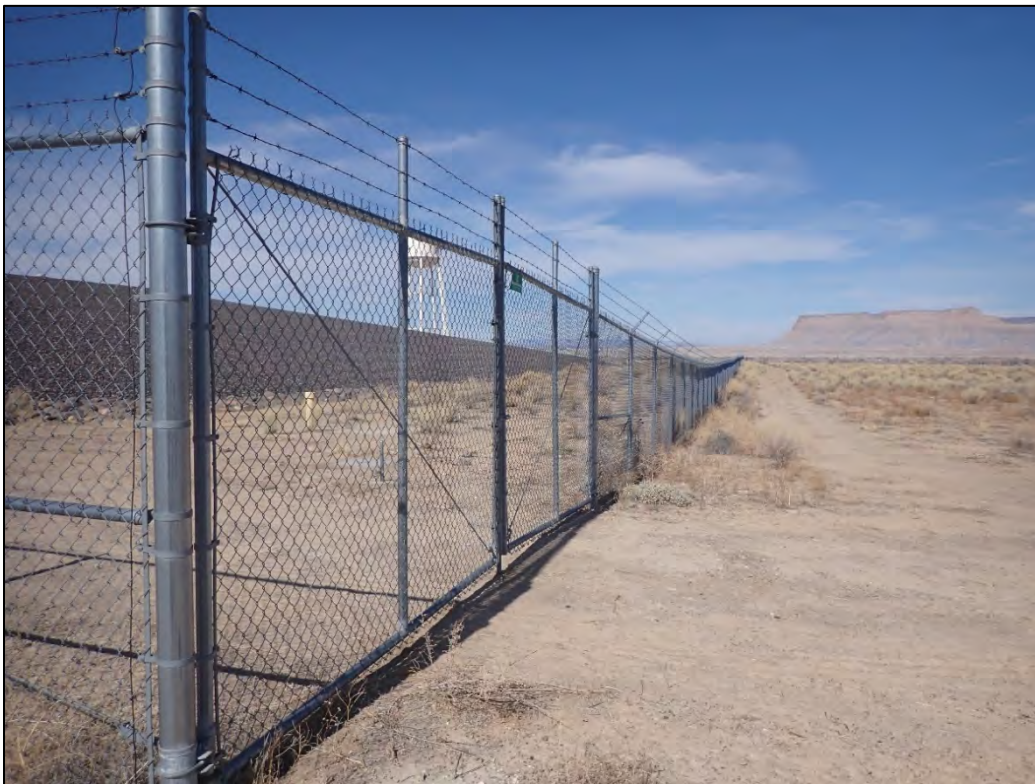
*PL-2. East Vehicle Gate and Fence*

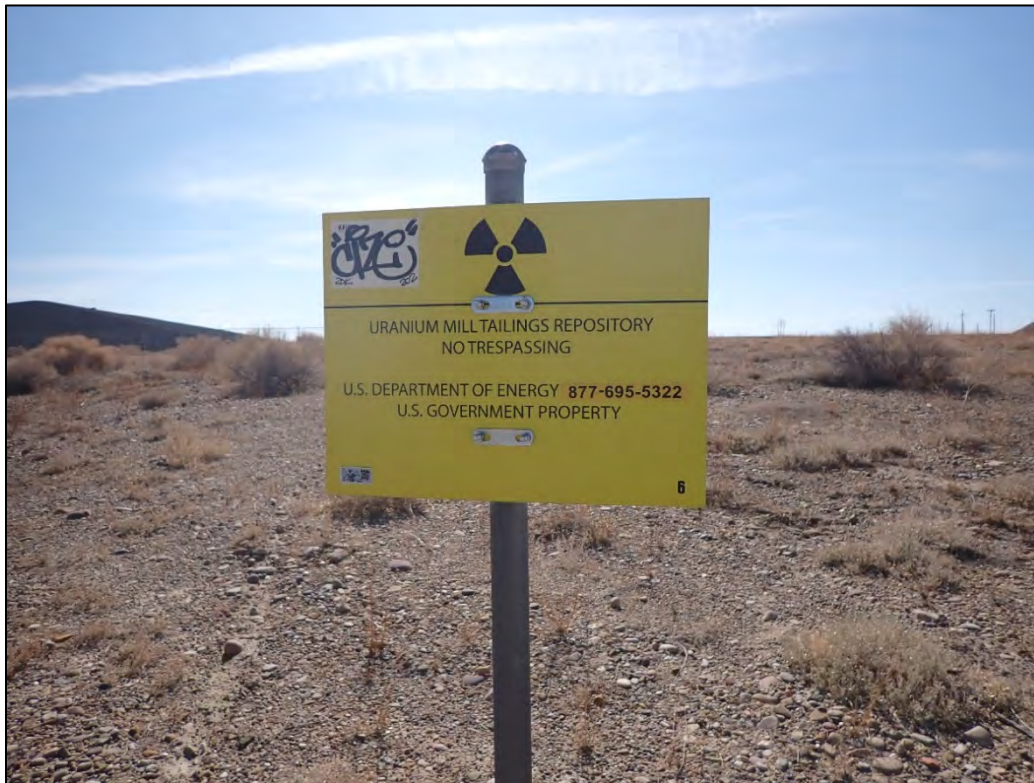
Seventeen perimeter signs, attached to steel posts set in concrete, are positioned along the unfenced property boundary. All perimeter signs were legible, although inspectors noted that perimeter sign P6 contained graffiti (PL-3). Because the sign is legible, it will not be replaced at this time.

The area between the security fence and the site boundary is primarily open space but includes access roads, a stormwater diversion channel, and monitoring wells. The site property boundary is not fenced, and trespassing occurs on the site from several access points through state- and privately-owned land. Unauthorized access to the site is primarily from the west through a former mill access gate that has broken off its hinges; LM is not responsible for the gate or associated fence. The site is also accessible through remote, unfenced, open-access points to the north and east. The site will continue to be monitored for adverse public use typically indicated by trash, tire ruts, and vandalism. Inspectors did not find new trash dumps or indications of vandalism (except for graffiti on perimeter sign P6) during the inspection.

*PL-3. Graffiti on Perimeter Sign P6*

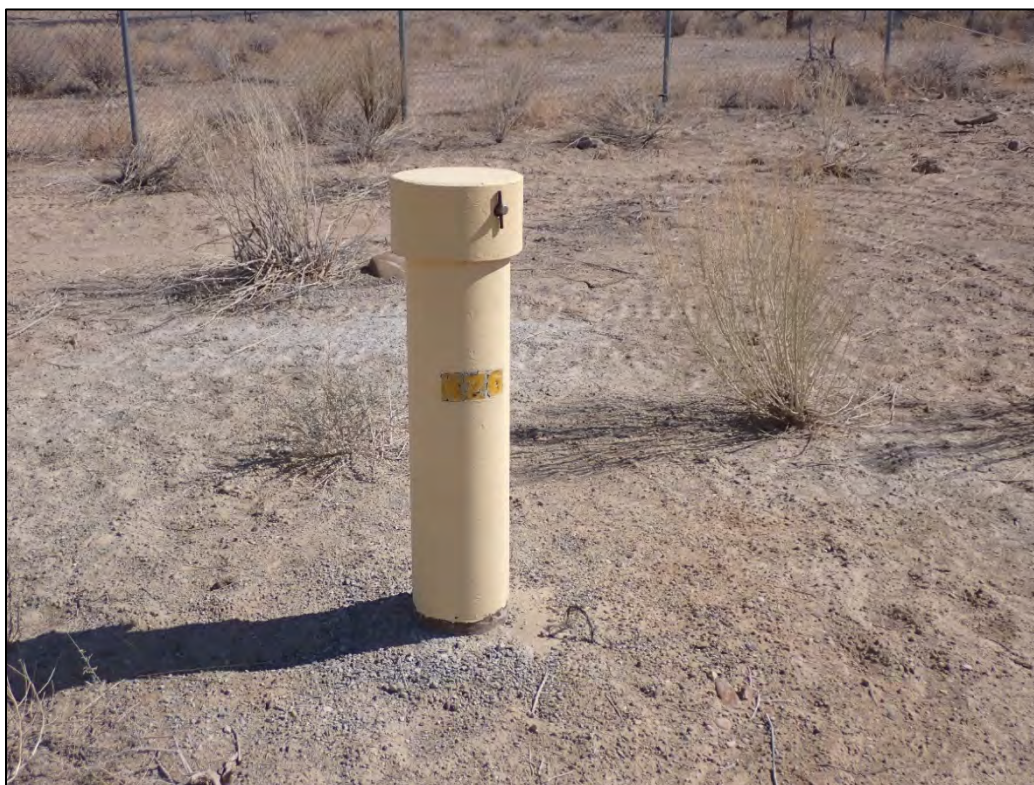
Twenty-two monitoring wells are on or near the site. The LTSP establishes four POC wells at the site for postclosure groundwater monitoring. All wellhead protectors observed during the inspection were undamaged and locked. Some of the concrete monitoring well collars were cracked, but the wellhead protectors were stable, and repairs are not necessary. Well identification numbers were faded or missing on several wells (PL-7). Well identification numbers will be reapplied before the next inspection.

*PL-7. Faded Identification Numbers on Monitoring Well 0176*

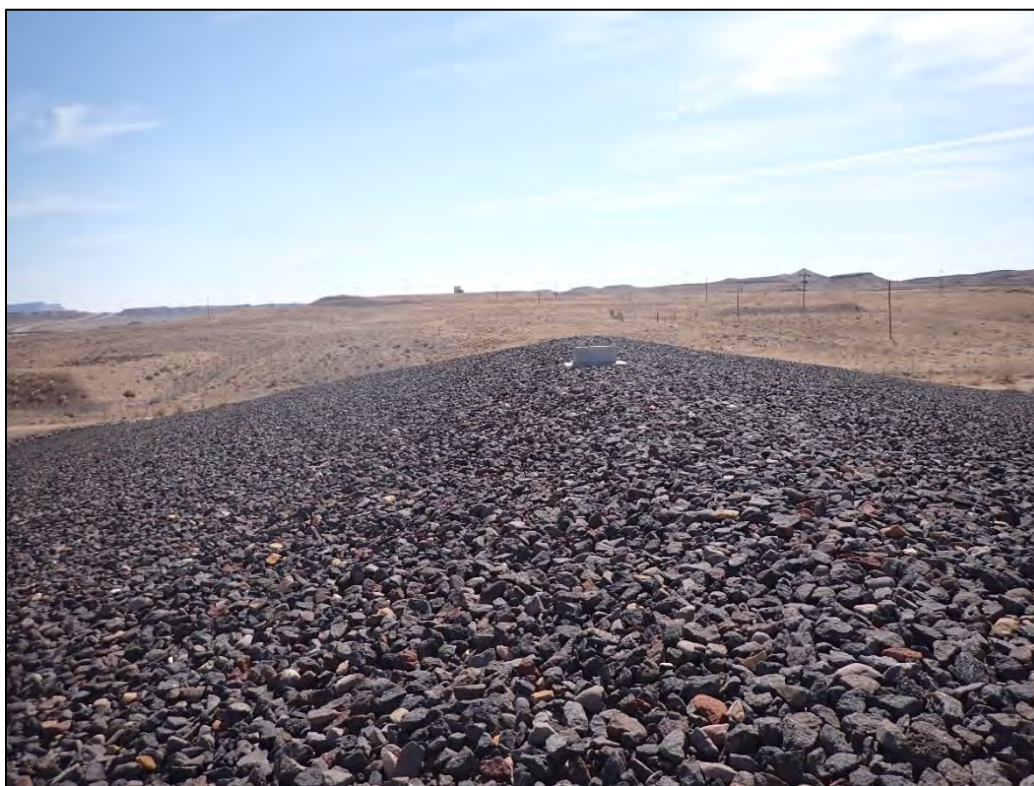
The disposal cell, completed in 1989, occupies 6 acres. The slopes of the disposal cell cover are armored with riprap, consisting primarily of competent basalt with a small fraction of sedimentary rocks, to control erosion. A small percentage of the rock, including basalt and sedimentary rock, has degraded, but the riprap cover is functioning as designed. Inspectors found no evidence of settling, slumping, erosion, or other modifying process that might affect the integrity of the disposal cell (PL-8, PL-9, and PL-10).

*PL-8. Site Marker SMK-2 on Disposal Cell Top Slope*

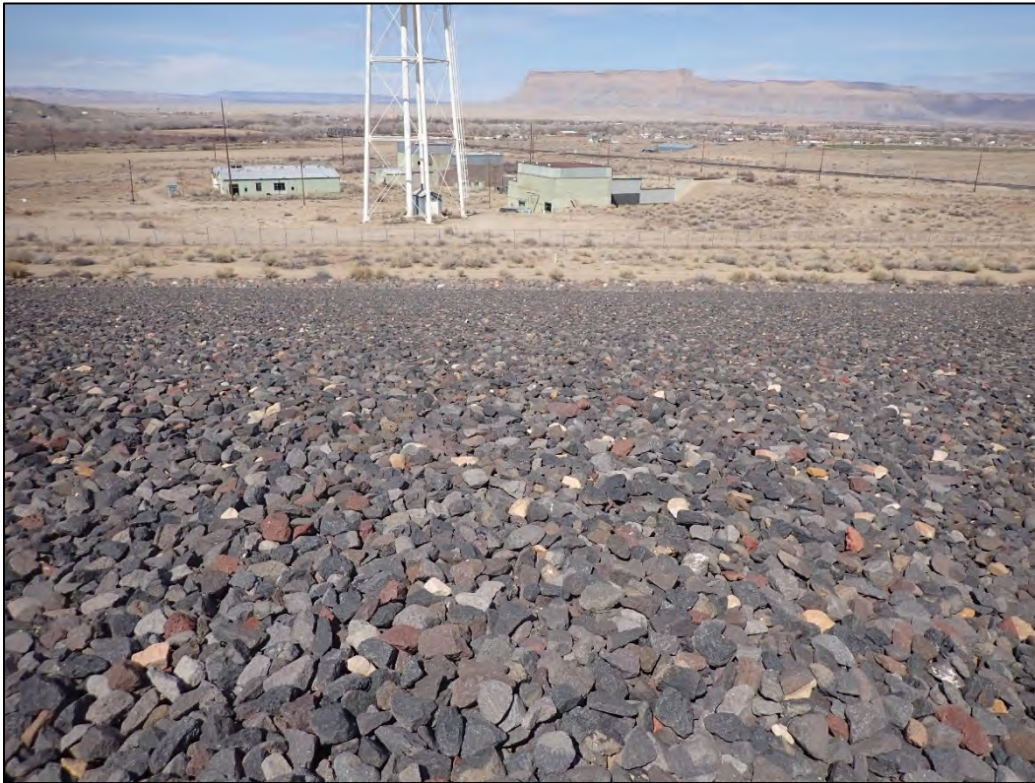
*PL-9. Disposal Cell Northwest Side Slope*

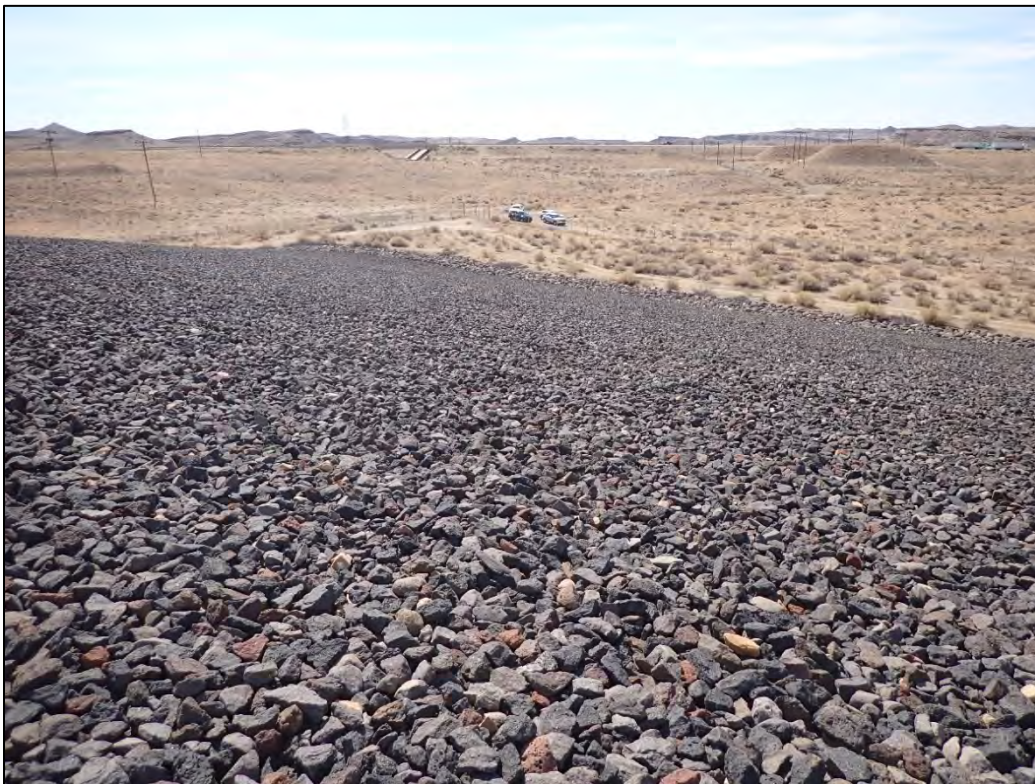
*PL-10. Disposal Cell Southwest Side Slope*

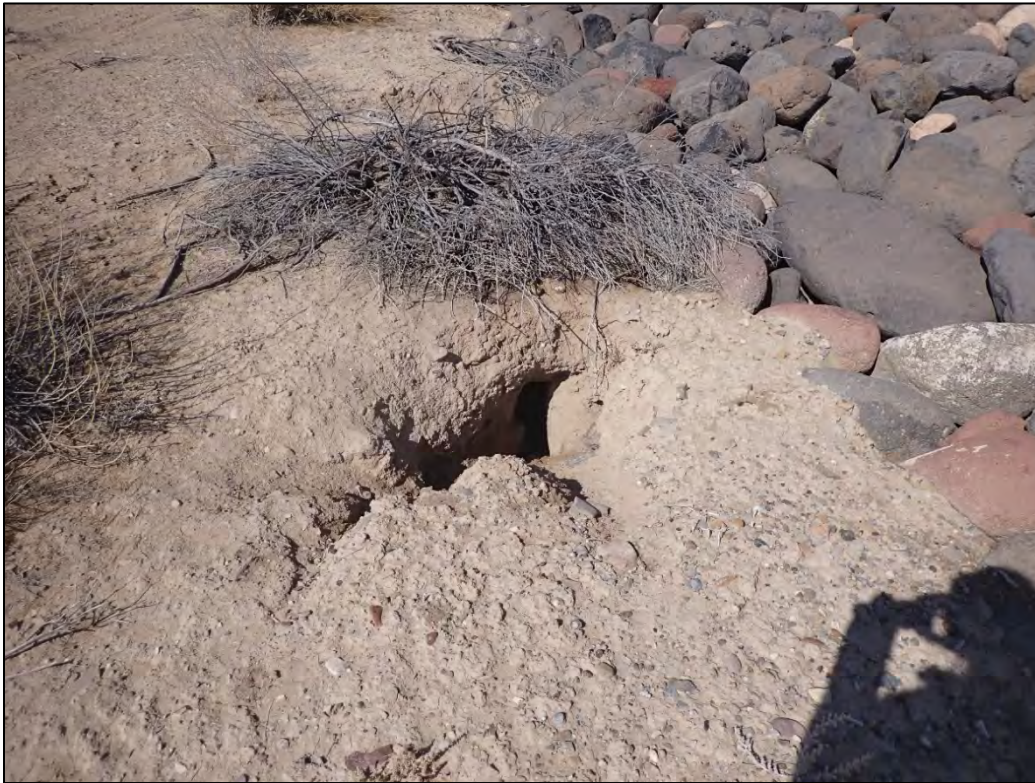
*PL-11. Soil Piping on Edge of Rock Apron*

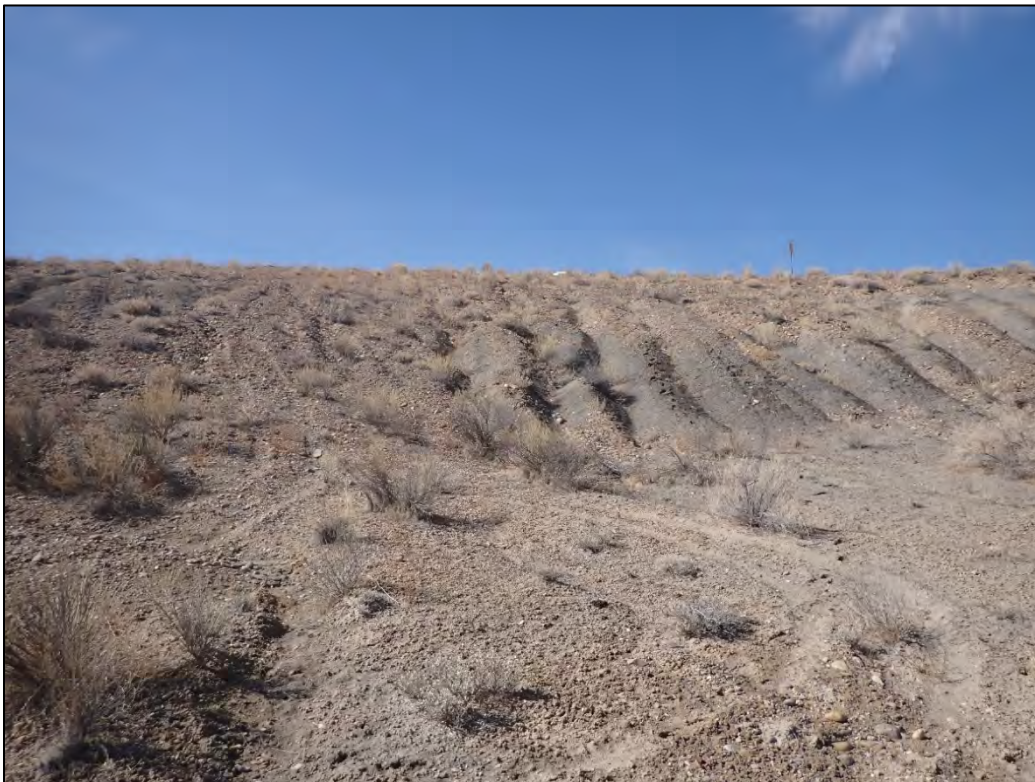
*PL-12. Soil Erosion by Boundary Monument BM-7 (Offsite)*

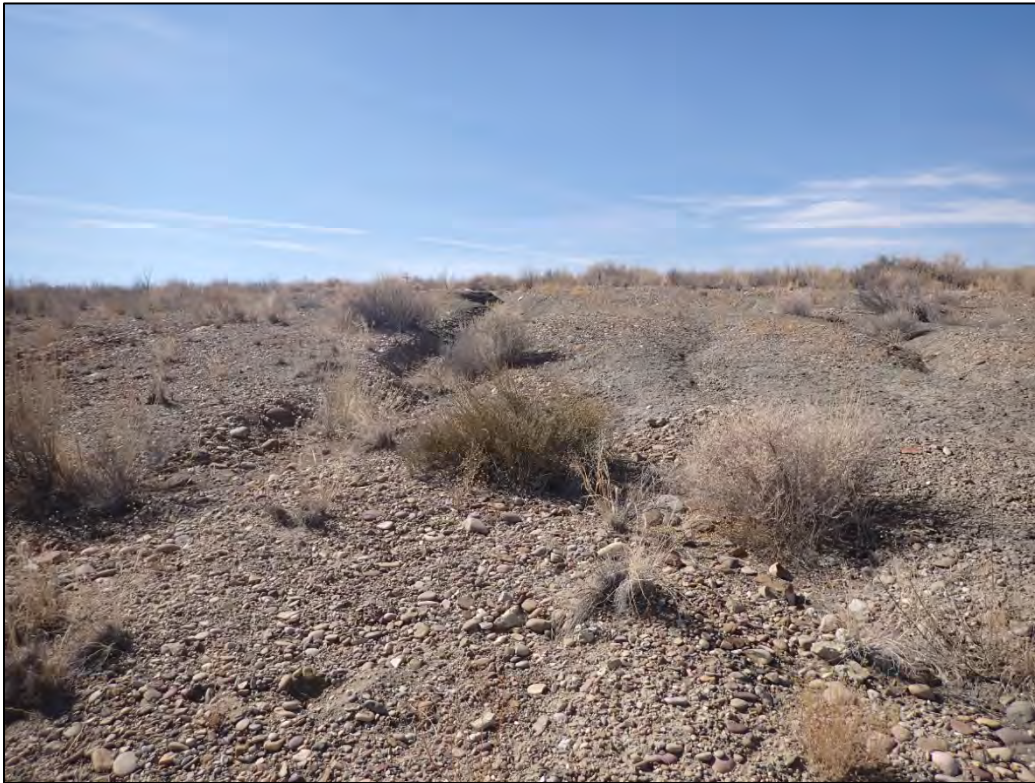
*PL-13. Soil Erosion by Boundary Monument BM-8 (Onsite)*

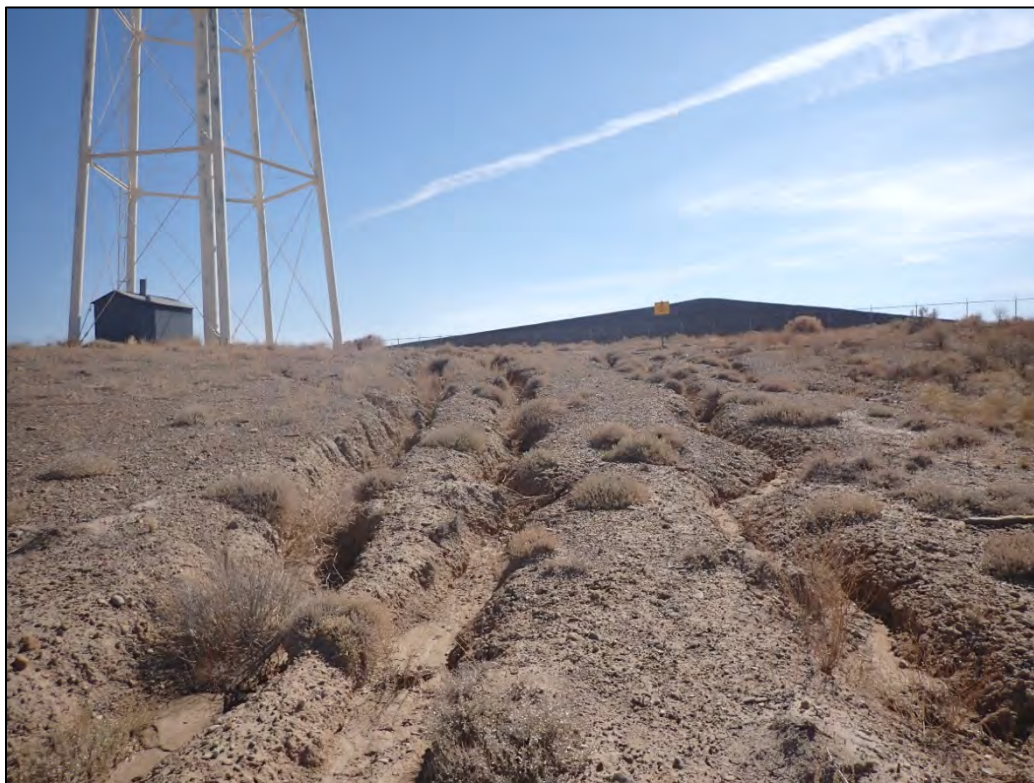
Areas of erosion noted during previous inspections include the natural drainage near the southwest side of the site and rills and gullies northwest of the water tower (PL-15). Evidence of continued erosion in these areas was apparent but does not threaten the integrity of the disposal

*PL-15. Soil Erosion (Offsite)*

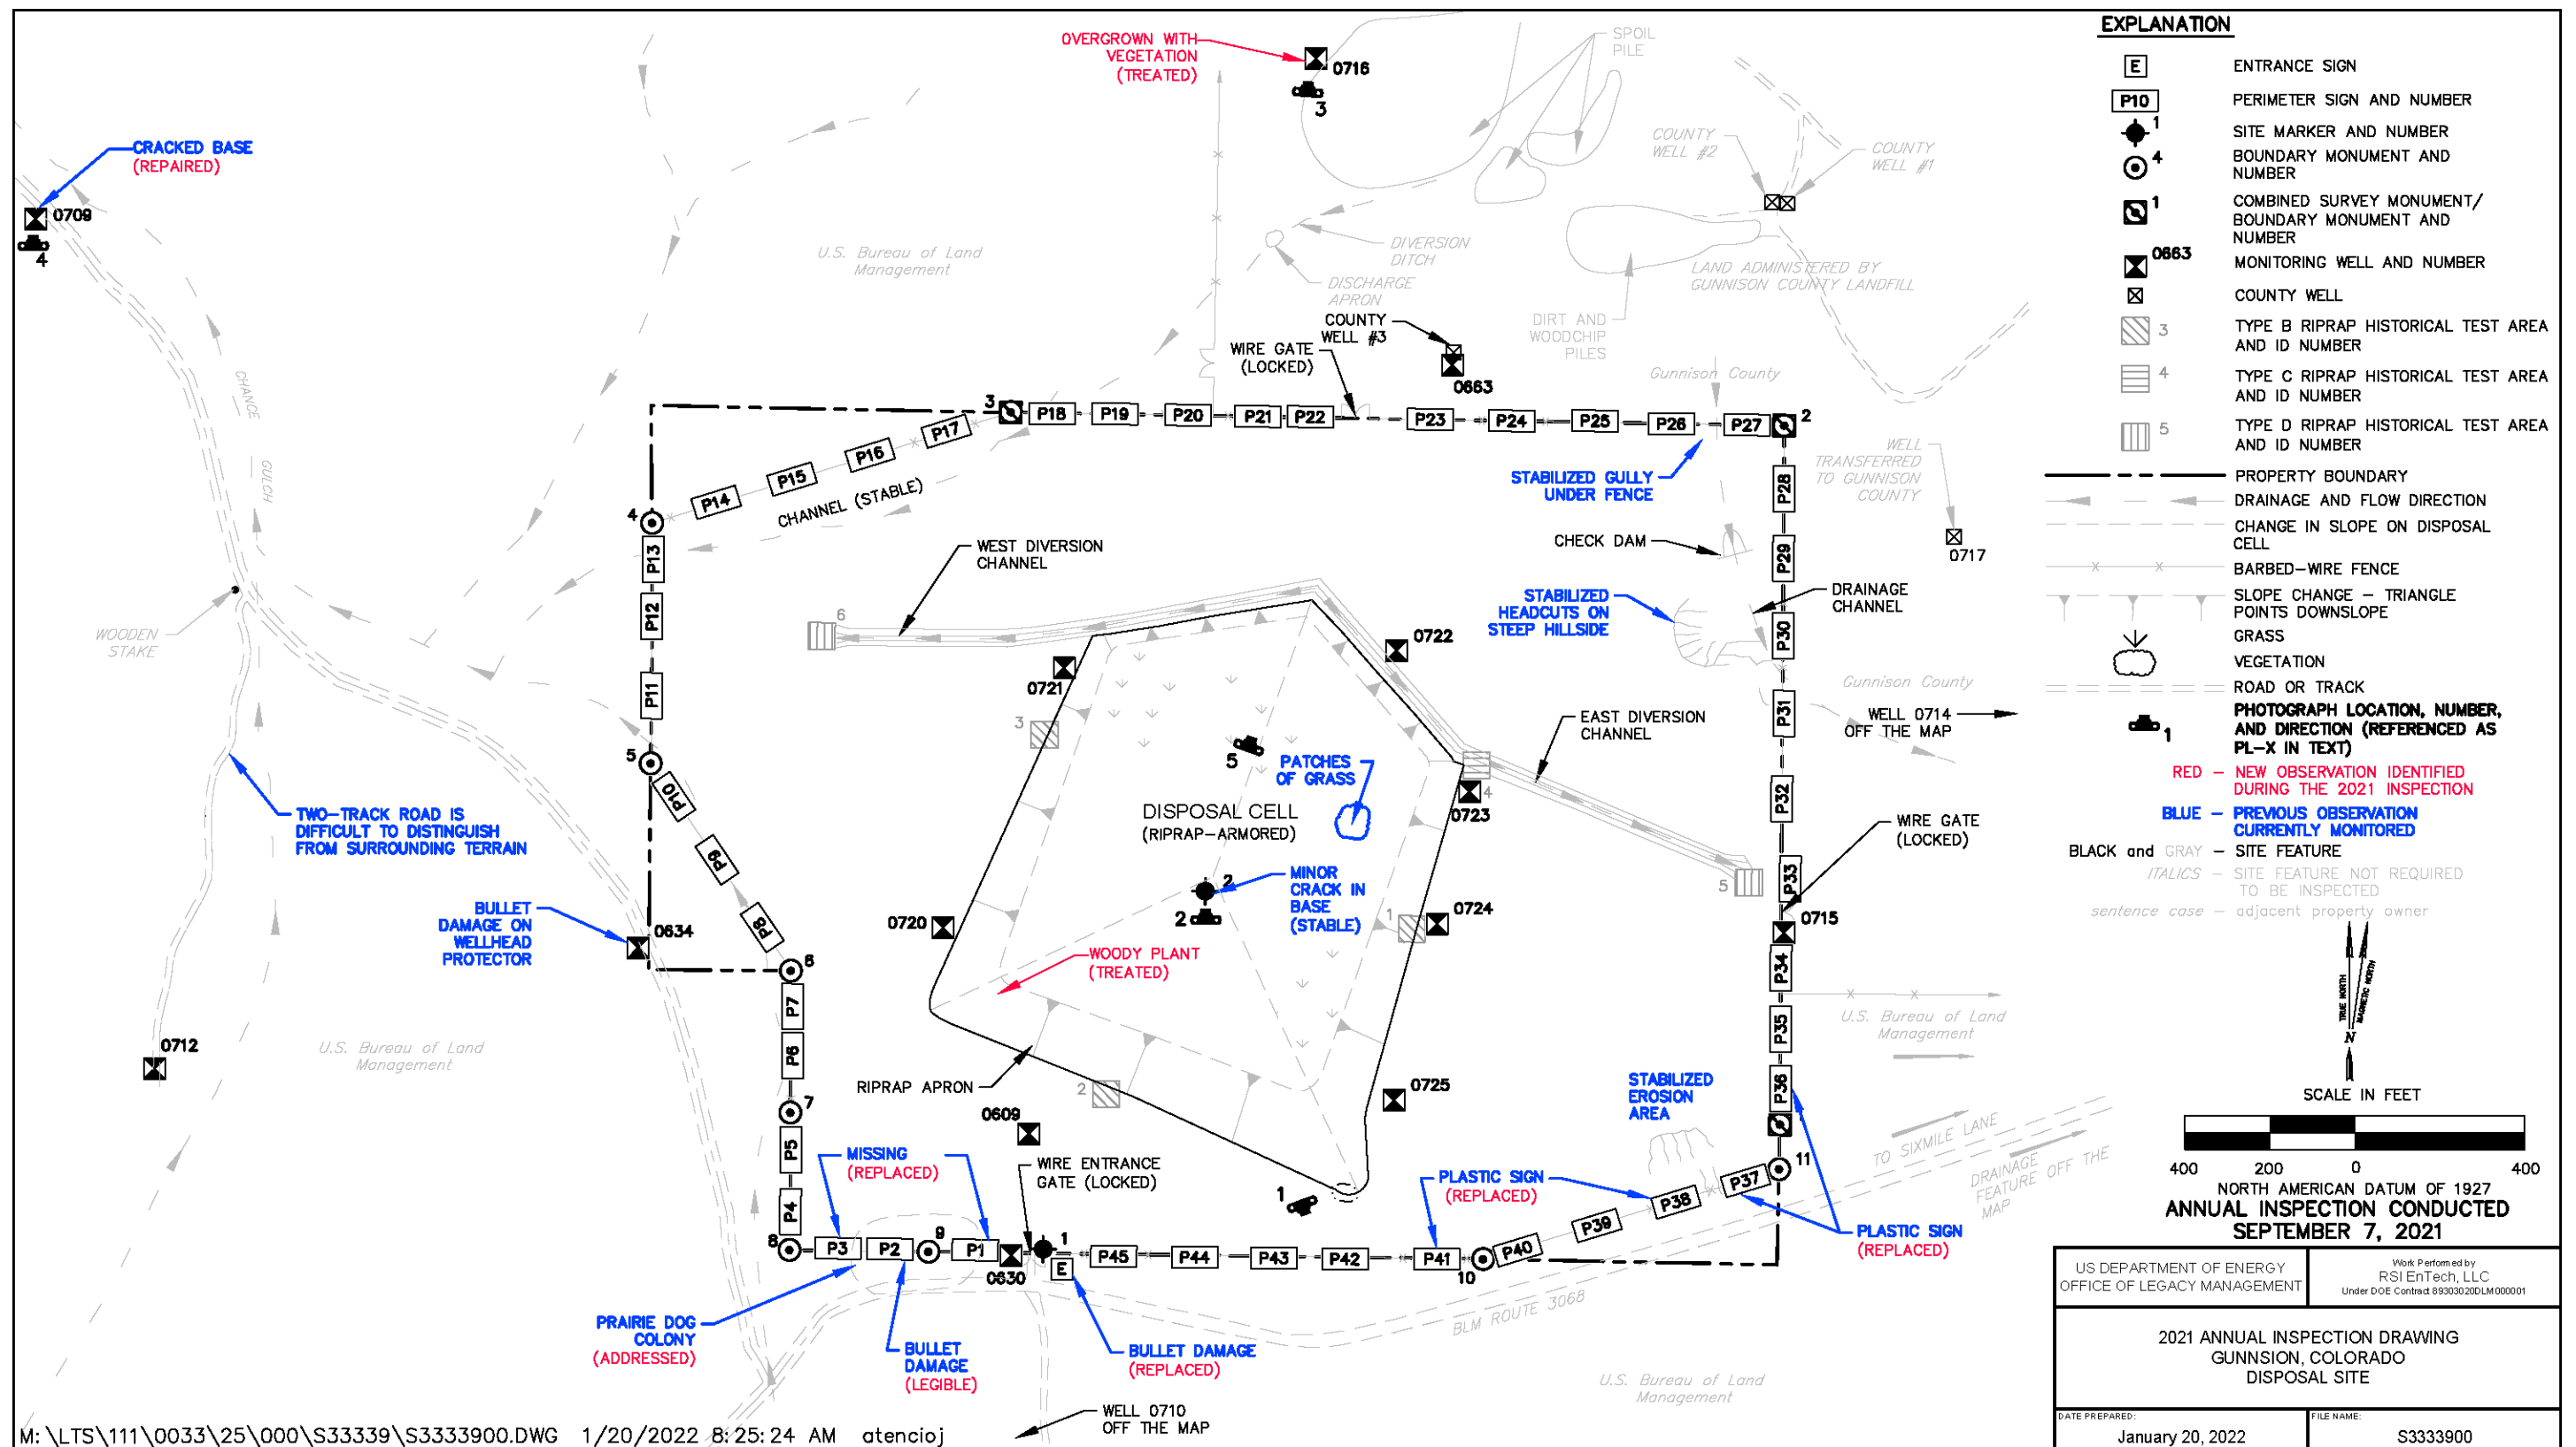
Figure 8-1. 2021 Annual Inspection Drawing for the Gunnison, Colorado, Disposal Site

Figure 8-1 shows the locations of site features, including site surveillance features and inspection areas, in black and gray font. Site features that are present but not required to be inspected are shown in italic font. Observations from previous inspections that are currently monitored are shown in blue text, and new observations identified during the 2021 annual inspection are shown in red. Inspection results and recommended maintenance activities associated with site surveillance features are included in the following subsections. Photographs to support specific observations are identified in the text and in Figure 8-1 by photograph location (PL) numbers. The photographs and photograph log are presented in Section 8.10.

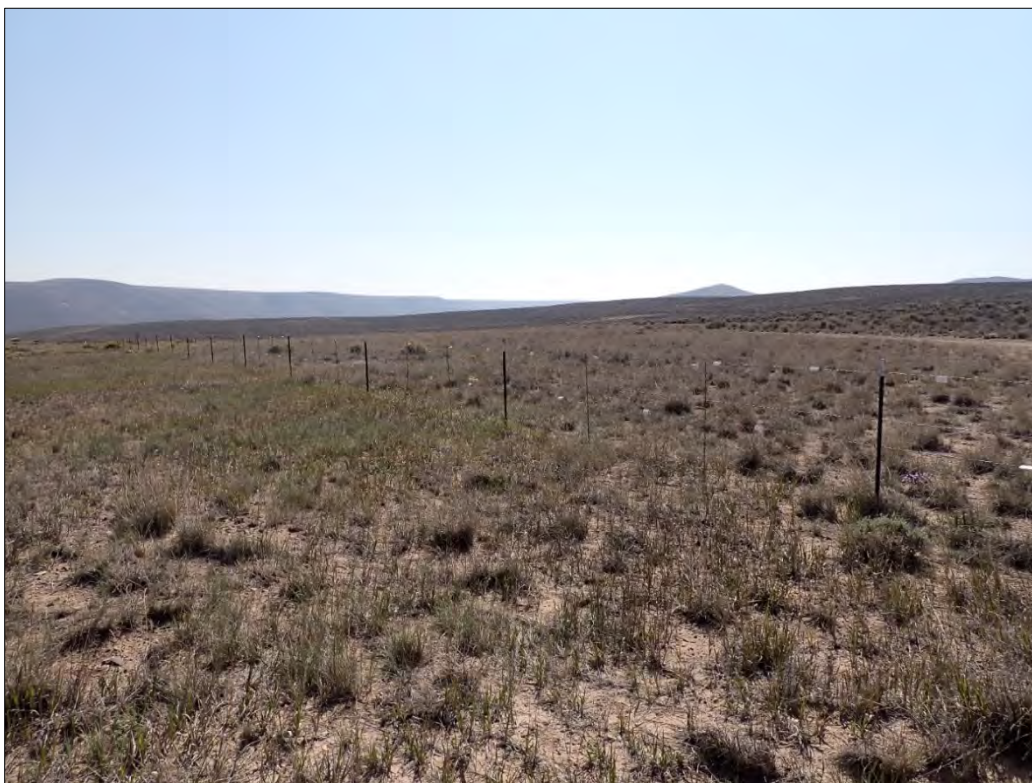
*PL-1. Southeast Perimeter Fence with Flagging*

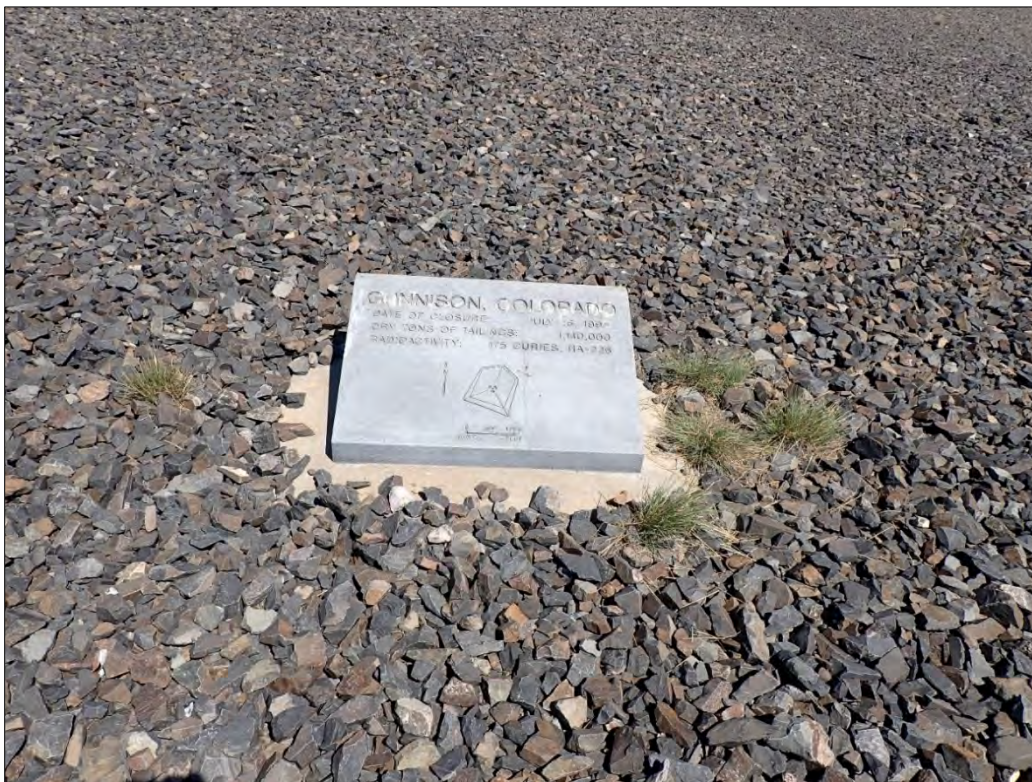
The site has two granite site markers. Site marker SMK-1 is just inside the entrance gate, and site marker SMK-2 (PL-2) is on the top slope of the disposal cell. The base of site marker SMK-2 has a small, insignificant crack and remains stable. No maintenance needs were identified.

*PL-2. Site Marker SMK-2*

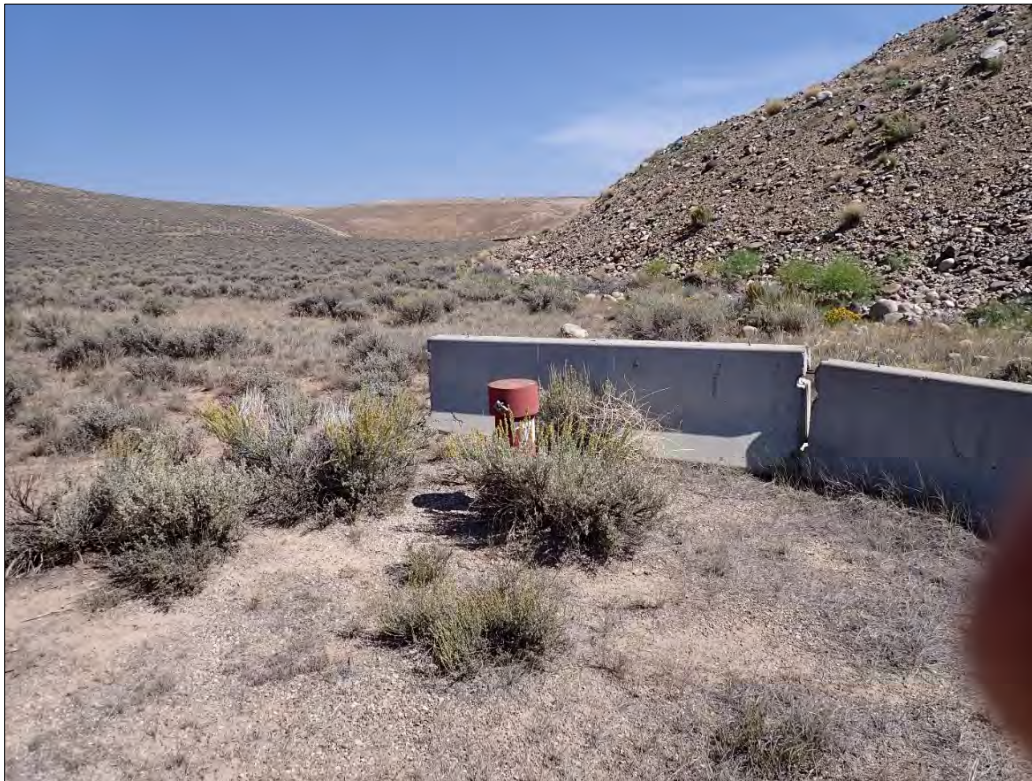
Gunnison County owns the land that adjoins the site boundary to the north and east and uses the land for a municipal landfill. The nearest landfill operations continue to be approximately 400 feet north of the site. Although landfill activities do not affect the site, inspectors will continue to monitor the level of activity occurring near the site boundary and surveillance features (e.g., fences and monitoring wells). With regard to groundwater flow, the landfill operations are cross gradient from the disposal cell. The only current concern for activities that could affect a site asset is a spoil pile near monitoring well 0716 (Figure 8-1 and PL-3). Inspectors will continue to monitor this area. No other maintenance needs were identified.

*PL-3. Well 0716 Overgrown with Vegetation and Nearby Spoil Pile*

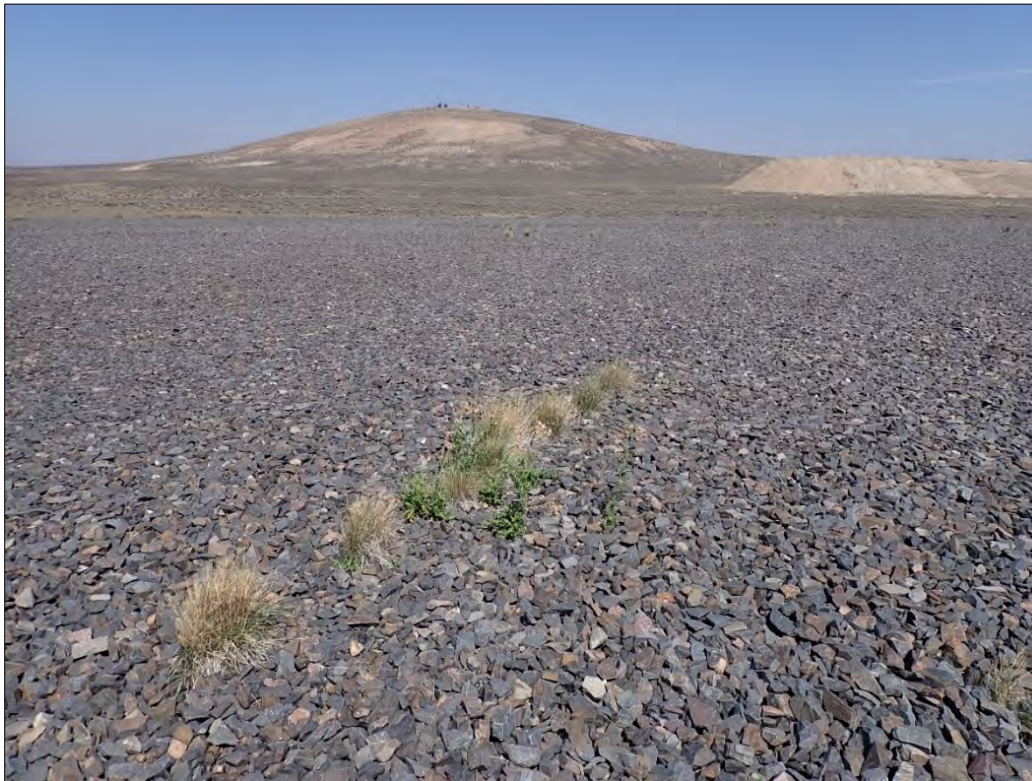
*PL-5. Vegetation on Disposal Cell Top Slope*

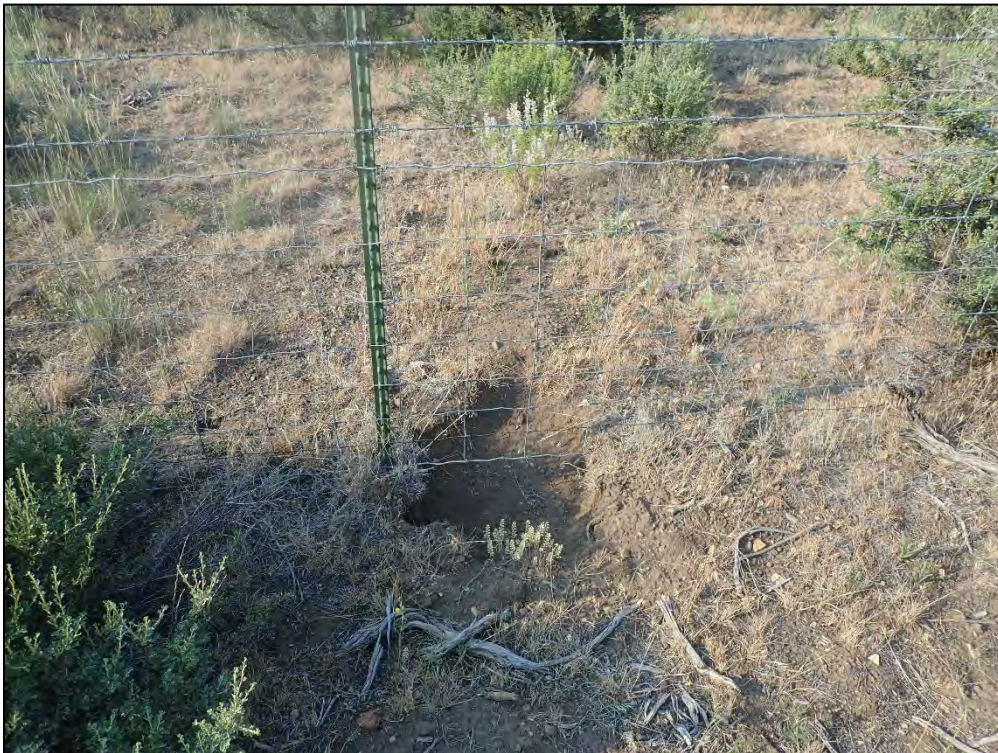
*PL-2. Animal Burrow near Northeast Corner of Site*

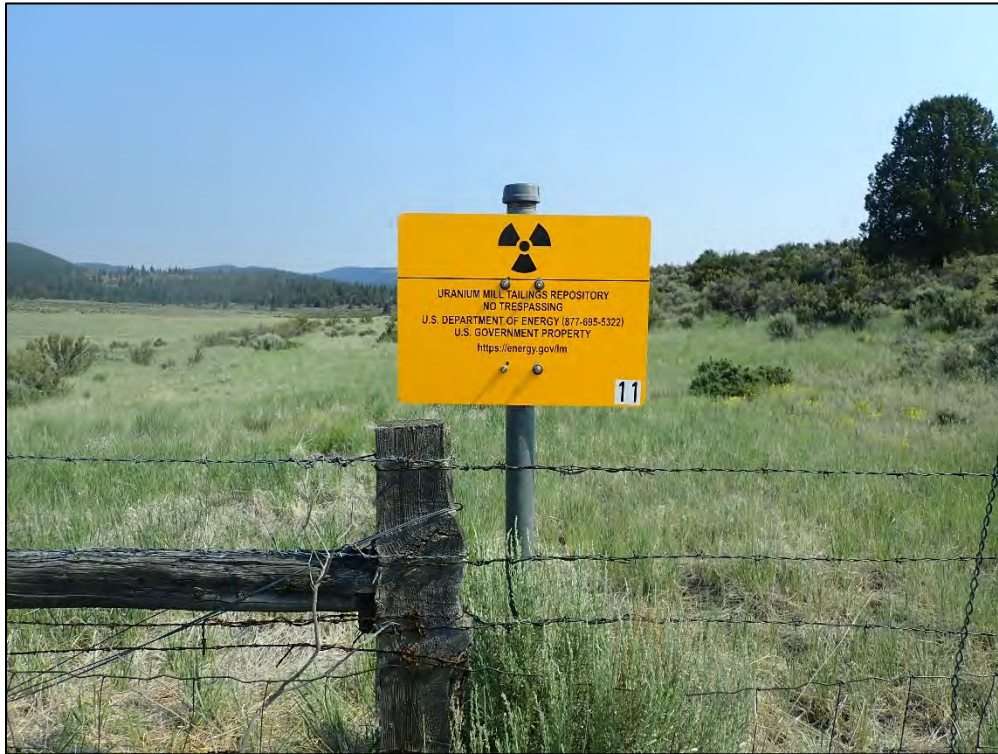
*PL-3. New Perimeter Sign P11*

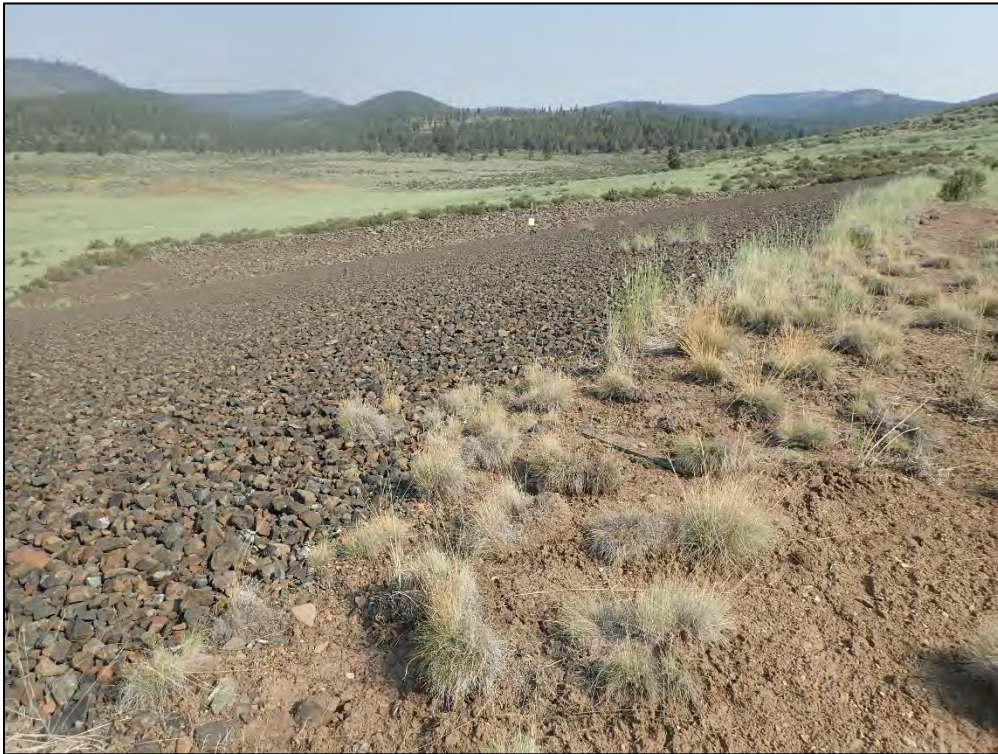
*PL-9. Top Edge of West Side Slope*

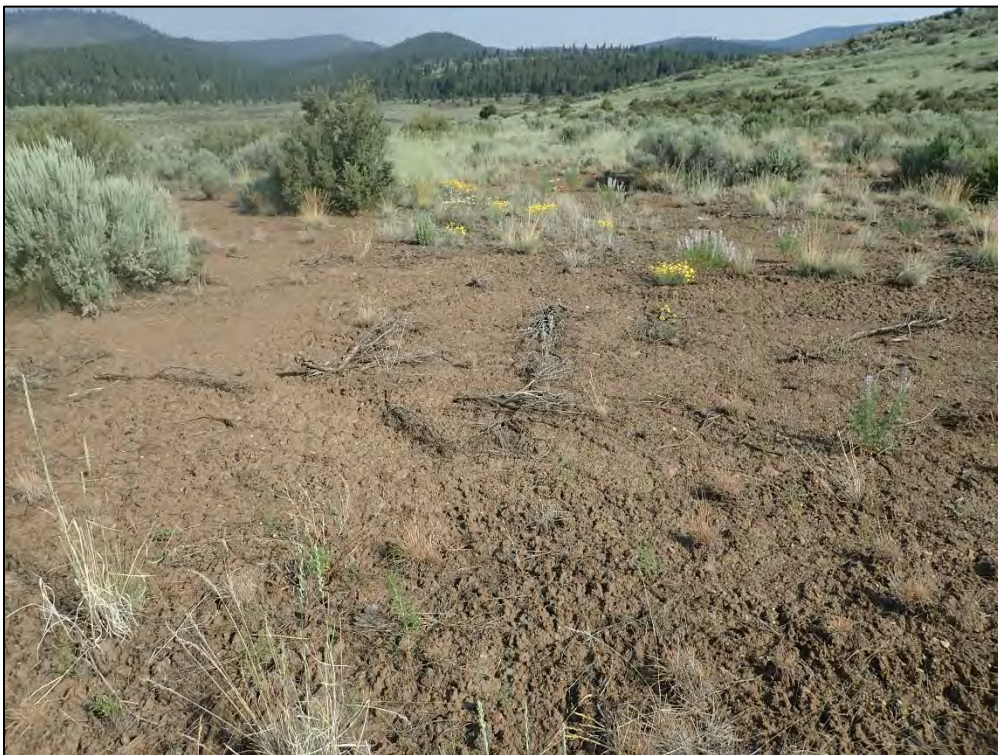
*PL-10. Reclamation of 2018 Soil Cover Study Test Area*

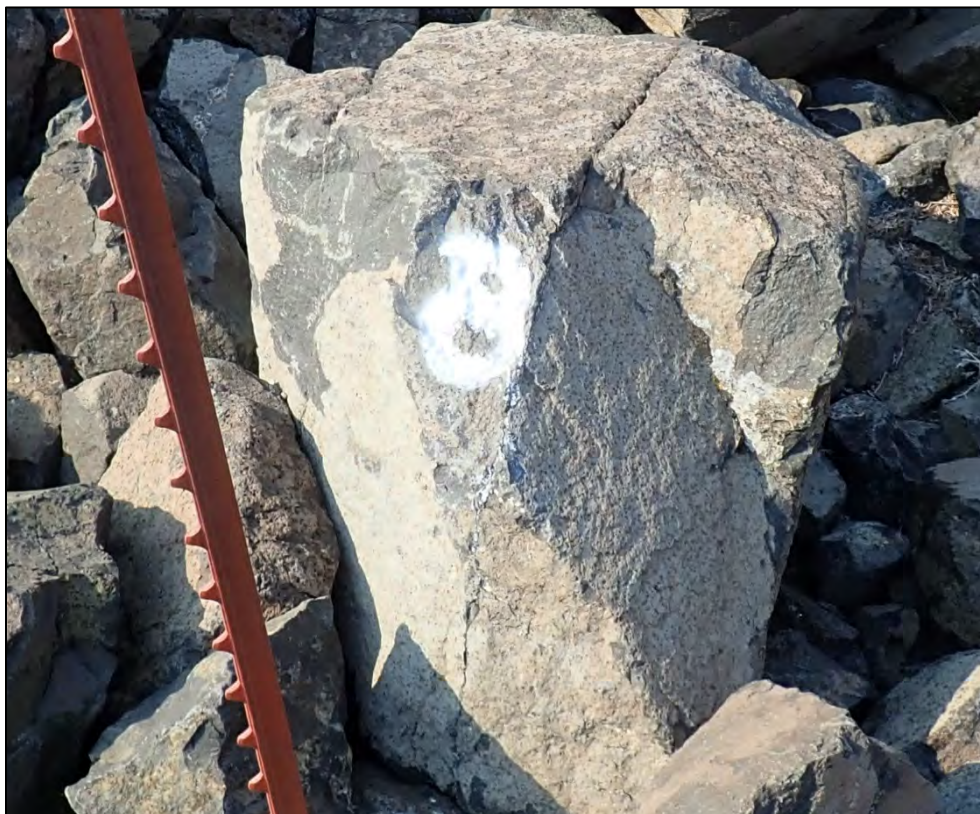
*PL-11. Riprap Monitoring Location No. 8 in the Energy Dissipation Area*

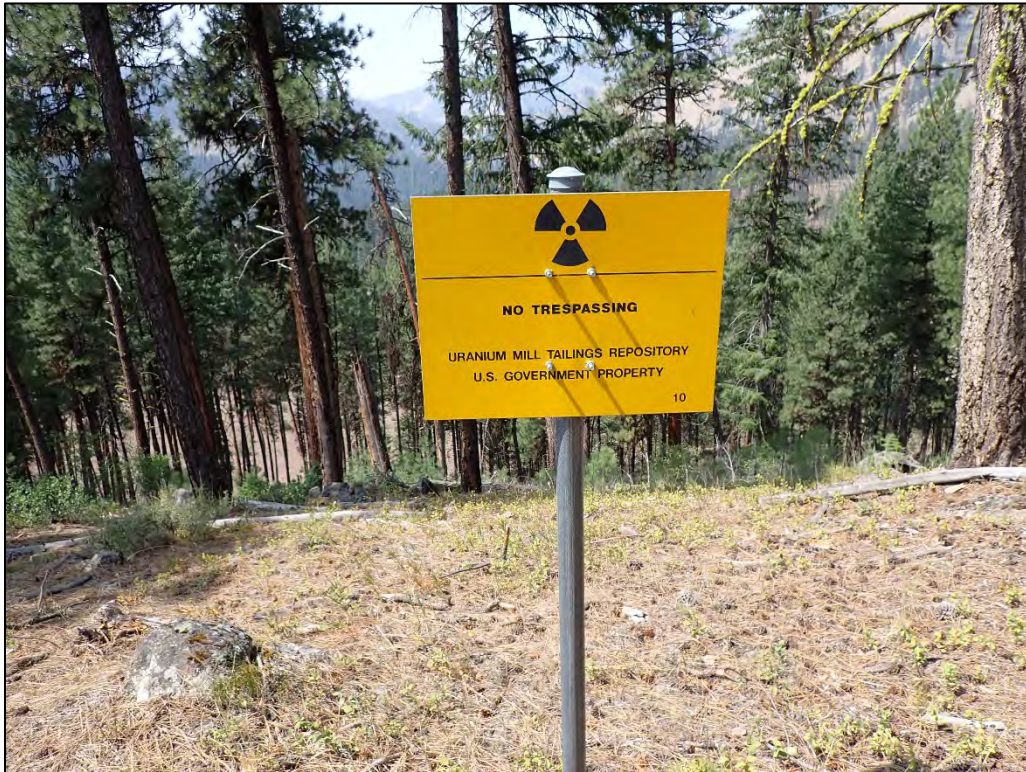
There are 18 perimeter signs attached to steel posts set in concrete positioned along the unfenced property boundary (PL-2). Several perimeter signs (P2, P3, P4, P13, and P15) have bullet damage but remain legible. Perimeter sign P3 was rotated about 90 degrees from its original position but was repaired during the inspection. Perimeter sign P7 is slightly bent from tree fall but remains legible. No maintenance needs were identified.

*PL-2. Perimeter Sign P10*

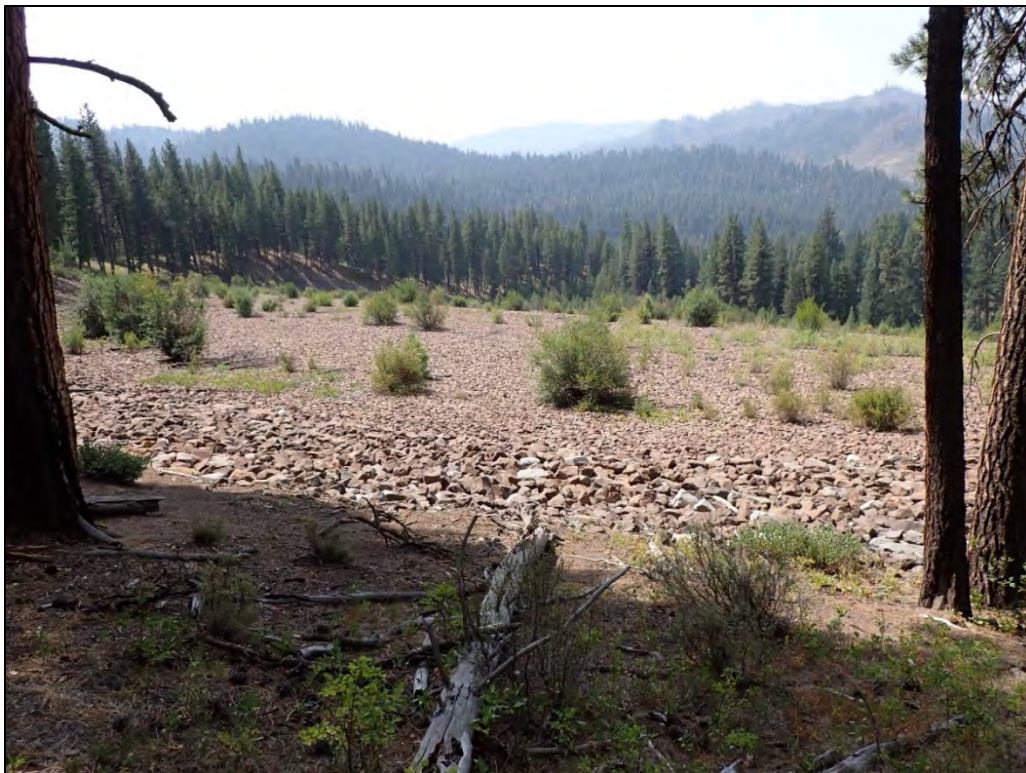
Natural vegetation continues to encroach on the top and side slopes of the disposal cell. Although the LTSP states that control of vegetation growth on the cell is not needed, LM concluded that controlling the growth of conifers—primarily ponderosa pine—would be a best management practice. Unlike the shrubs and other vegetation growing on the disposal cell, mature conifers could potentially become uprooted during windstorms and damage the surface of the disposal cell. Numerous ponderosa pine trees were observed on the disposal cell top and side slopes and were cut down and left in place in September 2018. Other plants growing on the disposal cell were not removed, as they do not present a physical threat to the integrity of the disposal cell (PL-5). No maintenance needs were identified.

*PL-5. Disposal Cell Cover*
