## 2021 Annual Site Inspection and Monitoring Report for Uranium Mill Tailings Radiation Control Act Title I Disposal Sites

March 2022

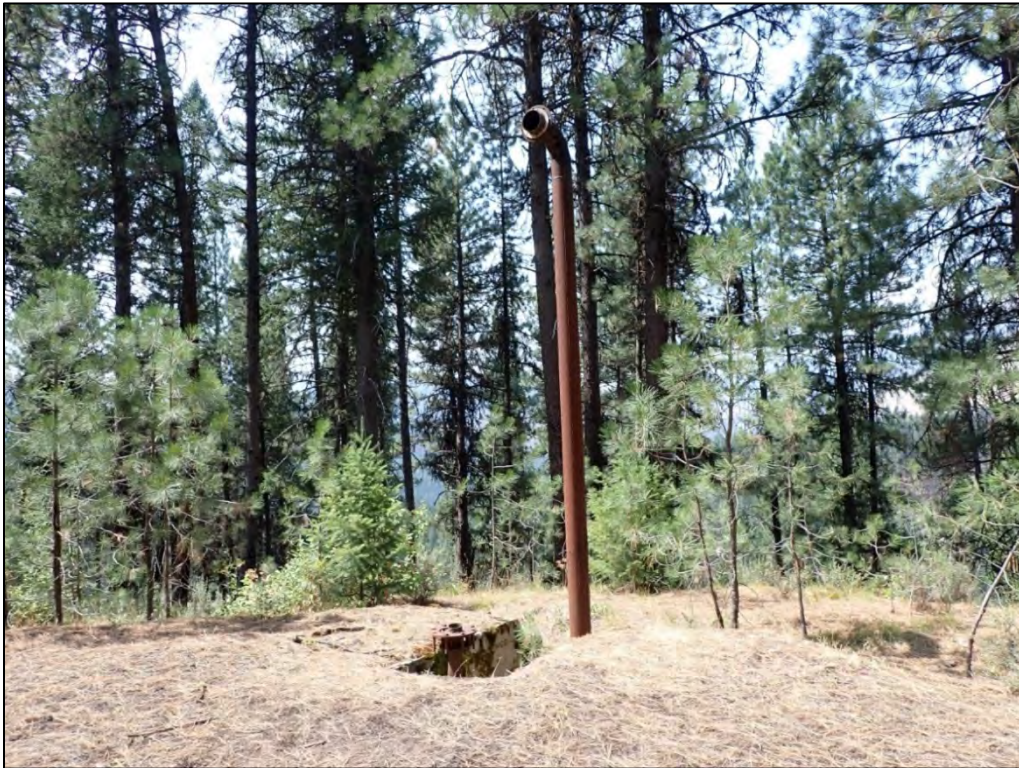
*PL-6. Remains of Concrete and Piping from Former Milling Operations*

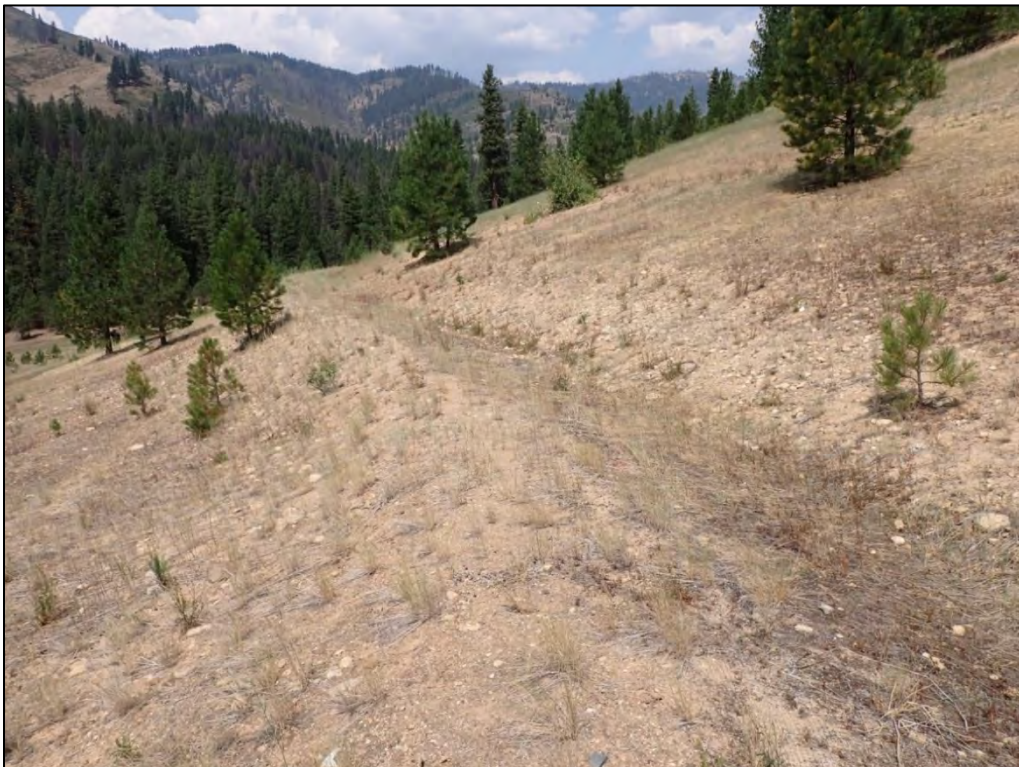
intercept stormwater runoff and route it offsite into Clear Creek. Over the years, minor erosion has breached the benches in several locations, and LM has repaired such erosion on numerous occasions, most recently in October 2016. The three interceptor benches (PL-7) and a collection ditch are inspected annually to ensure that erosion in this area does not affect overall site stability. During this year's inspection, the 2016 repairs appeared intact, and LM will continue to monitor the area as the vegetation continues to establish.

*PL-7. Interceptor Bench 2*

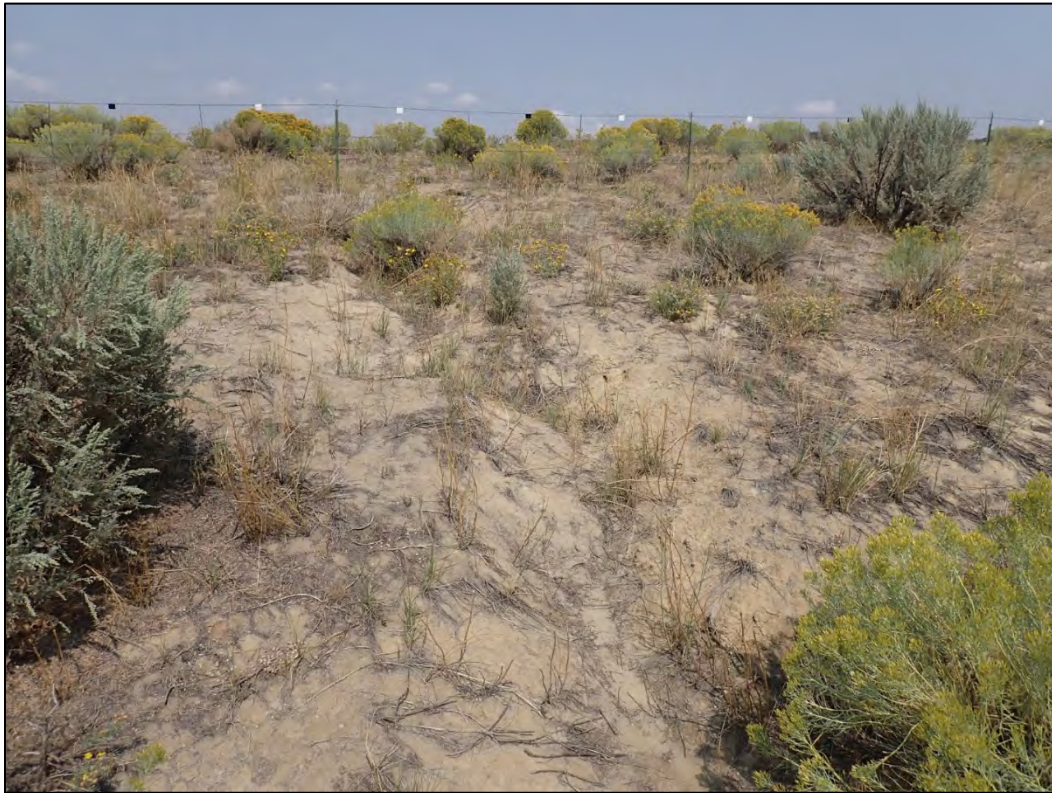
To facilitate LM's land management, a four-strand barbed-wire perimeter fence encloses the disposal cell, drainage structures, and much of the site. The site is in wintering grounds frequented by big-game animals (primarily pronghorn, deer, and elk) and is also surrounded by open range used to graze cattle. Minor damage to the perimeter fence from animal contact periodically occurs. On July 27, 2021, plastic fence flags were attached to the top strand of the perimeter fence to alert wildlife and reduce animal entanglements or strikes against fence lines (PL-3).

*PL-3. Perimeter Fence Line*

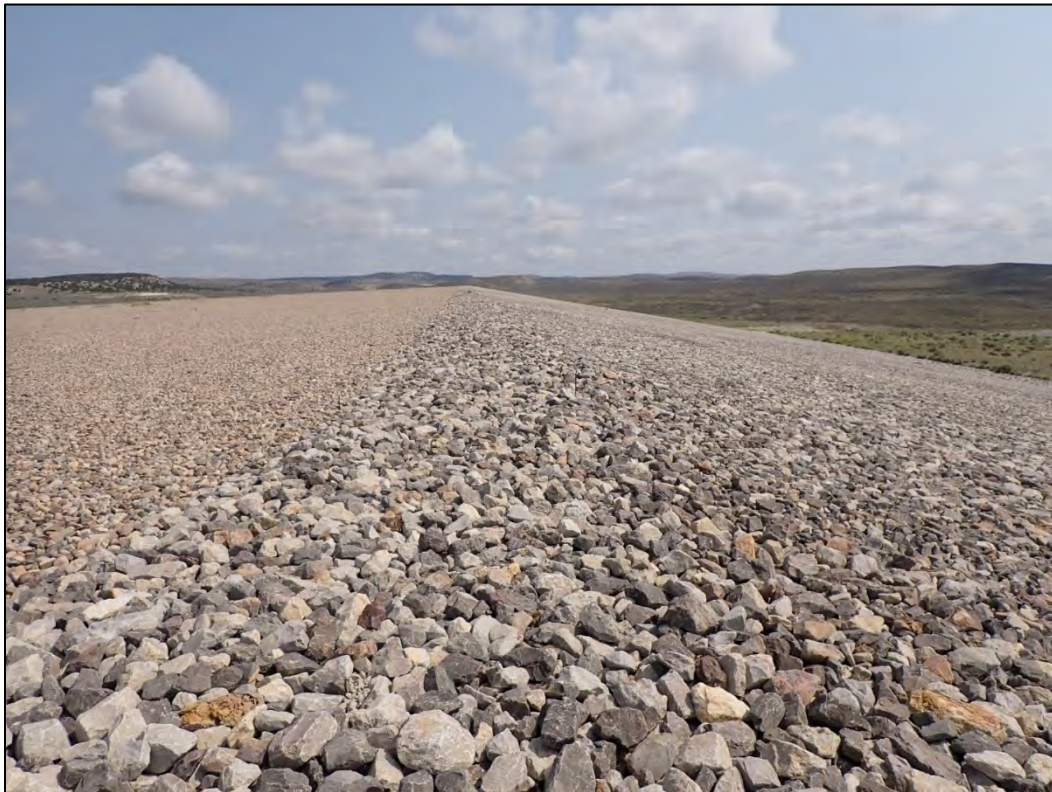
The disposal cell, completed in 1998, occupies 66 acres; it is armored with riprap to control erosion and deter animal and human intrusion (PL-8). There was no evidence of erosion, settling, slumping, rock degradation, or other modifying processes that might affect the integrity of the disposal cell. Scattered shallow-rooted plants continue to establish on the disposal cell top and side slopes; these plants do not affect the integrity of the cell. Deep-rooted plants and noxious weeds are controlled as required by the LTSP.

*PL-8. Disposal Cell Top Slope and Southeastern Side Slope Interface*

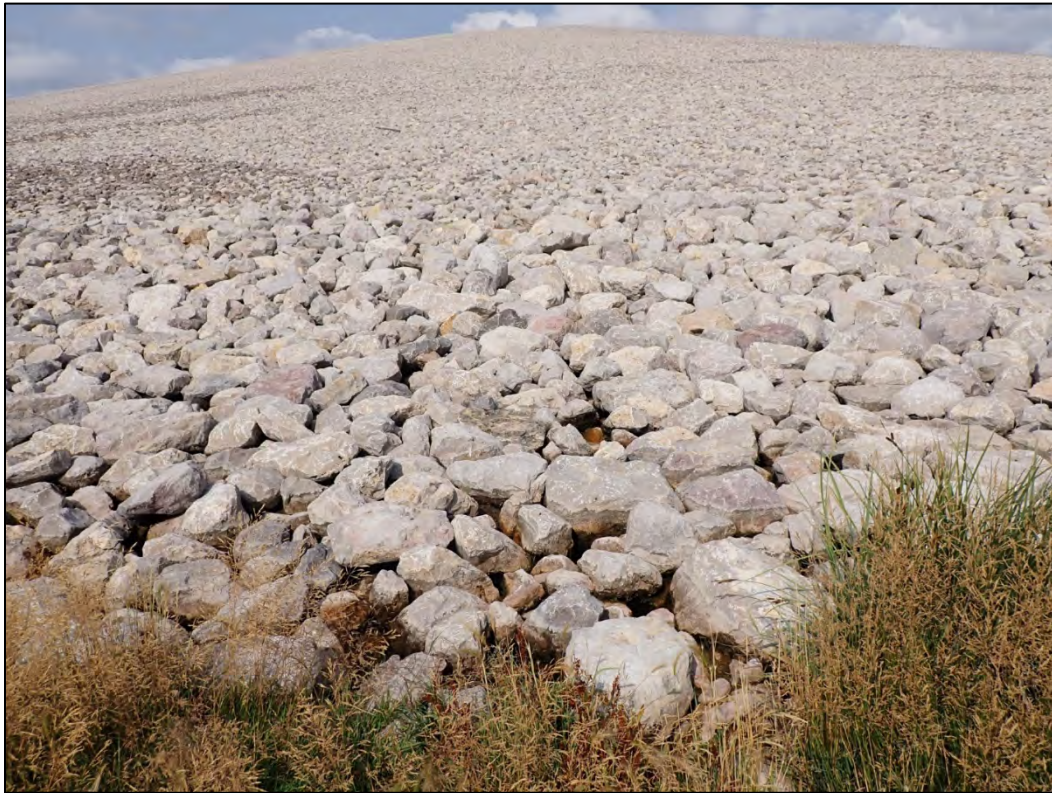
The Maybell, Colorado, Uranium Mill Tailings Radiation Control Act (UMTRCA) Title I Disposal Site was inspected on September 2, 2021. Standing water was observed in the disposal cell apron on the eastern toe slope. Inspectors identified several minor maintenance needs but found no cause for a follow-up inspection. Groundwater monitoring is not required.

*PL-9. Standing Water in Side Slope Apron*

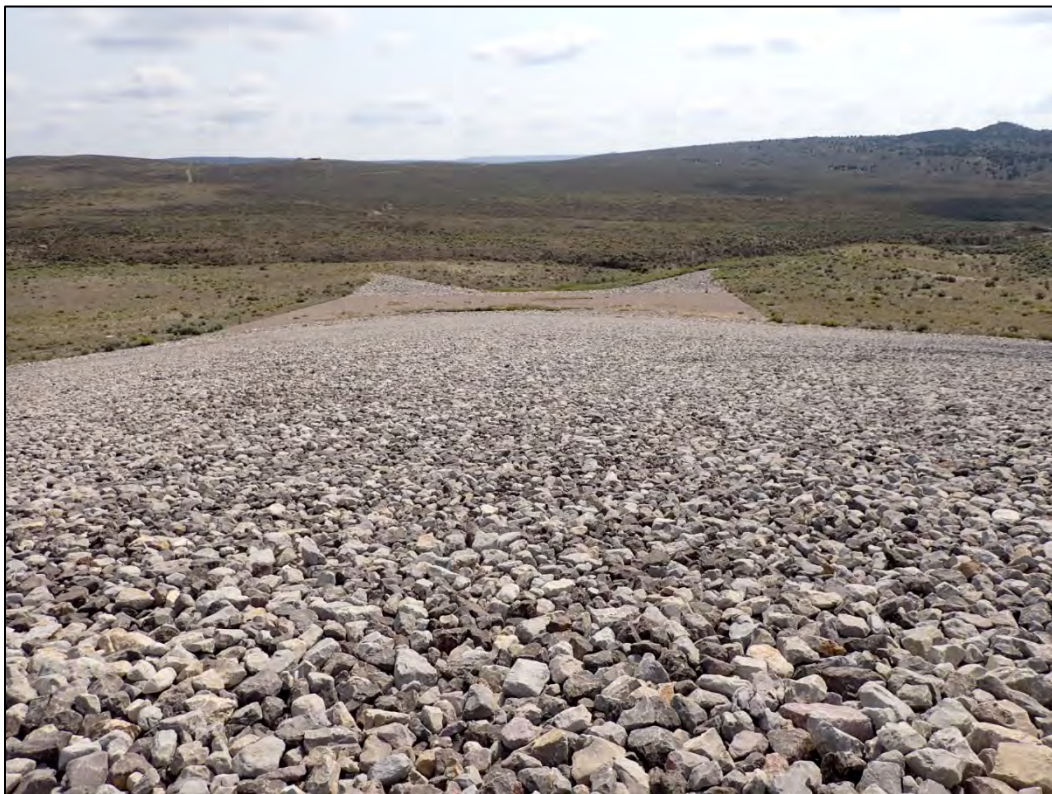
In accordance with the LTSP, inspectors looked for seeps on the east and southeast side slopes of the disposal cell, because slimes were encapsulated in this portion of the cell. No seeps were observed at the toe of the disposal cell in these areas. Stormwater runoff from the disposal cell discharges at this location, and standing water was observed in the easternmost portion of the disposal cell toe slope apron upgradient of the cobble blanket (PL-9 and PL-10). A storm was recorded in the area a few days before the annual inspection, and standing water has been observed at this location in the past. A 2003 laboratory analysis of evaporite minerals from this location confirmed that no constituents attributable to the disposal cell contents were present. No other maintenance needs were identified.

*PL-10. Disposal Cell Eastern Side Slope and Cobble Blanket*

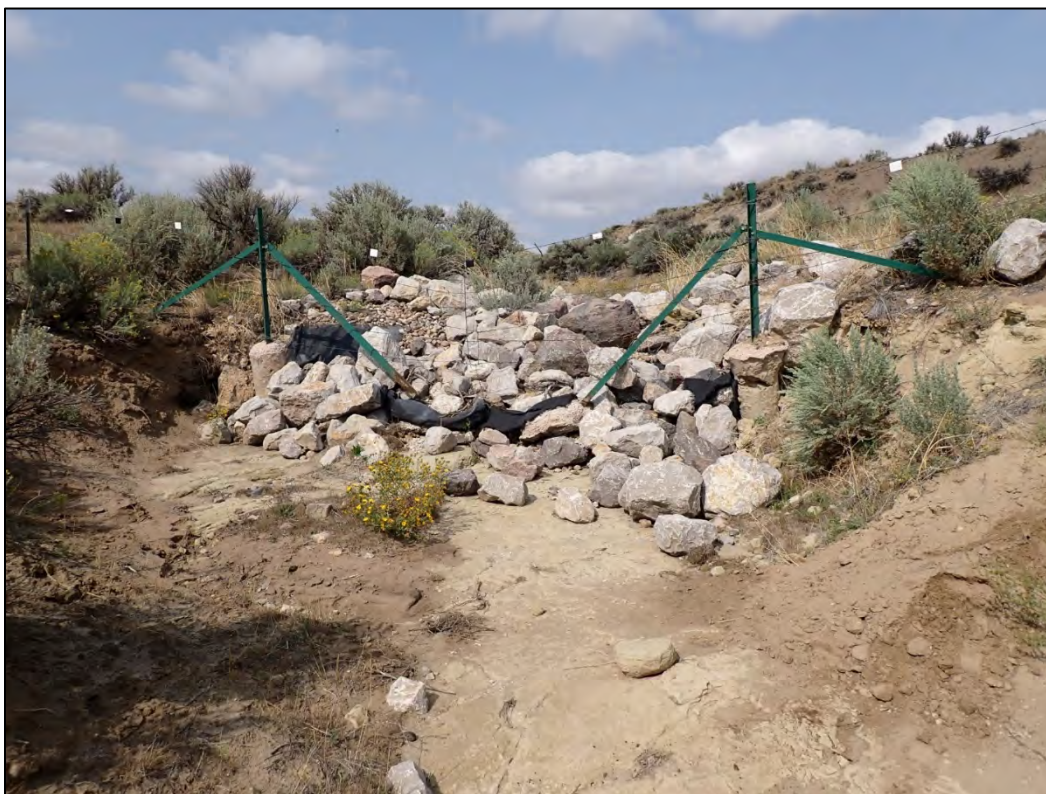
*PL-12. Exposed Geofabric in Diversion Channel No. 1 Outlet*

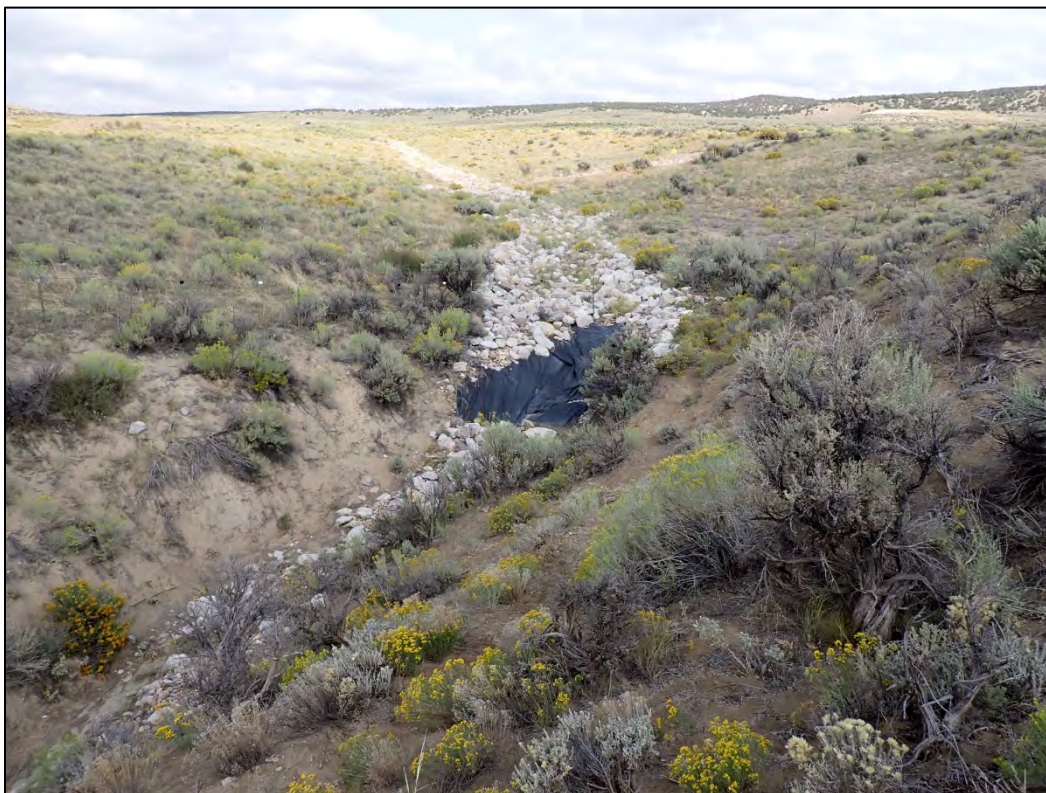
*PL-13. Exposed Geofabric in Swale No. 1 Outlet*

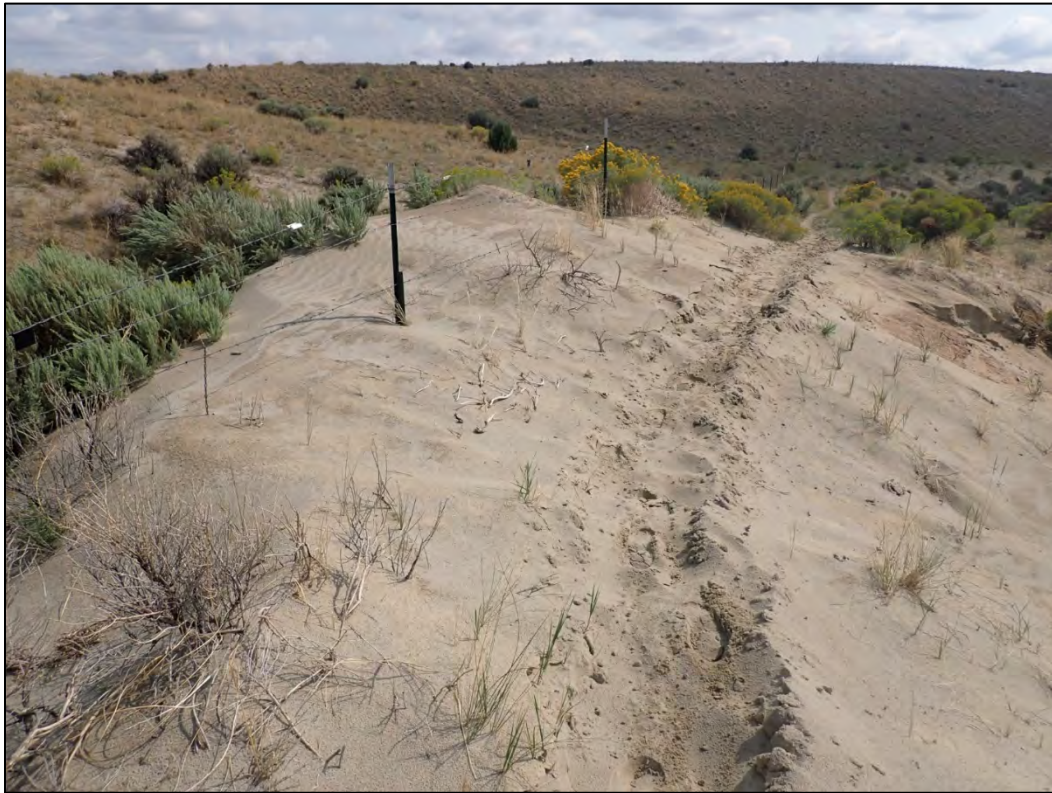
*PL-15. Sand Accumulation Along Southern Fence Line Near Johnson Pit*

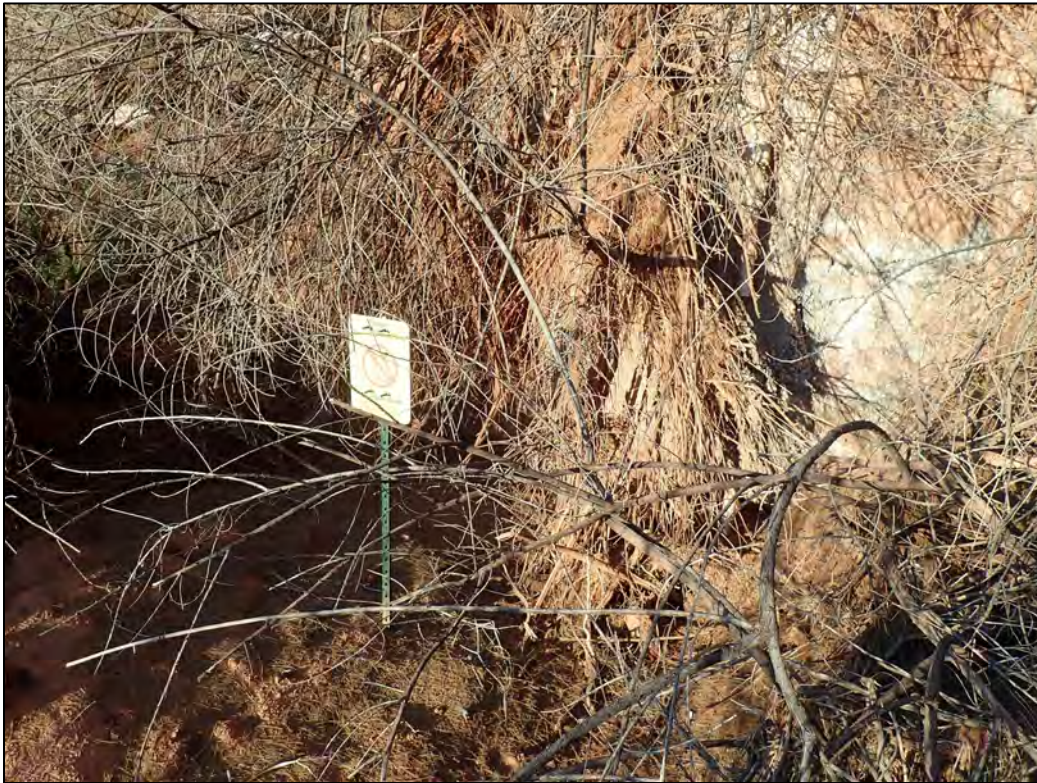
Since 2010, groundwater discharge from seeps had been observed at cross-gradient seep 0248, which typically exhibits dripping conditions; however, during the 2021 inspection seep 0248 was dry. Upgradient (background) seep 0261 (PL-5) was observed to be dripping during the inspection; it is approximately 0.5 mile upstream of seep 0248 in Gypsum Creek.

*PL-1. Seep 0248*

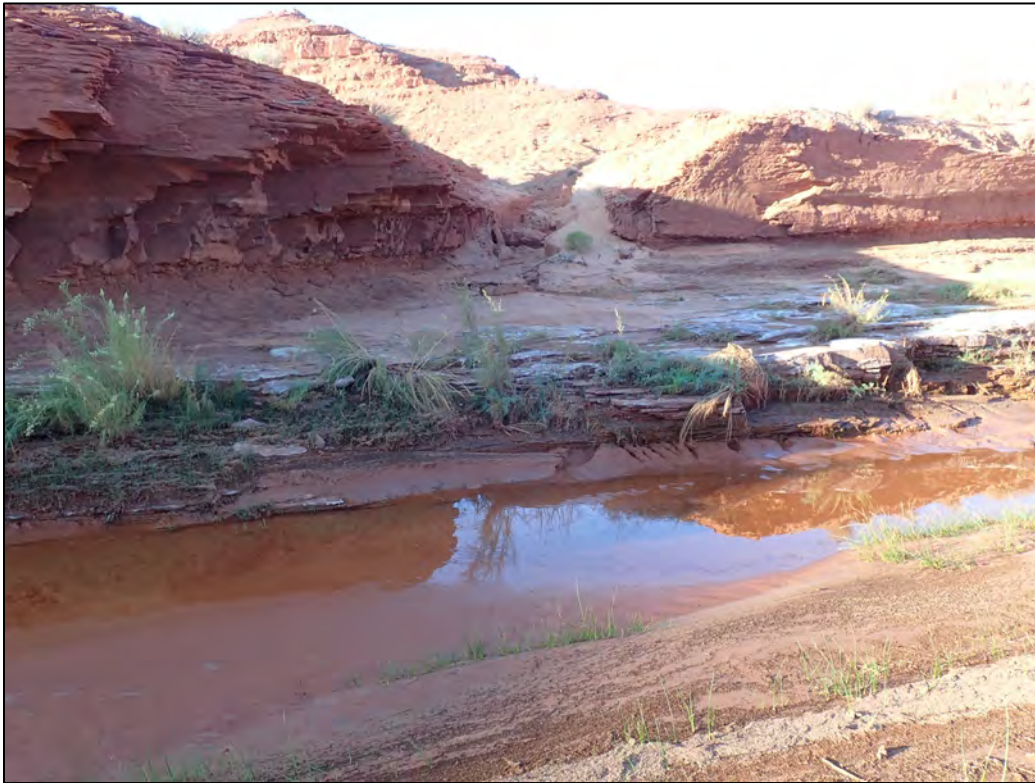
*PL-5. Seep 0261 (Background Seep)*

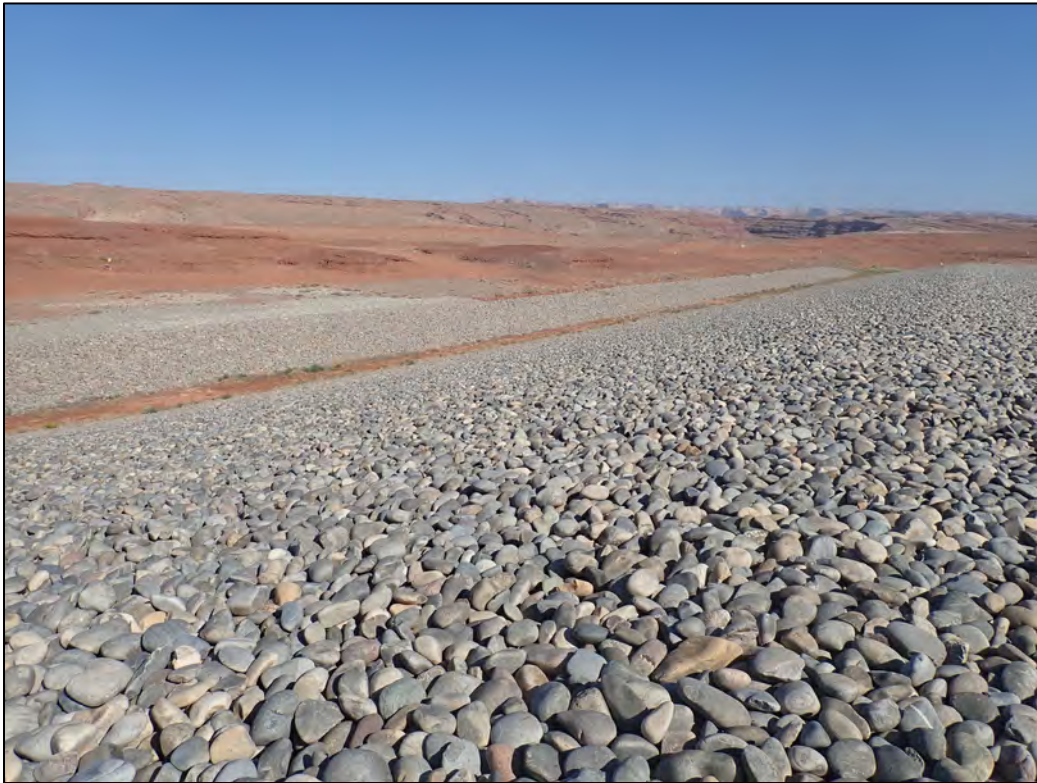
*PL-14. Sloughed Rock*

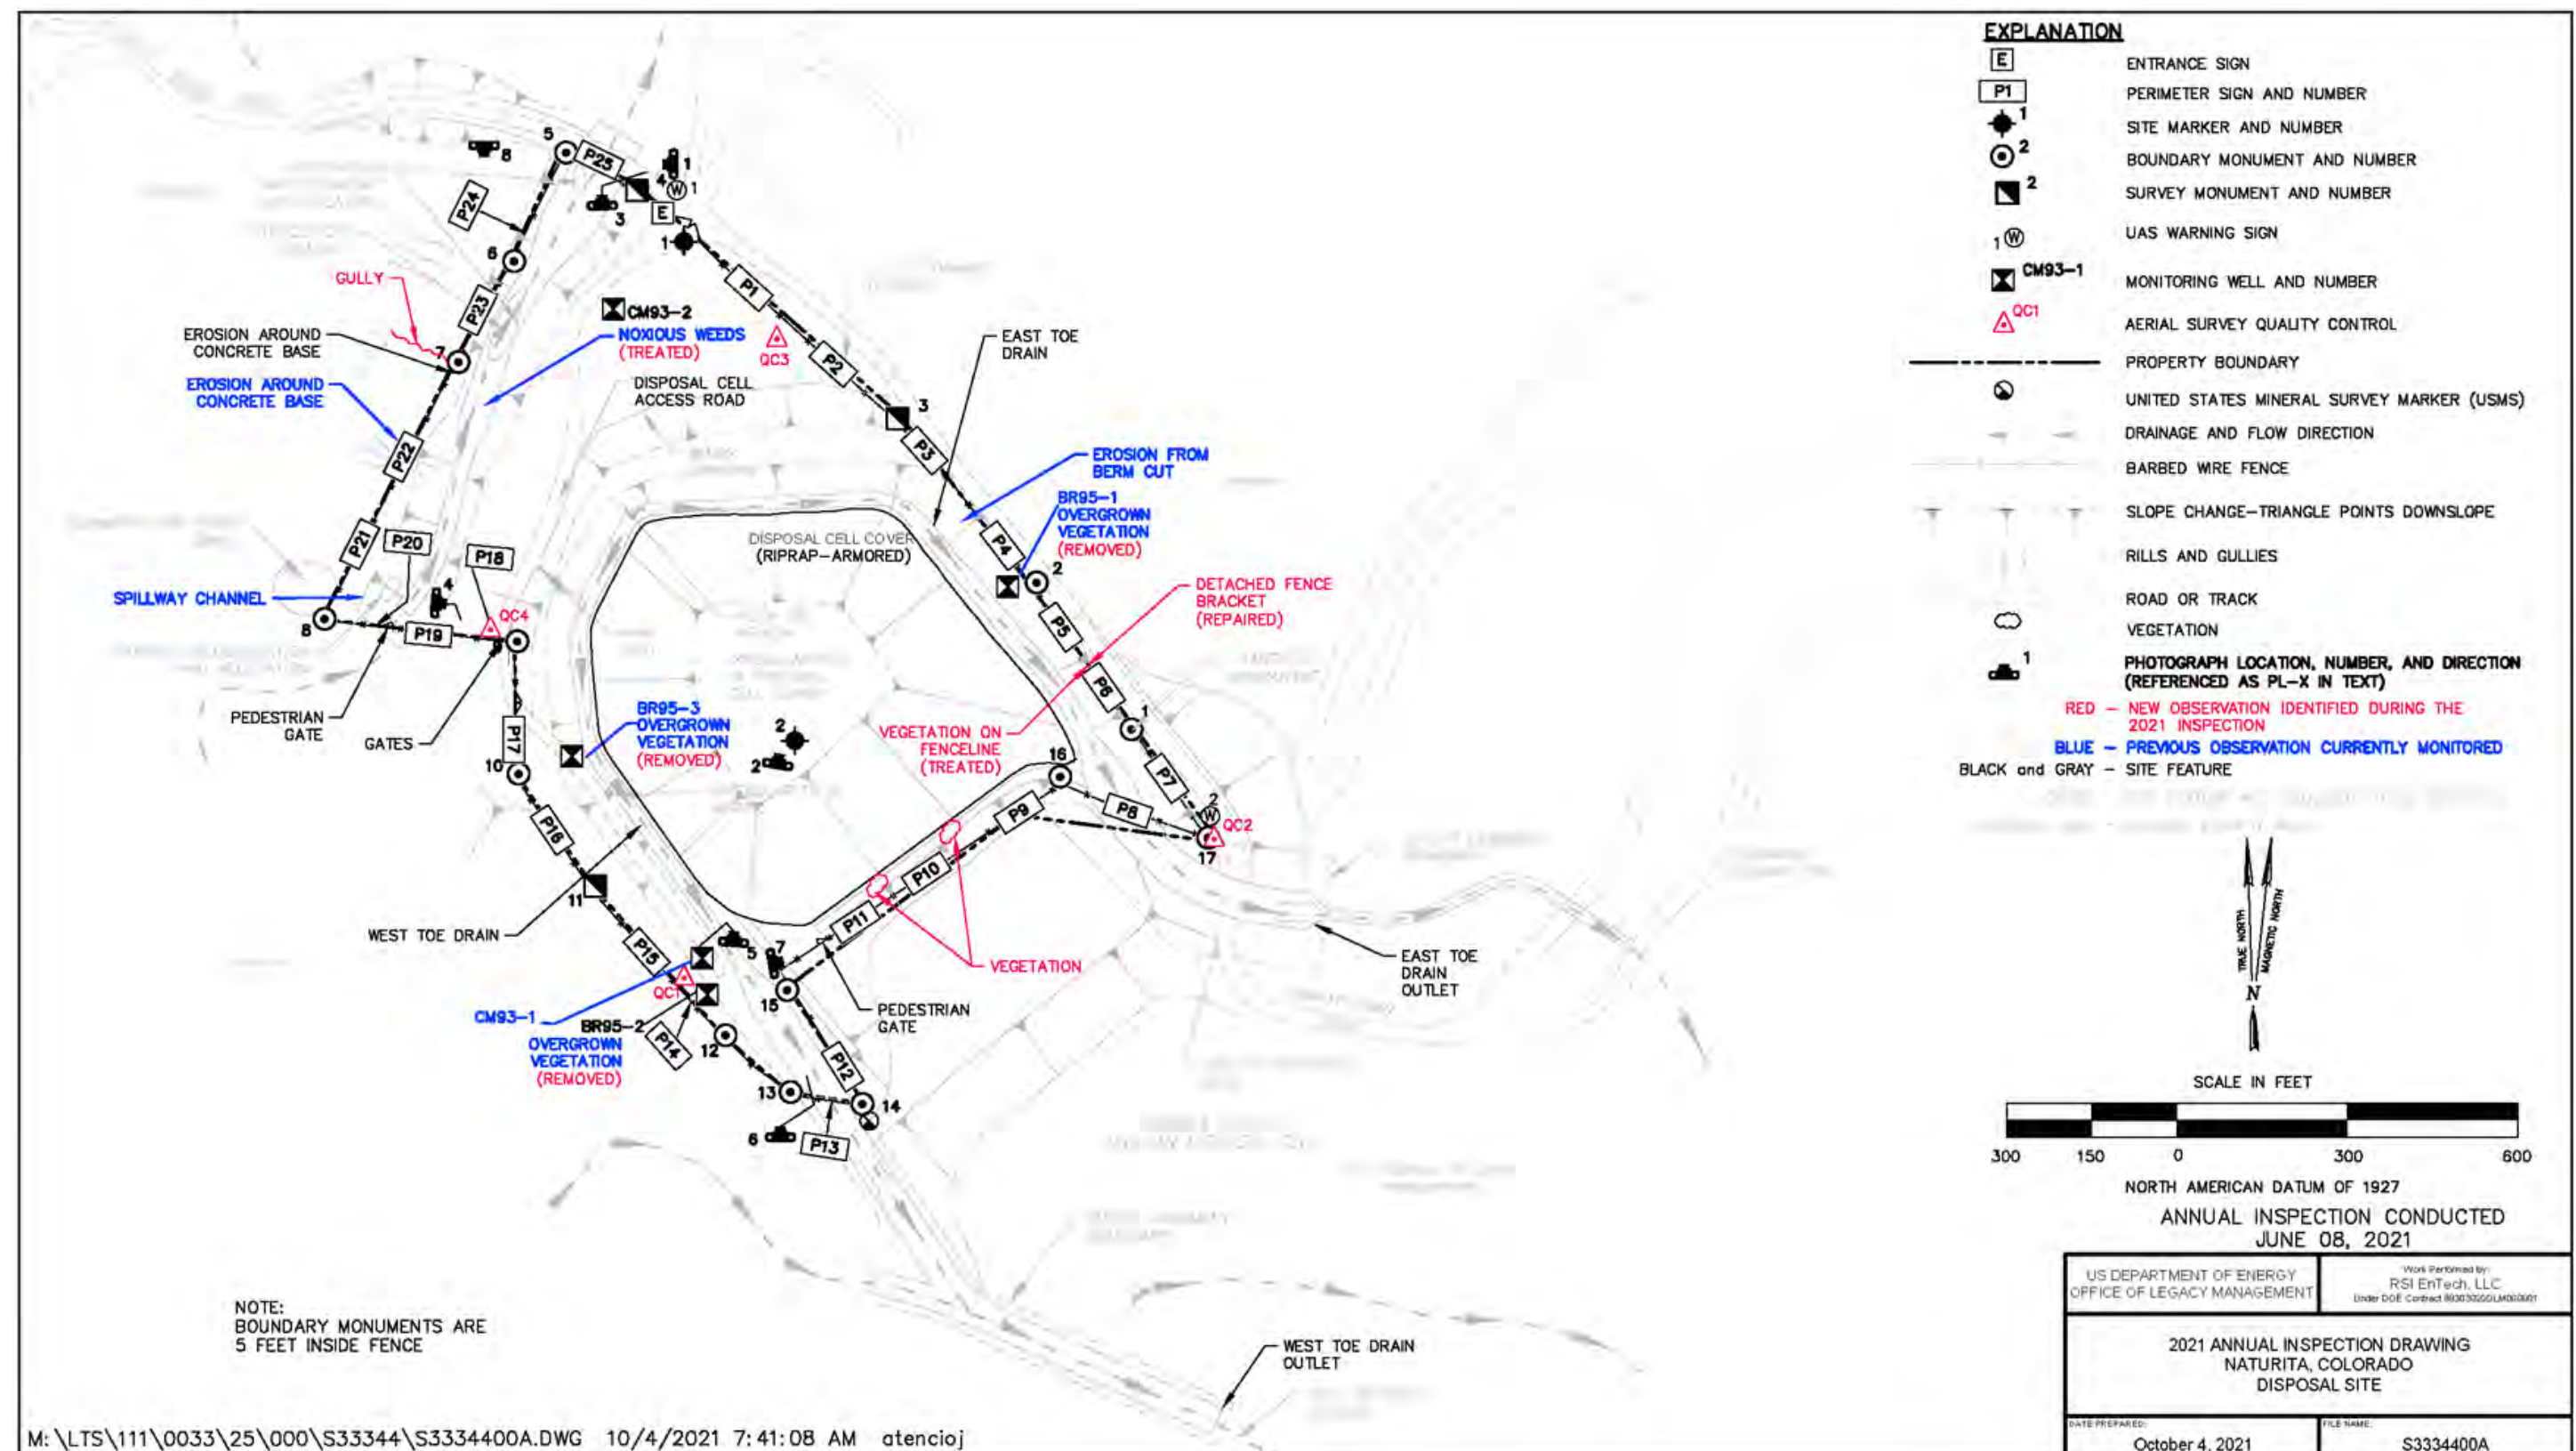
Figure 13-1. 2021 Annual Inspection Drawing for the Naturita, Colorado, Disposal Site

During the 2019 inspection, headcutting erosion was identified within the spillway channel below the sedimentation pond on the outlying area northwest of the site. Inspectors noted minor increases in erosion in this area during the 2021 inspection and will continue to monitor this area.

Erosion in the steep cliff below the previous berm cut alongside County Road EE22 does not threaten the integrity of the disposal cell or site features. The berm cut was repaired in 2020. Inspectors will continue to monitor this area. No maintenance needs were identified.

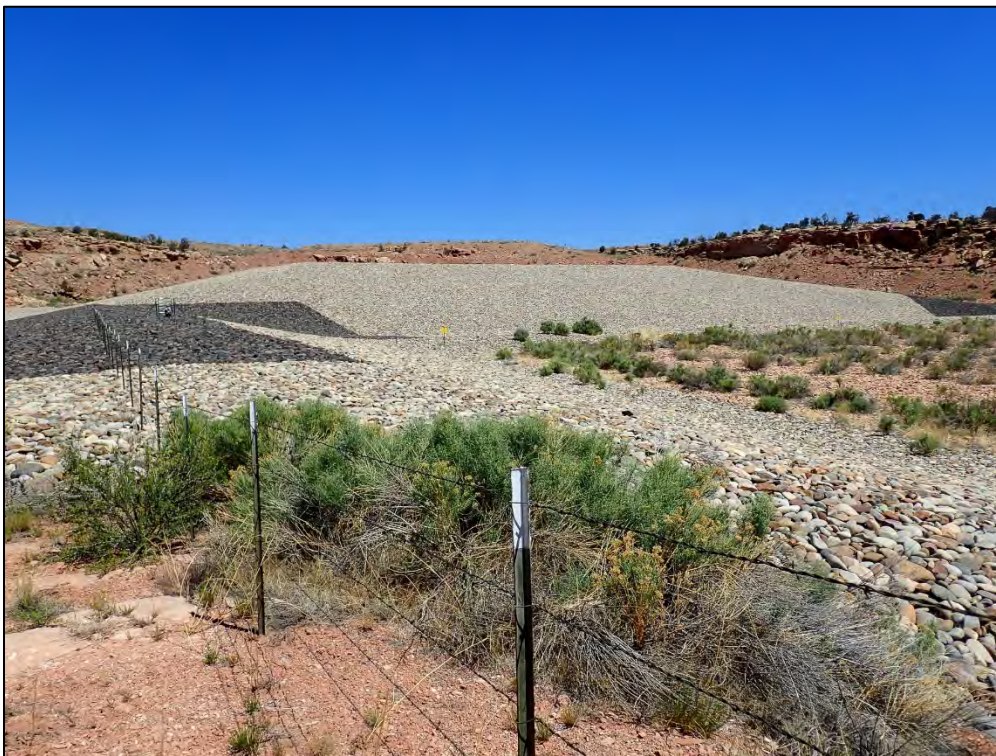
The disposal cell, completed in 1998, occupies 10 acres (PL-6). The disposal cell is armored with riprap to control erosion. The riprap is rounded, with larger diameter rock on the side slopes versus on the top slope. There was no evidence of settling, slumping, erosion, rock degradation, or other modifying processes that might affect the integrity of the disposal cell.

Irregularities in the riprap on the top slope of the disposal cell continue to be observed. The irregularities consist of slightly darker rock that are not lower than surrounding areas and have not changed over time. Another irregularity in the apron area on the west side of the disposal cell appears to be old vehicle tracks. The irregularity does not present a threat to the disposal cell or surrounding area. Inspectors will continue to monitor these areas for potential impacts. No maintenance needs were identified.

*PL-6. Disposal Cell*

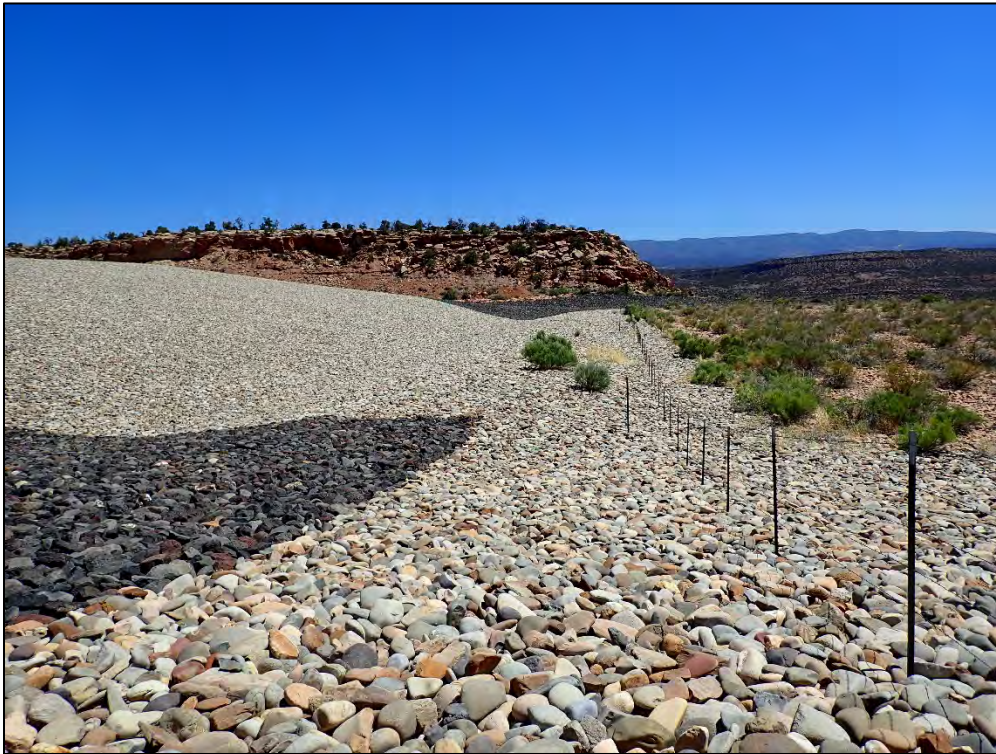
- Treated vegetation growing in the fence line near perimeter sign P6
- Repaired detached fence bracket near perimeter sign P6

*PL-7. Vegetation Growing near Southern Fence Line*

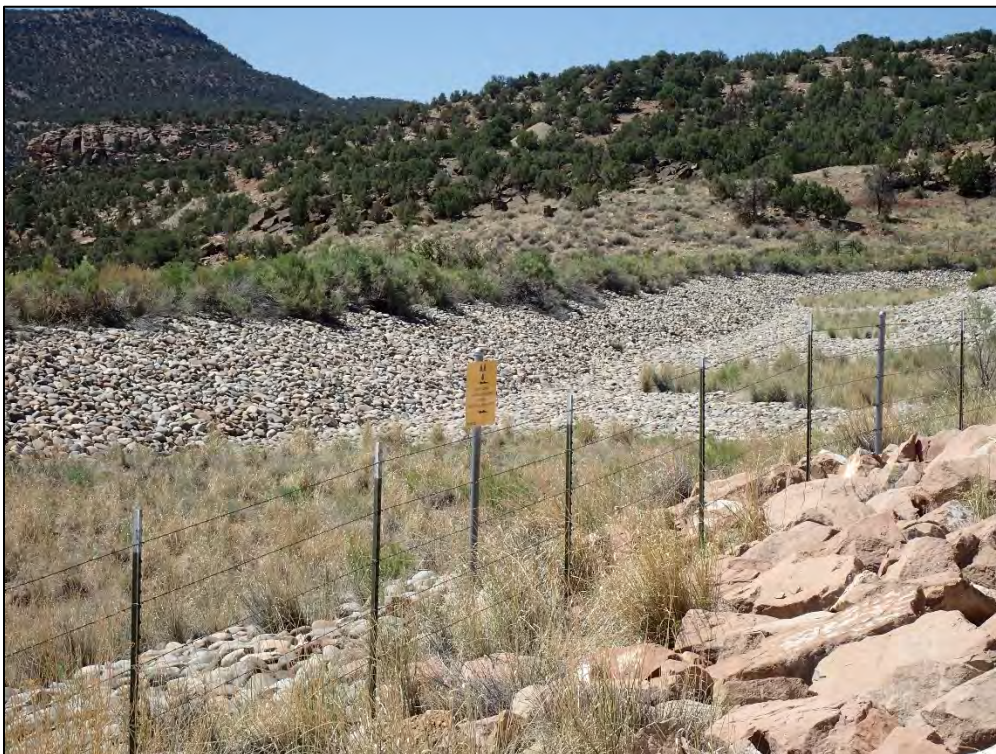
*PL-8. Vegetation Growing in Interceptor Channel*

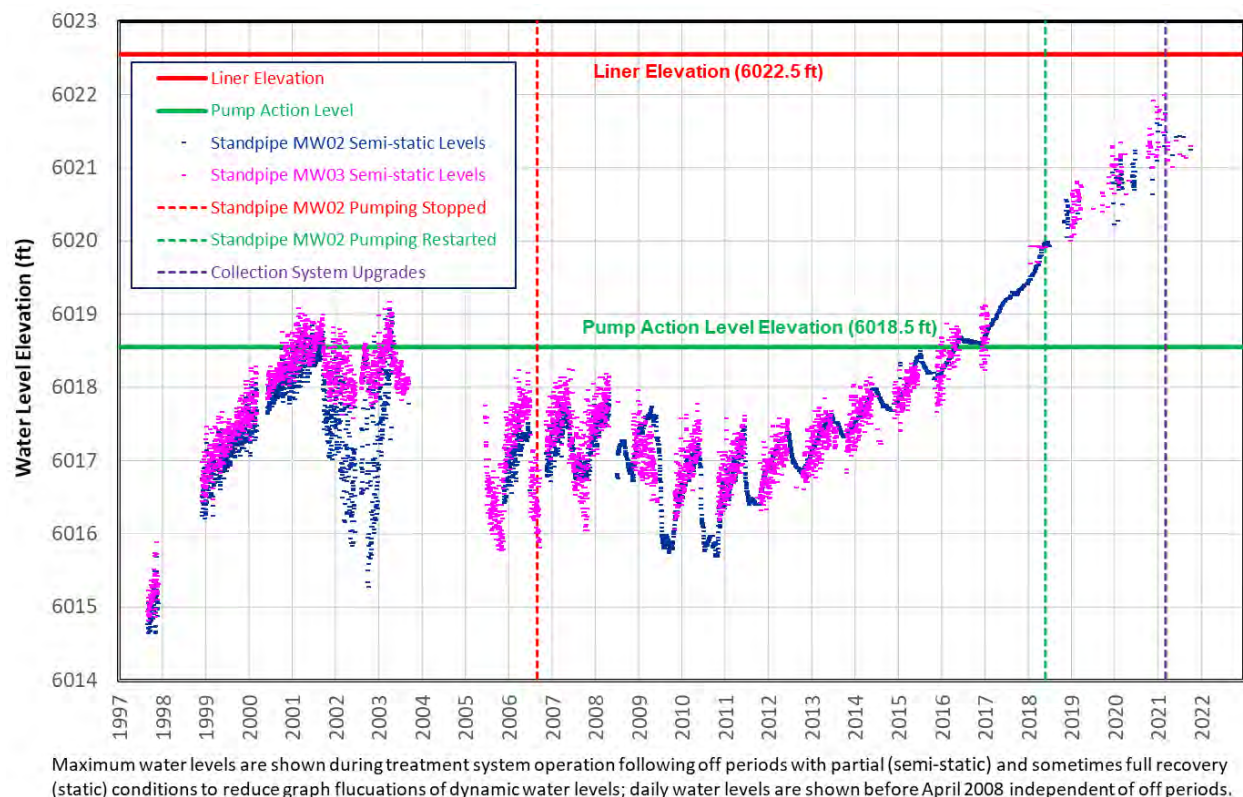
Real-time disposal cell water elevations collected in 2018 (using pressure transducers and dataloggers) continued to indicate that daily maximum or semistatic pore-water levels in standpipes SP-02 and SP-03 exceed the 6018.55 ft (6016 ft) pump action level (see Figure 14-2). In 2019, LM modified the seasonal pumping regimen for year-round pumping while a long-term solution is evaluated and implemented.

Data fluctuations for both standpipes observed from 2018 to 2021 are the result of partial overnight recharge due to well inefficiencies, and nonstatic levels have been filtered from the dataset shown in Figure 14-2. Downhole video taken in 2020 for both standpipes revealed fouling in the perforated interval. Redevelopment of standpipe SP-02 to remove mineral scale and biofouling was completed in December 2020. Initial testing results indicate an increase in production volume from standpipe SP-02 of approximately 22%. Downhole video in standpipe SP-03 also identified approximately 7.6 ft of 6- to 10-inch diameter rock riprap at the bottom of the standpipe. Potential methods to remove the rock and redevelop the standpipe are being considered to increase production.

*Figure 14-2. Disposal Cell Pore-Water Levels in Standpipes SP-02 and SP-03 at the Rifle, Colorado, Disposal Site*

In March 2021, the solar-powered pumping system was upgraded to provide additional operation of the pumps by increasing electrical storage ability. By adding batteries to store solar-generated electricity, the pumps are able to operate throughout the night and on overcast days. This should yield a more consistent and lower pore-water elevation and increase annual dewatering volume. The pumping system will continue to have limited availability in winter because aboveground effluent lines are susceptible to freezing.

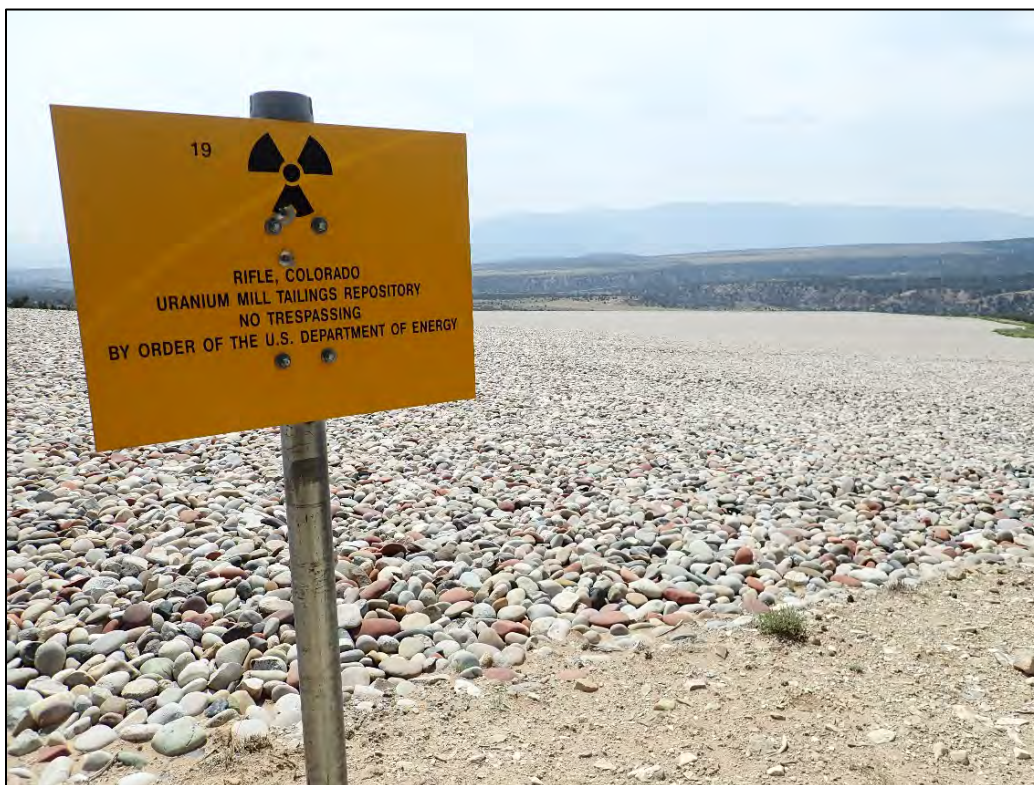
There are 27 perimeter signs positioned along the perimeter. Perimeter signs P0 through P11 are attached to the stock fence, and signs P12 through P26 are attached to steel posts set in concrete and set back 5 ft from the boundary (PL-2). Perimeter signs P15 and P19 have bullet damage, but remain legible and do not need to be replaced at this time. Perimeter sign P18 has shown minor cracks and peeling but remains legible. No other maintenance needs were identified.

*PL-2. Perimeter Sign P19*

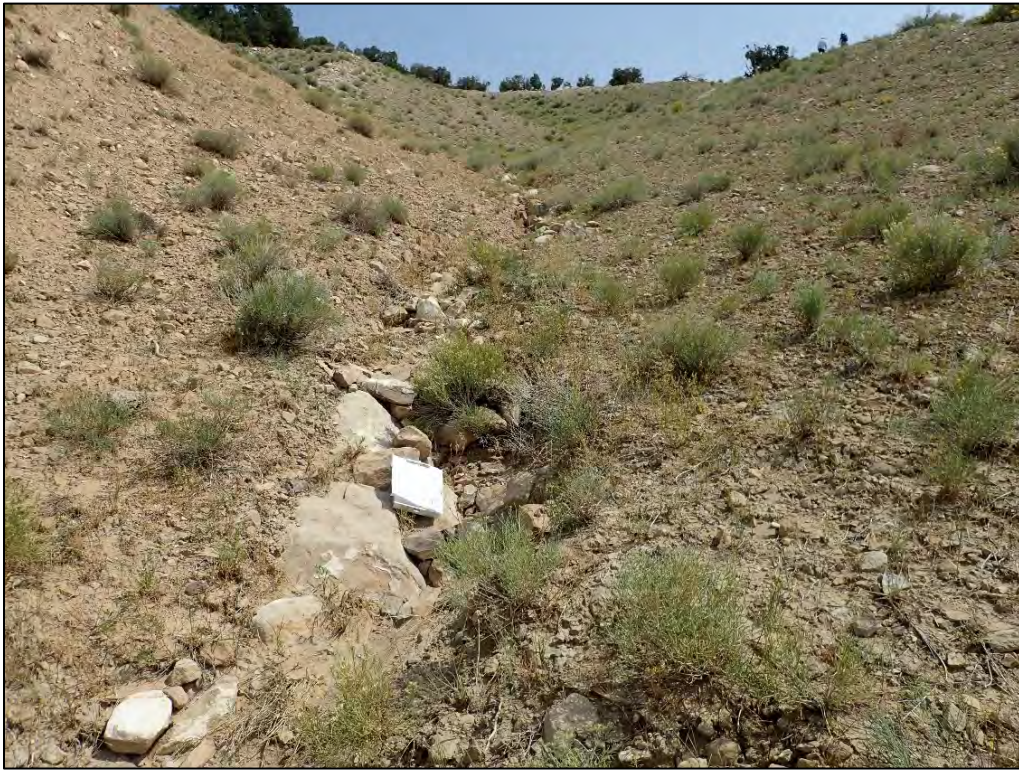
*PL-7a. Gully Erosion in Interceptor Trench Outfall in 2021*

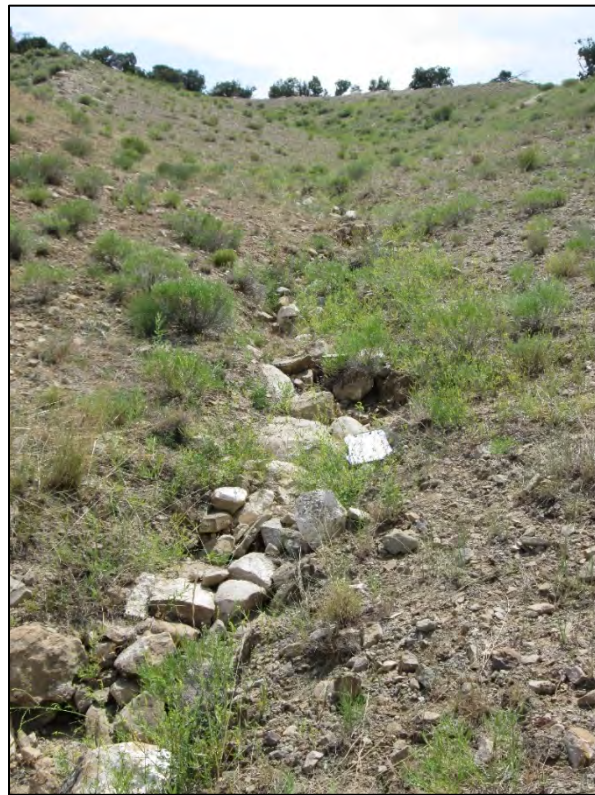
*PL-7b. Gully Erosion in Interceptor Trench Outfall in 2016—Photo for Comparison*

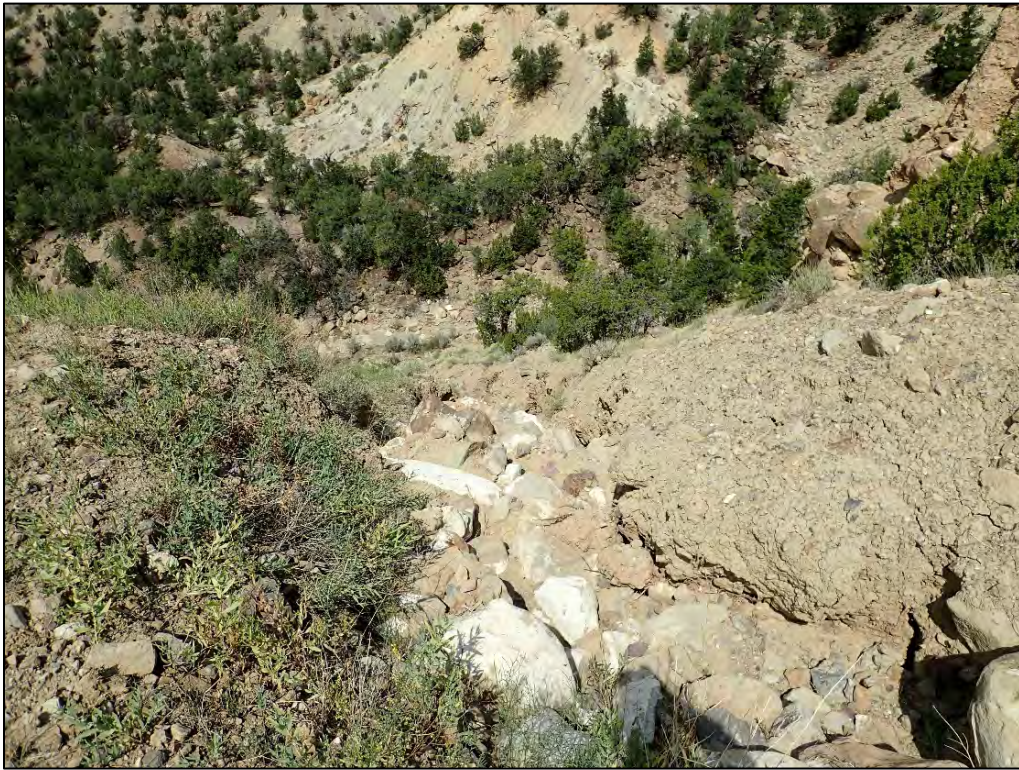
*PL-8a. Gully Erosion in Interceptor Trench Outfall in 2021*

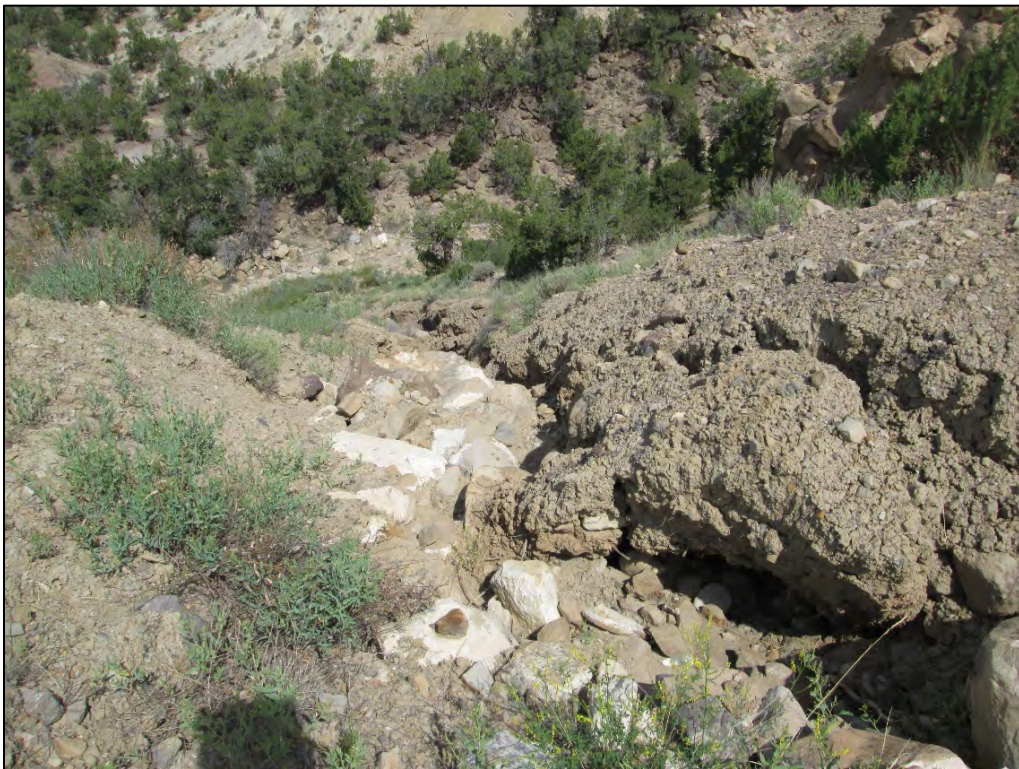
*PL-8b. Gully Erosion in Interceptor Trench Outfall in 2016—Photo for Comparison*
