## 2021 Annual Site Inspection and Monitoring Report for Uranium Mill Tailings Radiation Control Act Title I Disposal Sites

March 2022

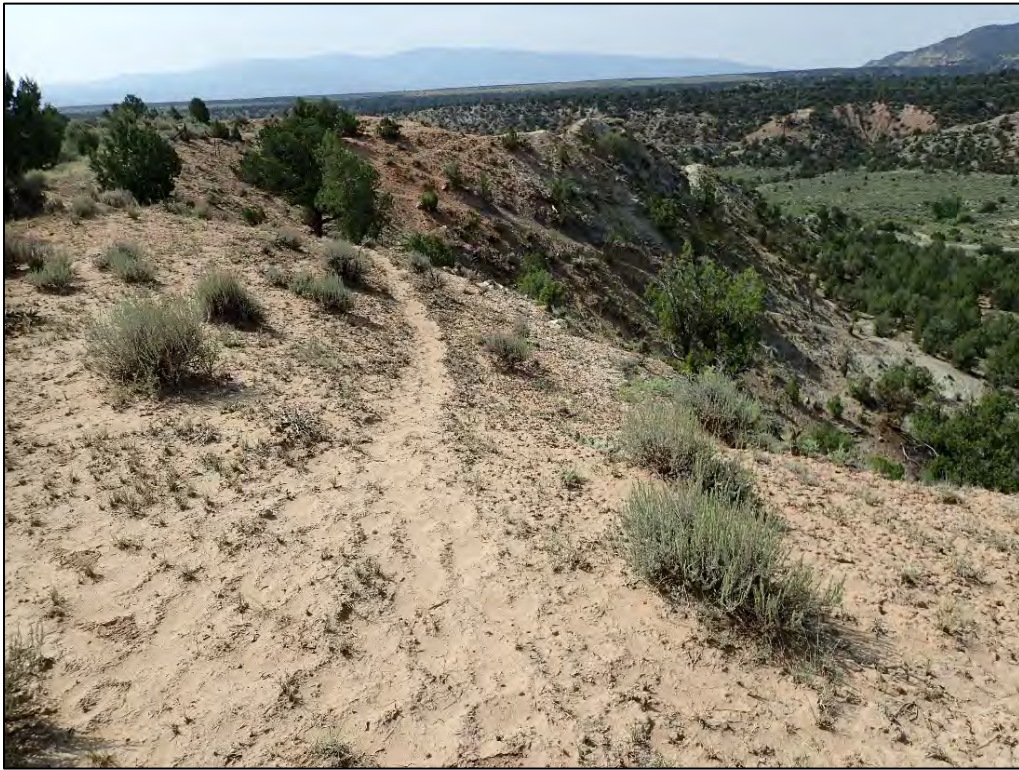
A four-strand barbed-wire stock fence at the south end of the site extends to the edge of steep-sided arroyos that bound the site on the east and west. In previous years, livestock associated with an adjacent BLM grazing allotment would go around the fence to graze onsite vegetation. Results from the 2021 inspection showed evidence of continued livestock grazing, discussed further in Section 14.4.2.3. Strands of the barbed-wire fence were repaired in June 2021, and no additional maintenance needs were identified during the inspection. Two barbed-wire personnel gates are at the southeast corner of the site. The northern gate, which provides access to DOE property, was locked with a chain and padlock. The southern gate is left open to allow livestock on the adjacent BLM allotment to pass through the fence.

*PL-9. Cattle Trail on Southwest Side of Site*

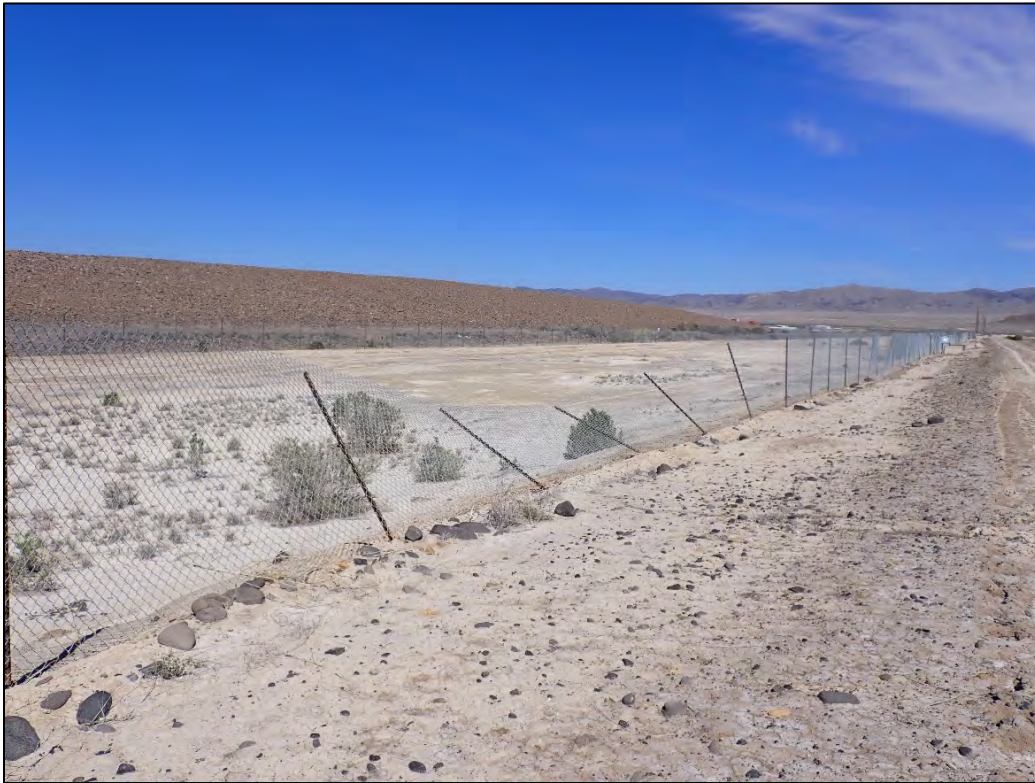
*PL-1. Down Fence Along South Side of Cell*

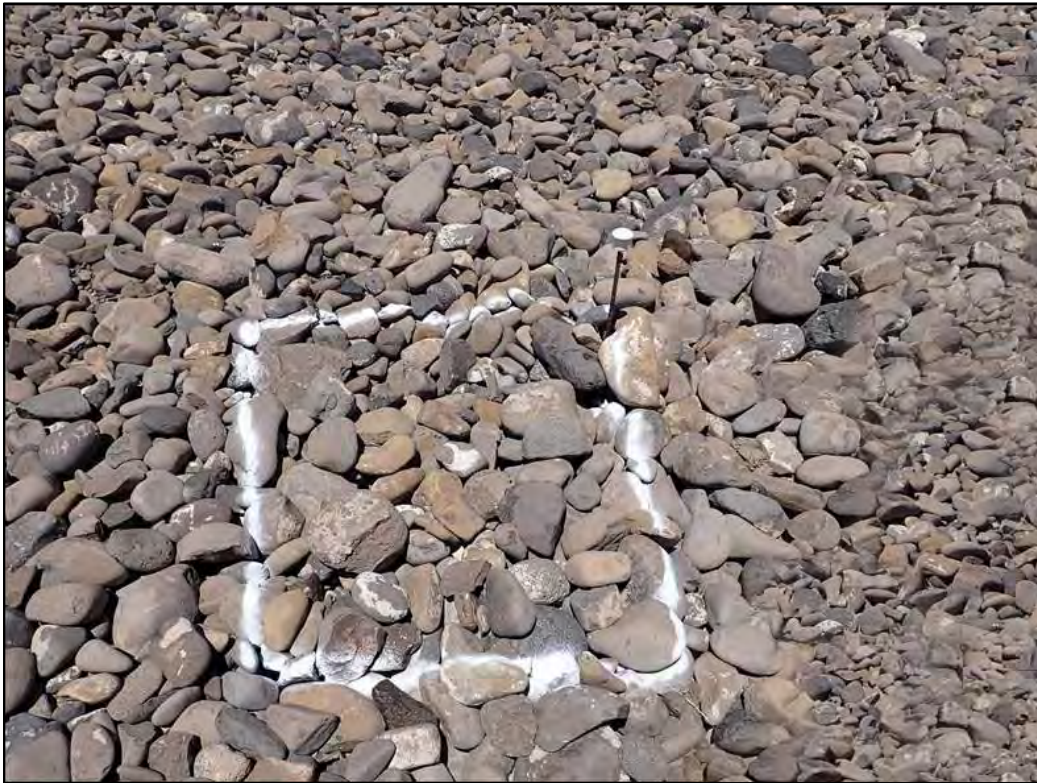
One of several types of rock used for the disposal cell erosion-protection riprap layer has exhibited minor degradation since the disposal cell was constructed. As a result, eight rock-quality monitoring plots, each measuring 1 square meter (indicated by Roman numerals I–VIII in Figure 15-1), were established in 2010 to monitor for continued rock degradation.

*PL-5. (a) Rock Quality Plot No. I—2021*

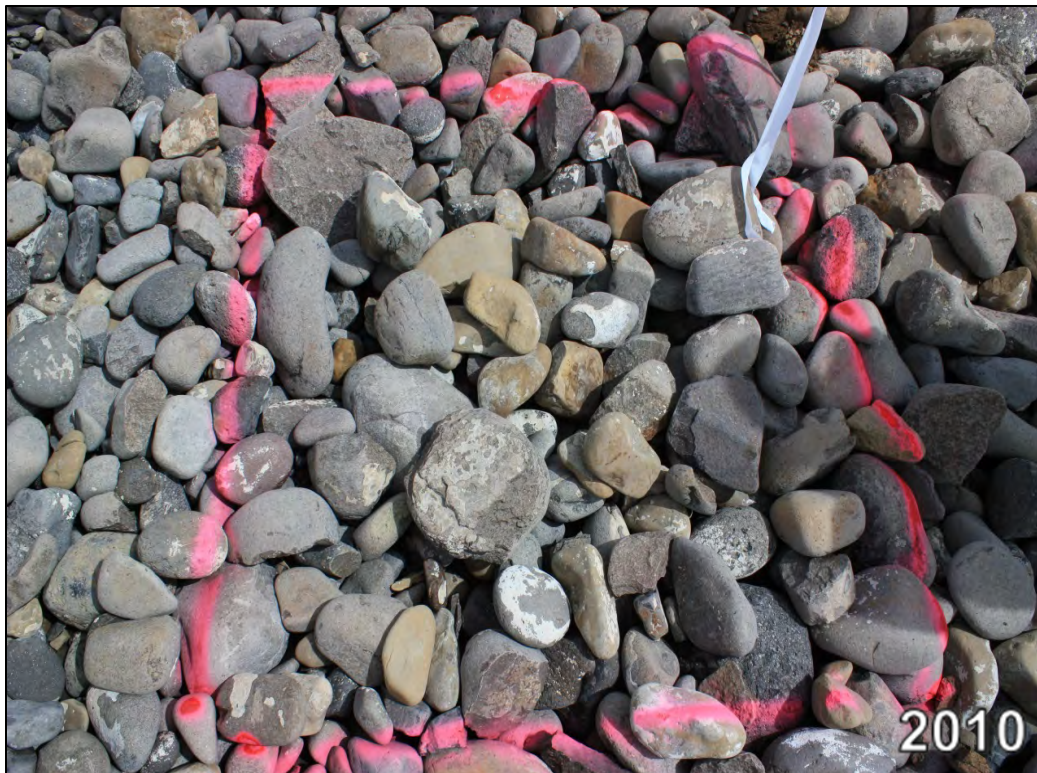
*PL-5. (b) Rock Quality Plot No. I—2010 Photo for Comparison*

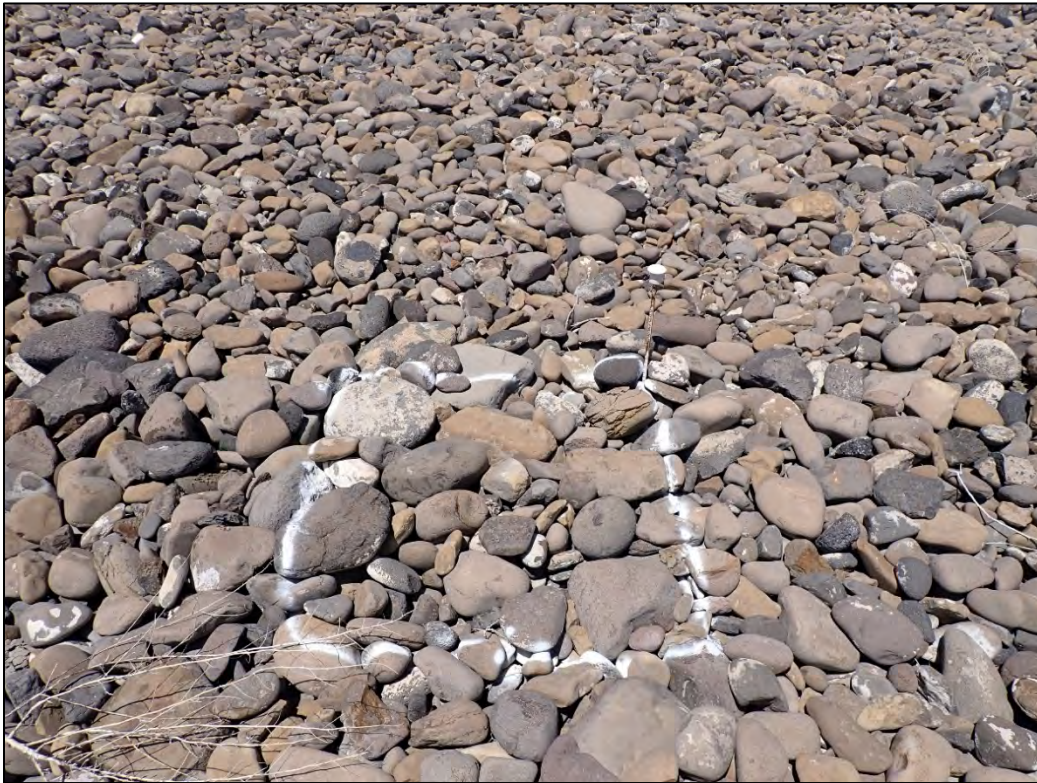
*PL-6. (a) Rock Quality Plot No. II—2021*

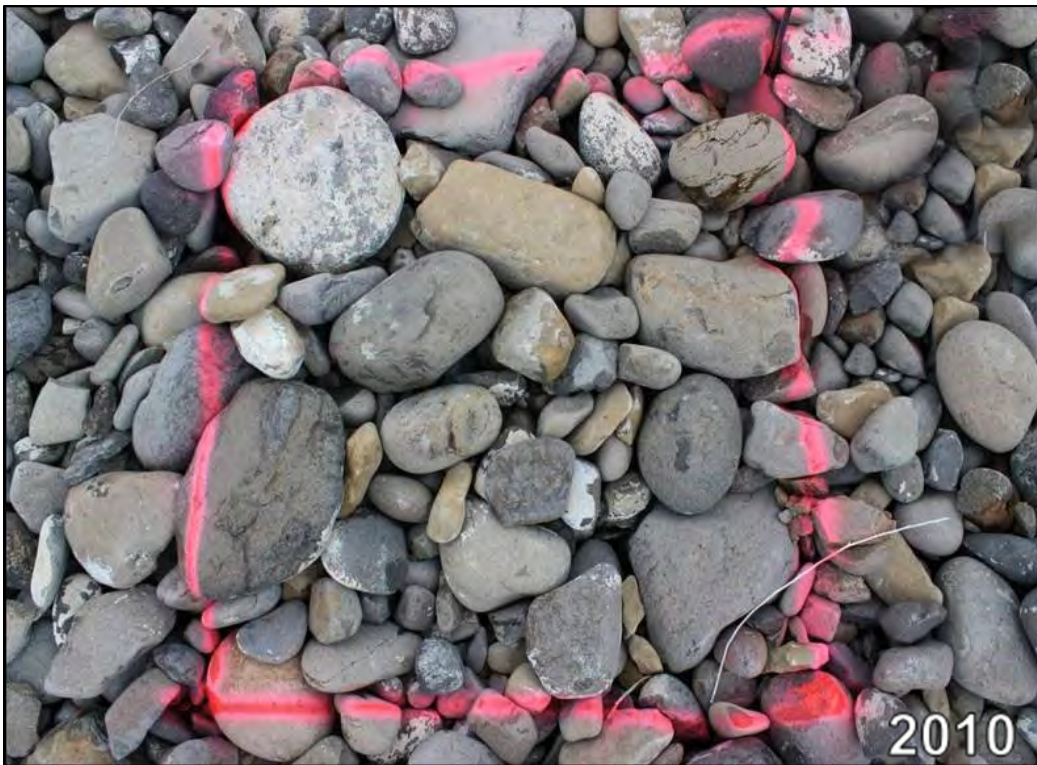
*PL-6. (b) Rock Quality Plot No. II—2010 Photo for Comparison*

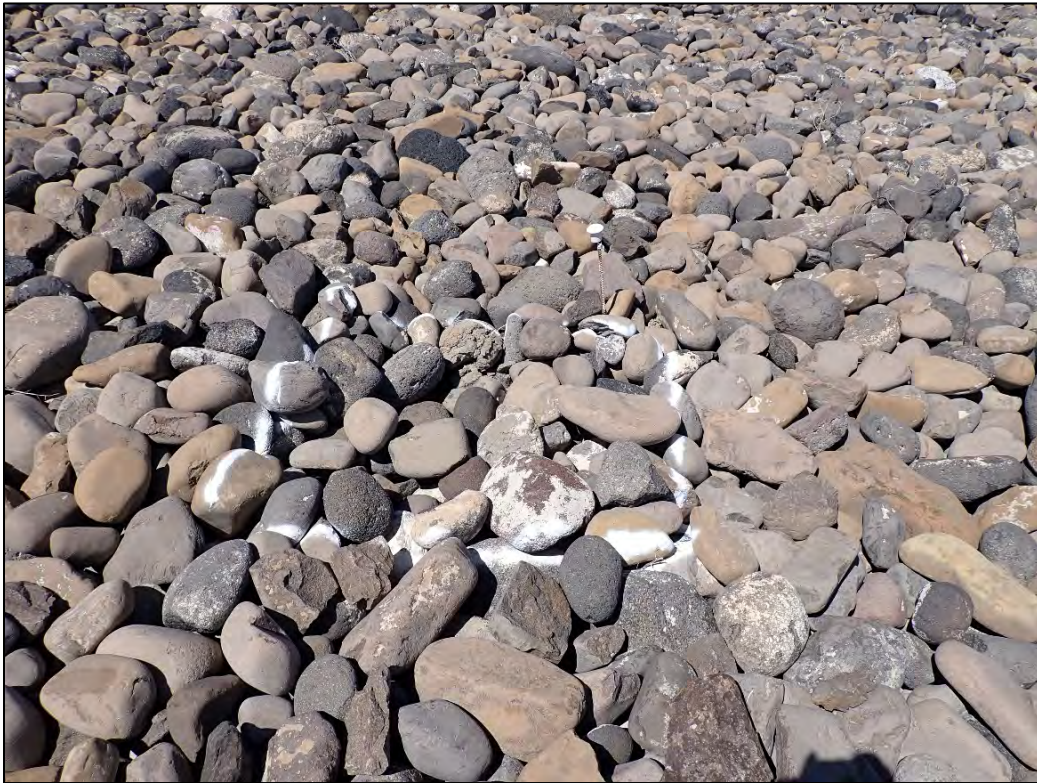
*PL-7. (a) Rock Quality Plot No. III—2021*

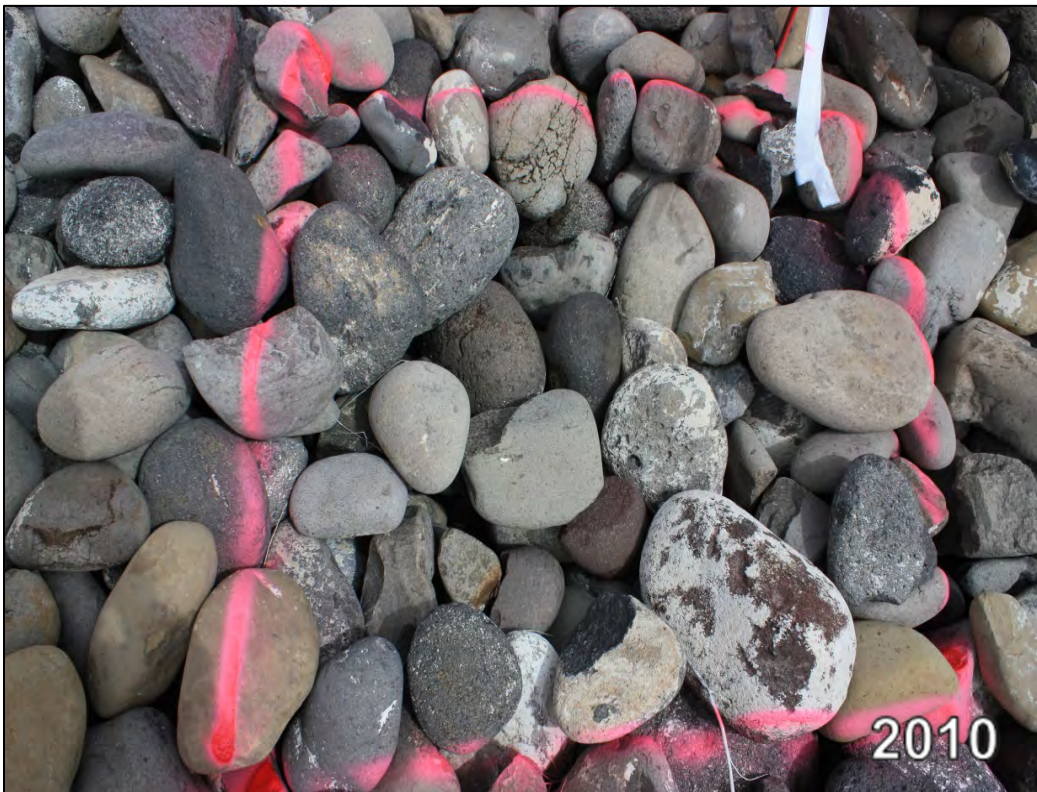
*PL-7. (b) Rock Quality Plot No. III—2010 Photo for Comparison*

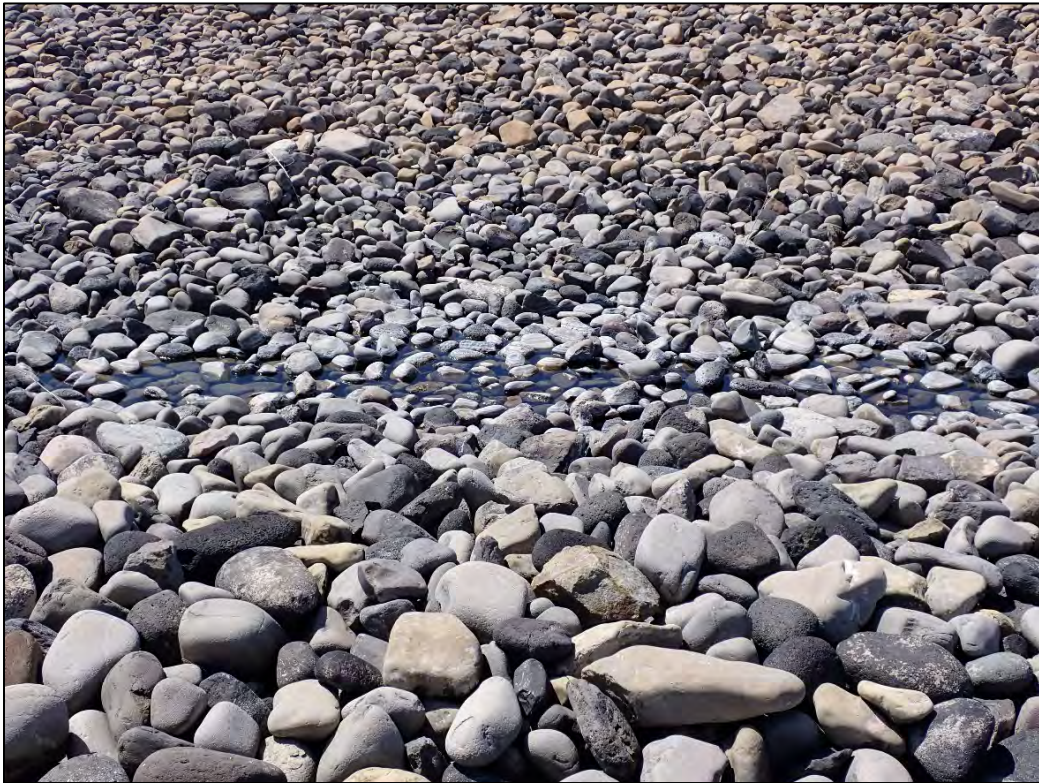
*PL-8. Standing Water in Southeast Cell Toe Drainage*

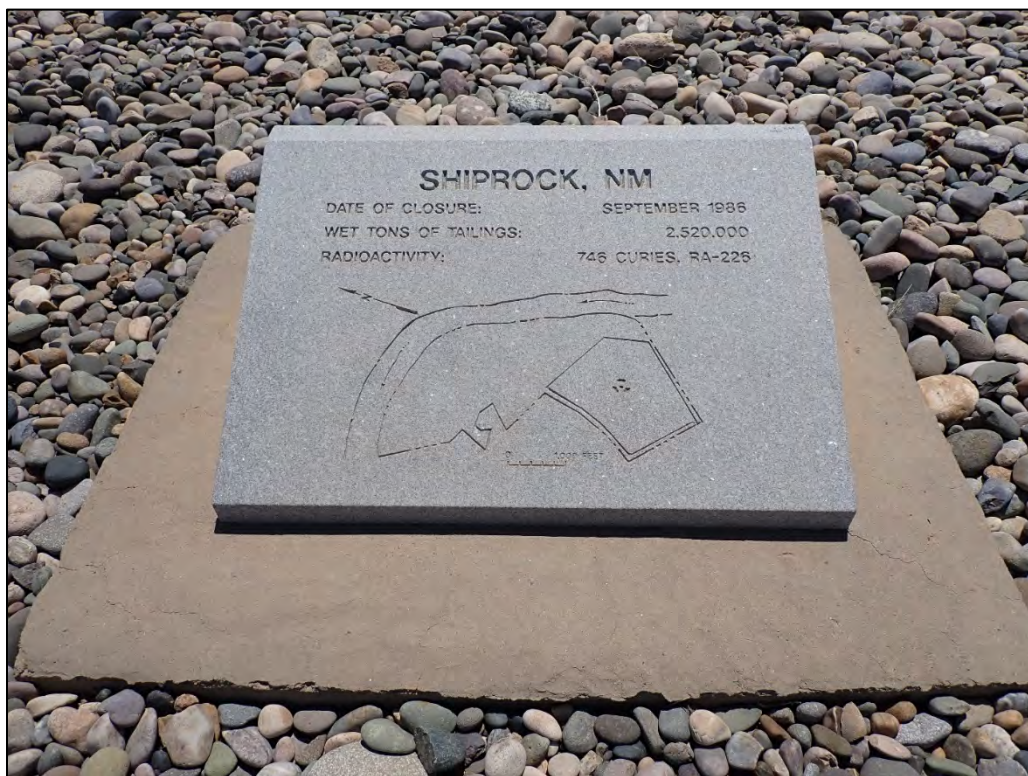
The site has two granite site markers. Site marker SMK-1 is just inside the west gate and contains minor cracks in its concrete base. Although the cracks were sealed in 2018, they are beginning to open and will start to deteriorate (PL-2). Inspectors also noted that a minor amount of soil had eroded from the north side of the concrete base. Both of these items will be repaired before the next inspection. Site marker SMK-2 is on the top slope of the disposal cell and is stable and legible (PL-3).

*PL-3. Site Marker SMK-2 on Cell Top*

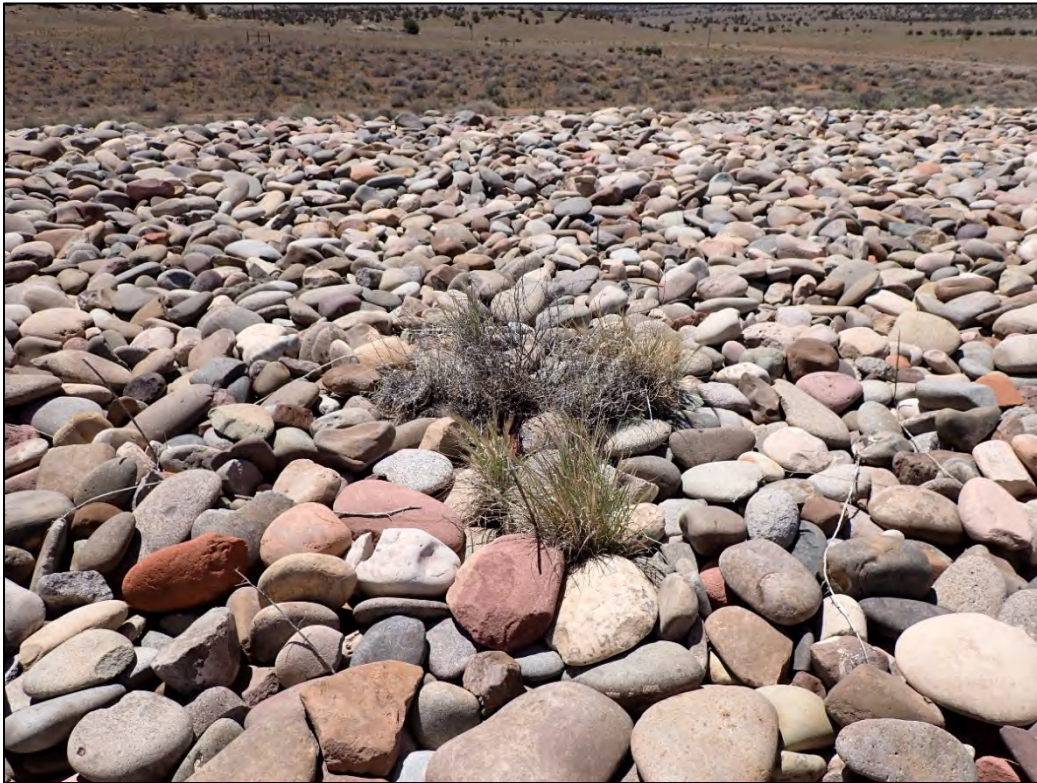
*PL-7. Vegetation Growing on Disposal Cell Cover*

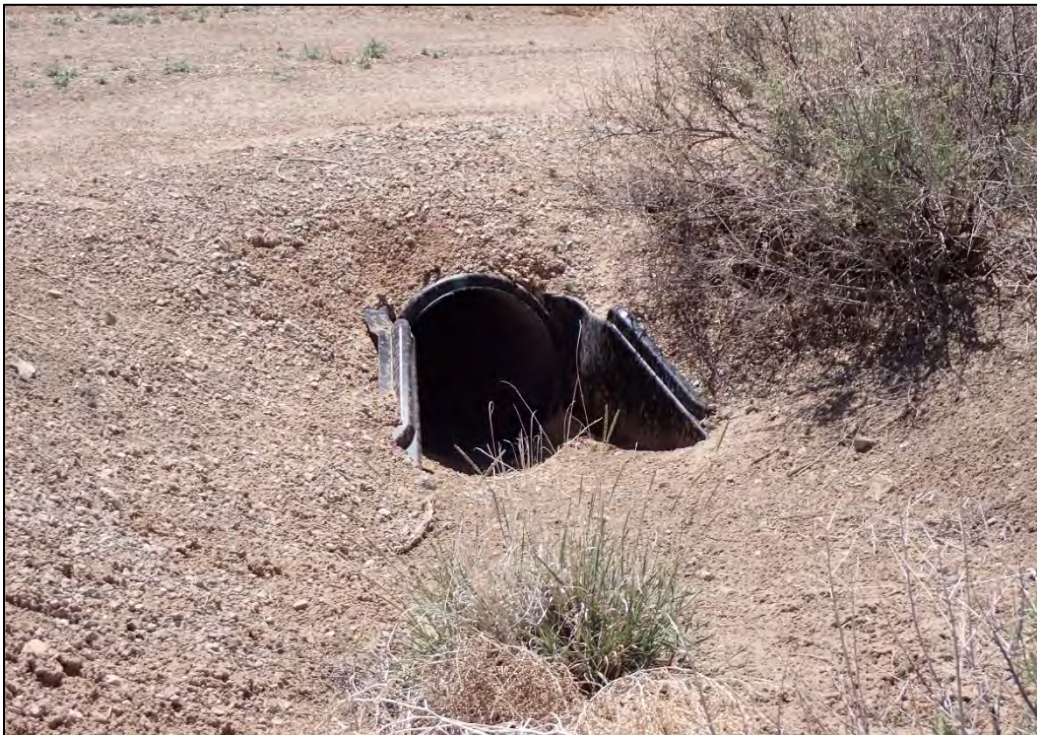
*PL-8. North Side of Culvert Under Access Road Inside Gate*

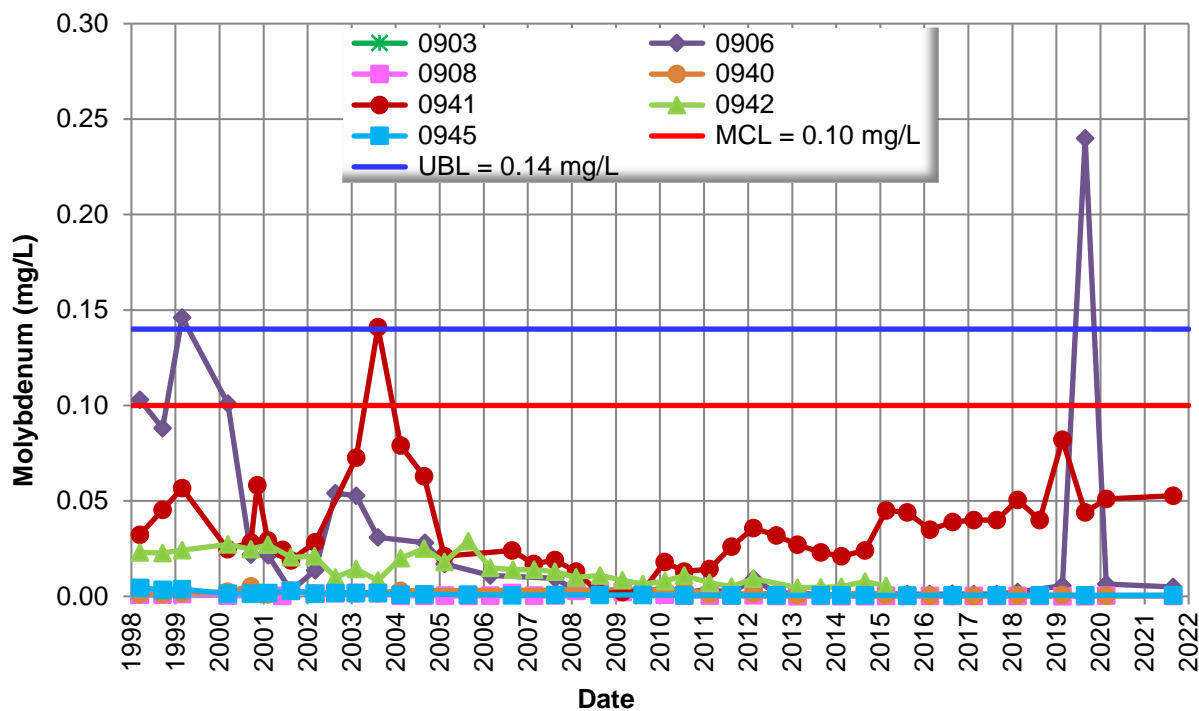
Figure 19-3. Molybdenum in Groundwater at the Tuba City, Arizona, Disposal Site

Since 2004, molybdenum concentrations have been below both the 0.10 milligram per liter (mg/L) MCL and the 0.14 mg/L UBL in all LTSP evaluative wells except well 0906 in August 2019 (Figure 19-3). Molybdenum concentrations in the westernmost downgradient well 0908 and in distal downgradient well 0903 (approximately 1250 feet south of the site perimeter) continue to be comparable to concentrations in background well 0945. Well 0906 exceeded the UBL for molybdenum in August 2019 for the first time since 1999. The UBL exceedance in well 0906 was measured during the 2019 pumping campaign. Molybdenum in well 0906 decreased below the MCL in February 2020 and remained below the MCL in August 2021.

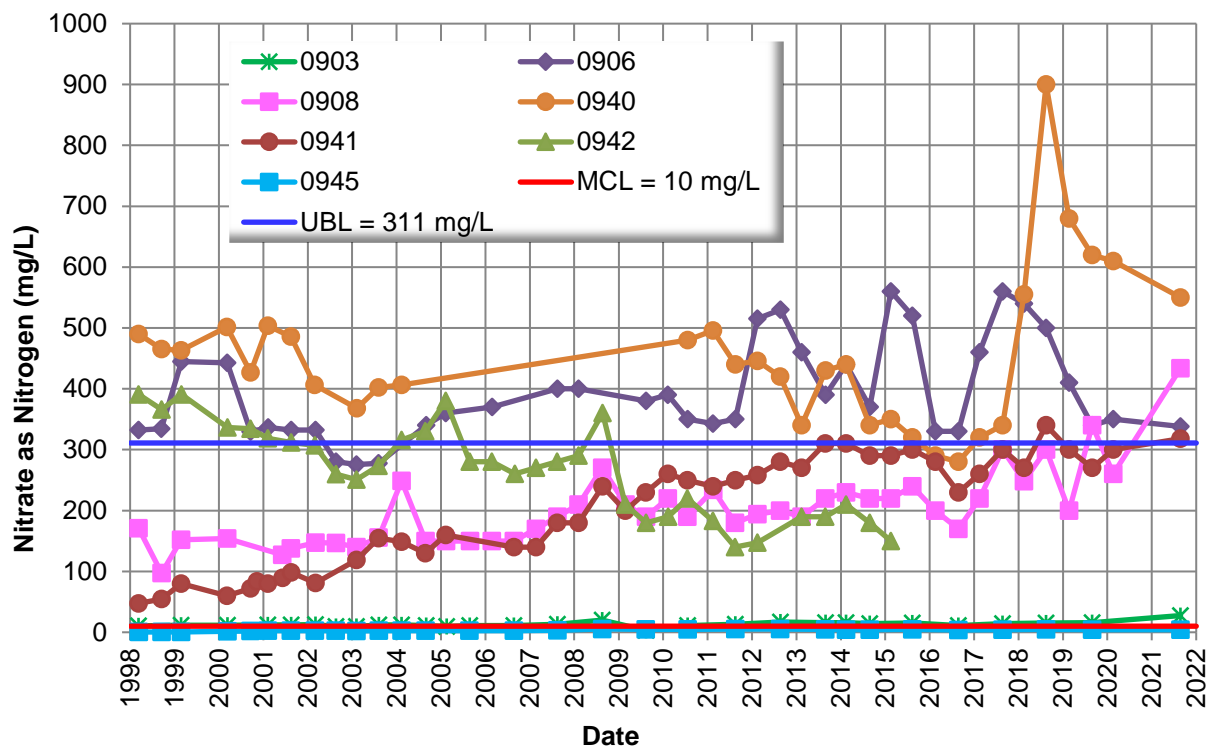
Figure 19-4. Nitrate in Groundwater at the Tuba City, Arizona, Disposal Site

Nitrate concentrations have historically exceeded the 10 mg/L MCL in all LTSP evaluative wells except background well 0945 (Figure 19-4). Exceedances of the 311 mg/L UBL were observed at compliance wells 0906 (338 mg/L), 0908 (434 mg/L), 0940 (550 mg/L), and 0941 (318 mg/L) in August 2021. Nitrate concentrations in distal downgradient well 0903 have regularly exceeded the MCL since 2004 but remained below the UBL in 2020.

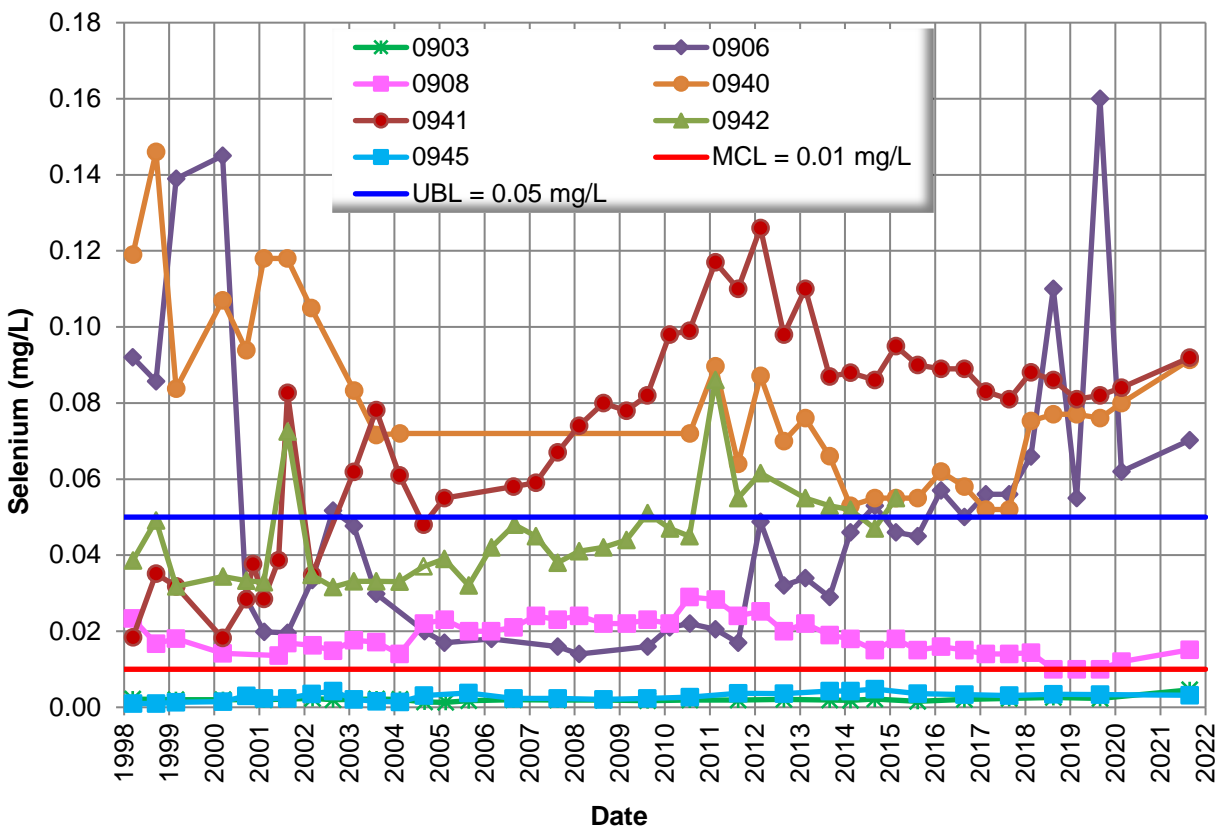
*Figure 19-5. Selenium in Groundwater at the Tuba City, Arizona, Disposal Site*

Selenium concentrations have historically exceeded the 0.01 mg/L MCL in all LTSP evaluative wells except background well 0945 and distal well 0903 (Figure 19-5). Concentrations in well 0908 exceeded the UBL for selenium in 1997 and have since remained at or slightly above the 0.01 mg/L MCL since August 2018. Selenium concentrations in well 0942 exceeded the UBL in February 2015, and that well has not been sampled since. Concentrations continued to exceed the 0.05 mg/L UBL in wells 0906, 0940, and 0941, all of which are immediately downgradient of the disposal cell. Selenium concentrations increased in well 0941 from 0.018 mg/L in 1998 to 0.09 mg/L in 2021. Selenium concentrations in distal downgradient well 0903 have consistently been below both the UBL and the MCL and, since late 2004, below levels measured in background well 0945.

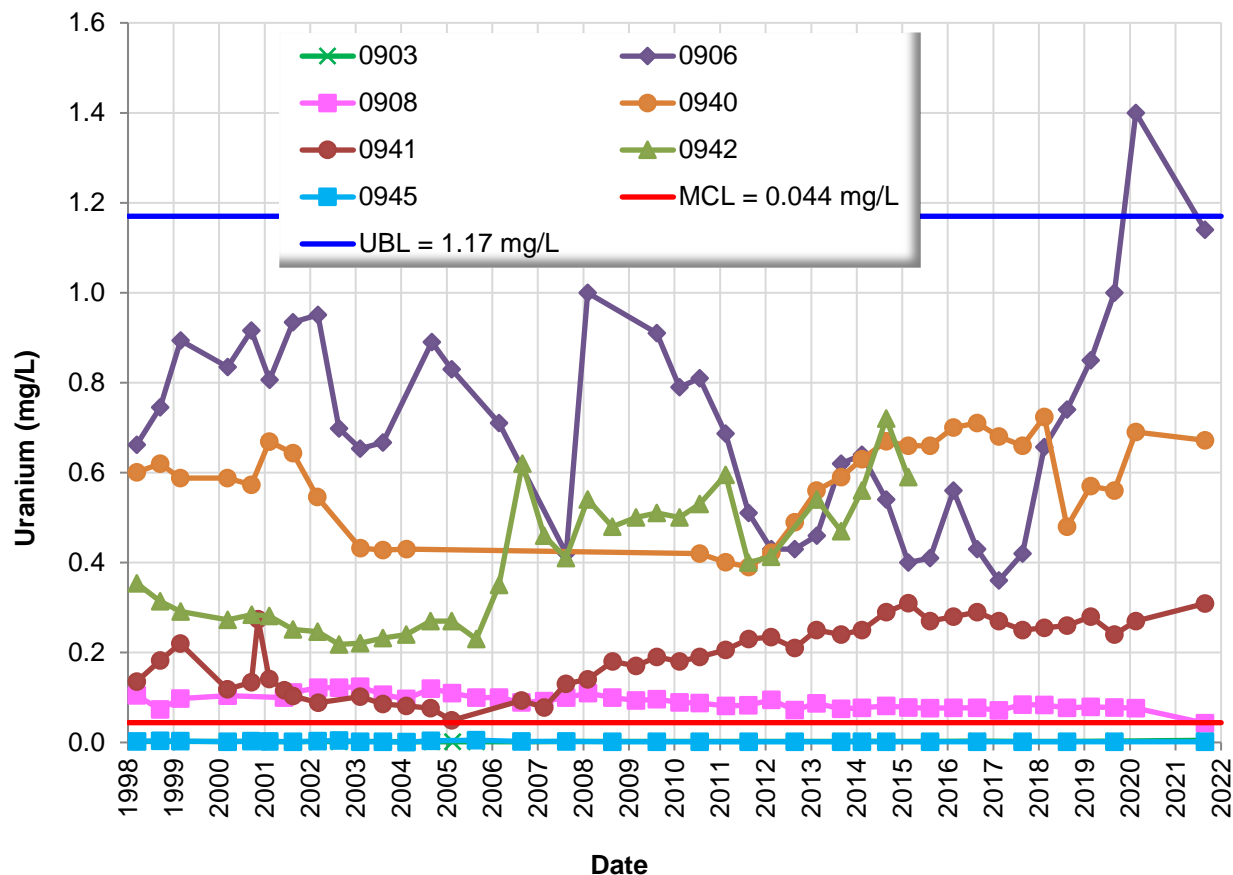
Figure 19-6. Uranium in Groundwater at the Tuba City, Arizona, Disposal Site

Uranium concentrations have historically exceeded the 0.044 mg/L MCL in all compliance wells except for distal downgradient well 0903 and background well 0945, both of which have always been below the MCL (Figure 19-6).

Uranium concentrations in central downgradient well 0941 have gradually increased since 2005 from 0.05 mg/L to 0.31 mg/L. Concentrations in well 0906 have more recently increased from 0.36 mg/L in February 2017 to 1.4 mg/L in February 2020, above the 1.17 mg/L UBL, then to 1.14 mg/L in August 2021, just below the UBL. Uranium concentration in well 0908 decreased to 0.043 mg/L, just below the MCL, in August 2021; this was the first time uranium concentrations were below the MCL in this well since evaluative monitoring began.

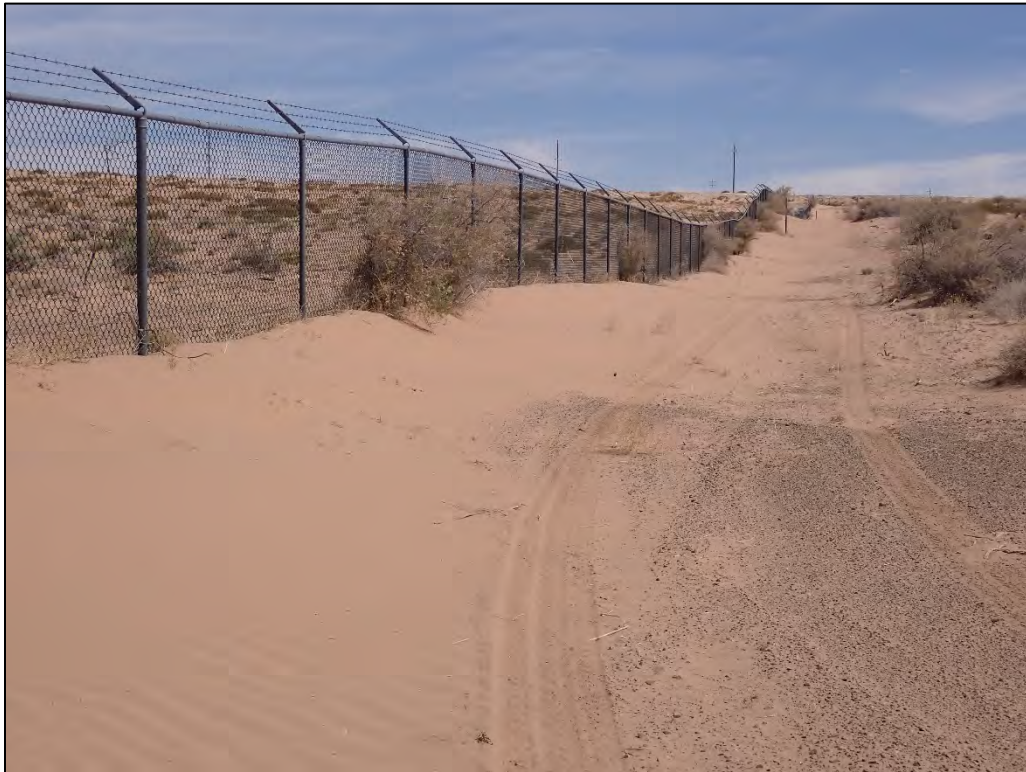
*PL-1. Windblown Sand Accumulation Along Western Perimeter Fence*

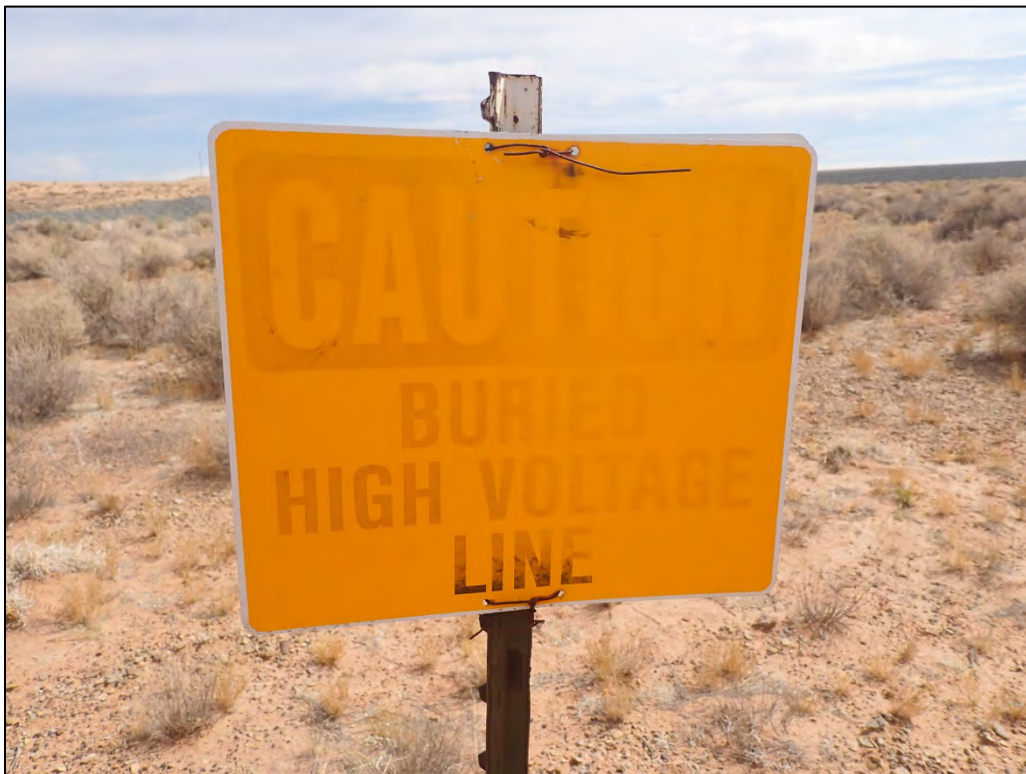
*PL-6. Faded Caution Sign for Buried High Voltage Line*

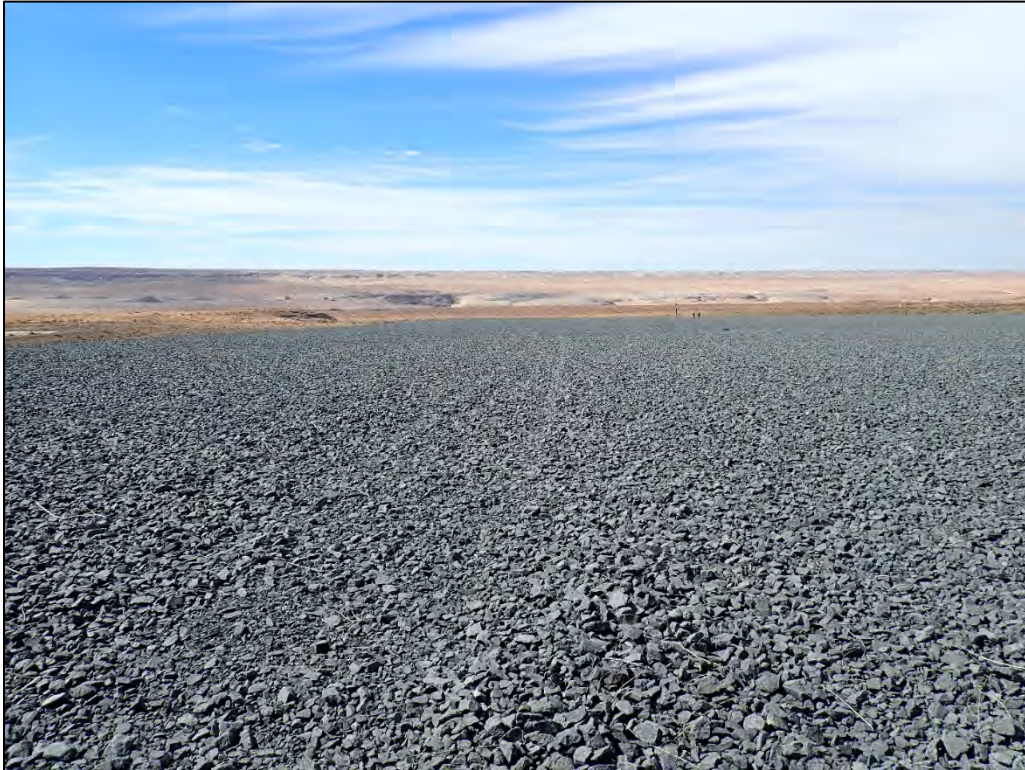
*PL-9. Tire Tracks on Disposal Cell Top*

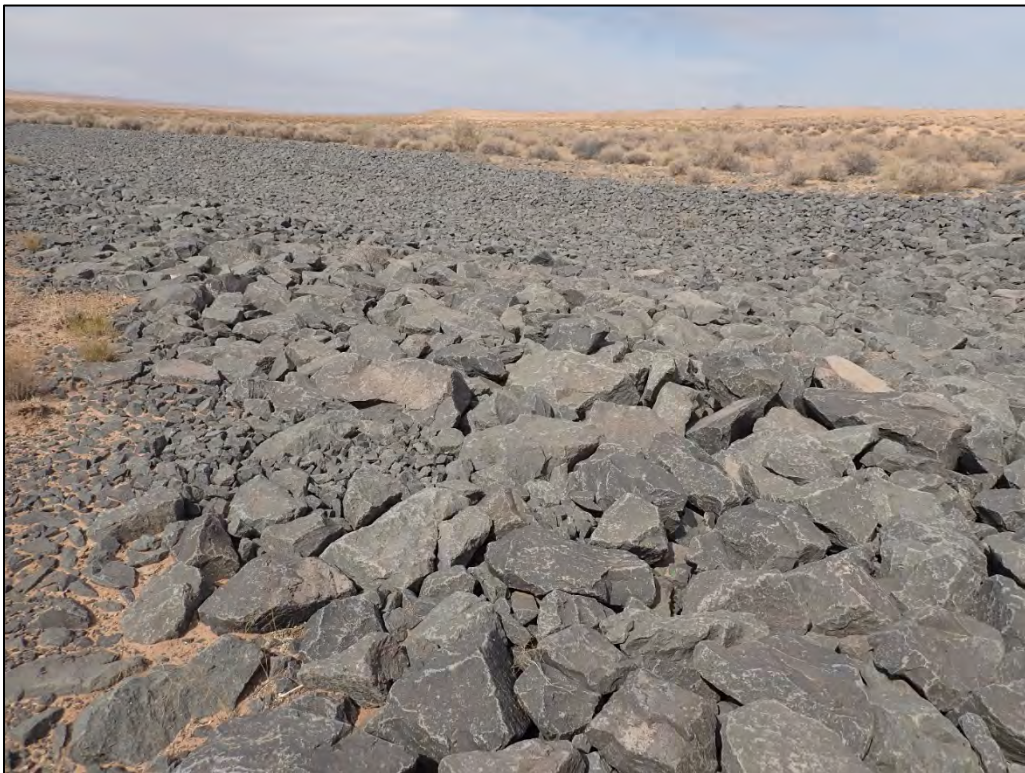
*PL-10. Minor Sedimentation and Plant Growth in Mouth of South Apron Ditch*

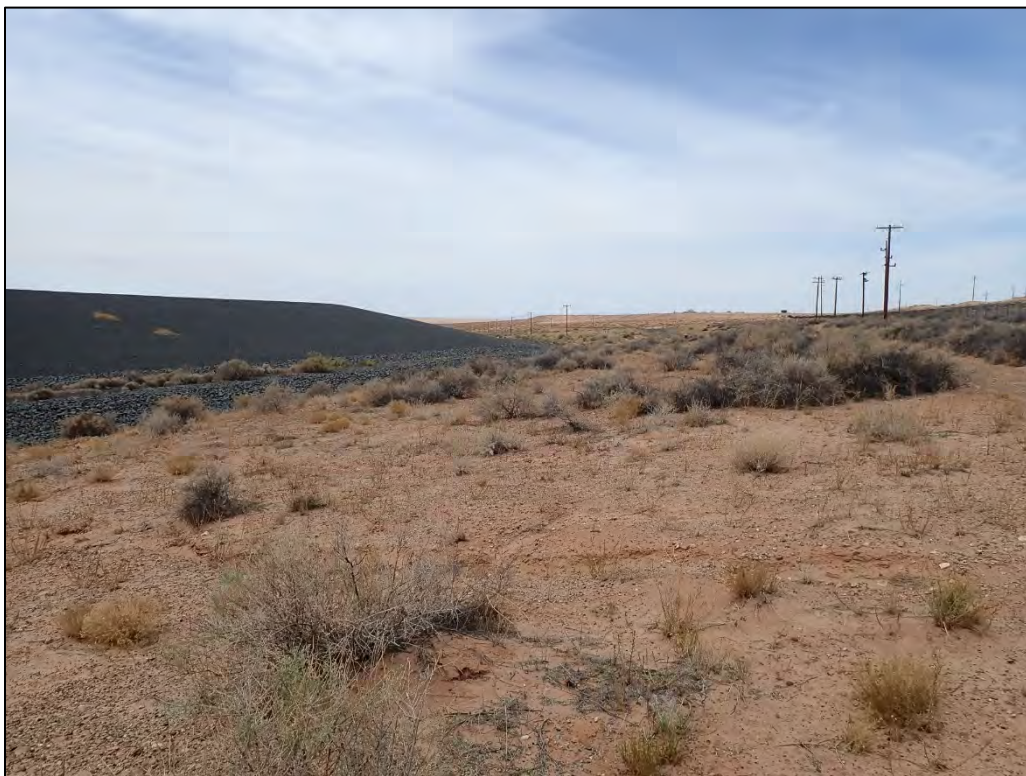
*PL-11. Drought-Stricken Vegetation in Reclaimed Area*

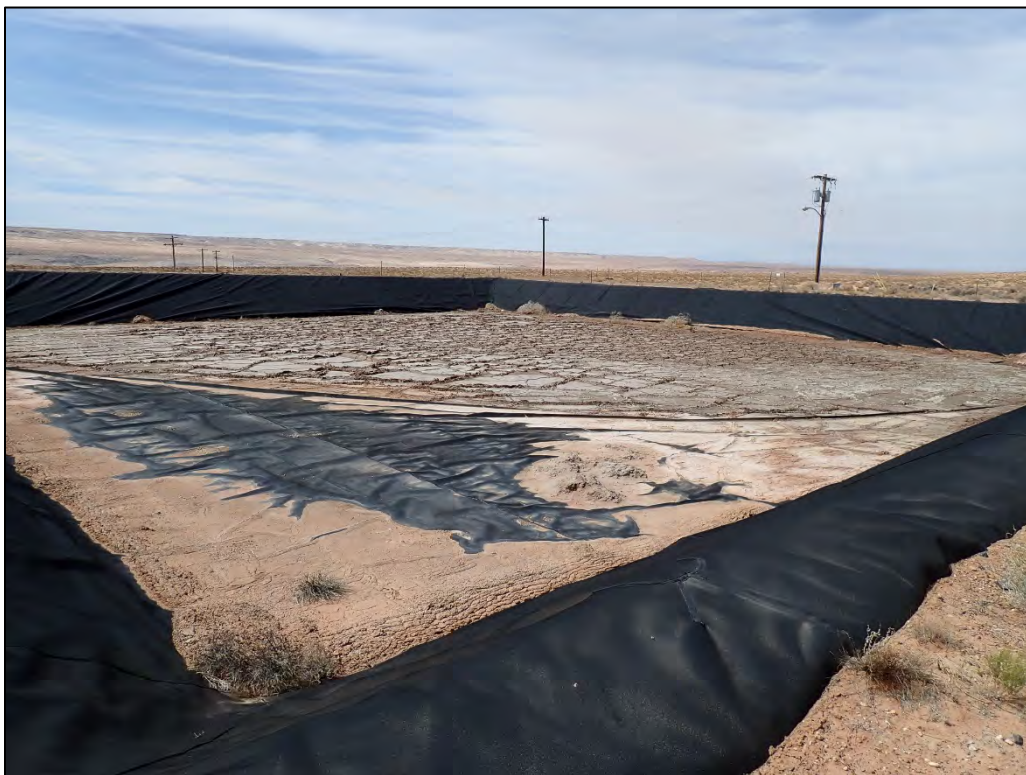
*PL-12. Evaporites and Windblown Sand in Inactive Evaporation Pond*
