**Leak Rate Considerations Related to the
SDU 6 Sumps**

June 2022

Prepared by: Savannah River Mission Completion LLC
Closure and Waste Disposal Authority
Aiken, SC 29808

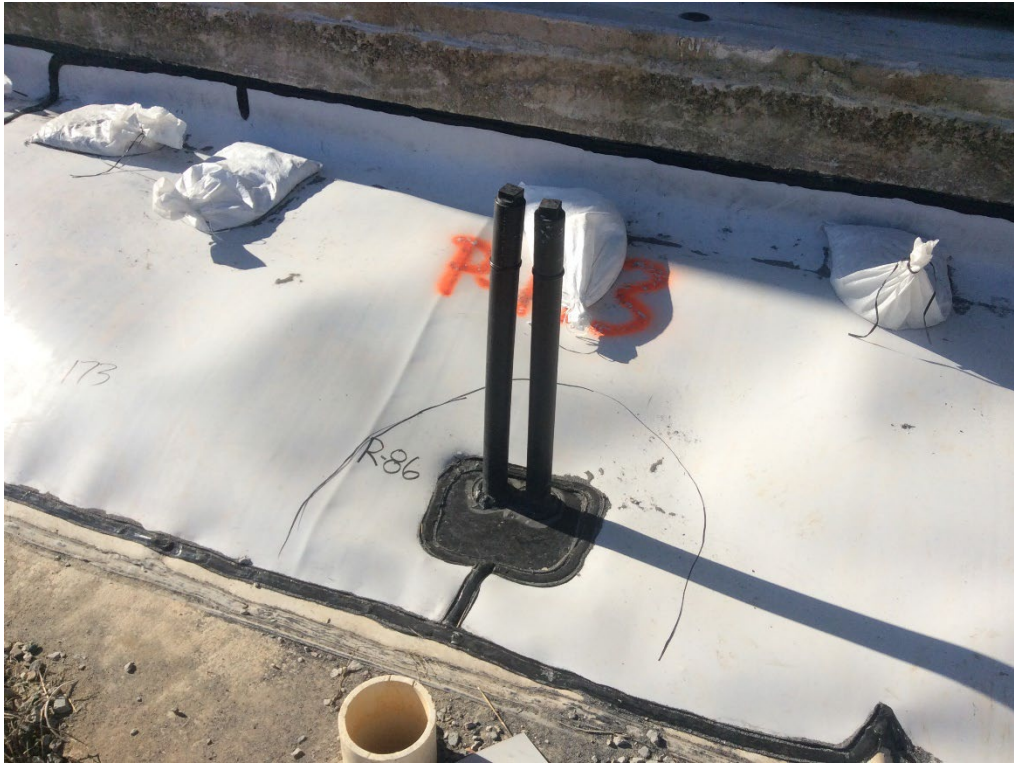
Figure 2.3-7: Installation of HDPE Over the Mud Mats at East Sump

The four sumps include a single pipe that penetrates through the top HDPE to allow water to be removed from the sumps. At the East Sump of SDU 6, the leak detection systems also include a second pipe for a liquid detection probe per design drawing C-CY-Z-00006 (Figure 2.3-7). These pipes are all made of 2-inch diameter HDPE. Continuous extrusion welds were used to seal the extrusions through the HDPE.

In March 2017, only a few months after the second leak tightness test, SDU 6 was transferred from the SDU 6 Project Team (construction) to the SDF Operations. It was immediately noted that the East Sump alarm was actuated almost continuously (Riley, 2022). When the sump was pumped and the alarm cleared, it would re-actuate within an hour (Riley, 2022). It was assumed that the water in the sump was due to construction water and rainwater that had been received during the sealing of the HDPE liner around the perimeter of the SDU after the leak tightness testing had been completed (Riley, 2022). It may be noted that the soils surrounding the HDPE appear to be damp in Figure 2.3-6, supporting this hypothesis.
