From: Cary, Richard H. <Richard.Cary@pseg.com>
Sent: Wednesday, May 17, 2023 8:48 AM
To: nmfs.gar.incidental-take@noaa.gov; EndangeredSpecies Resource
Cc: Corbett, Heather [DEP]; Fehring, Shana [DEP]; Neilan, Brian [DEP]
Subject: [External_Sender] Salem Generating Station - Incidental Take Report: Sturgeon 5/16/2023
Attachments: Sturgeon Incidental Take Report for 05-16-2023.pdf

Appendix C, Part 2A (Sturgeon)

Site of Collection: PSEG Salem Generating Station; SGS Unit 1, intake 12A

STURGEON DATA COLLECTION FORM

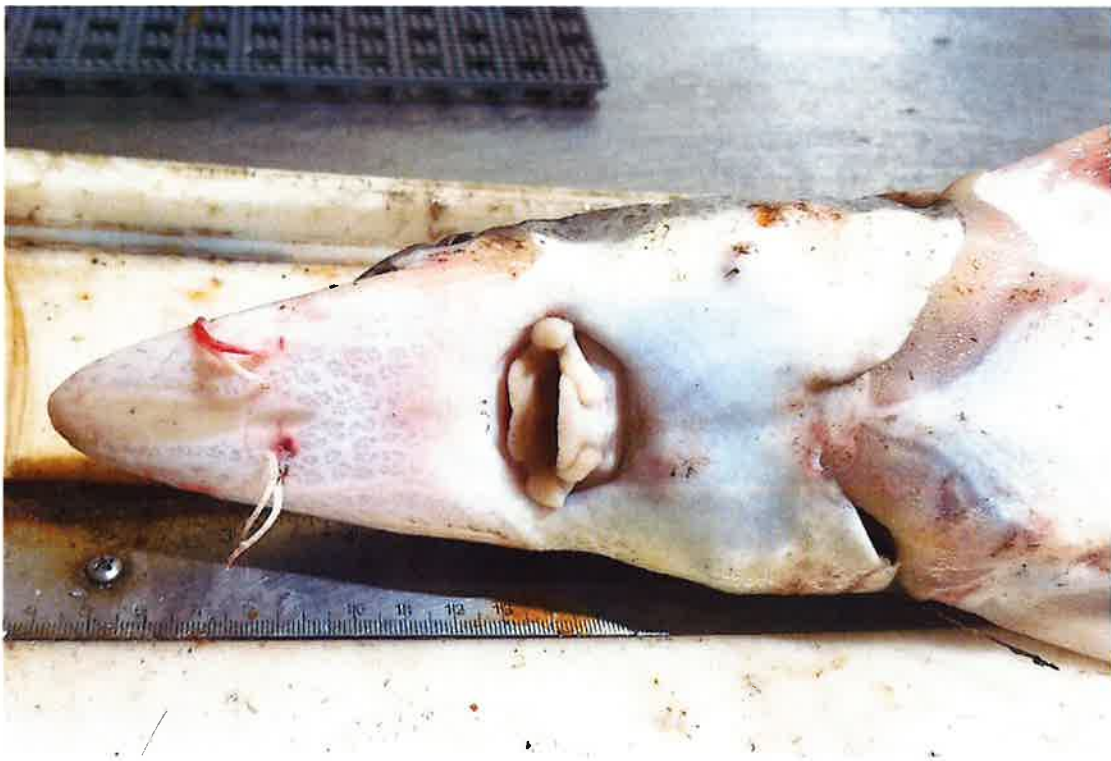
A dorsal view of the head, showing the characteristic elongated rostrum. Severe bruising is evident on the torso, posterior to the head (05/16/2023).
