PNNL-36836

# Nondestructive Evaluation of Electron Beam Welds

June 2024

Prepared for the U.S. Nuclear Regulatory Commission Office of Nuclear Regulatory Research Under Contract DE-AC05-76RL01830 Interagency Agreement: NRC-31310022S022

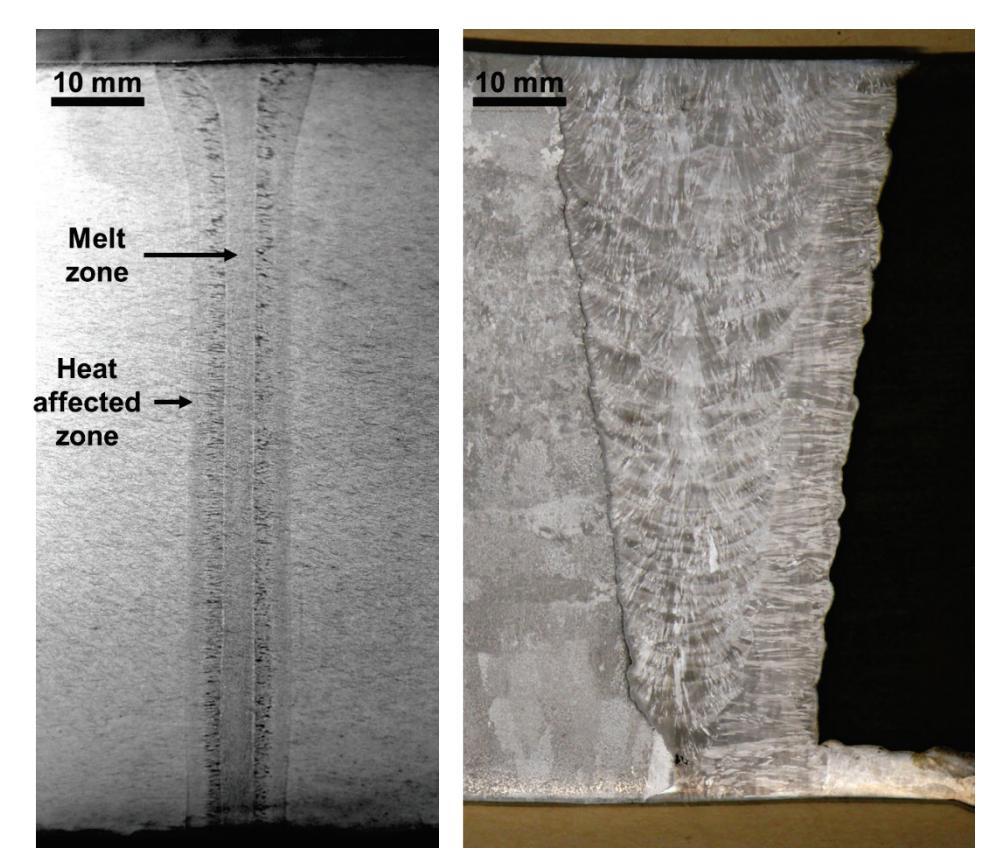
Figure 2: Comparison of EBW and conventional dissimilar metal weld profiles. The left photograph shows a profile from a mockup in this study. The right photograph shows a profile from a cast austenitic stainless steel to carbon steel dissimilar metal weld.

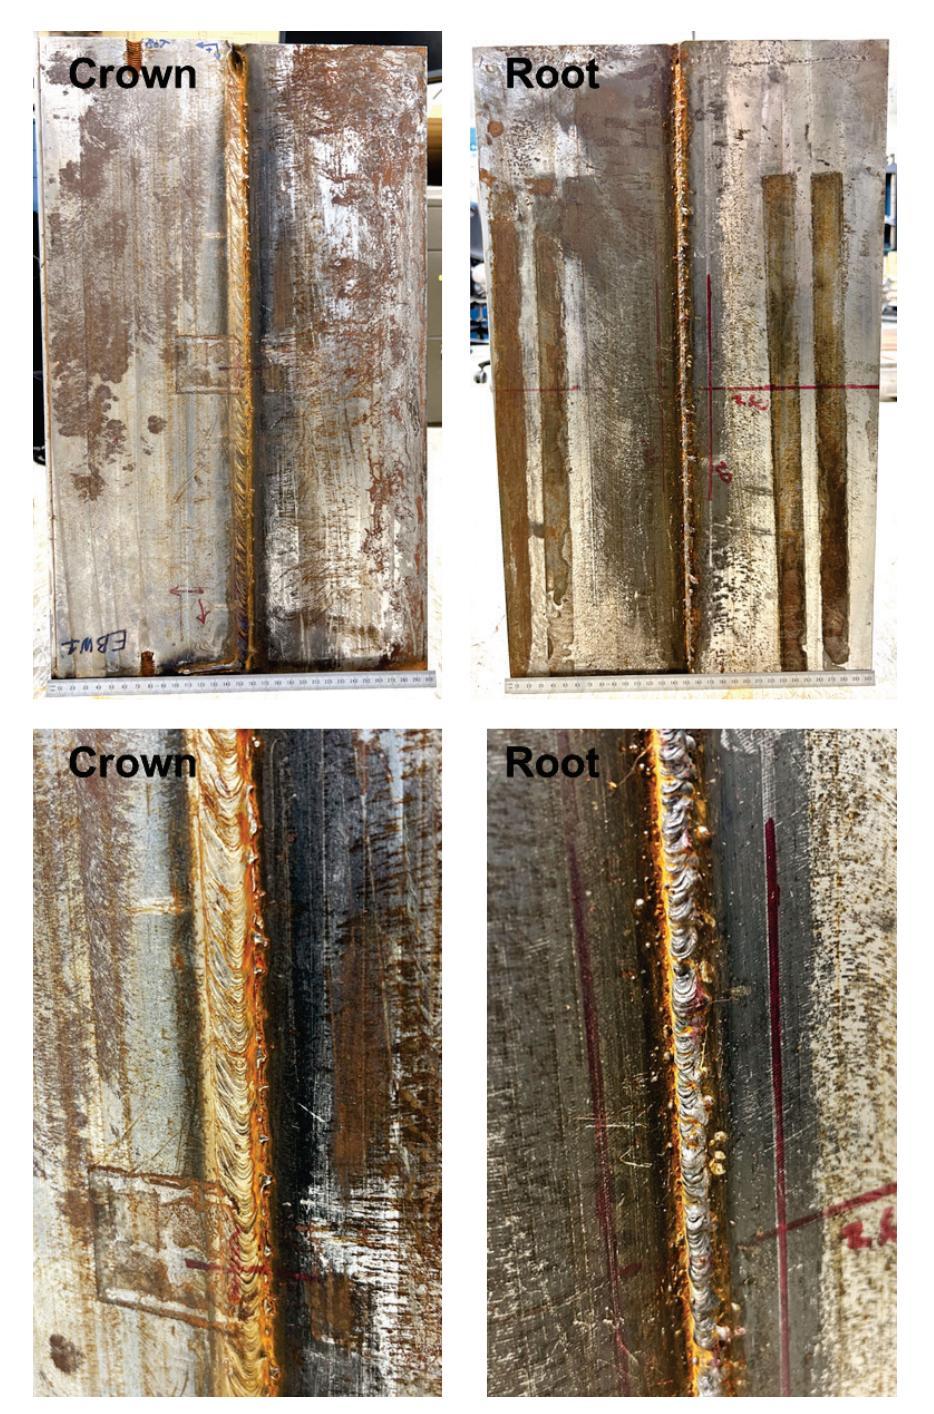
Block 1 was welded with the correct EBW parameters and settings resulting in a defect-free weld. Figure 10 shows the weld crown and root, including closeups of the crown and root. The weld crown was generally smooth compared to the root, which was characterized by coarseness and splatter, normal for EBW.

Figure 10: Photographs of the block 1 weld crown and root. The top photographs are of the whole block face, and the bottom photographs are closeups.

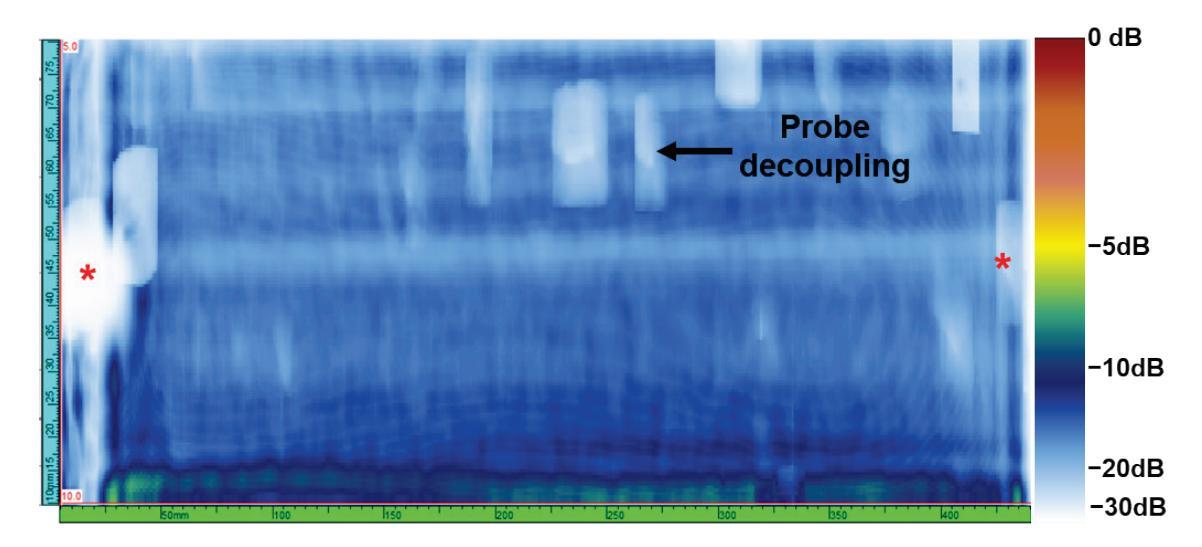
The 0° UT scan of block 1 is shown in figure 11. Overall, the UT signals were weak and relatively uniform, indicating a lack of echoes from the weld joint. Thus, this weld joint appeared to be well fused. There were several regions with signal dropout due to probe decoupling. The red asterisks indicate areas of lower signal intensity due to the holes drilled into the blocks for the lifting bolts (two such holes are visible in figure 8); these regions occurred in every 0° UT scan to some degree.

Figure 11: 0° UT scan of block 1. Overall, the UT signals were weak and relatively uniform indicating a well-fused joint. Some regions of poor probe coupling were visible. Asterisks indicate positions of lifting bolt holes. Note that the horizontal scale is compressed with respect to the vertical scale to fit the image on the page.

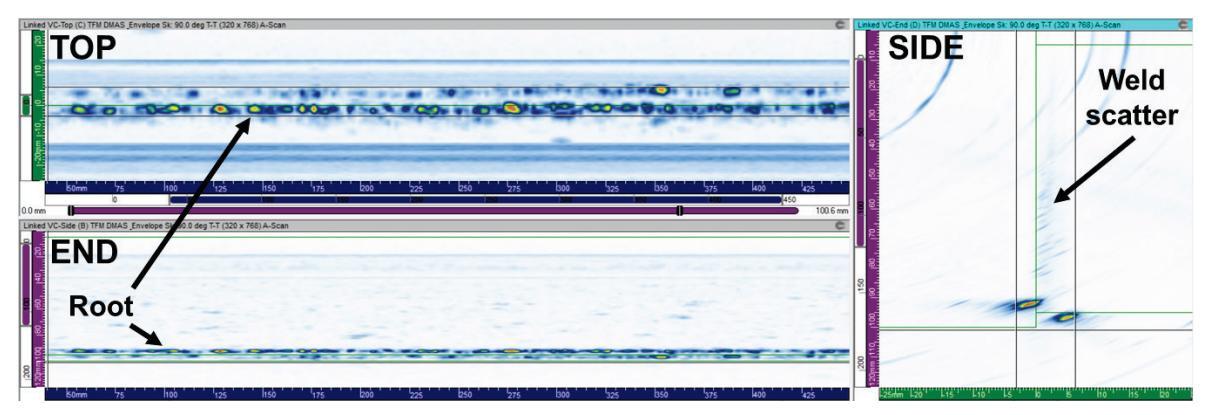
#### Figure 27: FMC scan of block 1 from the top surface.

Figure 27 shows the 4 MHz scan of block 1 (ideal weld conditions) at 45 mm back from the joint line. There are no indications of note in the scan other than the weld root. The weld region is visible in the side view as a vertical column of signal slightly above the noise background; this signal is attributed to backscatter from the weld microstructure. Some scatter is also visible throughout the end view as light blue speckles.

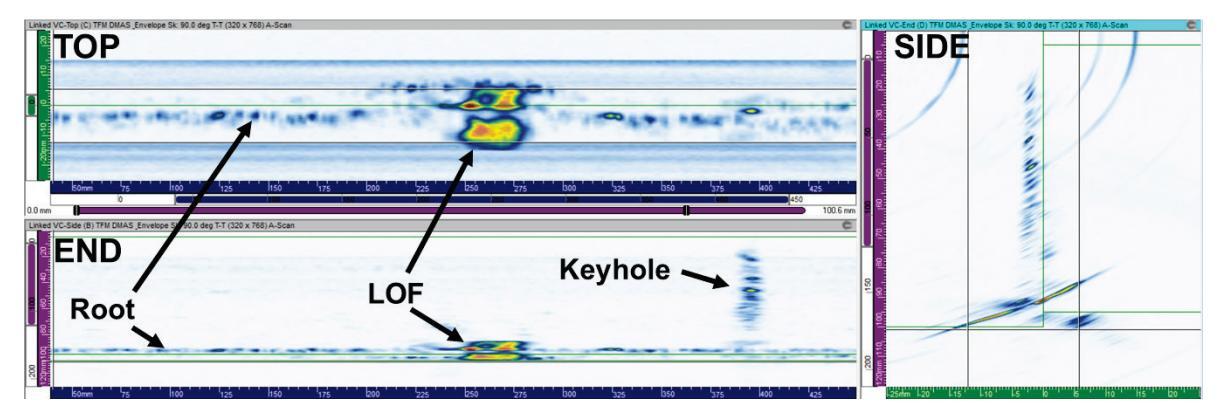
Figure 28 shows the 4 MHz scan of block 2 (small LOF and through-wall keyhole) at 45 mm from the joint line. The LOF defect is clearly visible, although it is unclear if it can be accurately depth-sized. The strong echo is from the corner of the unfused portion and indicates that the LOF is surface-connected; this echo is not necessarily a specular reflection from the defect itself. Recall the face of the defect is smooth and vertical, so we do not expect an appreciable specular echo using a PE method. No tip signals were detected. The keyhole defect is also clearly visible. The echoes from the keyhole are strongest through approximately the midpoint of the specimen due to the position of the probe. We observed that scans closer to the joint line better insonified the top portion of the keyhole while scans further back better insonified the bottom portion. In the side view, the weld scatter observed in figure 27 is obscured by the stronger echoes from the keyhole, although some low-amplitude scatter was visible in the end view as light blue speckles.

Figure 28: FMC scan of block 2 from the top surface.

- FMC using PE showed corner echoes from unfused sections in blocks 2 and 3, the keyhole defect in block 2, and the fusion line in plate 3 (see figure 28 and 29, respectively). The LOP defect in plate 4 was faintly visible in the side view in figure 31.

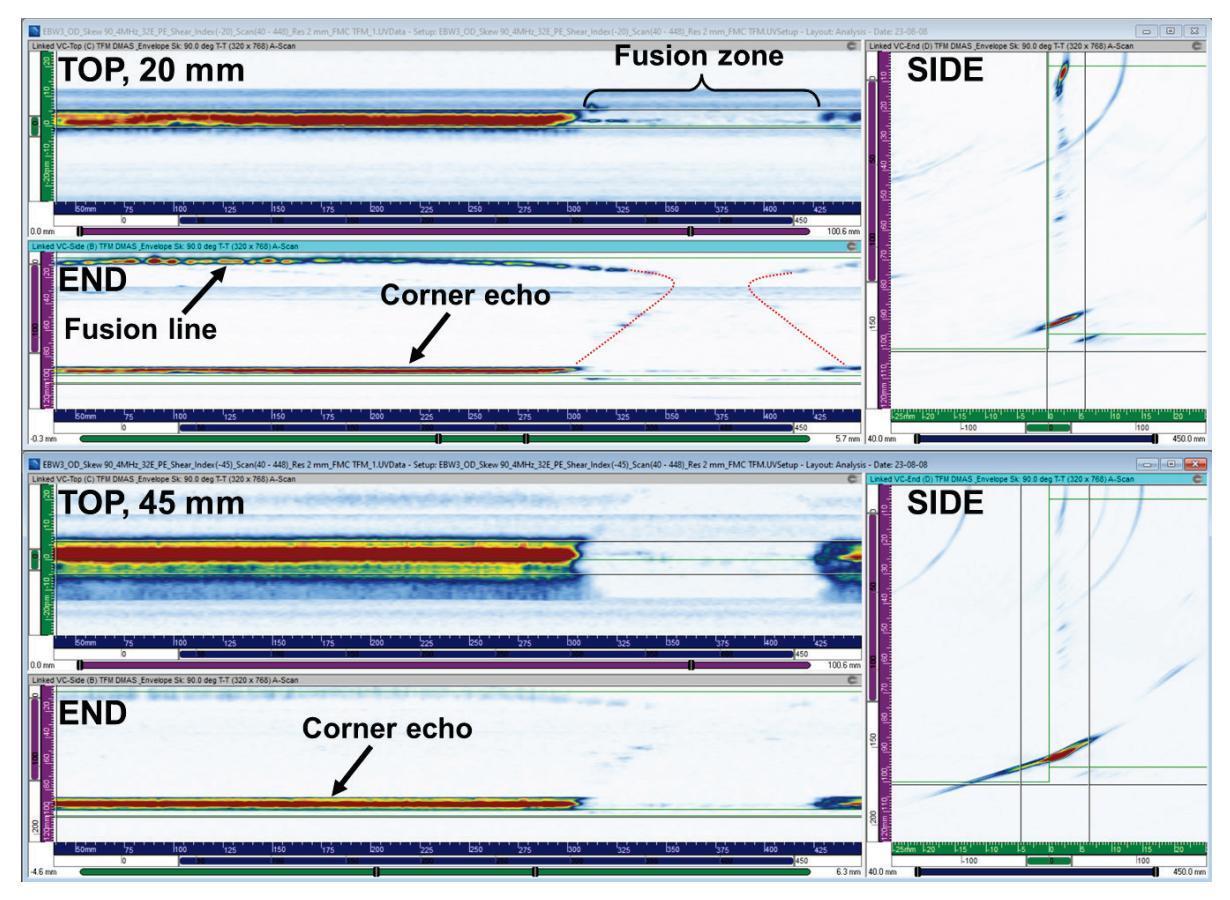
Figure 29 shows two scans of block 3 (large LOF) at 20 mm and 45 mm from the joint line. There is a prominent corner echo except where the block was fused. The fusion zone is indicated by the black bracket. The hourglass shape of the fusion zone, as shown in figure 15, is faintly visible in the end views from scatter-like signals highlighted by the red dotted lines in the 20 mm scan. Note that the soft gain was turned up high enough to see those faint signals, which resulted in the corner echo signal being strongly saturated. Echoes from the fusion line near the top surface are visible in the 20 mm scan (and appear more faintly in the 45 mm scan). We hypothesize that the top portion of the joint line was fused because visual observation suggested the weld crown was fused to both blocks (see figure 14). Also, the flared shape of the top of the weld zone would be able to fuse the top of the blocks without affecting most of the rest of the joint line, such as illustrated in figure 3 panel B. Other than the fusion-line echo, there were no indications from the FMC scans about the depth of the LOF. For example, looking at the end view, the signal from within the fusion zone (between the red lines) looks identical to the signal from the rest of the block. As described in section 3.3.1, when using PE UT there is no specular reflection detected from the unfused regions because the smooth vertical, planar surfaces of the joint lines reflect sound away from the probe while fused regions are not detected because the sound is transmitted through.

Figure 29: FMC scans of block 3 from the top surface.

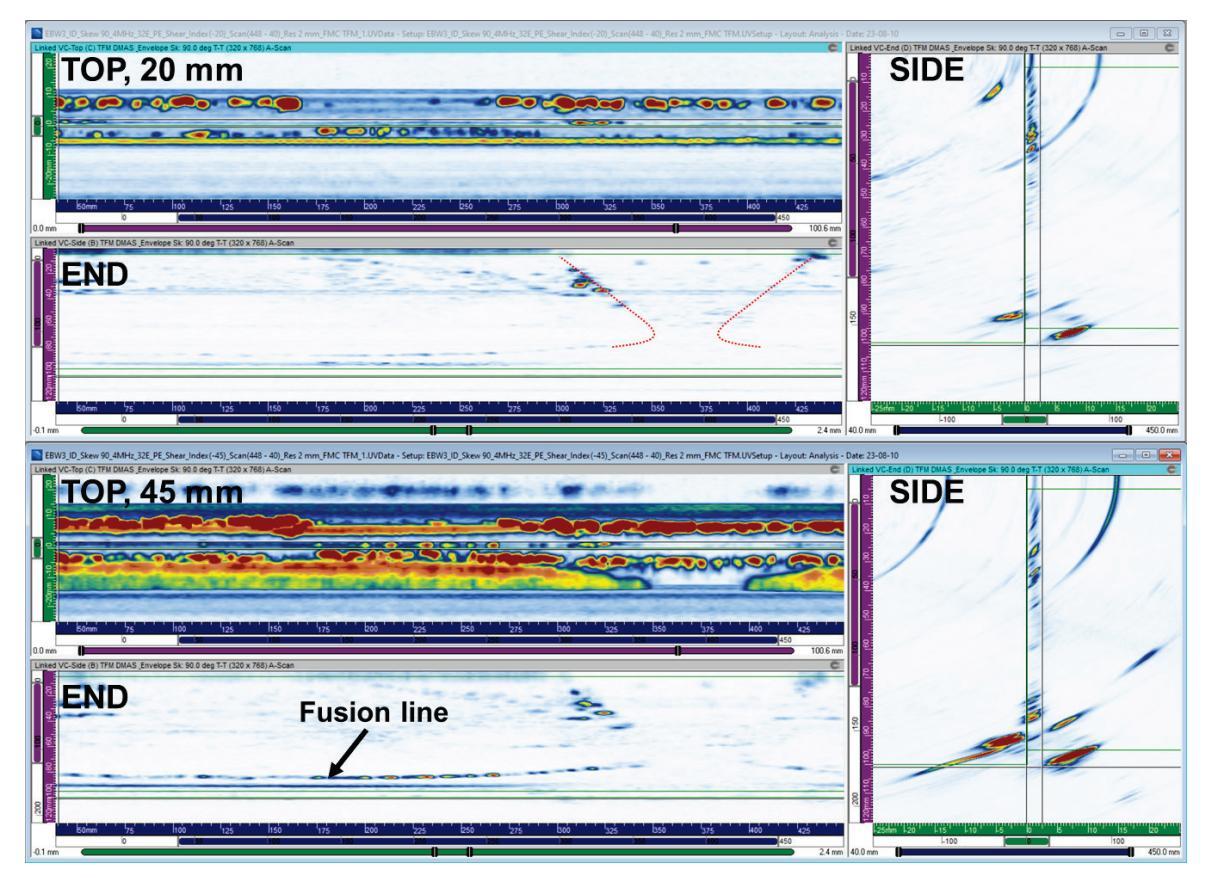
Scans from the bottom surface of block 3 are shown in figure 30. In this case, the fusion line appeared at the bottom of the 45 mm scan (much more faintly in the 20 mm scan) and could potentially be misconstrued as a crown signal. There was no corner echo to delineate the fusion zone since the top of the weld appeared to be fused along the entire block. Echoes from the boundary between the fused and unfused areas (red dotted lines in the 20 mm scan) were readily visible, and we interpreted them as weld defects. However, based on our experience with conventional V welds, there was not compelling evidence of a substantial LOF defect in this image.

Figure 30: FMC scans of block 3 from the bottom surface.

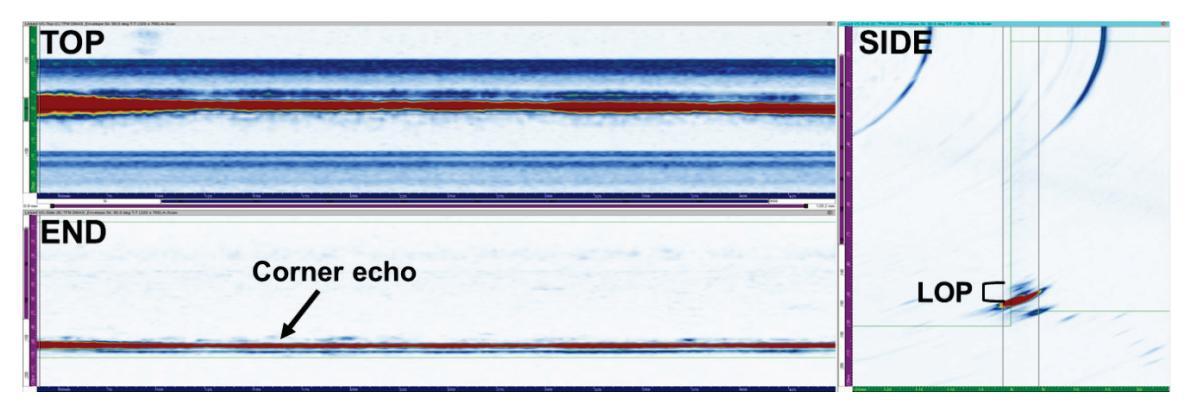
The FMC scan of block 4 (LOP along the full length) at 45 mm from the joint line is shown in figure 31. As with the scans from block 3, the soft gain was increased such that the corner echo was strongly saturated so other features would be visible. The presence of a corner echo across the entire scan suggested that there was an LOP defect. However, because it does span the entire block, the corner echo could easily be mistaken for a root echo in a blind test. The depth of the LOP was only faintly visible in the side view with the gain turned up high and measured to be about 5 mm. We recognized the LOP signal because we knew from the 0° scans that the LOP depth was likely less than 10 mm (see section 4.5). The LOP echo was not any more prominent in scans at different distances from the joint line, and it was not visible at all in the scans from the bottom surface. The rest of the scan appeared similar to that of block 1.

Figure 31: FMC scan of block 4 from the top surface.

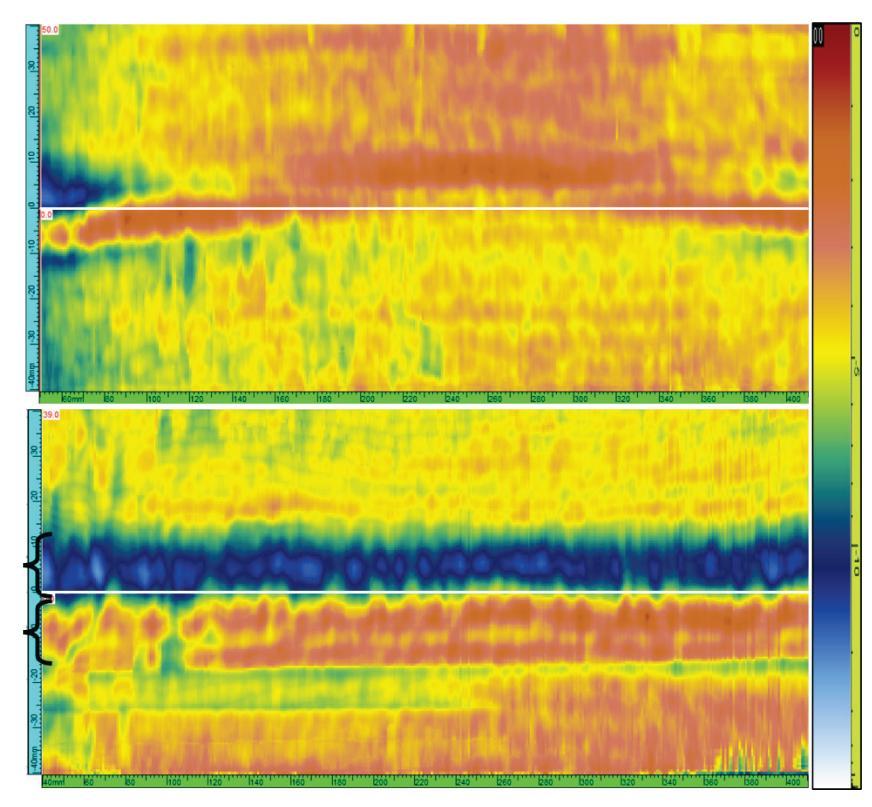
The TOFD scans of block 1 (ideal weld parameters) are shown in figure 32. The top and bottom panels are the scans from the top and bottom surfaces, respectively. The joint line is indicated by the white horizontal lines. Overall, the signal strength was relatively high (red is the strongest signal; see the logarithmic color scale on the right) indicating that there was little in the weld region to interfere with the sound energy transmission. Recall that strong signals in the TOFD scans indicate the sound energy was not impeded in its path from the transmit probe to the receive probe. Some variations in the signal strength were likely due to surface conditions and probe coupling. In the bottom scan, some horizontal bands of signal variation were observed flanking the joint line, as indicated by the black brackets. We hypothesize that these regions were due to scattering effects from the tapering at the top of the weld (see figure 2).

Figure 32: TOFD scans of block 1. Top: scan from the top of the block. Bottom: scan from the bottom of the block. The color scale indicates signal intensity with red being the highest.

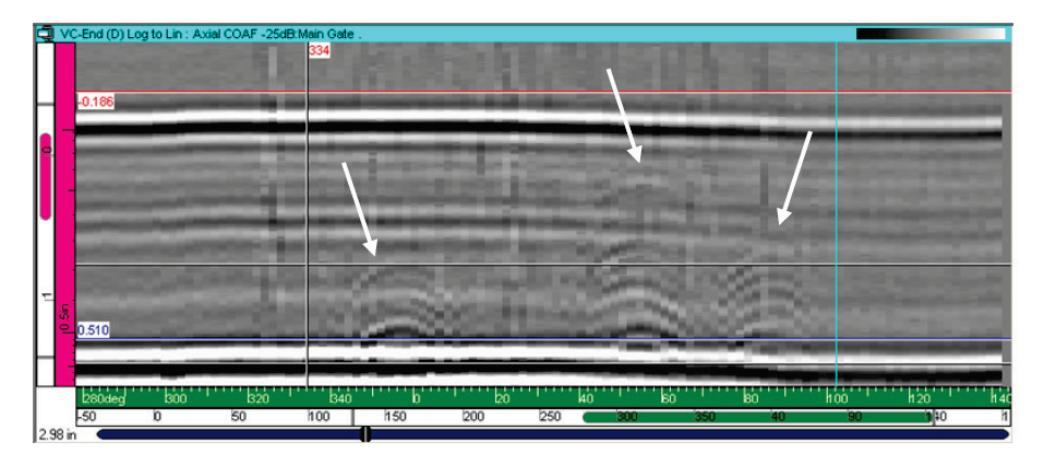
Overall, the pitch-catch TOFD setup was effective at helping identify and size the weld defects. We note that the UT signals observed using our TOFD setup are different from those typically observed when using a conventional TOFD approach, where tip diffracted signals are of primary interest. Figure 36 is an example of diffracted tip signals (white arrows) from a conventional TOFD scan (Cumblidge et al. 2010). Our TOFD signals were also different from those from typical PE approaches, where a defect causes an echo signal as opposed to a lack of signal, as in our TOFD approach. Therefore, we suggest that additional training will be needed to familiarize inspectors with how to recognize and interpret the types of signal responses that this TOFD method will give when inspecting EBW joints similar to those presented herein.

Figure 36: Example of conventional TOFD data. Tip diffracted signals are indicated by the white arrows.

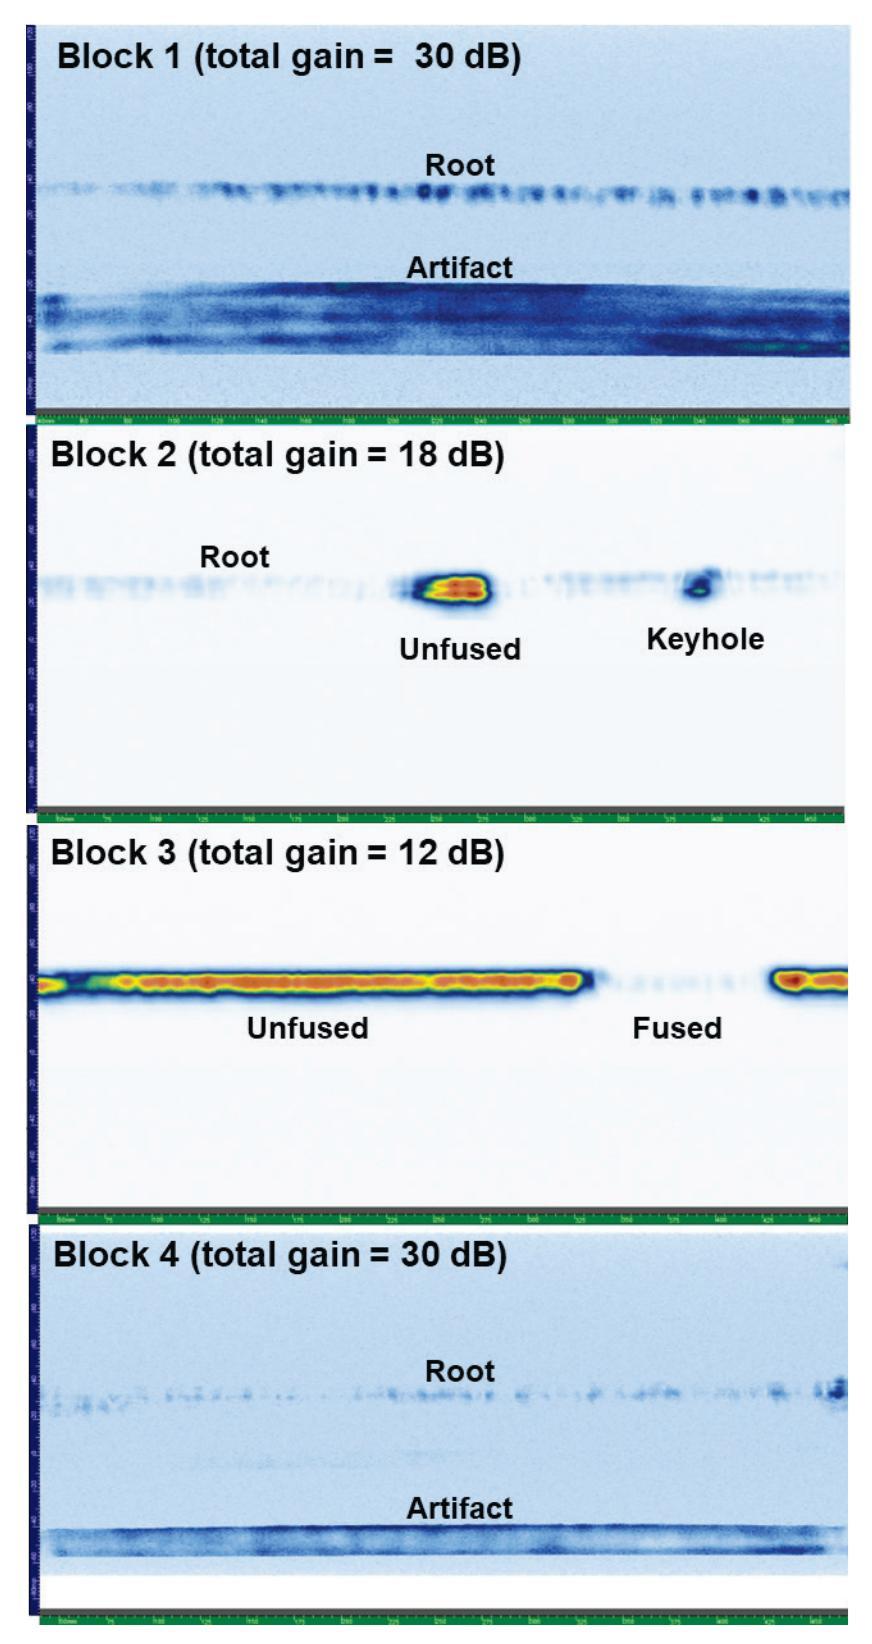
Figure 37 shows tandem scans from all four blocks. The scans were all acquired from the top surface of the block with the same hardware gain. Different software gains were used in the figure, as noted. The vertical axes are the ultrasound, or depth, dimensions and the horizontal axes are along the length of the welds. The color scale is the same as shown in figure 26.

The scan from block 1 showed what appeared to be a weak weld root signal, but it was recorded in the image at a depth of  $\approx$ 40 mm. However, recall that the receive probe was about 40 mm behind the transmit probe, so this echo is indeed likely from the joint line at the block's bottom surface. We note that these scans were acquired after the plates were machined smooth, so there was no protruding weld crown or root. Thus, it is unclear exactly what the source of the echo response was. Regardless, it was a very weak response. There was also an artifact from an unidentified source, possibly a wedge echo. The block 2 scan clearly showed the unfused region and the keyhole (again at  $\approx$ 40 mm depth), but no depth sizing information was available. A root signal was faintly visible at the reduced gain. The block 3 scan showed a strong corner echo (at  $\approx$ 40 mm depth) with distinct signal intensity differences between the fused and unfused regions; again, no depth sizing information was available despite having scanned across the joint line. Finally, the block 4 scan showed a faint root signal (at  $\approx$ 40 mm). In this case the root signal to the LOF. The LOF defect was not visible in the tandem scan.

Figure 37: Tandem scans from the top surface.

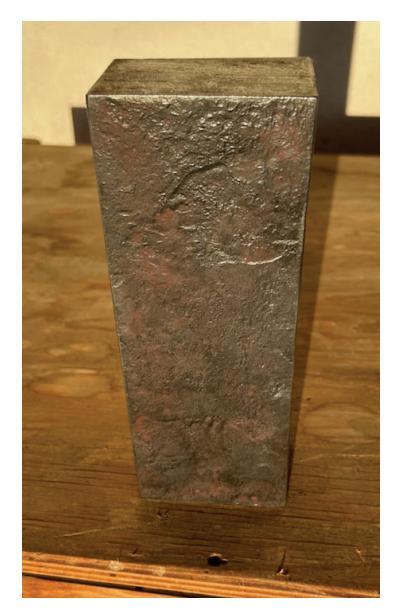
The heat treatment caused significant oxidation to the surface of the cut section. Figure 38 shows the cut face of the section after heat treatment followed by cleaning with an angle grinder wire brush attachment. To perform the post-heat-treatment UT, we had to machine the surfaces smooth, which entailed removing 1-2 mm of material from all faces of the section. Removing that material did not compromise the pre- and post-heat-treatment UT comparisons.

Figure 38: Photograph of the cut face of the section after heat treatment.

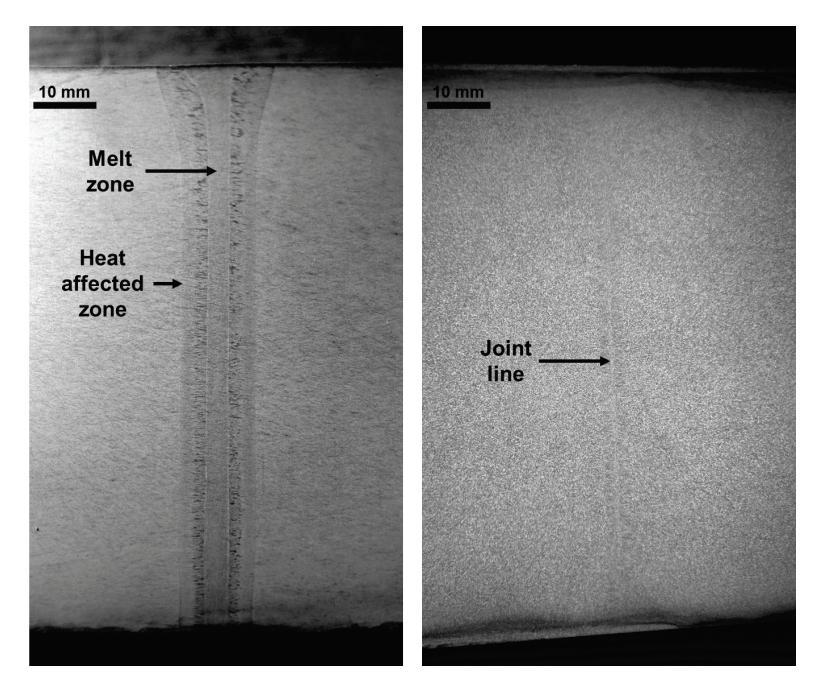
Figure 39 shows the polished and chemically etched cut surface before and after heat treatment. Prior to heat treatment, the HAZ and the melt zone were readily visible and were

separated by regions of larger and predominantly horizontal grain structure. After heat treatment, the microstructure in the weld was largely homogenized with a faint indication of the joint line and melt zone. The flared region of the top of the weld was visible only under favorable lighting conditions. The grain structure of the parent material also appears to be different, with the grains in the post-heat-treatment photo characterized by a fine speckle appearance.

#### Figure 39: Photographs of the weld region before (left) and after (right) heat treatment.

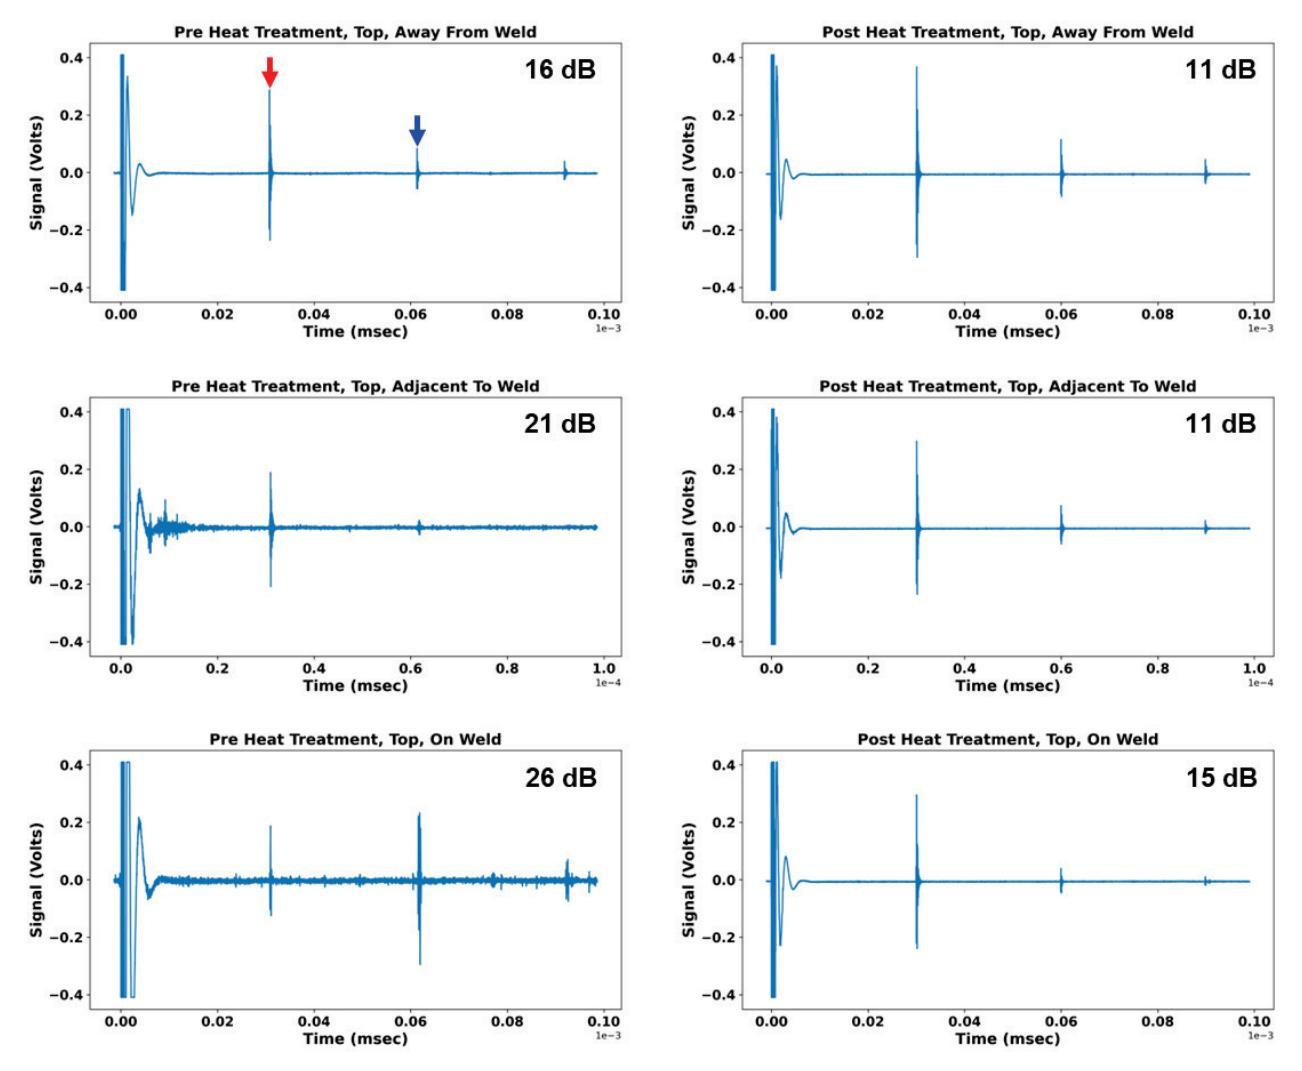
After heat treatment and machining, we repeated the pre-heat-treatment UT measurements. Figure 40 shows representative A-scans from each position before (left) and after (right) heat treatment. Most A-scans showed typical echo trains, with echo heights reduced in time due to attenuation. However, the pre-heat-treatment A-scan acquired on the joint line (bottom left panel) had second echoes (blue arrow) with higher amplitudes than the first echoes (red arrow). We do not have an explanation for this phenomenon, but it was consistently observed in all five measurements. The post-heat-treatment A-scan (bottom right panel) was more similar to the other A-scans in the figure, confirming that the microstructural changes shown in figure 39 improved the overall inspectability of the weld.

Figure 40 also shows the hardware gains for each scan. Away from the weld (top row), 5 dB (1.78x) less gain was needed for the post-heat-treatment scan compared to pre-heat-treatment scan. Adjacent to the weld (middle row), 10 dB (3.16x) less gain was needed. On the weld (bottom row), 11 dB (3.55x) less gain was needed. The reduced post-heat-treatment hardware gains are a direct indication that the UT properties of the section were improved by changes in the microstructure due to the heat treatment, especially on the weld.

Figure 40: A-scans acquired from the top of the section taken pre (left) and post (right) heat treatment. The red and blue arrows indicate the first and second echoes used to calculate attenuation.

- Heat treatment performed on a section of block 1 improved ultrasonic transmission through the weld material. As shown in figure 40, when the weld region comprised the full metal path, the UT signals were less attenuated after heat treatment. However, the weld was not a factor in inspectability because the weld and HAZ represented a small fraction of the overall metal path during the TOFD scans. Although heat treatment is not necessary for the sole purpose of improving inspectability, it will not adversely affect inspectability if done for metallurgical reasons. Heat treatments are also not expected to repair defects or negatively impact the detectability of the types of welding defects discussed in this report.

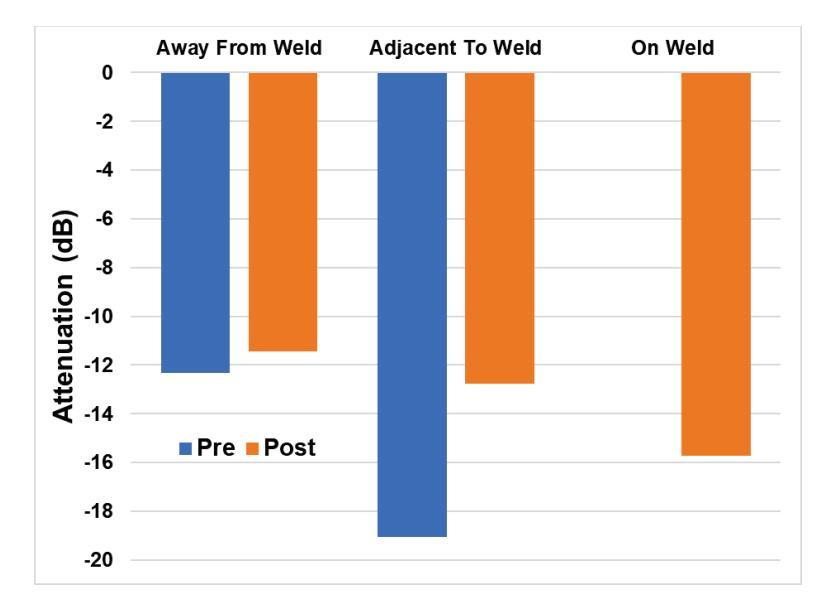
where *A* is the attenuation in dB,  $I_1$  is the first echo amplitude, and  $I_2$  is the second echo amplitude. Figure 41 is a bar chart showing the average attenuation values for each measurement set. Prior to heat treatment, there was about 7 dB (2.24x) more attenuation adjacent to the weld than away from the weld (i.e., over parent material). After heat treatment, the difference was only 1 dB (1.12x). On the weld, there was about 4 dB (1.58x) more attenuation after heat treatment than there was through parent material. This can be attributed to the slight difference in microstructure that persisted at the joint line (see figure 39). Note that the pre-heat-treatment attenuation on the weld was not calculated due to the unusual nature of the A-scan, as described above.

Figure 41: Attenuation values measured pre and post heat treatment.

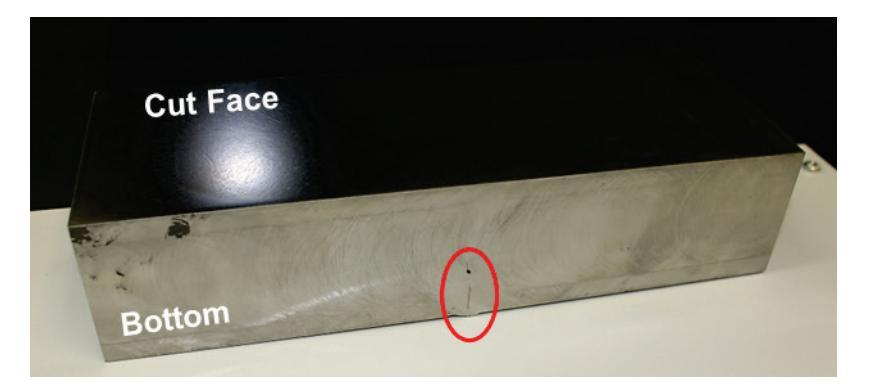
After heat treatment, we noticed a small surface-breaking flaw on the bottom of the cut section at the joint line; see figure 43. The flaw was detectable using 0° UT from the end of the section (looking perpendicularly toward the weld) and appeared to be approximately 3 cm deep and 1.5 cm wide. The flaw was detected in the pre-heat-treatment A-scans and was possibly an unintentional LOF defect that occurred during beam pullout or shutdown at the end of the welding process. We note that the flaw was not visible in the 0° scan shown in figure 11. The flaw may have been missed due to its proximity to the edge of the block (recall that the 0° scans had about a 1 cm buffer from the edge of the blocks; see section 4.1).
