Subject: GE Over/Under Voltage time delay relay PN: 12IAV69A1A

Project: DRE-76112, Revision 2

Subject: **Failure Analysis of:** Undervoltage Relay

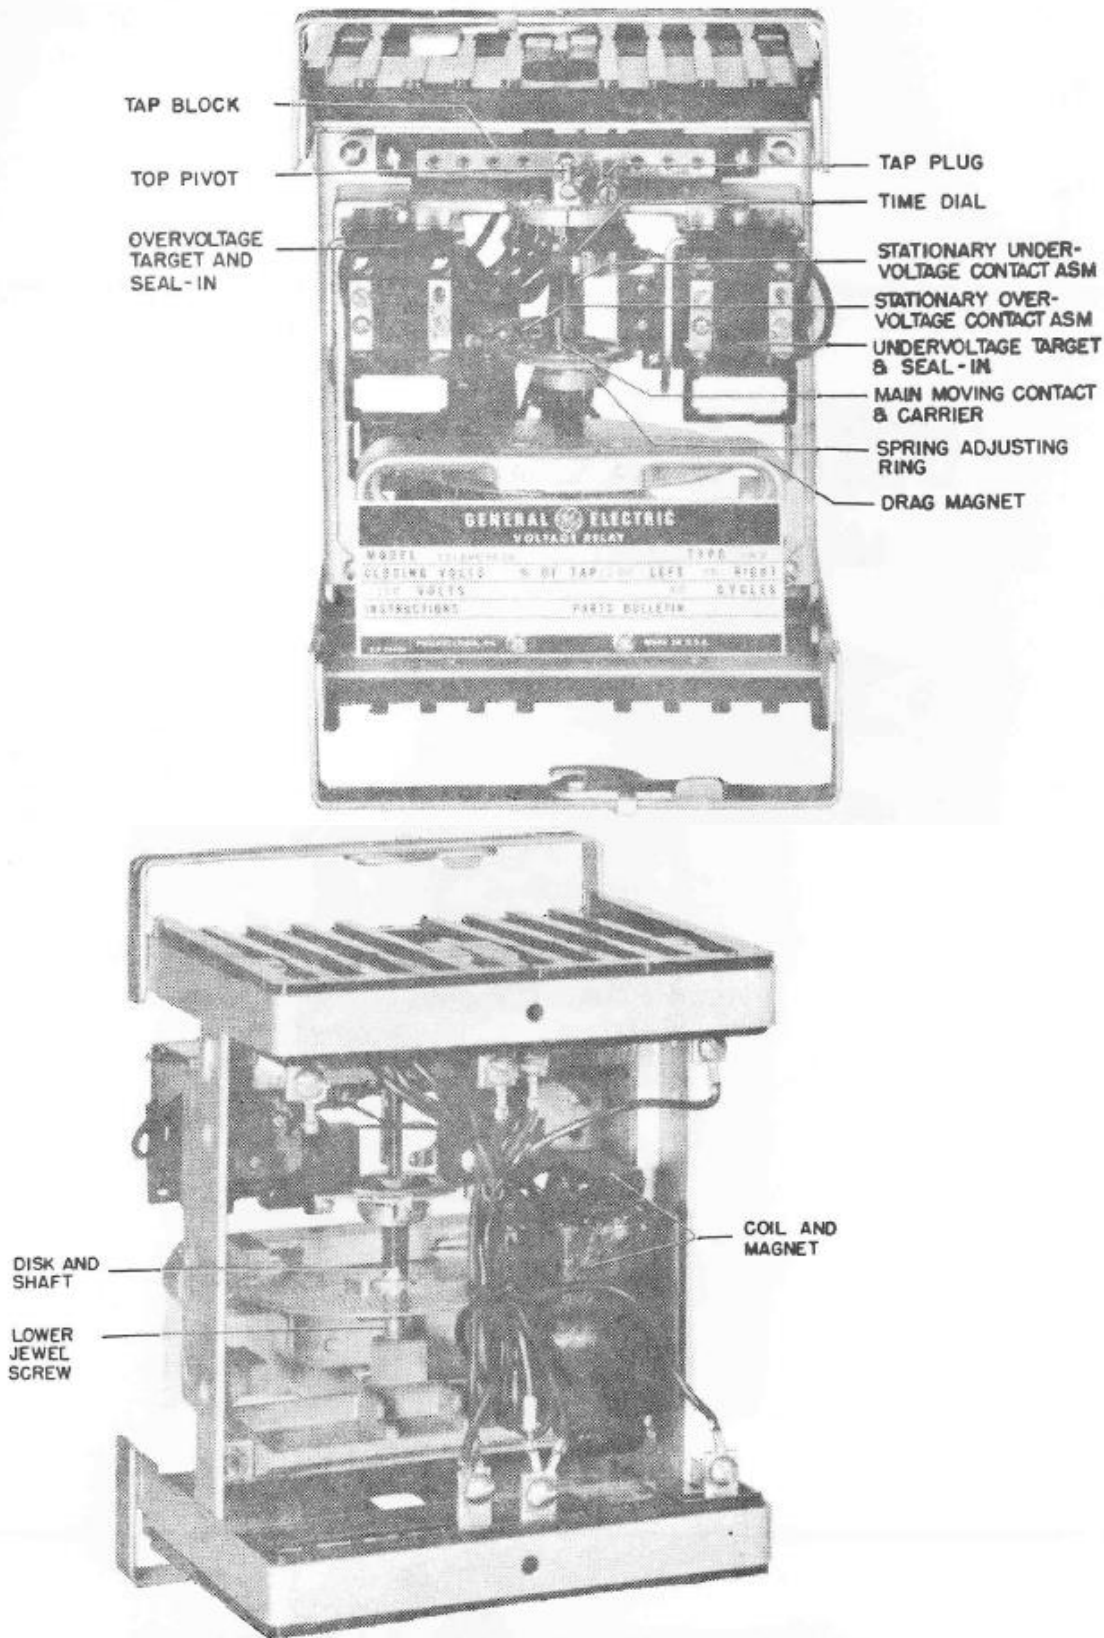
Fig. 1A (8031862) Back View of Relay Type IAV69A Withdrawn From Case.

Figure 3. Front and back view of the relay Type IAV69A are shown above with a parts breakdown.
